## CONDITION REPORT

Report No: 2016223346

MFC Auction House  
M57 Pretoria Rd, Glenmarais, KEMPTON PARK  
Gauteng

| Manufacturer | KIA | Registration Number | FP30KZGP |

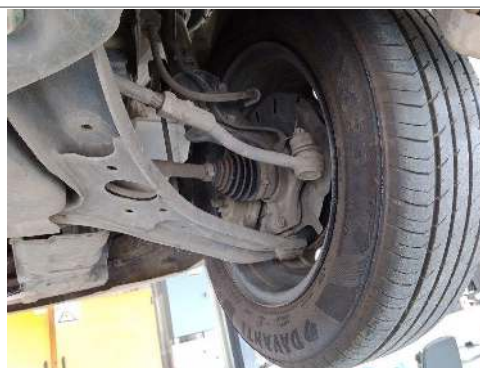
RF TYRE TREAD

| | Size | Load/Speed Index | Manufacture | Model | Type* | Production Date | Tread Depth (mm) |
|---|---|---|---|---|---|---|---|
| Front Right | 185/65R15 | 88H | Davanti | DX390 | V | 2123 | 2 mm |

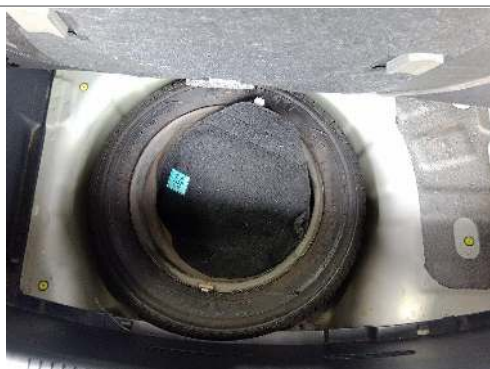
Sparewheel

| | Size | Load/Speed Index | Manufacture | Model | Type* | Production Date | Tread Depth (mm) |
|---|---|---|---|---|---|---|---|
| Spare | 185/65R15 | 92T | Barum | Brilliantis | V | //////// | 2 mm |

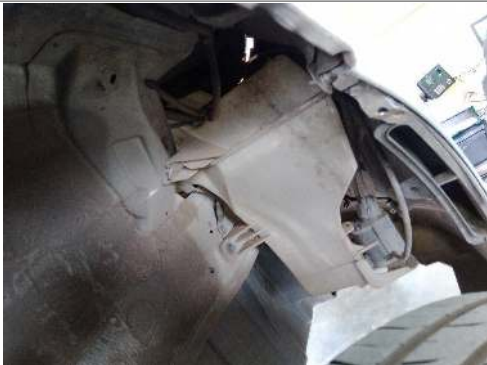
R/F fender liner missing

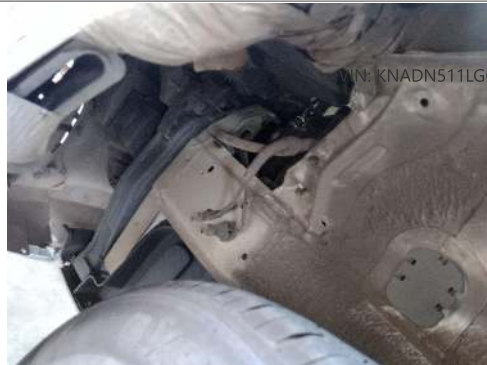
L/F fender liner missing

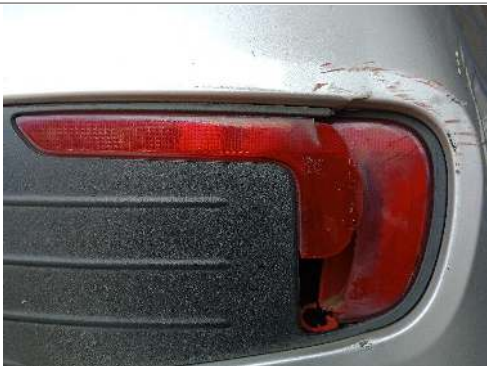
R/R reflector broken

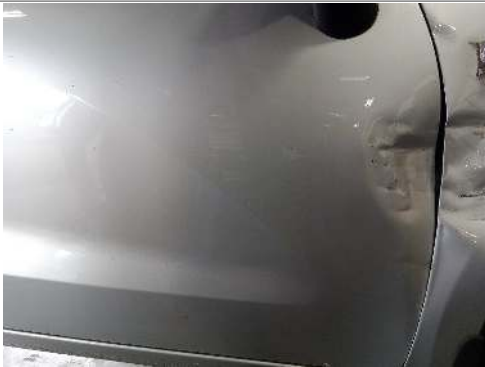
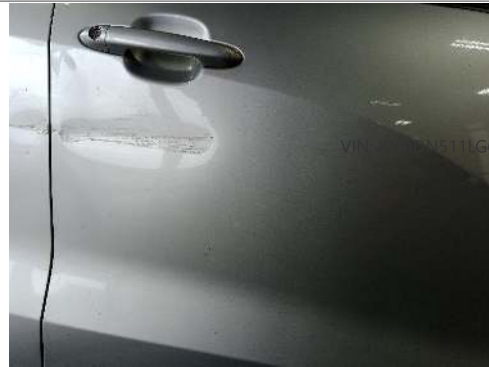
| Damage | Repair Way |
|---|---|
| Door Front Right Damaged | Repair |

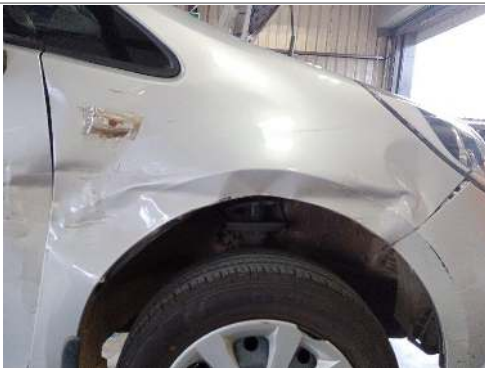
| Damage | Repair Way |
|---|---|
| Front Fender Right Damaged | Repair |

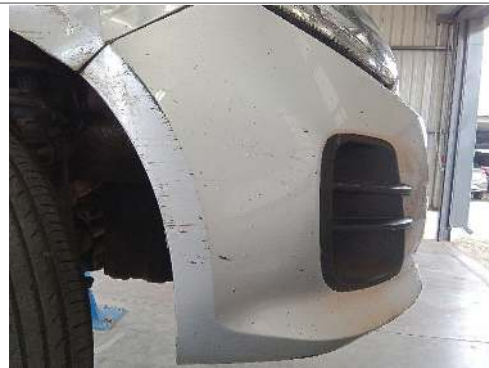
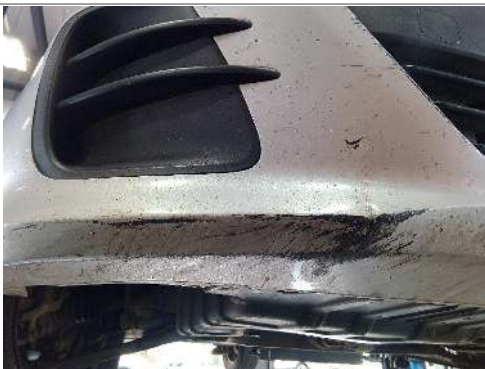
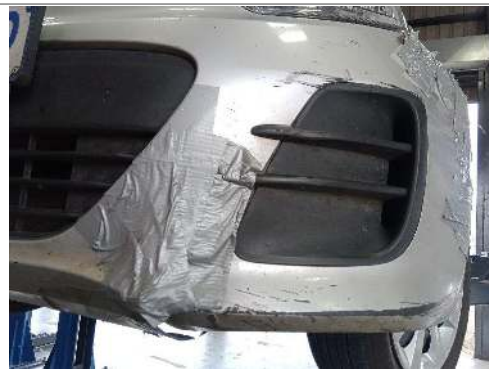
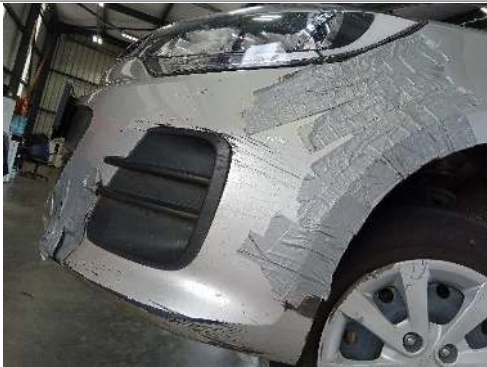
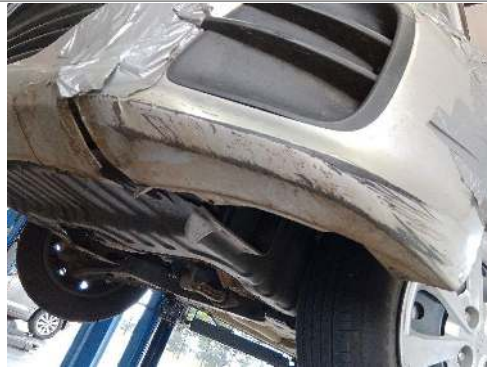
| Damage | Repair Way |
|---|---|
| Front Bumper Paintwork • Scratched | Repair |

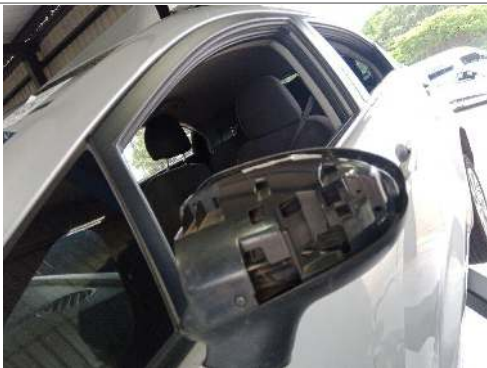
| Damage | Repair Way |
|---|---|
| Side Mirror Left Damaged | Replace |

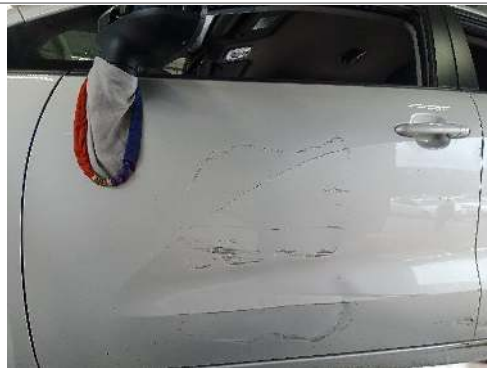
| Damage | Repair Way |
|---|---|
| Door Front Left Damaged | Repair |

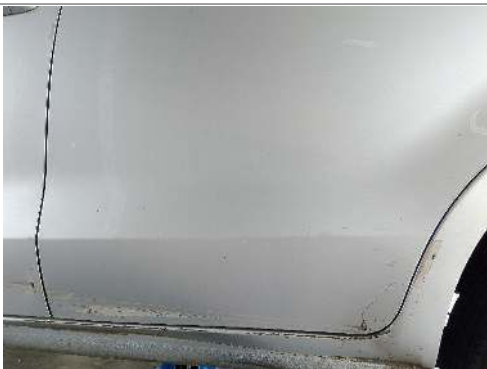
| Damage | Repair Way |
|---|---|
| Door Rear Left Paintwork • Scratched | Repair |

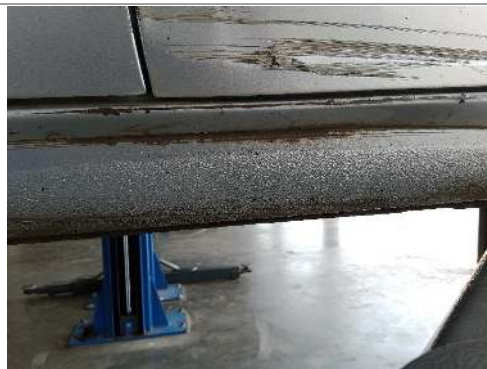
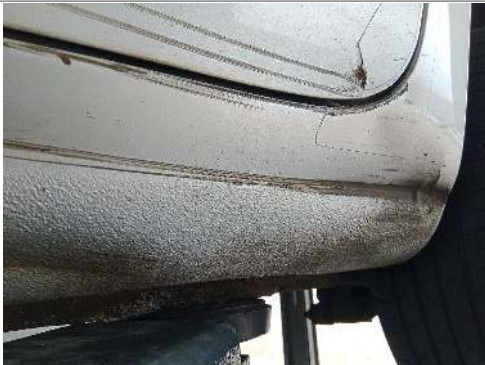
| Damage | Repair Way |
|---|---|
| Sill Panel Left Damaged | Repair |

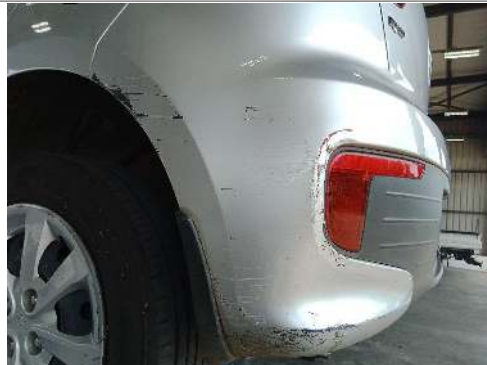
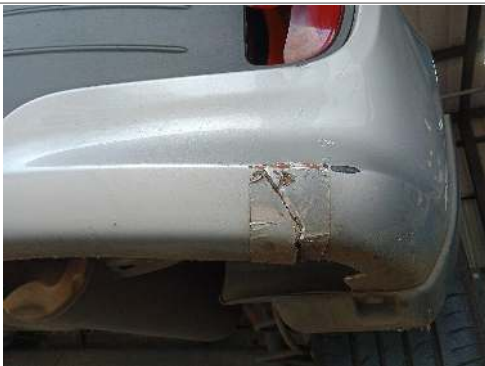
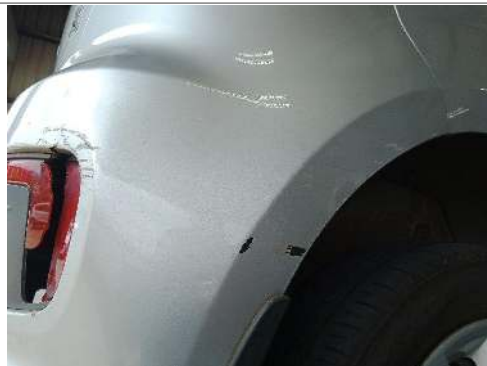
| Damage | Repair Way |
|---|---|
| Rear bumper Paintwork • Scratched | Repair |

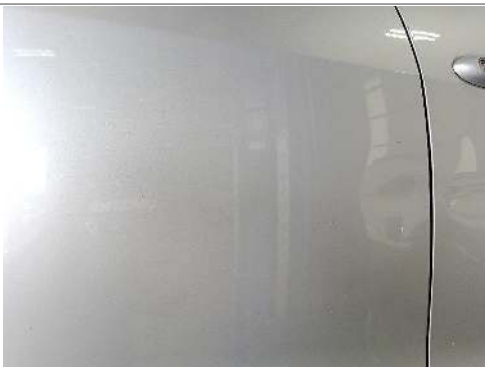
| Damage | Repair Way |
|---|---|
| Door Rear Right Dented | Repair |

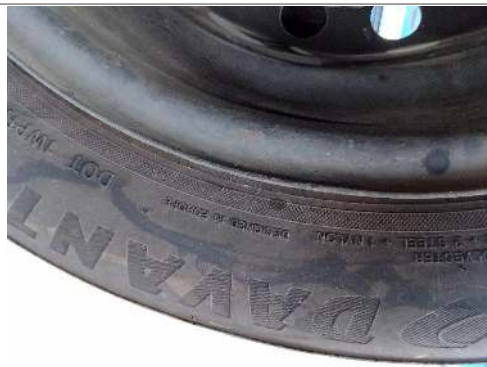
| Damage | Repair Way |
|---|---|
| Rim Front Right Dented | Repair |

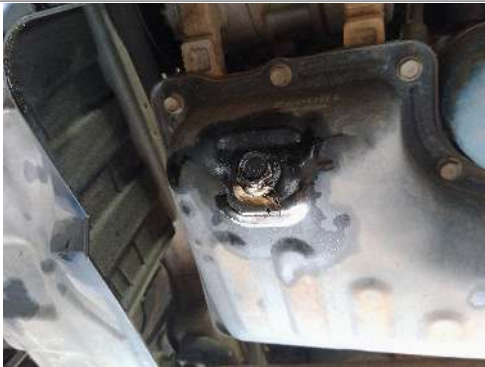
| Damage | Repair Way |
|---|---|
| Engine Oil Leak | Repair |
| Engine Noise Idling / Hunting | Repair |

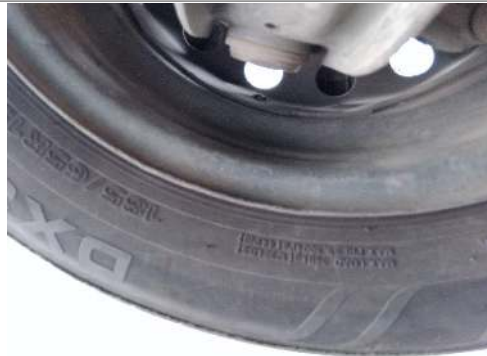
| Damage | Repair Way |
|---|---|
| Rim Front Left Dented | Repair |

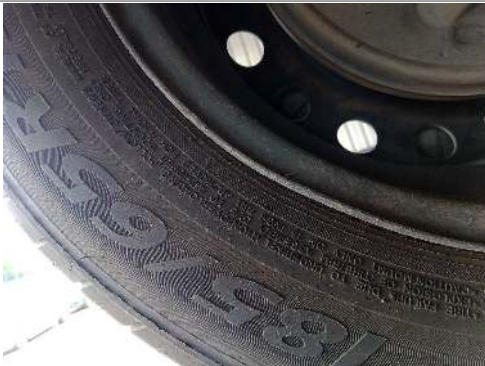
| Damage | Repair Way |
|---|---|
| Rim Rear Left Dented | Repair |

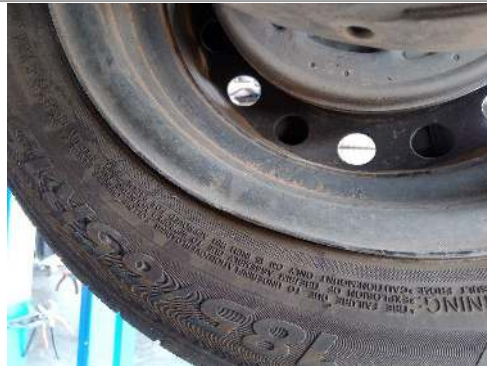
| Damage | Repair Way |
|---|---|
| Rim Rear Right Dented | Repair |

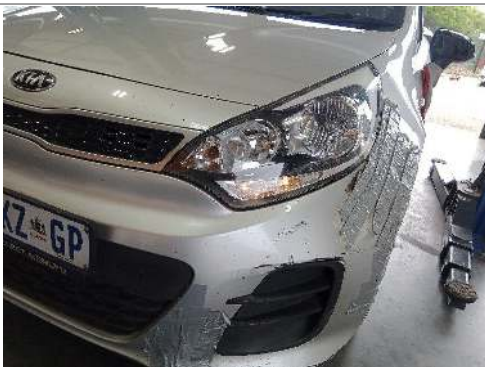
| Damage | Repair Way |
|---|---|
| Dim Light Left Defective | Repair |

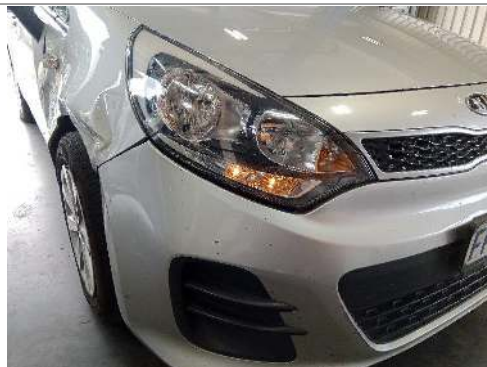
| Damage | Repair Way |
|---|---|
| Dim Light Right Defective | Repair |

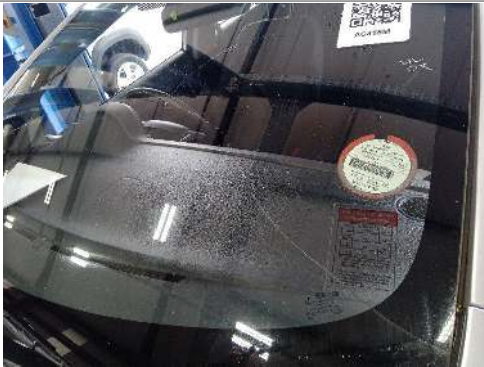
| Damage | Repair Way |
|---|---|
| Windscreen Cracked | Replace |
