## CONDITION REPORT

Report No: 2016191495

| Manufacturer | KIA | Registration Number | FV93JYGP |
| Model | RIO | Register Number | |

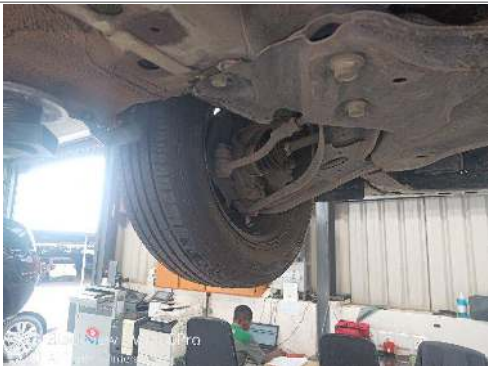
LF TYRE TREAD

| | Size | Load/Speed Index | Manufacture | Model | Type* | Production Date | Tread Depth (mm) |
|---|---|---|---|---|---|---|---|
| Front Left | 185/65R15 | 88H | Dunlop | Sp sport | V | 4521 | 3 mm |

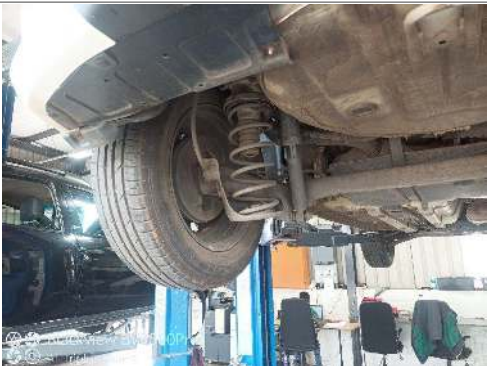
LR TYRE TREAD

| | Size | Load/Speed Index | Manufacture | Model | Type* | Production Date | Tread Depth (mm) |
|---|---|---|---|---|---|---|---|
| Rear Left | 185/65R15 | 88H | Dunlop | Sp sport | V | 4521 | 3 mm |

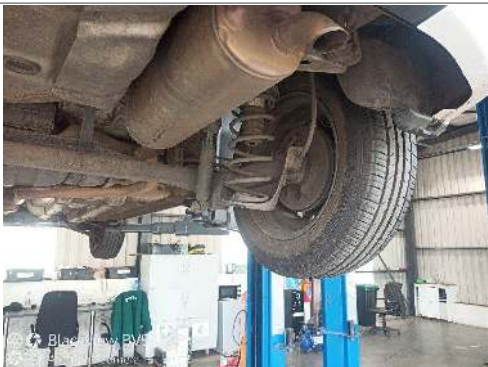
RR TYRE TREAD

| | Size | Load/Speed Index | Manufacture | Model | Type* | Production Date | Tread Depth (mm) |
|---|---|---|---|---|---|---|---|
| Rear Right | 185/65R15 | 88H | Dunlop | Sp sport | V | 4621 | 3 mm |

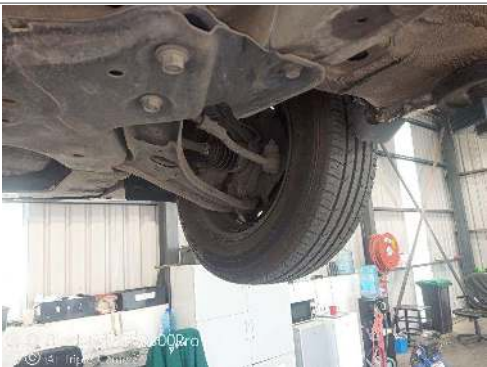
RF TYRE TREAD

| | Size | Load/Speed Index | Manufacture | Model | Type* | Production Date | Tread Depth (mm) |
|---|---|---|---|---|---|---|---|
| Front Right | 185/65R15 | 88H | Dunlop | Sp sport | V | 4621 | 3 mm |

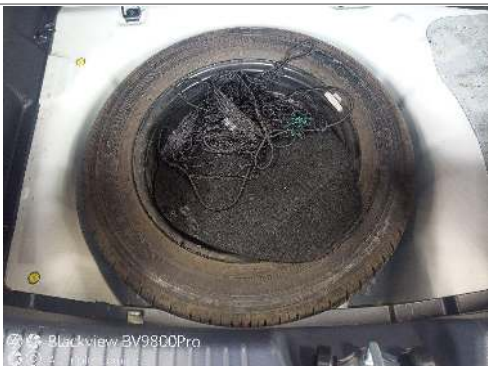
Spare wheel

| | Size | Load/Speed Index | Manufacture | Model | Type* | Production Date | Tread Depth (mm) |
|---|---|---|---|---|---|---|---|
| Spare | 185/65R15 | 88H | Kumho | Solus | V | 2716 | 5 mm |

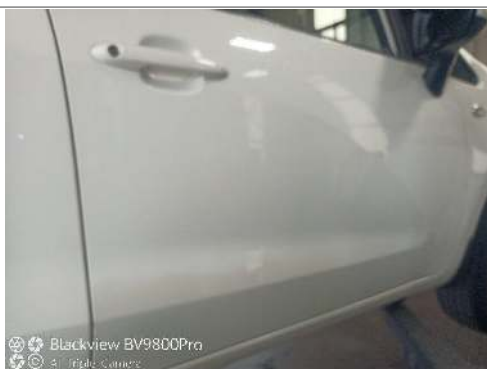
| Damage | Repair Way |
|---|---|
| Door Front Right Paintwork • Discoloured | Repair |

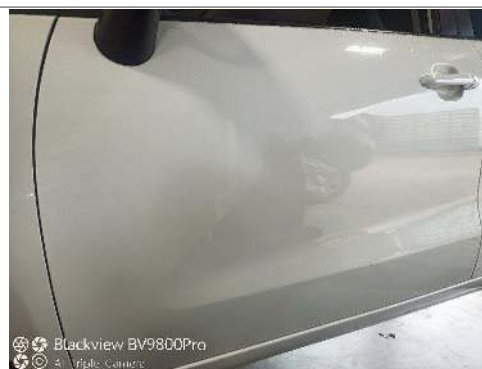
| Damage | Repair Way |
|---|---|
| Door Front Left Paintwork • Discoloured | Repair |

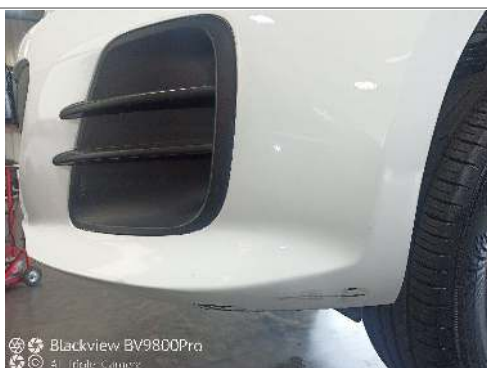
| Damage | Repair Way |
|---|---|
| Front Bumper Paintwork • Scratched | Repair |

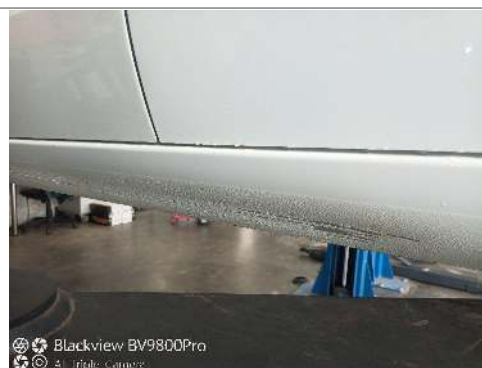
| Damage | Repair Way |
|---|---|
| Sill Panel Left Paintwork • Scratched | Repair |

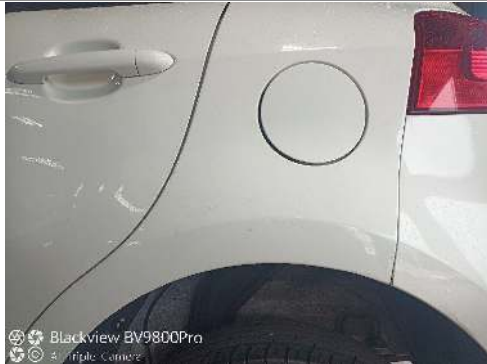
| Damage | Repair Way |
|---|---|
| Rear Fender Left Paintwork • Scratched | Repair |

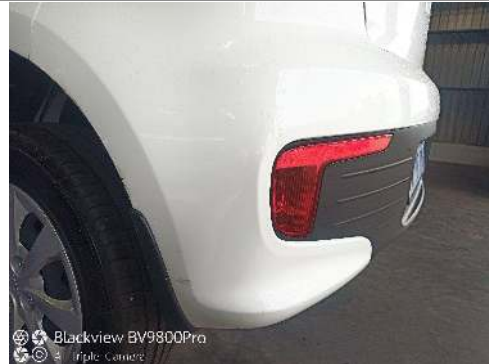
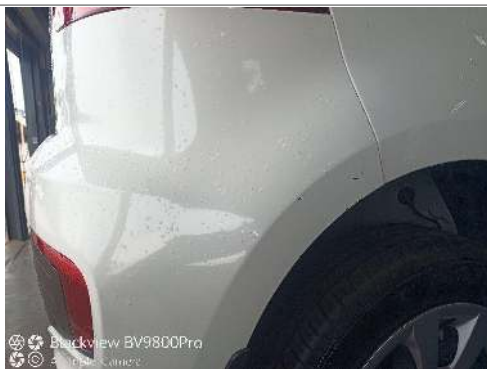
| Damage | Repair Way |
|---|---|
| Rear bumper Paintwork • Scratched | Repair |
