MFC Auction House
M57 Pretoria Rd, Glenmarais, KEMPTON PARK
Gauteng

CONDITION REPORT

Report No: 2016212157

DATE
27/12/2023

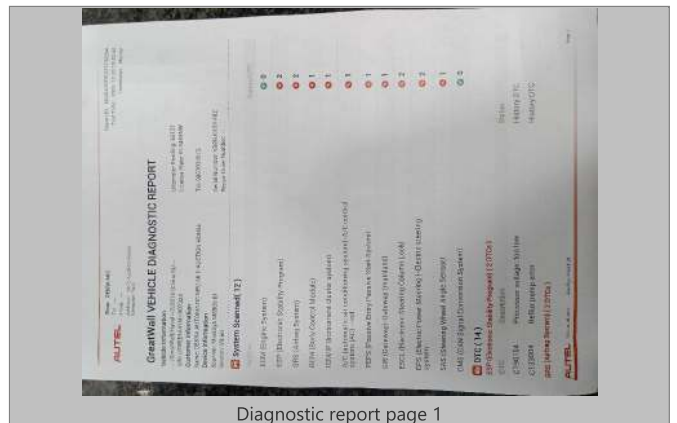
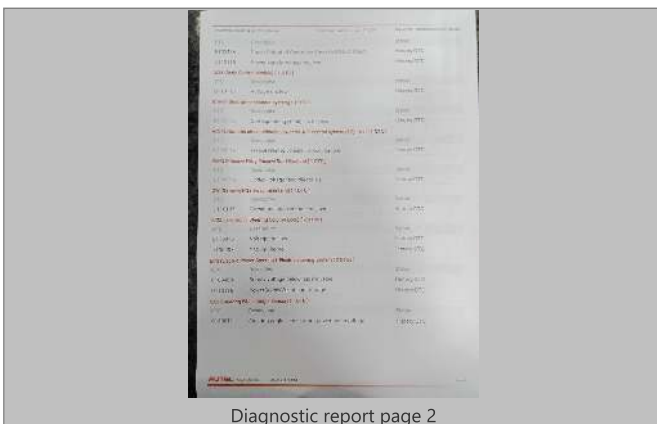
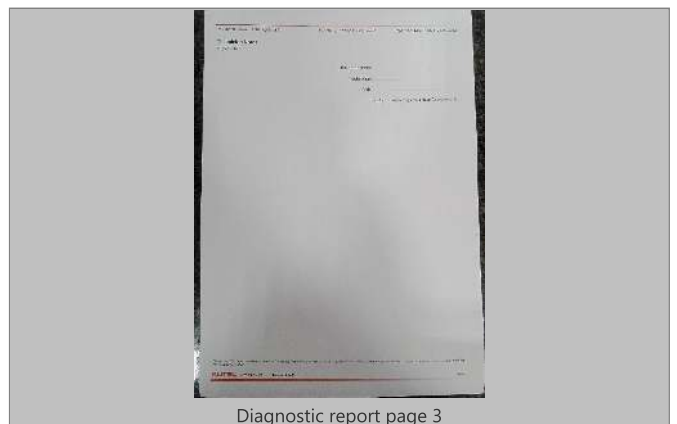
Diagnostic report page 1

No	System	Code	Description	Status
1	ESP(ELECTRONIC STABILITY PROGRAM)	C190104	PROCESSOR VOLTAGE:TOO LOW

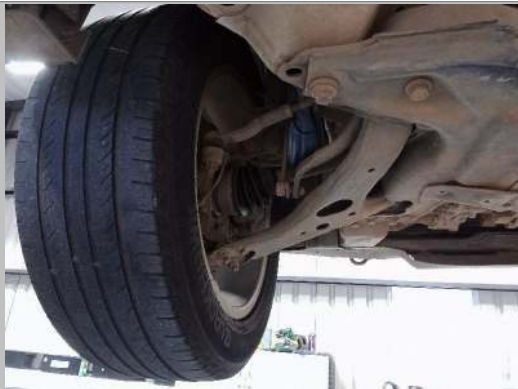
LF TYRE TREAD

Size	Load/Speed Index	Manufacture	Model	Type*	Production Date	Tread Depth (mm)
Front Left	235/55 R18	100V	Blackhawk	Street-H	V	4922	1 mm
Front Right	235/55 R18	100V	Blackhawk	Street-H	V	4922	2 mm
Rear Left	235/55 R18	100H	Kumho	Solus	V	3920	3 mm
Rear Right	235/55 R18	100H	Kumho	Solus	V	3820	4 mm
Spare	T155/85 R18	115M	Chaoyang	Temporary	V	4120	3 mm

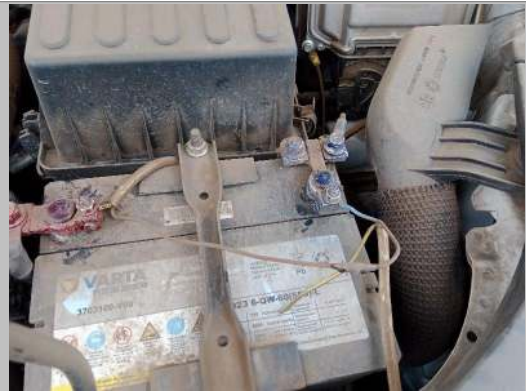
Damage	Repair Way
Engine Wiring Defective	Repair
Fog Light Front Left Defective	Repair
Seat Front Left Dirty	Repair
Seat Front Right Damaged	Repair
Seat Rear Dirty	Repair
Hood Lining Dirty	Repair
Side Mirror Right Paintwork • Scratched	Repair
Rear Fender Left Paintwork • Scratched	Repair
Door Front Left Paintwork • Scratched	Repair
Door Front Right Dented	Repair
Door Rear Left Dented	Repair
Door Rear Right Paintwork • Scratched	Repair
Rear bumper Paintwork • Scratched	Repair
Sill Panel Left Paintwork • Scratched	Repair
Roof Dented	Repair
Windscreen Cracked	Replace

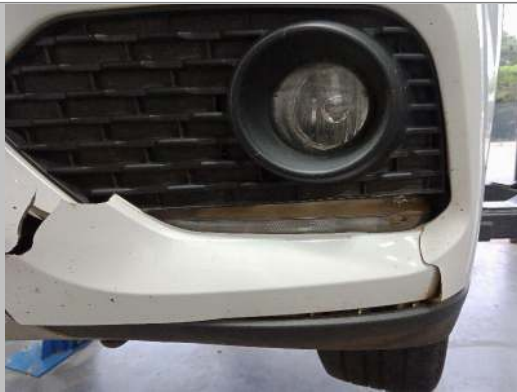
Fog Light Front Left

General Comments: ACCORDING TO AGE AND MILEAGE OF VEHICLE NORMAL WEAR AND TEAR ON INTERIOR, EXTERIOR, ELECTRICAL AND MECHANICAL PARTS.
 Engine Compartment: Engine bay dirty. Brake fluid level ok. Fuse box cover missing.
 Lights: Aftermarket light bar fitted to front of vehicle. Front left dim light not working.
 Interior: Vehicle interior dirty and some interior panels scratched. Loose wiring on drivers side. Cigarette burns on front left and right interior A pillar covers.
 Body • Exterior: Dents and scratches on some body panels. Spray work on some body panels. Some body panels misaligned. Stone chips on some body panels.
 Axle and Suspension: Abnormal noise coming from front and rear suspension.
 Undercarriage: Vehicle undercarriage dirty.
