## CONDITION REPORT

Report No:  
2016976331  
DATE  
12/08/2025

| Manufacturer | HAVAL | Registration Number | LK76BHGP |
| Model | JOLION 1.5T LUXURY [2021-2024] | Register Number | |

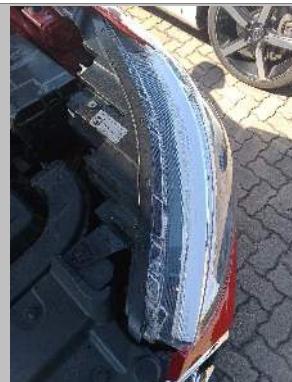
| Damage | Repair Way |
|---|---|
| Headlight Left Damaged | Replace |

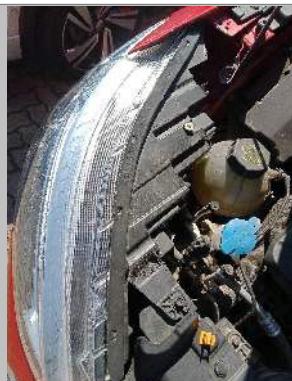
| Damage | Repair Way |
|---|---|
| Headlight Right Damaged | Replace |

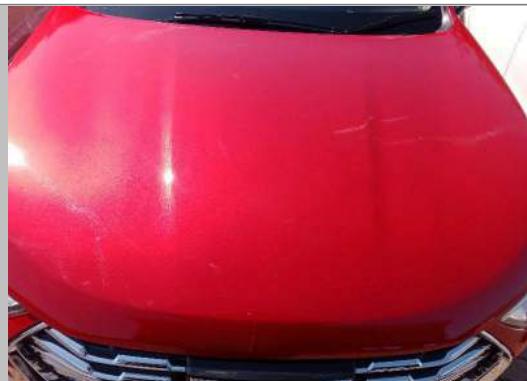
| Damage | Repair Way |
|---|---|
| Bonnet Residual Traces of Repair | Repair |

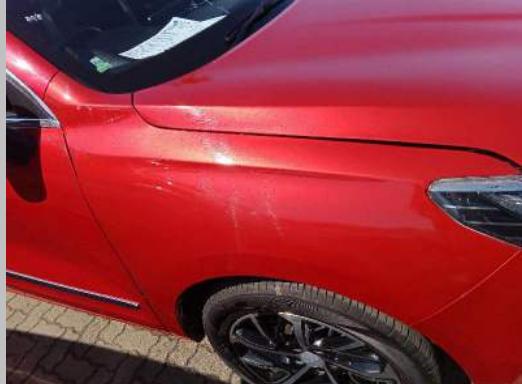
| Damage | Repair Way |
|---|---|
| Front Fender Right Residual Traces of Repair | Repair |

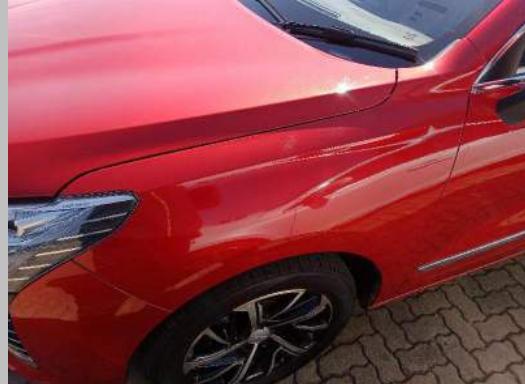
| Damage | Repair Way |
|---|---|
| Front Fender Left Residual Traces of Repair | Repair |

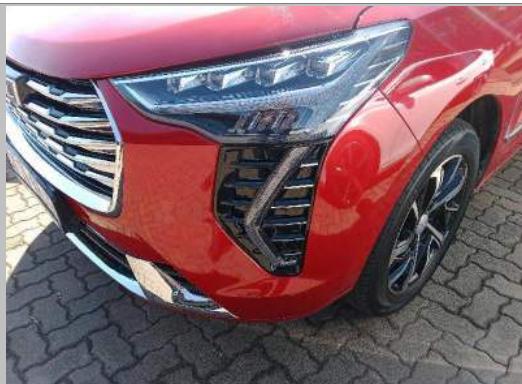
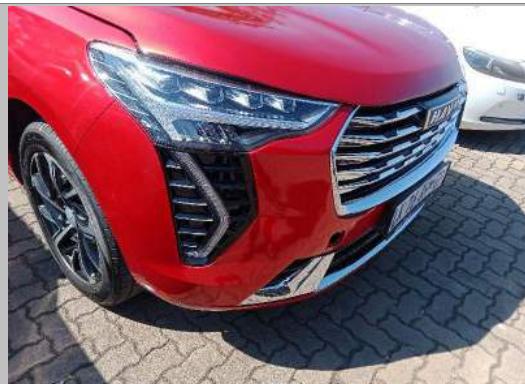
| Damage | Repair Way |
|---|---|
| Front Bumper Paintwork • Scratched | Repair |

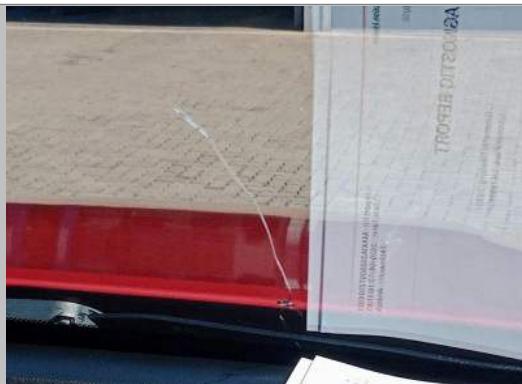
| Damage | Repair Way |
|---|---|
| Windscreen Cracked | Replace |

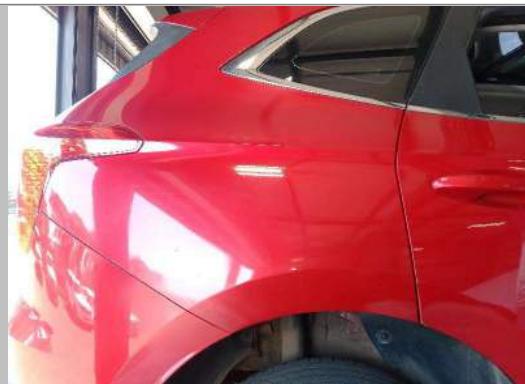
| Damage | Repair Way |
|---|---|
| Rear Fender Right Residual Traces of Repair | Repair |

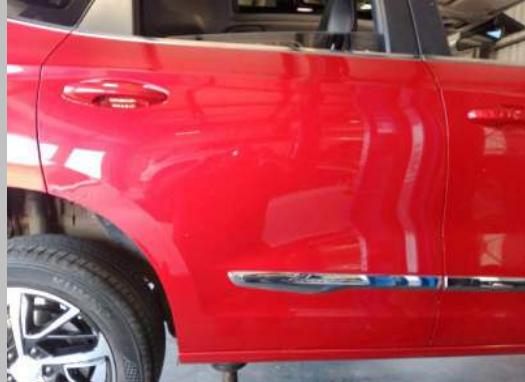
| Damage | Repair Way |
|---|---|
| Door Rear Right Paintwork • Scratched | Repair |

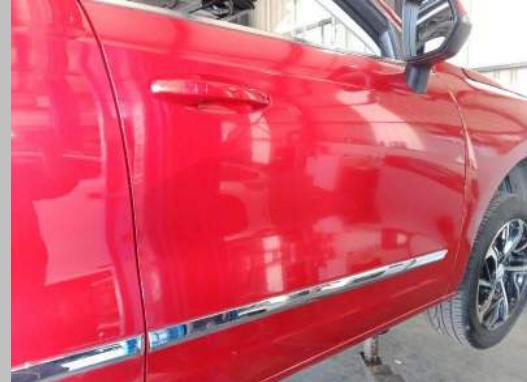
| Damage | Repair Way |
|---|---|
| Door Front Right Paintwork • Scratched | Repair |

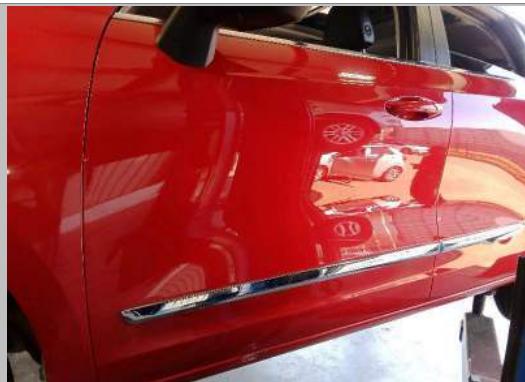
| Damage | Repair Way |
|---|---|
| Door Front Left Paintwork • Scratched | Repair |

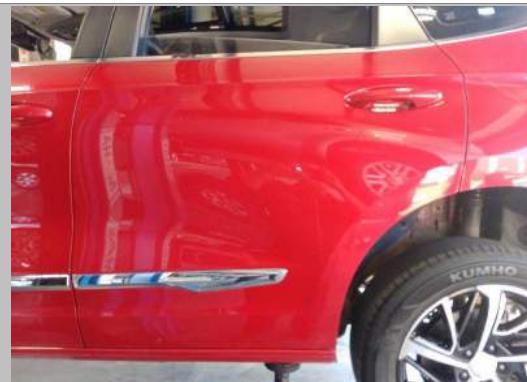
| Damage | Repair Way |
|---|---|
| Door Rear Left Paintwork • Scratched | Repair |

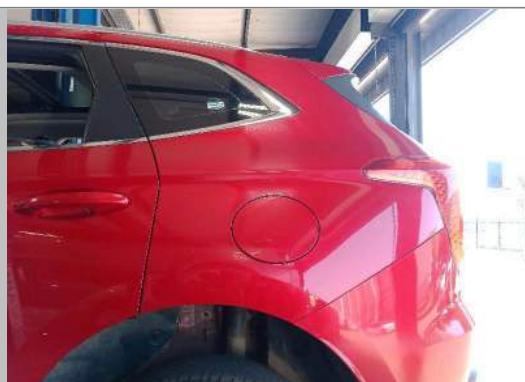
| Damage | Repair Way |
|---|---|
| Rear Fender Left Dented | Repair |

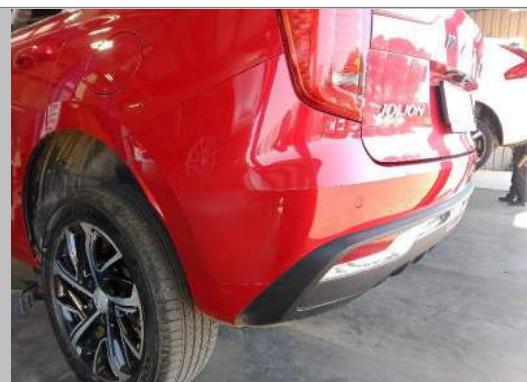
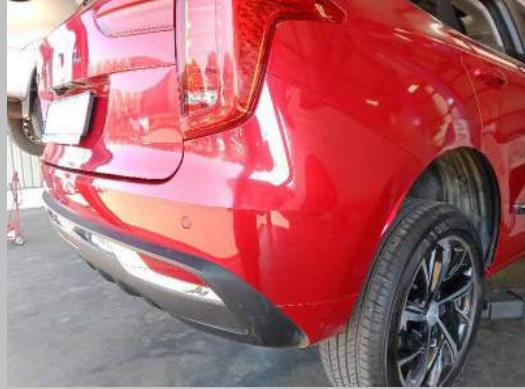
| Damage | Repair Way |
|---|---|
| Rear bumper Paintwork • Scratched | Repair |

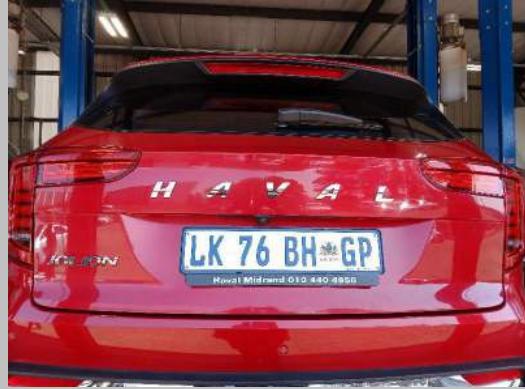
| Damage | Repair Way |
|---|---|
| Boot Lid / Hatch door Paintwork • Chipmarks | Repair |

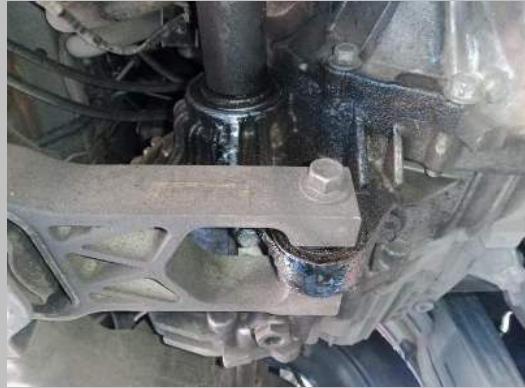
| Damage | Repair Way |
|---|---|
| Gearbox Oil Leak | Repair |
