MFC Auction House  
M57 Pretoria Rd, Glenmarais, KEMPTON PARK  
Gauteng

DEKRA MFC  
M57 Pretoria Rd - 1619  
KEMPTON PARK - GT  
08610 33572

## Assignment

## VEHICLE INSPECTION

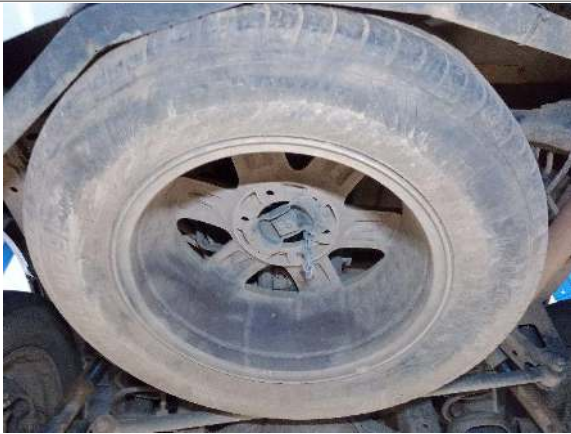
Spare wheel

| | Size | Load/Speed Index | Manufacture | Model | Type* | Production Date | Tread Depth (mm) |
|---|---|---|---|---|---|---|---|
| Spare | 235/65 R17 | 104H | Wideway | Speedmax | V | 0000 | 2 mm |

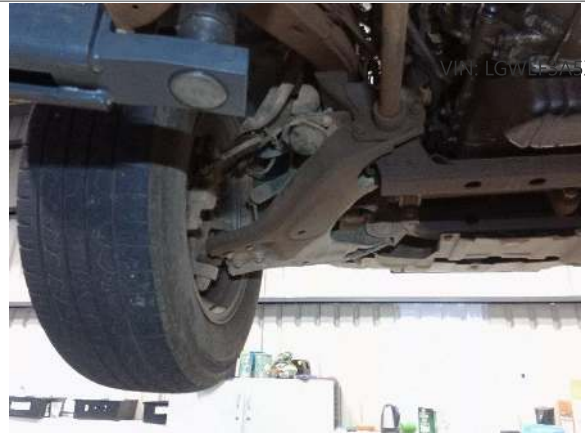
LF TYRE TREAD

| | Size | Load/Speed Index | Manufacture | Model | Type* | Production Date | Tread Depth (mm) |
|---|---|---|---|---|---|---|---|
| Front Left | 235/65 R17 | 104H | Hilo | Sport | V | 0120 | 3 mm |

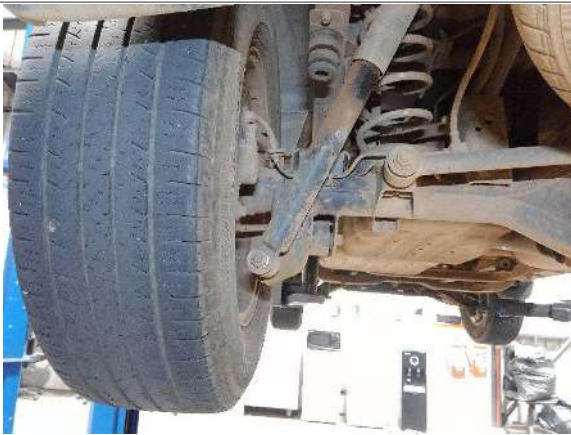
LR TYRE TREAD

| | Size | Load/Speed Index | Manufacture | Model | Type* | Production Date | Tread Depth (mm) |
|---|---|---|---|---|---|---|---|
| Rear Left | 235/65 R17 | 104H | Hilo | Sport | V | 0120 | 3 mm |

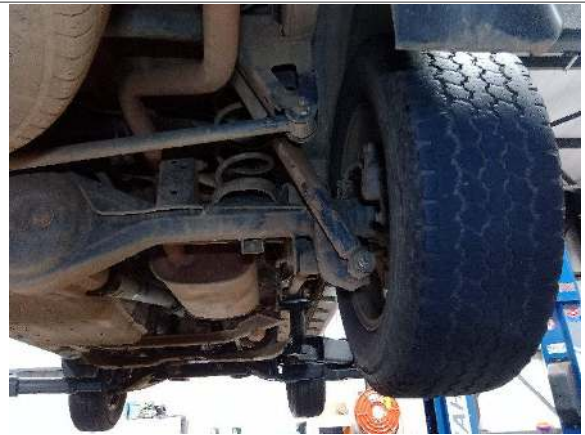
RR TYRE TREAD

| | Size | Load/Speed Index | Manufacture | Model | Type* | Production Date | Tread Depth (mm) |
|---|---|---|---|---|---|---|---|
| Rear Right | 235/65 R17 | 108T | Goodyear | Wrangler | V | 4217 | 2 mm |

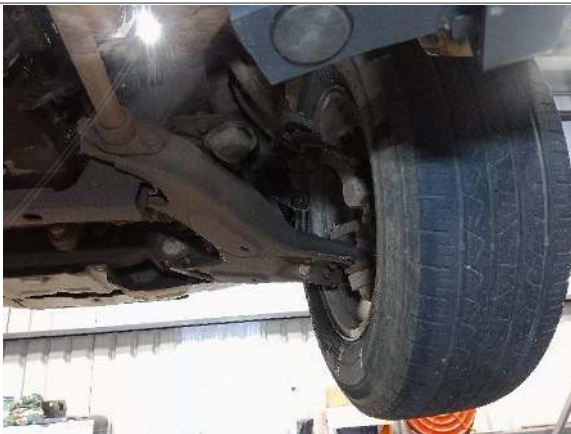
RF TYRE TREAD

| | Size | Load/Speed Index | Manufacture | Model | Type* | Production Date | Tread Depth (mm) |
|---|---|---|---|---|---|---|---|
| Front Right | 235/65 R17 | 104H | Hilo | Sport | V | 4219 | 2 mm |

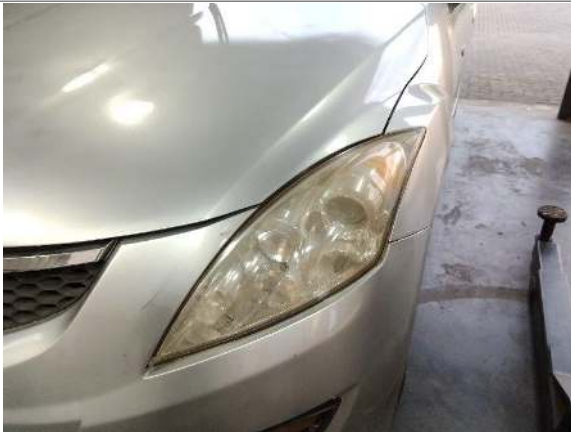
| | Damage | Repair Way |
|---|---|---|
| | Headlight Left Damaged | Replace |

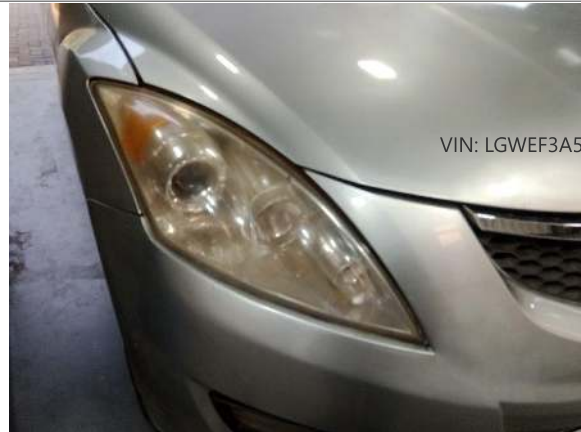
| | Damage | Repair Way |
|---|---|---|
| | Headlight Right Damaged | Replace |

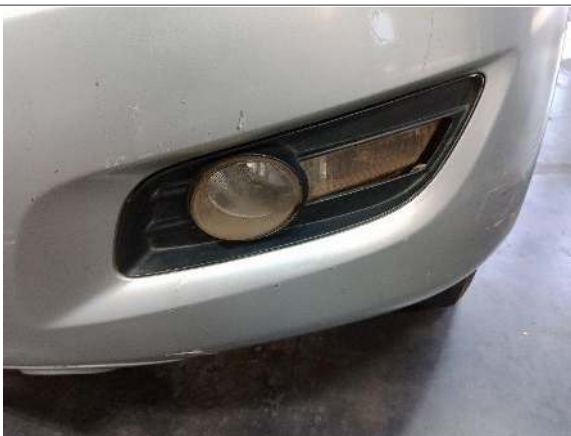
| | Damage | Repair Way |
|---|---|---|
| | Fog Light Front Left Damaged | Replace |

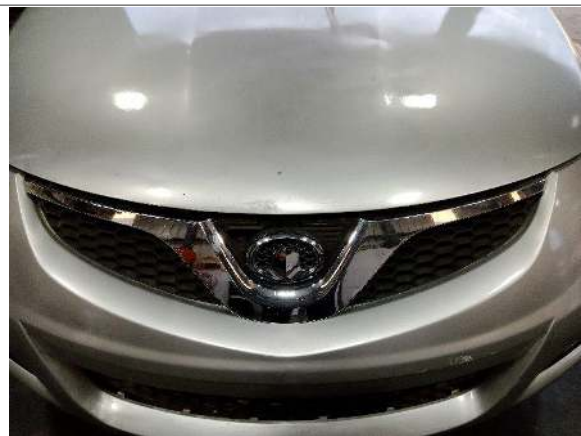
| Damage | Repair Way |
|---|---|
| Grill Damaged | Replace |

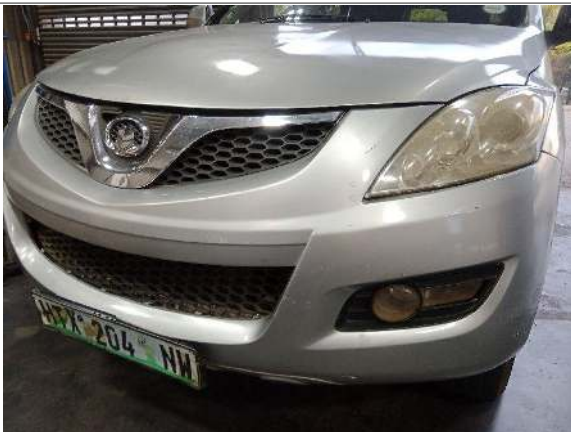
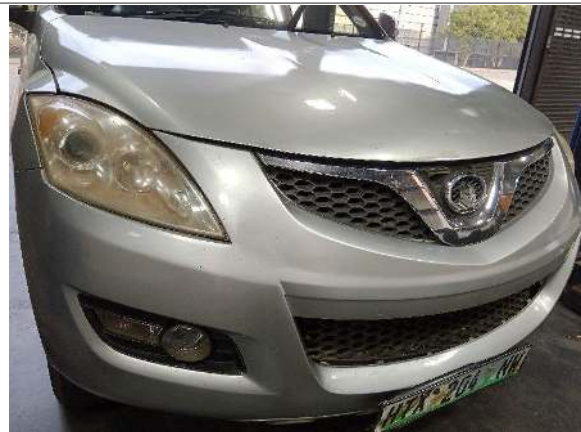
| Damage | Repair Way |
|---|---|
| Front Bumper Damaged | Repair |

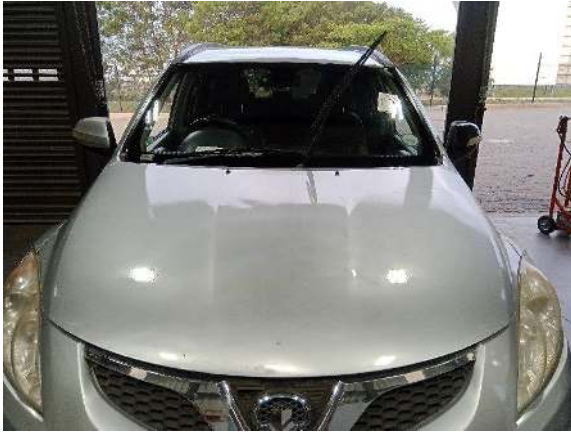
| Damage | Repair Way |
|---|---|
| Bonnet Residual Traces of Repair | Replace |

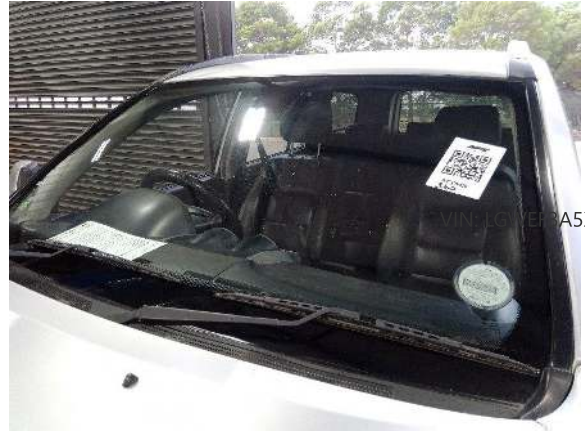
| Damage | Repair Way |
|---|---|
| Windscreen Chipped | Replace |

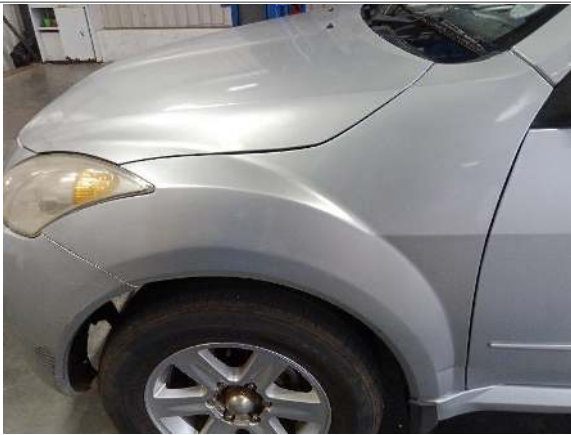
| Damage | Repair Way |
|---|---|
| Front Fender Left Residual Traces of Repair | Repair |

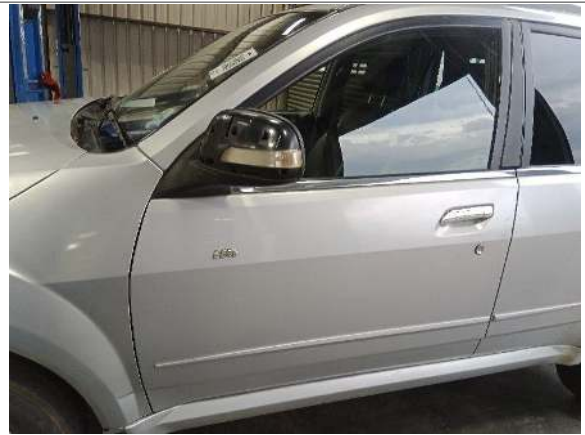
| Damage | Repair Way |
|---|---|
| Door Front Left Dented | Repair |

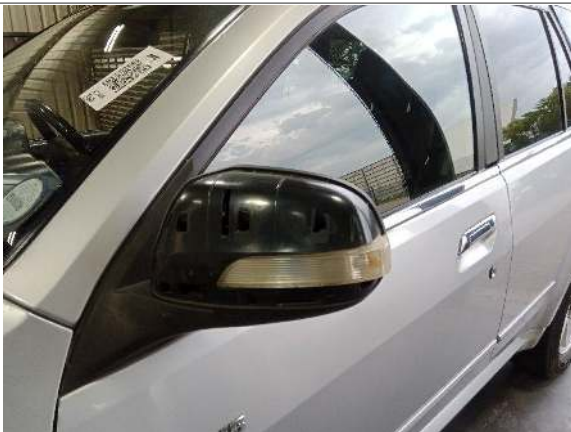
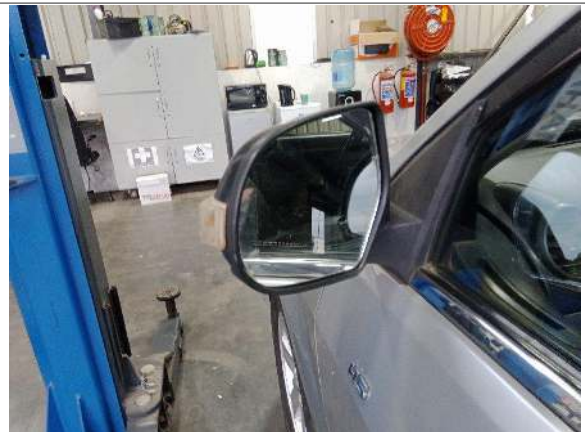
| | Damage | Repair Way |
|---|---|---|
| | Side Mirror Left Damaged | Replace |

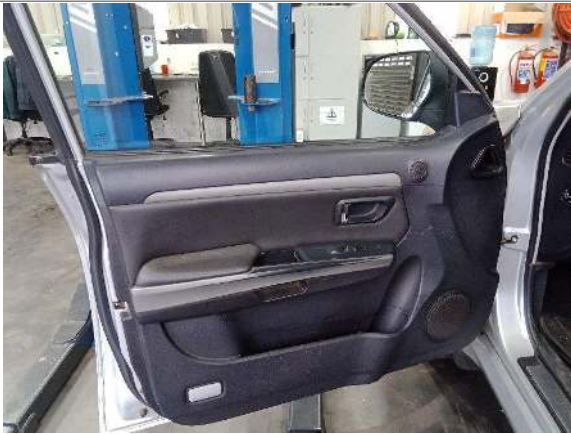
| | Damage | Repair Way |
|---|---|---|
| | Door Panel Front Left Defective | Repair |

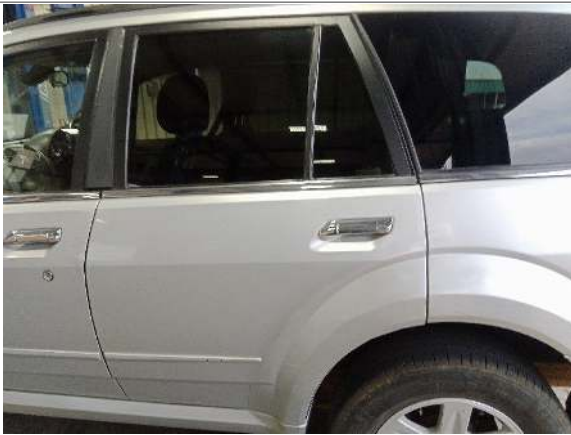
| Damage | Repair Way |
|---|---|
| Door Rear Left Residual Traces of Repair | Repair |

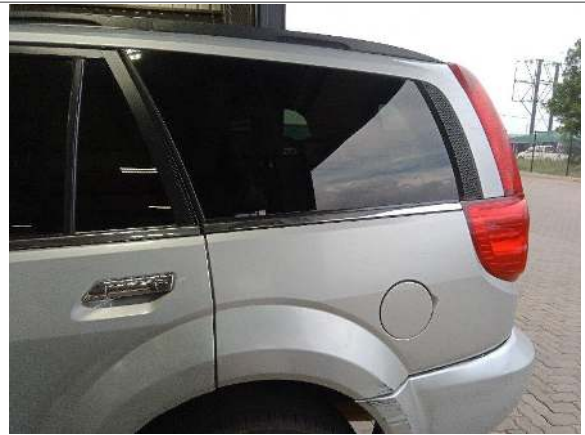
| Damage | Repair Way |
|---|---|
| Rear Fender Left Damaged | Repair |

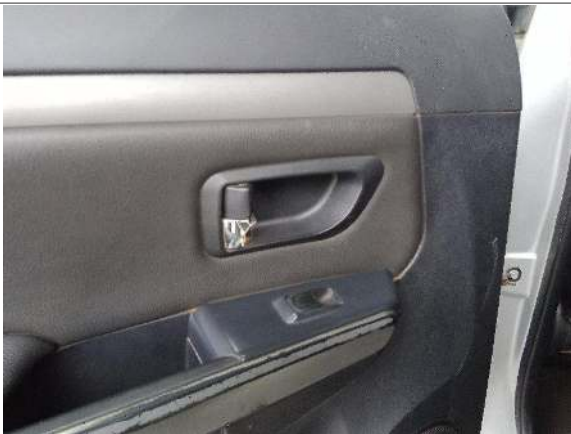
| | Damage | Repair Way |
|---|---|---|
| | Door Handle Rear Left Damaged | Replace |

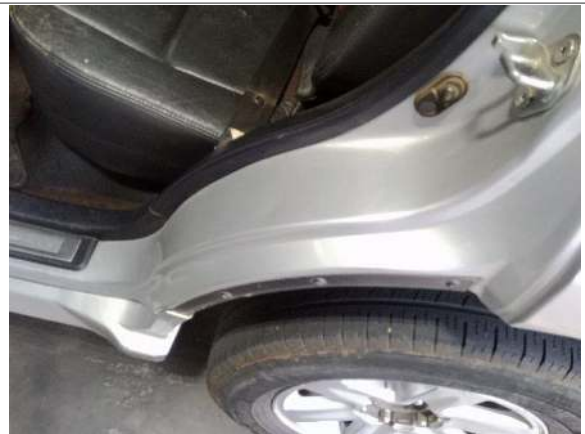
| Damage | Repair Way |
|---|---|
| C • Pillar Left Dented | Repair |

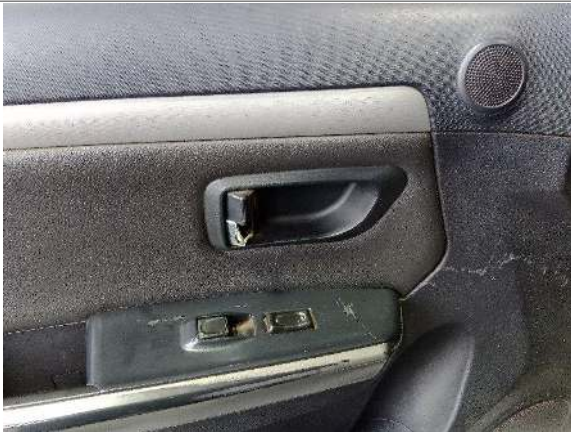
| | Damage | Repair Way |
|---|---|---|
| | Door Handle Front Left Damaged | Replace |

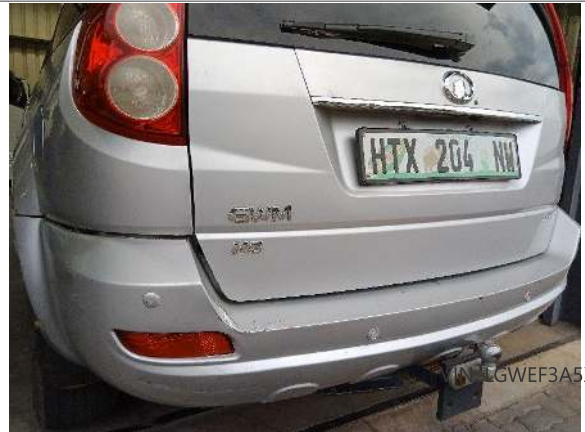
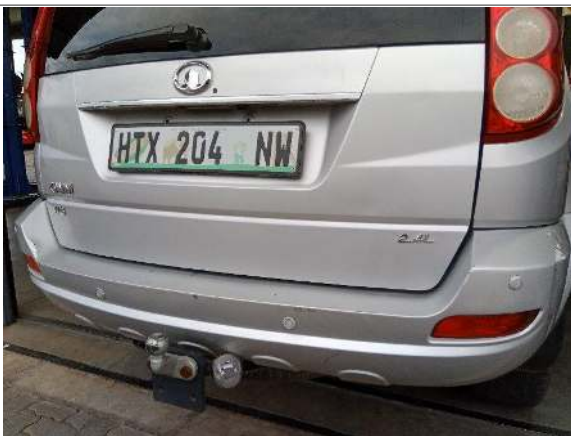
| Damage | Repair Way |
|---|---|
| Rear bumper Damaged | Repair |

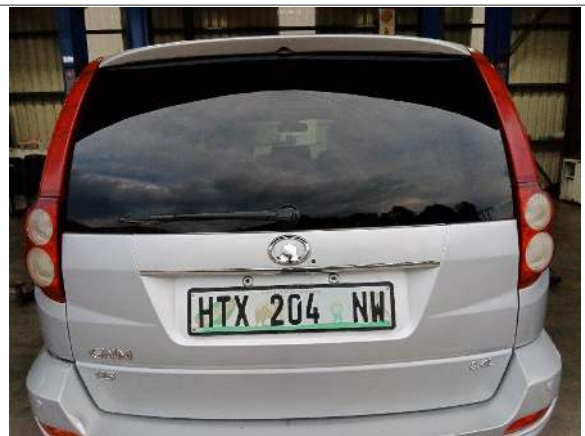
| Damage | Repair Way |
|---|---|
| Boot Lid / Hatch door Paintwork • Scratched | Repair |

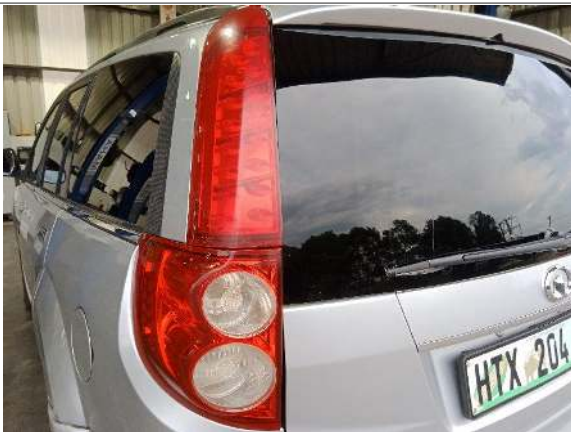
| | Damage | Repair Way |
|---|---|---|
| | Tail Light Left Defective | Replace |

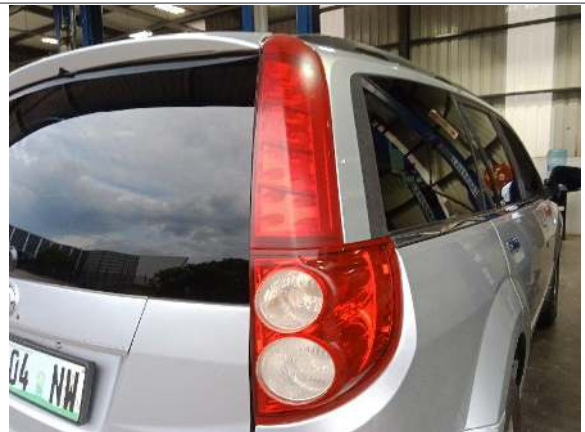
| | Damage | Repair Way |
|---|---|---|
| | Tail Light Right Defective | Replace |

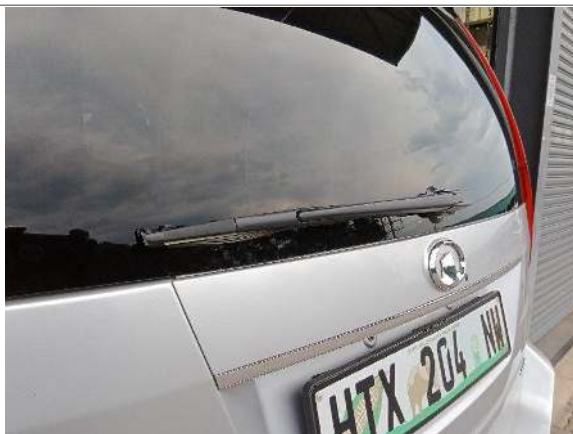
| | Damage | Repair Way |
|---|---|---|
| | Windscreen Wiper Damaged | Replace |

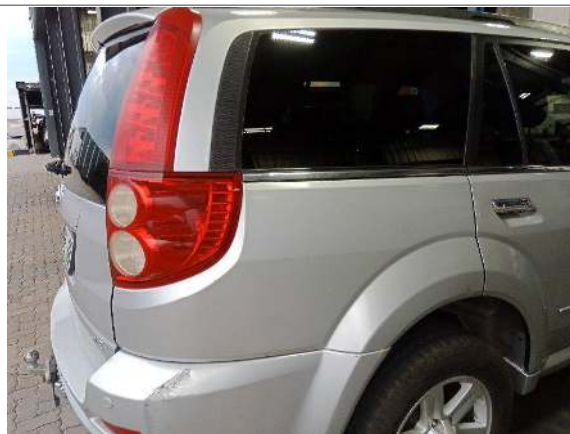
| Damage | Repair Way |
|---|---|
| Rear Fender Right Paintwork • Scratched | Repair |

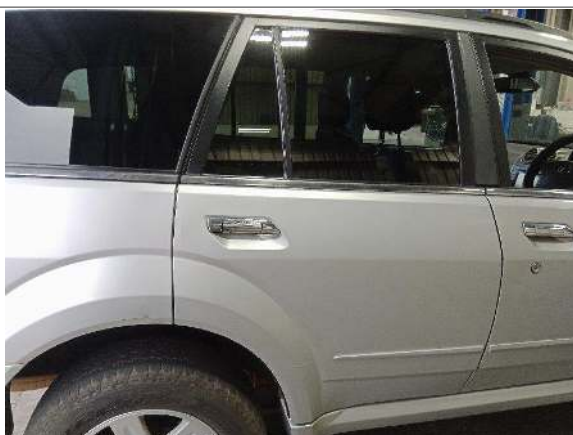
| Damage | Repair Way |
|---|---|
| Door Rear Right Damaged | Repair |

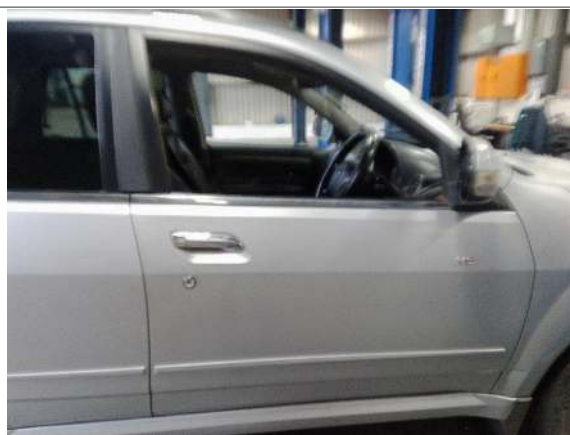
| Damage | Repair Way |
|---|---|
| Door Front Right Residual Traces of Repair | Repair |

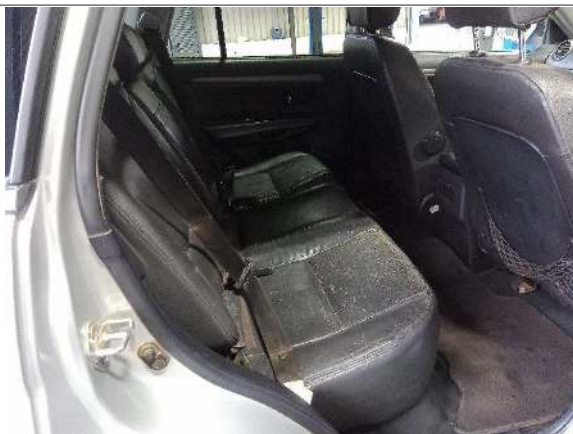
| | Damage | Repair Way |
|---|---|---|
| | Seat Rear Damaged | Repair |

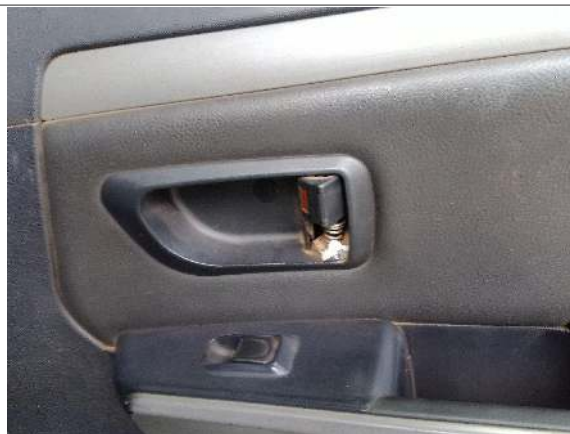
| | Damage | Repair Way |
|---|---|---|
| | Door Handle Rear Right Damaged | Replace |

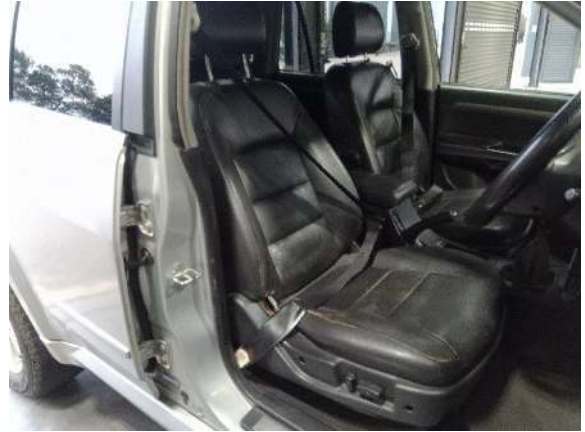
| | Damage | Repair Way |
|---|---|---|
| | Seat Front Right Damaged | Repair |

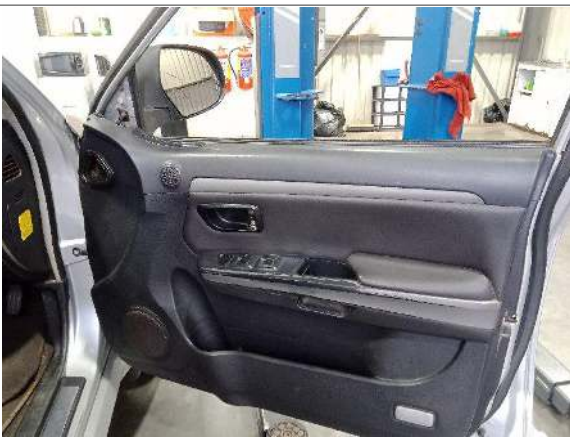
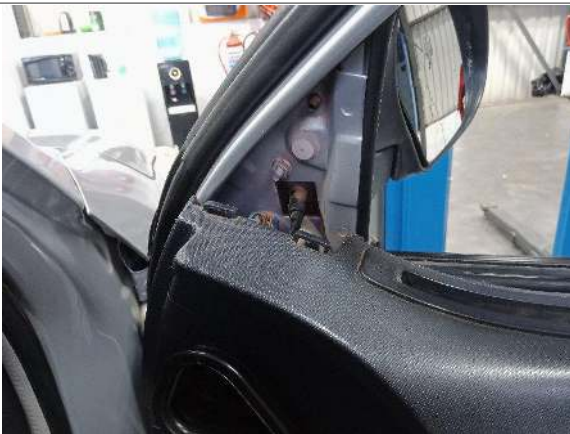
| | Damage | Repair Way |
|---|---|---|
| | Door Panel Front Right Defective | Repair |

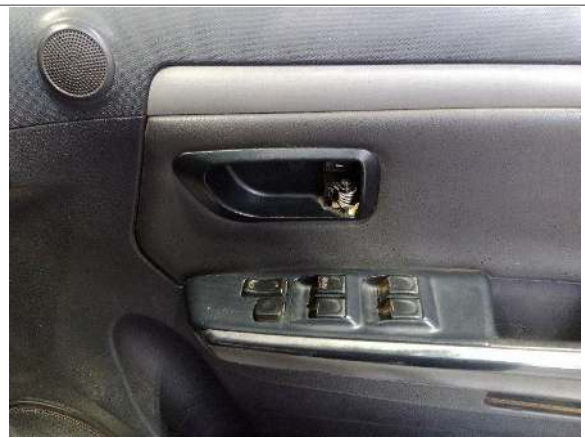
| | Damage | Repair Way |
|---|---|---|
| | Door Handle Front Right Missing | Replace |

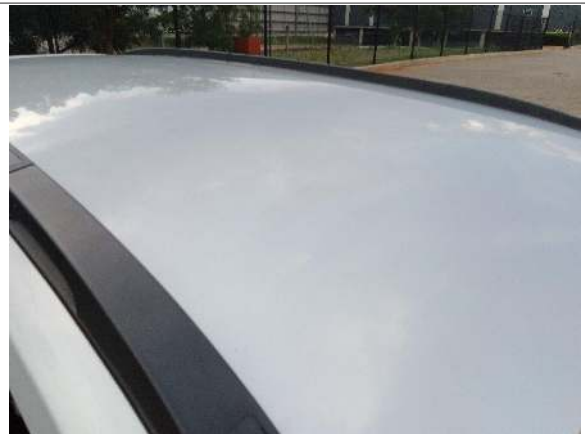
| Damage | Repair Way |
|---|---|
| Roof Dented | Repair |

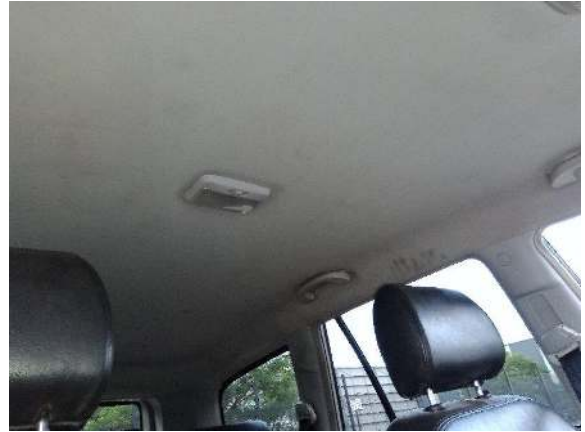
| | Damage | Repair Way |
|---|---|---|
| | Hood Lining Defective | Repair |

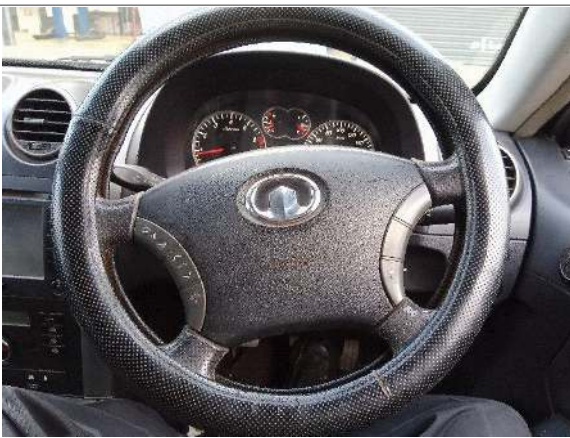
| | Damage | Repair Way |
|---|---|---|
| | Steering Wheel Trim Defective | Repair |

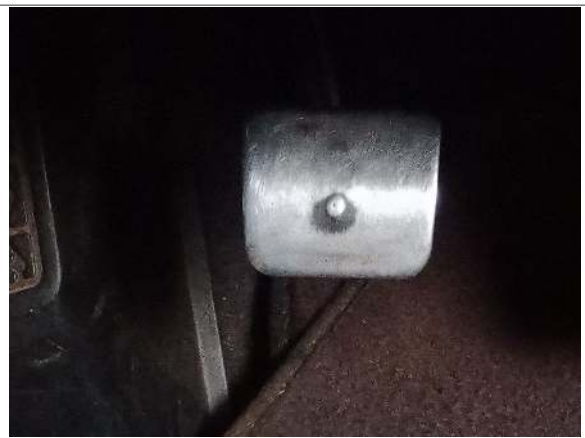
| | Damage | Repair Way |
|---|---|---|
| | Clutch Pedal Rubber Missing | Replace |

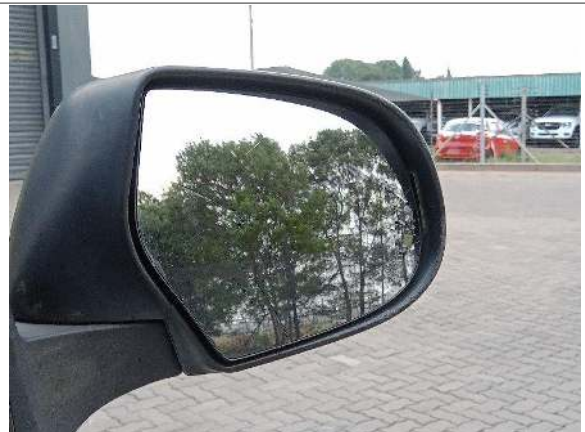
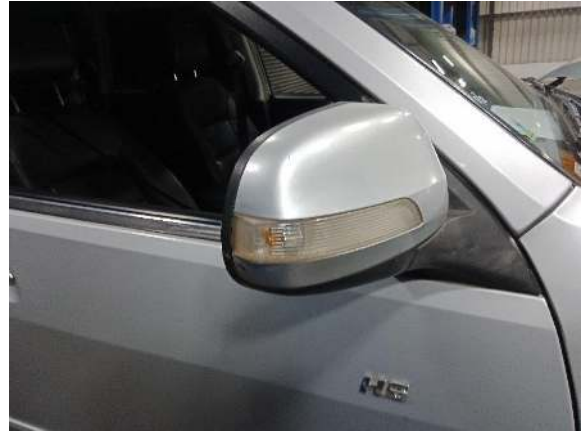
| Damage | Repair Way |
|---|---|
| Side Mirror Right Damaged | Replace |

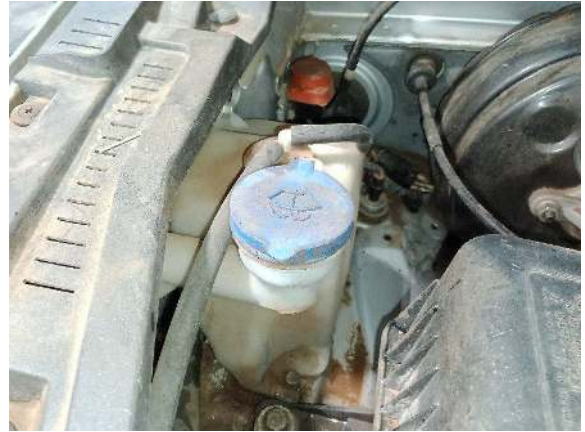
| | Damage | Repair Way |
|---|---|---|
| | Expansion Bottle Water Leak | Replace |

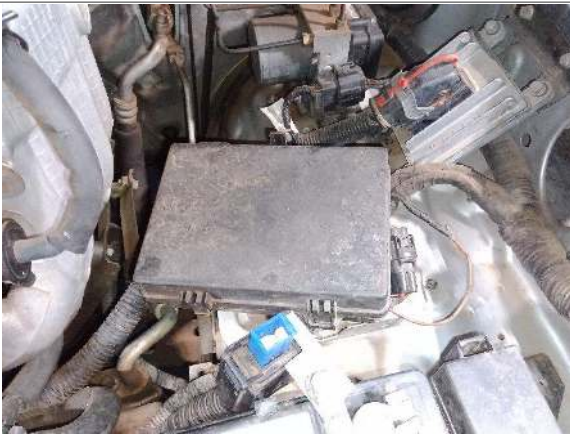
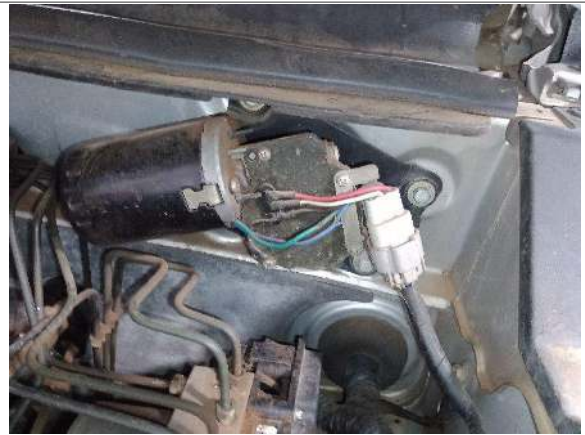
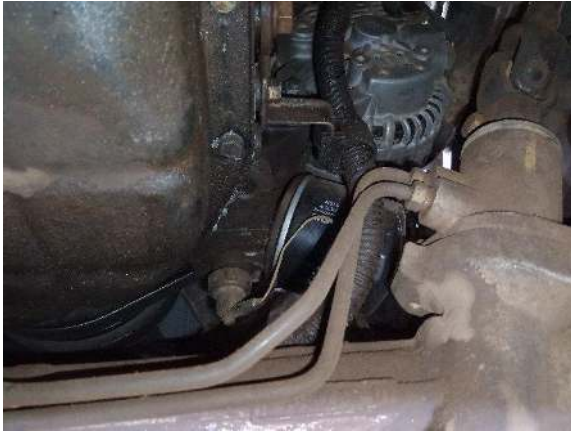
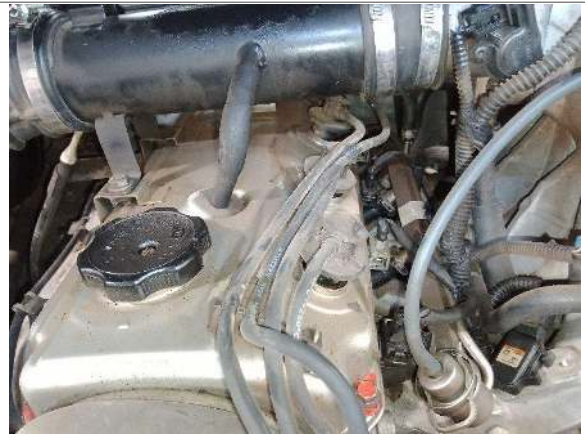
| | Damage | Repair Way |
|---|---|---|
| | Engine Wiring Defective | Repair |

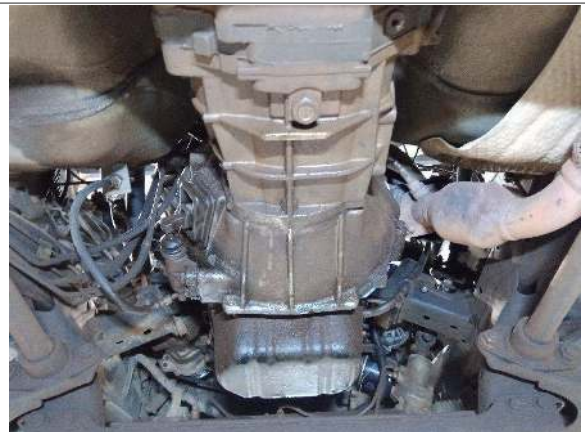
| Damage | Repair Way |
|---|---|
| Gearbox Oil Leak | Repair |

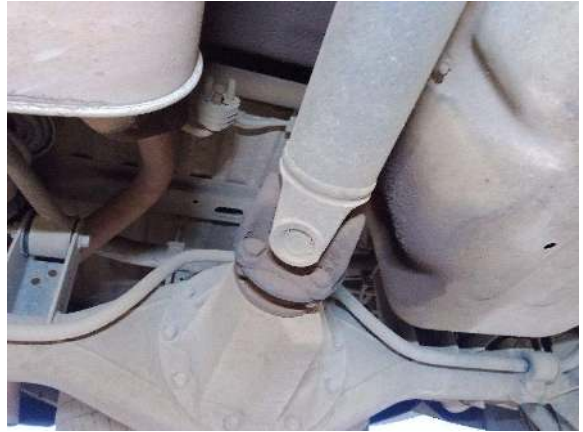
| Damage | Repair Way |
|---|---|
| Differential Oil Sweat | Repair |

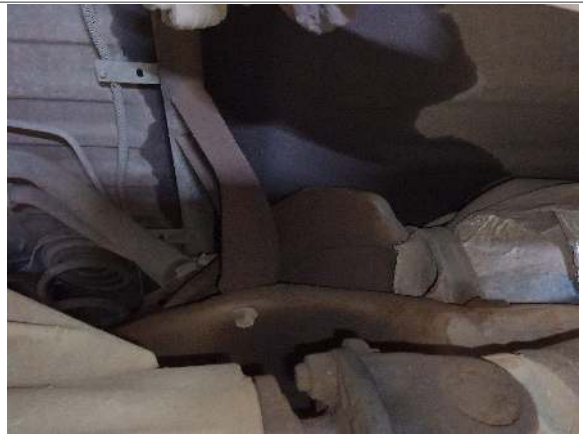
| Damage | Repair Way |
|---|---|
| Fuel Tank Sweat | Repair |

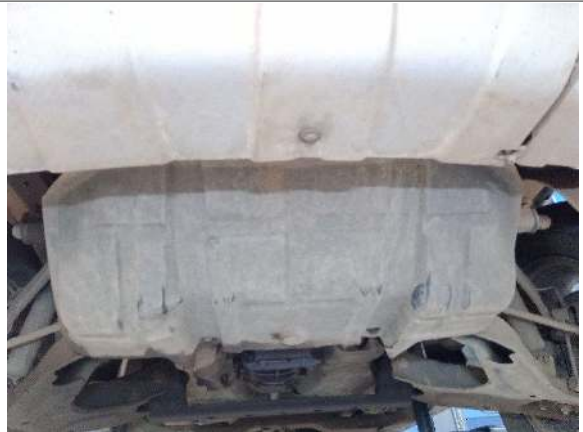
| Damage | Repair Way |
|---|---|
| Belly plates Damaged | Repair |

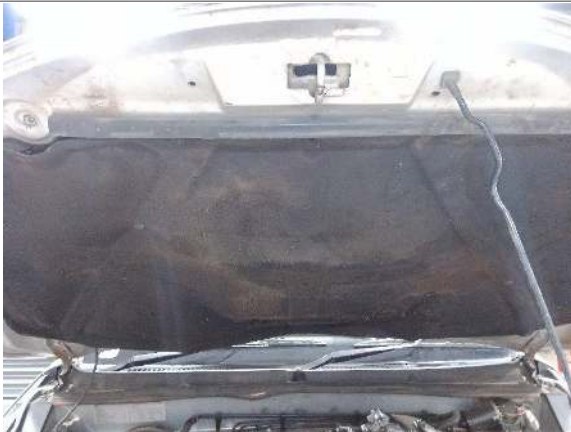
| | Damage | Repair Way |
|---|---|---|
| | Under bonnet insulation cover Damaged | Repair |

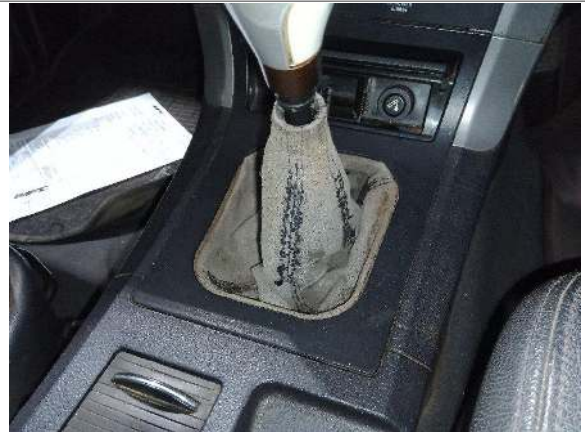
| | Damage | Repair Way |
|---|---|---|
| | Gear Lever Dust Boot Damaged | Repair |

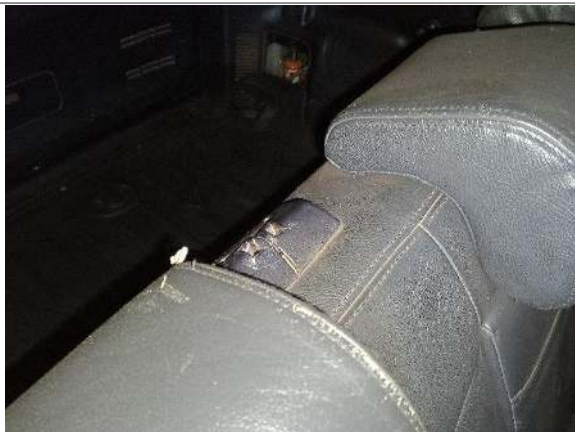
| | Damage | Repair Way |
|---|---|---|
| | Seat Belt Rear Middle Missing | Replace |
