CONDITION REPORT

Report No: 2016211794

MFC Auction House  
M57 Pretoria Rd, Glenmarais, KEMPTON PARK  
Gauteng

| Manufacturer | CHERY | Registration Number | KVX883MP |

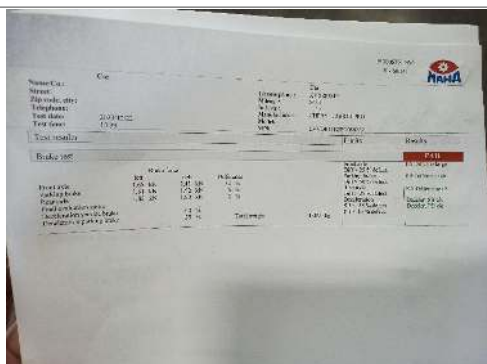
Brake test

| | Left | Right | | |
|---|---|---|---|---|
| Front | 1.65 | 2.41 | - | |
| Rear | 1.83 | 1.8 | - | |
| Emergency / Parking | 1.81 | 1.92 | - | |

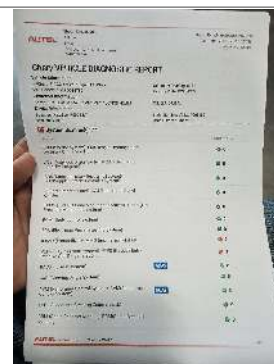
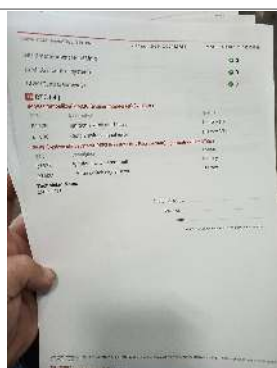
Diagnostic report

During the diagnostic no active error messages were detected. (See also attached Diagnostic Report. For more information regarding the Fault Codes (DTC) and the recommended rectifications please contact the workshops of the vehicle manufacture).

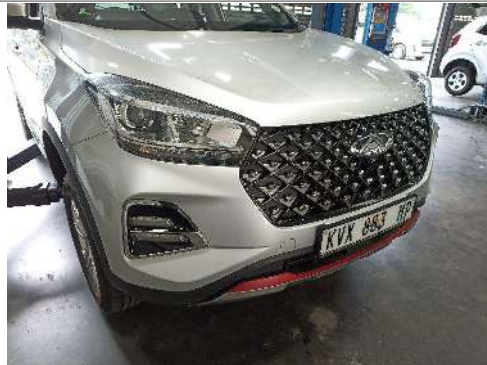
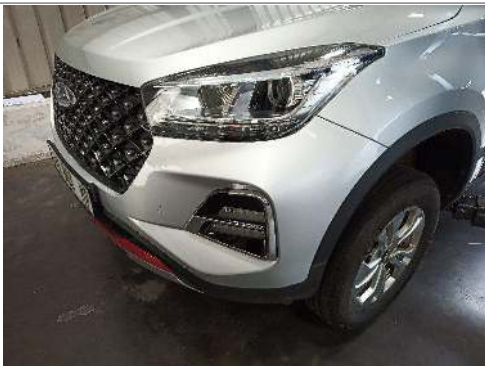
| Damage | Repair Way |
|---|---|
| Front Bumper Damaged | Repair |

Front Bumper

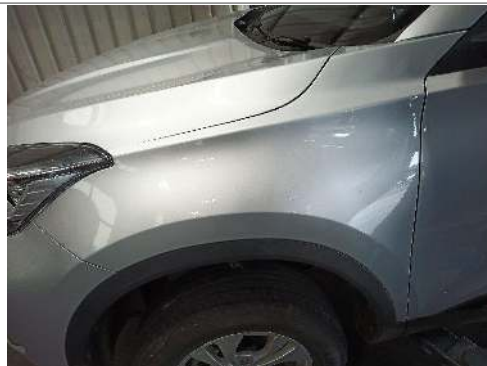
| Damage | Repair Way |
|---|---|
| Front Fender Left Damaged | Repair |

Front Fender Left

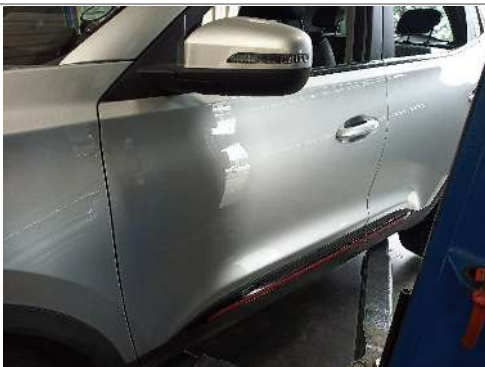
| Damage | Repair Way |
|---|---|
| Door Front Left Damaged | Repair |

Door Front Left

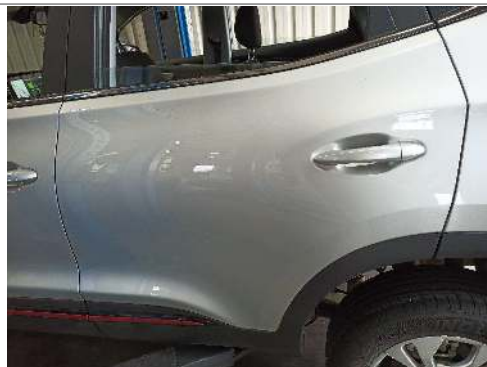
| Damage | Repair Way |
|---|---|
| Door Rear Left Damaged | Repair |

Door Rear Left

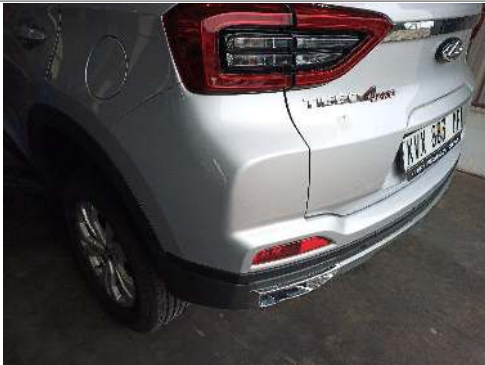
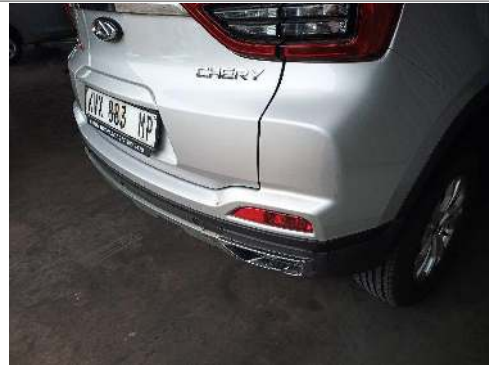
| Damage | Repair Way |
|---|---|
| Rear bumper Damaged | Repair |

Rear bumper

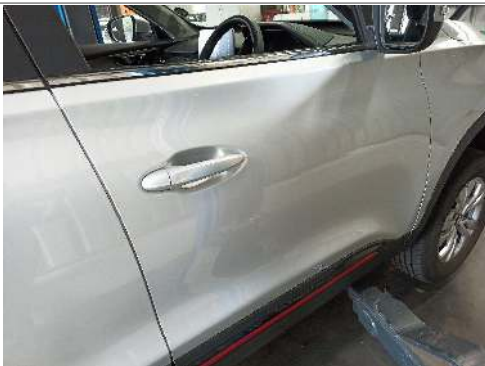
| Damage | Repair Way |
|---|---|
| Door Front Right Damaged | Repair |

Door Front Right

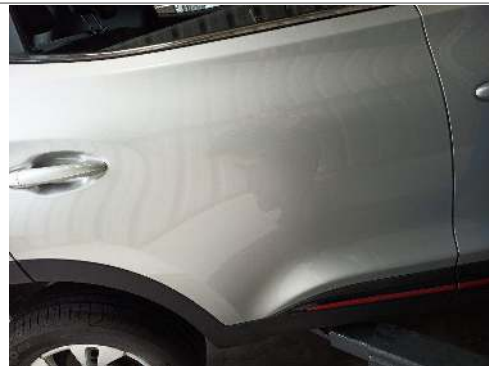
| Damage | Repair Way |
|---|---|
| Door Rear Right Damaged | Repair |

Door Rear Right

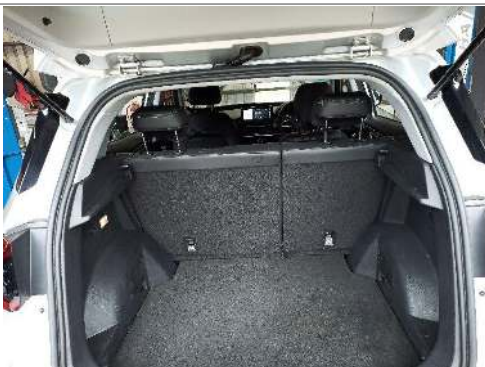
| Damage | Repair Way |
|---|---|
| Parcel Tray Missing | Replace |

Parcel Tray
