CONDITION REPORT

Report No:
2016999436
DATE
02/09/2025

Vehicle Type	PASSENGER VEHICLE	Registered Owner	MFC
Manufacturer	SUZUKI	Registration Number	KW27VJGP
Model	CELERIO	Register Number	
VIN	MA3KFC42S00516139	Date Of First Licensing	
Engine Number		Last COR	
Doors	5	License Expiry Date	31/10/2023
Color	SILVER	Power / Displacement	
Year Model		Paint Finish	TWO COAT METALLIC
Km Reading	121,148 KM	Fuel	PETROL
Cab / Body Type	HATCHBACK	Transmission	MANUAL

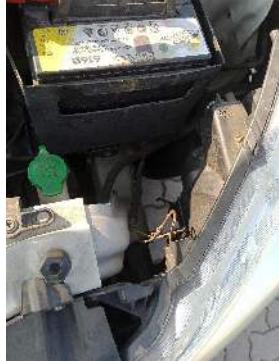
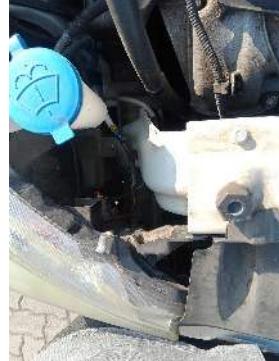
Damage	Repair Way
Engine Oil Leak	Repair
Engine Wiring Damaged	Repair
Radio/CD/USB Damaged	Repair
Tail Light Right Damaged	Replace
Headlight Left Damaged	Repair
Seat Front Right Damaged	Repair
Window Winder front right Damaged	Replace
Carpet Front Damaged	Repair
Steering Wheel Trim Damaged	Repair
Side Mirror Left Damaged	Replace
Front Bumper Damaged	Repair
Bonnet Damaged	Repair
Front Fender Left Damaged	Repair
Front Fender Right Damaged	Repair
Rear Fender Left Damaged	Repair
Rear Fender Right Damaged	Repair
Door Front Left Damaged	Repair
Door Front Right Damaged	Repair
Door Rear Left Damaged	Repair
Door Rear Right Damaged	Repair
Boot Lid / Hatch door Damaged	Repair
Rear bumper Damaged	Repair
Windscreen Damaged	Replace
Brake disc 1. Axle left Worn	Replace
Parking Brake Performance Left / Right Difference out of legal range	Repair
Tyre Front Left Worn	Replace
Tyre Rear Left Worn	Replace
Tyre Rear Right Worn	Replace
Gearbox Oil Leak	Repair

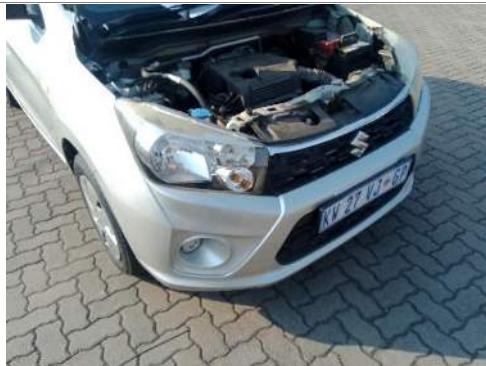
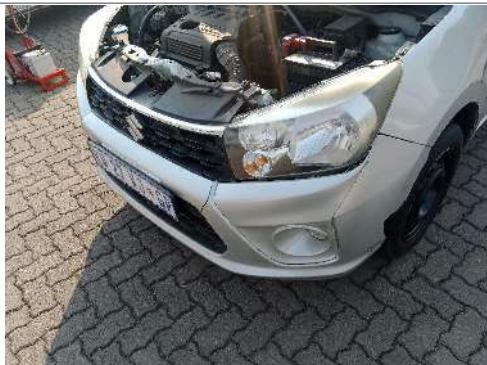
Front Bumper

Body • Exterior: Minor dents and scratches and stone chips to some body panels. Signs of repair work done to somebody panels. Poor alignment to somebody panels.

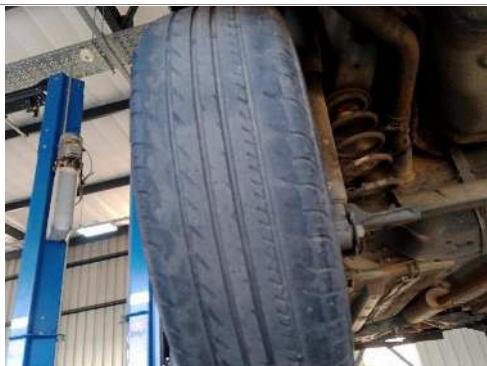
Tyre Rear Left

Size	Load/Speed Index	Manufacture	Model	Type*	Production Date	Tread Depth (mm)
Front Left	175/65R14	82T	General	Radial	V	3120	0 mm
Front Right	165/70R14	81S	Bridgestone	Radial	V	1218	1 mm
Rear Left	175/70R14	84H	Seamtyer	Radial	V	4419	0 mm
Rear Right	175/70R14	84H	Maxxis	Radial	V	0620	0 mm
