## CONDITION REPORT

Report No: 2016186904

| Manufacturer | SUZUKI | Registration Number | KLY712NW |
| Model | VITARA BREZZA | Register Number | |

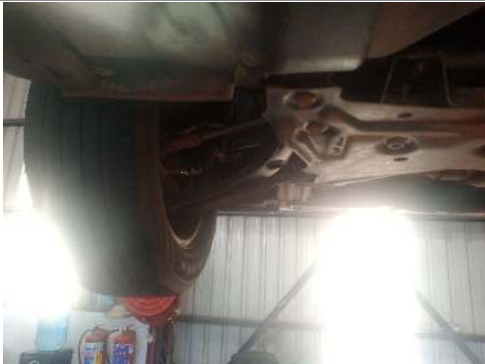
LF TYRE TREAD

| | Size | Load/Speed Index | Manufacture | Model | Type* | Production Date | Tread Depth (mm) |
|---|---|---|---|---|---|---|---|
| Front Left | 215/60R16 | 95H | Apollo | Radial | V | 5120 | 0 mm |

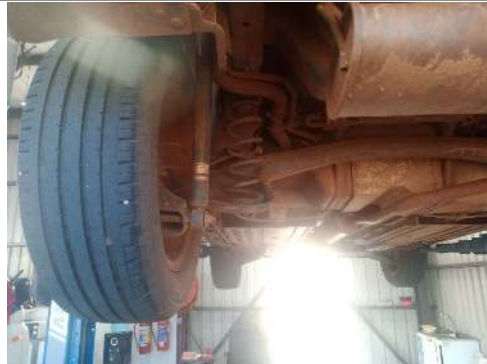
LR TYRE TREAD

| | Size | Load/Speed Index | Manufacture | Model | Type* | Production Date | Tread Depth (mm) |
|---|---|---|---|---|---|---|---|
| Rear Left | 215/60R16 | 95H | Apollo | Radial | V | 5120 | 2 mm |

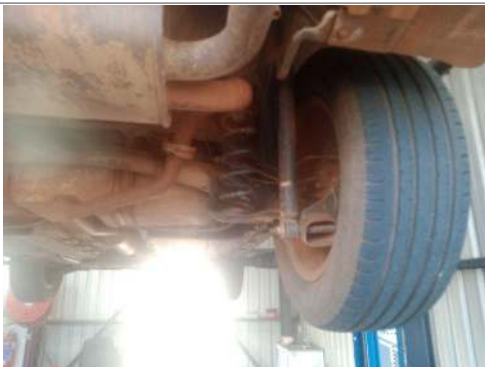
RR TYRE TREAD

| | Size | Load/Speed Index | Manufacture | Model | Type* | Production Date | Tread Depth (mm) |
|---|---|---|---|---|---|---|---|
| Rear Right | 215/60R16 | 95H | Apollo | Radial | V | 5120 | 2 mm |

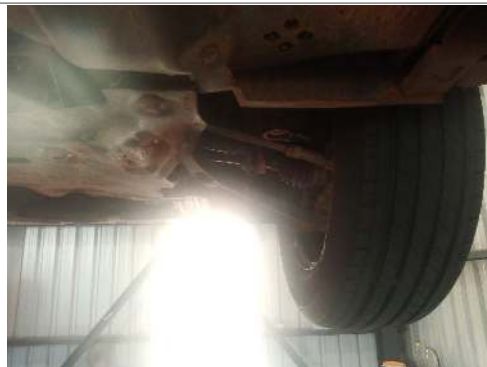
RF TYRE TREAD

| | Size | Load/Speed Index | Manufacture | Model | Type* | Production Date | Tread Depth (mm) |
|---|---|---|---|---|---|---|---|
| Front Right | 215/60R16 | 95H | Apollo | Radial | V | 5220 | 4 mm |

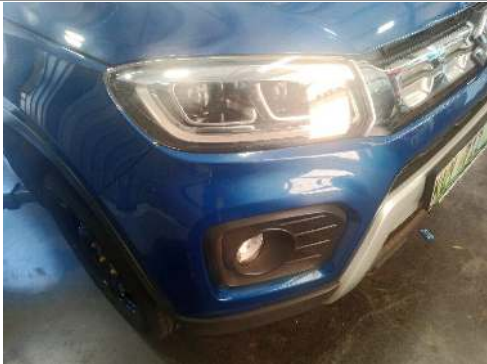
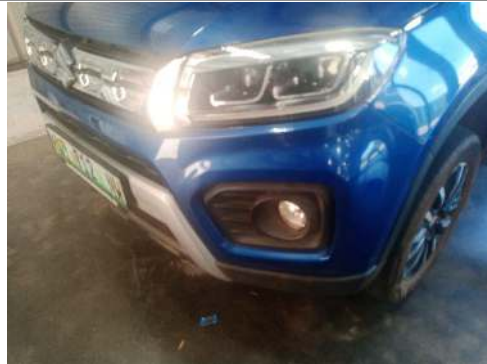
| Damage | Repair Way |
|---|---|
| Front Bumper Damaged | Repair |

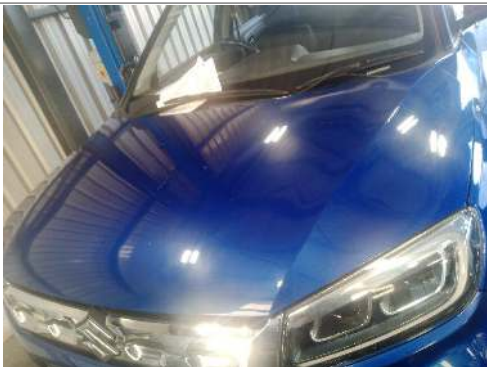
| Damage | Repair Way |
|---|---|
| Bonnet Damaged | Repair |

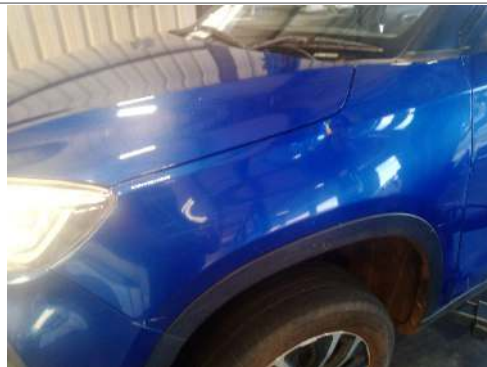
| Damage | Repair Way |
|---|---|
| Front Fender Left Damaged | Repair |

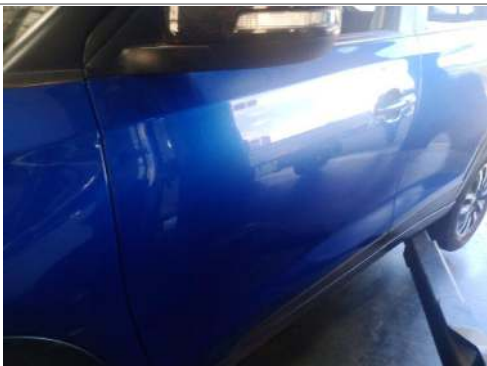
| Damage | Repair Way |
|---|---|
| Door Front Left Damaged | Repair |

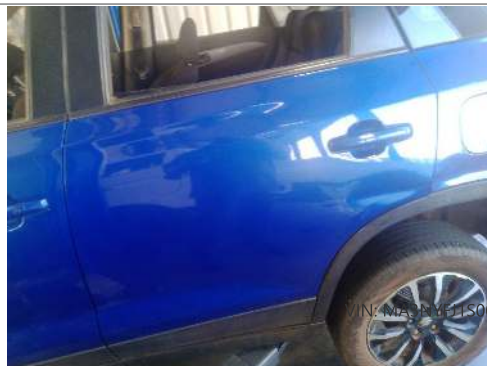
| Damage | Repair Way |
|---|---|
| Door Rear Left Damaged | Repair |

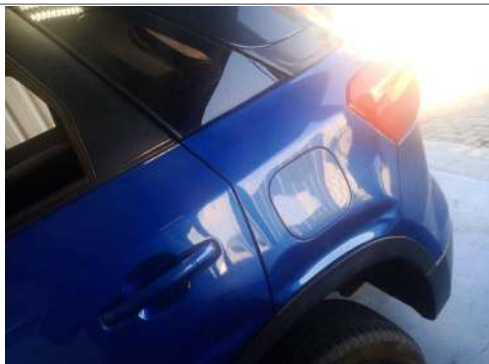
| Damage | Repair Way |
|---|---|
| Rear Fender Left Damaged | Repair |

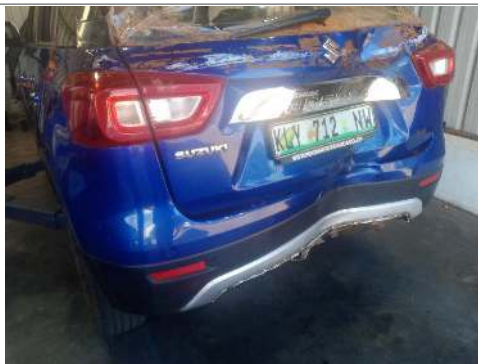
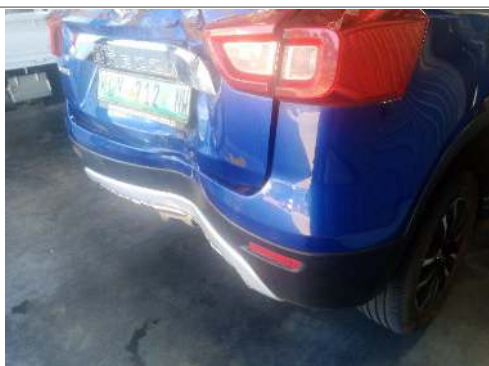
| Damage | Repair Way |
|---|---|
| Rear bumper Damaged | Repair |

Body • Exterior: Minor dents and scratches and stone chips to some body panels. Signs of repair work done to some body panels. Poor alignment to some body panels. Signs of impact damage to rear of vehicle. Repair work done to vehicle below standard. Vehicle body in poor condition.

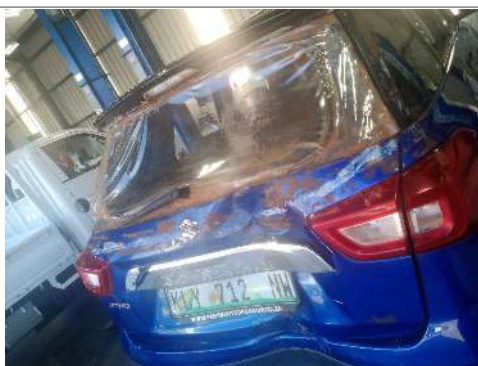
| Damage | Repair Way |
|---|---|
| Boot Lid / Hatch door Damaged | Repair |

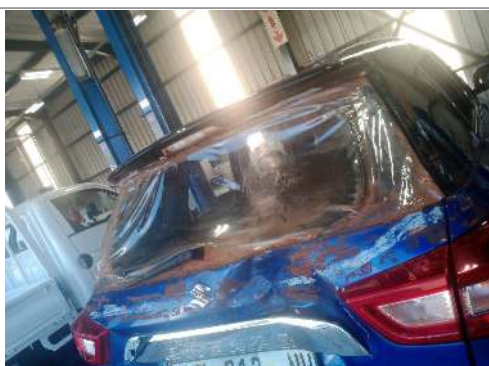
| Damage | Repair Way |
|---|---|
| Back Window Damaged | Repair |

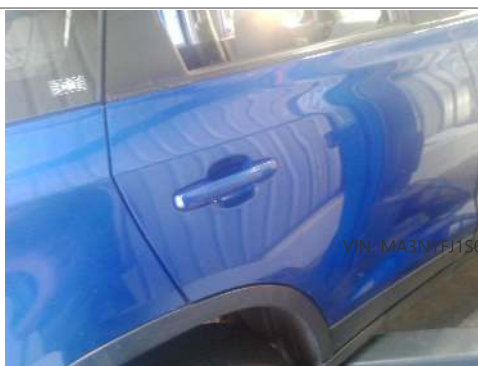
| Damage | Repair Way |
|---|---|
| Door Rear Right Damaged | Repair |

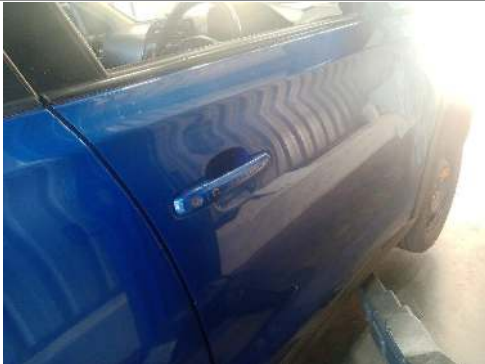
| Damage | Repair Way |
|---|---|
| Door Front Right Damaged | Repair |

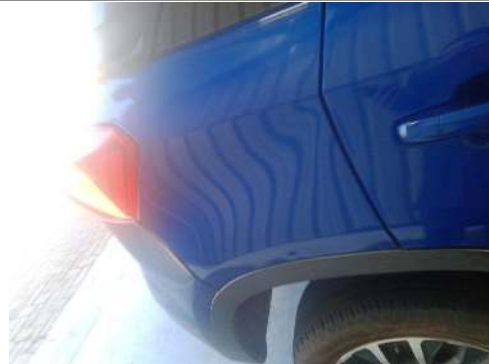
| Damage | Repair Way |
|---|---|
| Rear Fender Right Damaged | Repair |

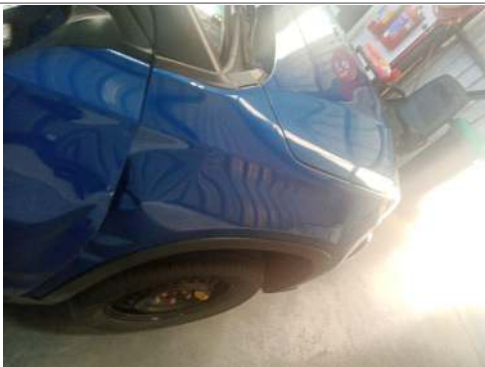
| Damage | Repair Way |
|---|---|
| Front Fender Right Damaged | Repair |

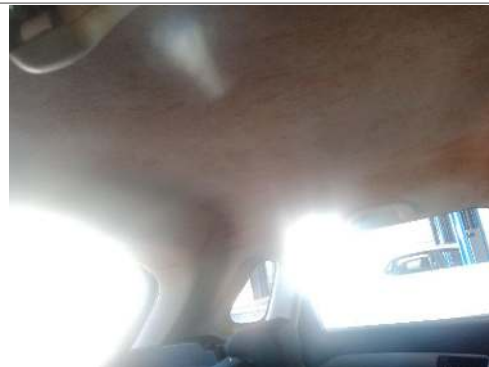
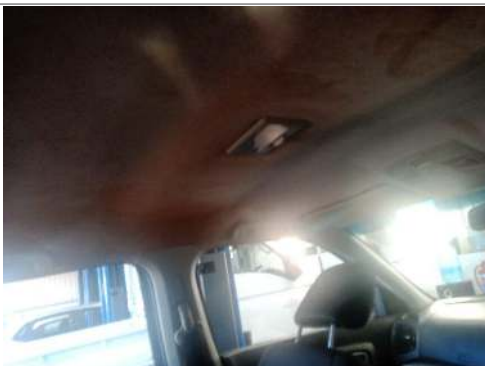
| Damage | Repair Way |
|---|---|
| Hood Lining Damaged | Replace |

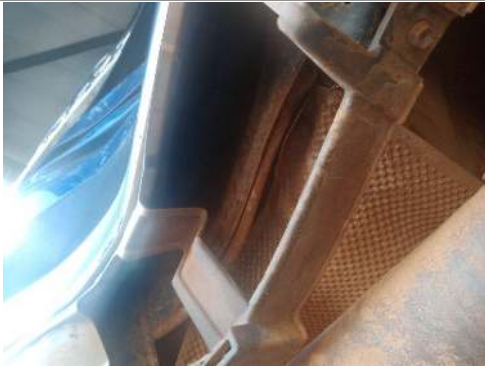
| Damage | Repair Way |
|---|---|
| Inner Boot Floor Pan and Spare Wheel Well Damaged | Replace |

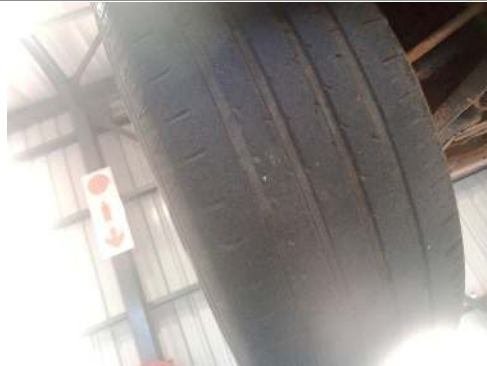
| Damage | Repair Way |
|---|---|
| Tyre Front Left Worn | Replace |
