CONDITION REPORT

Report No: 2016866051

DATE
06/05/2025

Vehicle Type	PASSENGER VEHICLE	Registered Owner	MFC AUCTION HOUSE
Manufacturer	SUZUKI	Registration Number	JDD456FS
Model	CELERIO 1.0 GL 5-DR [2022-ON]	Register Number	
VIN	MA3TFC62S00158009	Date Of First Licensing	
Engine Number		Last COR	
Doors	5	License Expiry Date	30/06/2025
Color	WHITE	Power / Displacement	
Year Model	2022	Paint Finish	M - METALLIC
Km Reading	57,196 KM	Fuel	PETROL
Cab / Body Type	HATCHBACK	Transmission	MANUAL

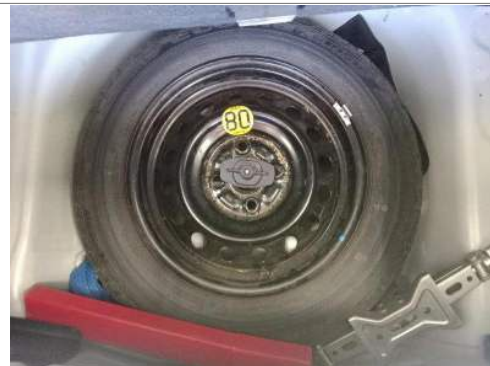
Size	Load/Speed Index	Manufacture	Model	Type*	Production Date	Tread Depth (mm)
Front Left	175/60R15	81H	Hilo	Genesys	V	4023	5 mm
Front Right	175/60R15	81H	Hilo	Genesys	V	4023	5 mm
Rear Left	175/60R15	81H	Hilo	Genesys	V	4023	5 mm
Rear Right	175/60R15	81H	Hilo	Genesys	V	4023	6 mm
Spare	165/70R14	81S	Bridgestone	Ecopia	V	//////	1 mm

Sparewheel

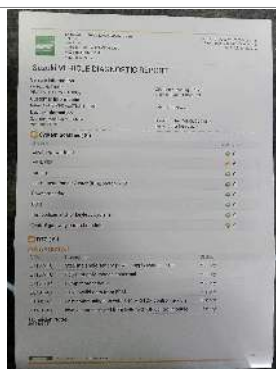
No	System	Code	Description	Status
1	ABS	C1137-1C	STEERING ANGLE SENSOR POWER SUPPLY SYSTEM ERROR

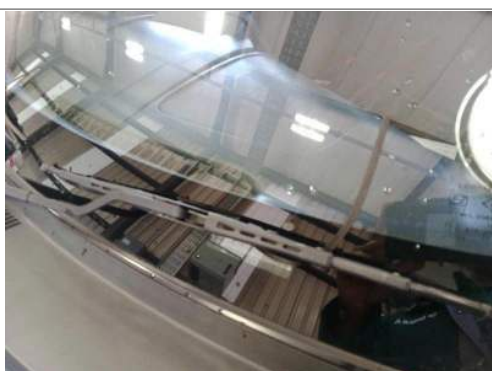
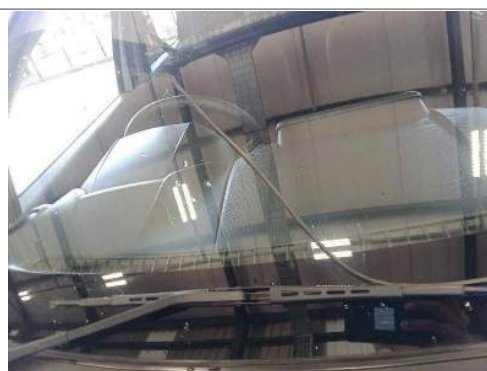
Damage	Repair Way
Windscreen Wiper Worn	Replace
Front Bumper Paintwork • Scratched	Repair
Front Fender Left Residual Traces of Repair	Repair
Service Brake Performance Rear Axle Left / Right	Repair
Difference out of legal range	
Parking Brake Performance Left / Right Difference out of legal range	Repair

Windscreen Wiper

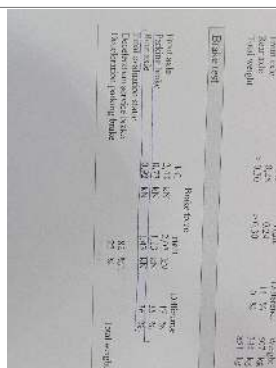
Left	Right	Axle Weight [KG]	Deceleration [m/s ²]
	Braking Force [KN]	Braking Force [KN]		
Front	2.4	2.0	-	
Rear	0.9	1.4	-	
Emergency / Parking	0.7	1.1	-

Parking Brake Performance

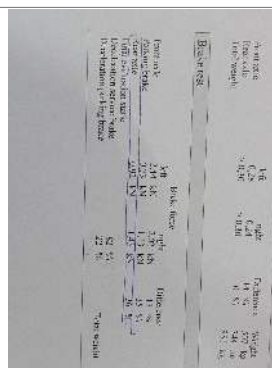
Service Brake Performance Rear Axle

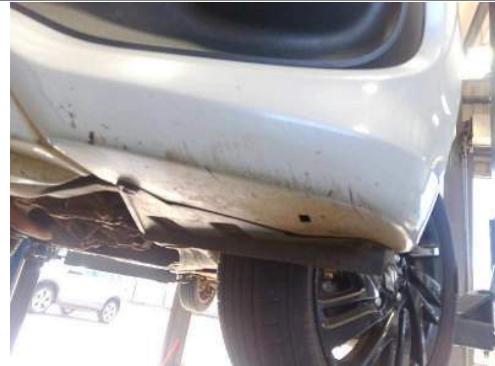
Front Bumper

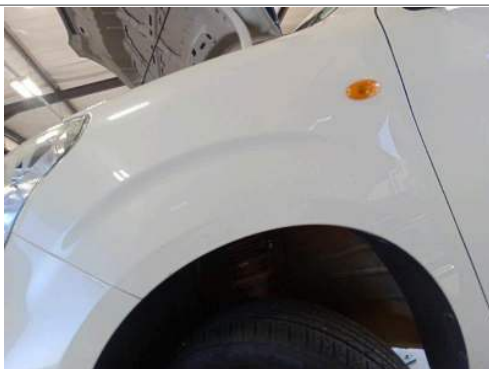
Front Fender Left
