MFC Auction House  
M57 Pretoria Rd, Glenmarais, KEMPTON PARK  
Gauteng

DEKRA MFC  
M57 Pretoria Rd - 1619  
KEMPTON PARK - GT  
08610 33572

## Assignment

| Manufacturer | FORD | Registration Number | CL15VVGP |

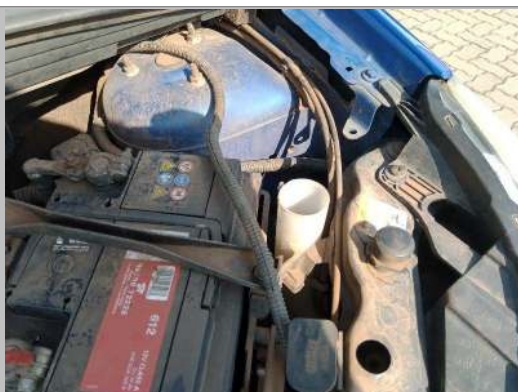
| | Damage | Repair Way |
|---|---|---|
| | Caps Missing | Replace |

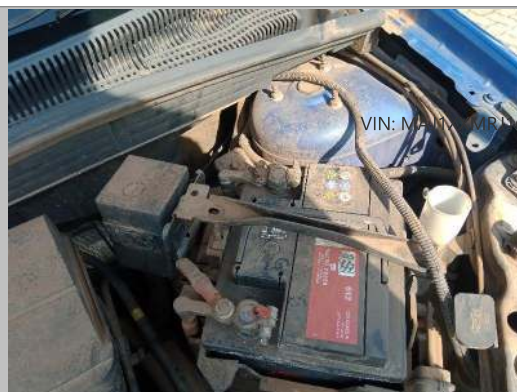
| | Damage | Repair Way |
|---|---|---|
| | Battery clamps Defective | Replace |

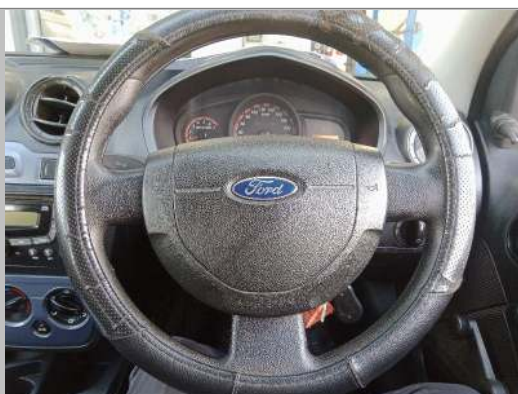
| | Damage | Repair Way |
|---|---|---|
| | Steering Wheel Trim Defective | Repair |

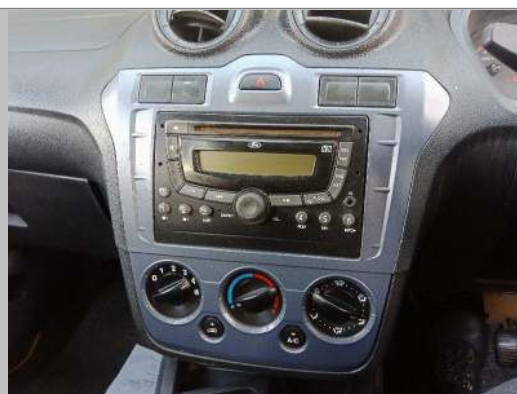
| | Damage | Repair Way |
|---|---|---|
| | Center Console / Cubbyhole + Lid Defective | Repair |

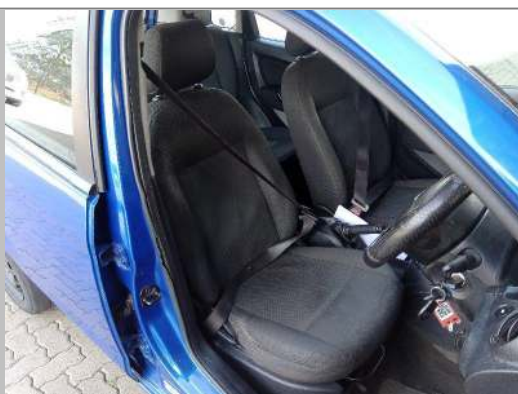
| | Damage | Repair Way |
|---|---|---|
| | Seat Front Right Defective | Repair |

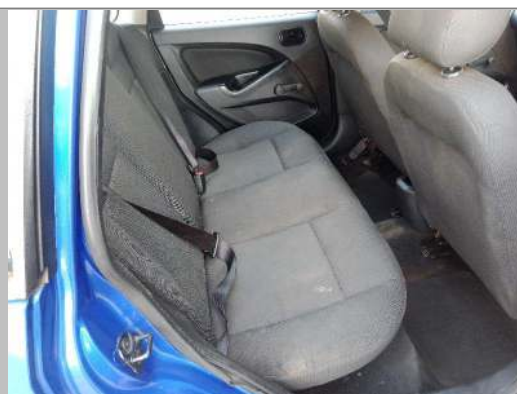
| | Damage | Repair Way |
|---|---|---|
| | Seat Rear Damaged | Repair |

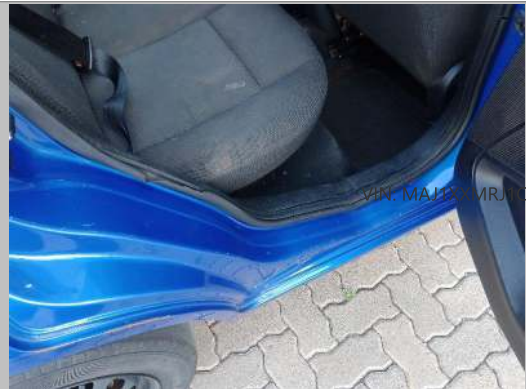
| Damage | Repair Way |
|---|---|
| Sill Panel Right Paintwork • Scratched | Repair |

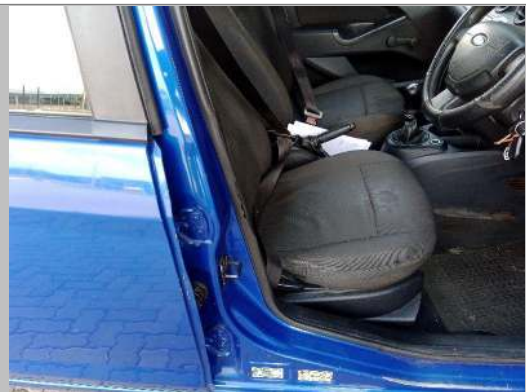
| | Damage | Repair Way |
|---|---|---|
| | Door Sealing Rubber Front Right Damaged | Replace |

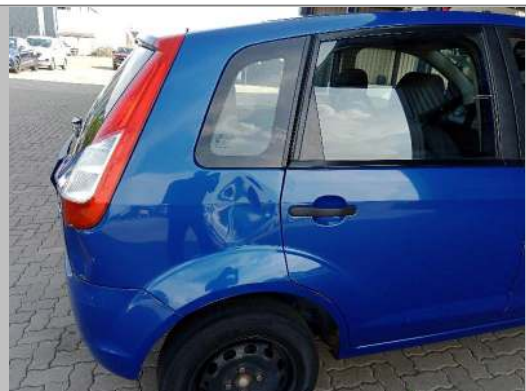
| Damage | Repair Way |
|---|---|
| Rear Fender Right Damaged | Repair |

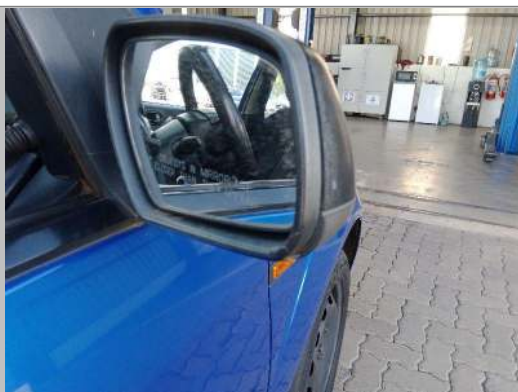
| Damage | Repair Way |
|---|---|
| Side Mirror Right Damaged | Repair |

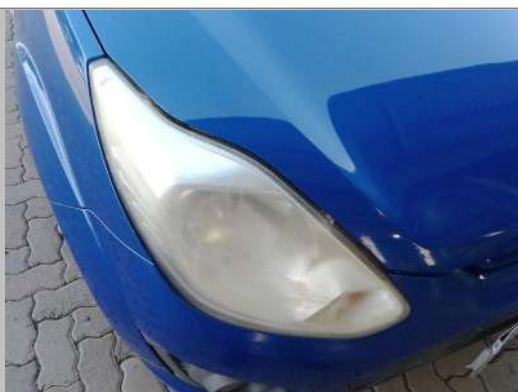
| | Damage | Repair Way |
|---|---|---|
| | Headlight Right Defective | Replace |

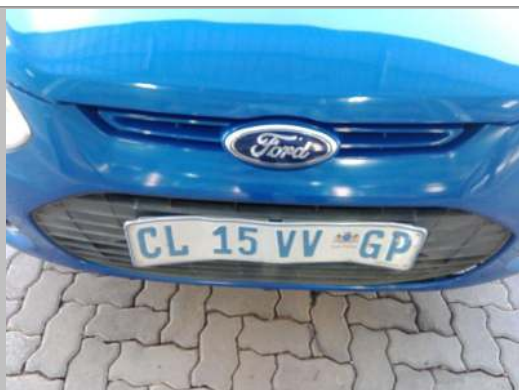
| | Damage | Repair Way |
|---|---|---|
| | Number Plate Front Damaged | Repair |

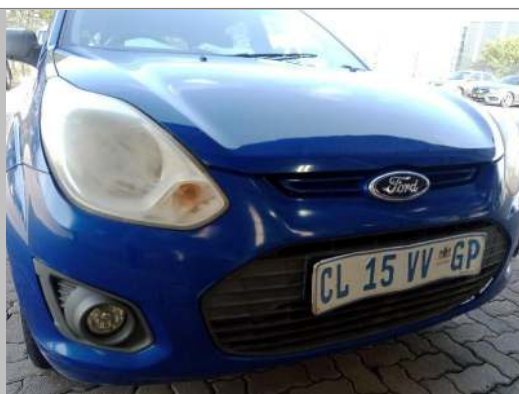
| Damage | Repair Way |
|---|---|
| Front Bumper Damaged | Repair |

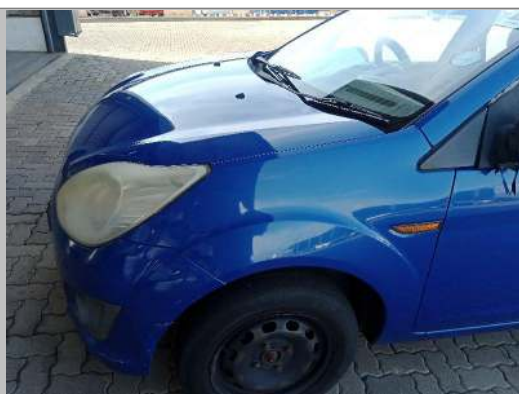
| Damage | Repair Way |
|---|---|
| Front Fender Left Damaged | Repair |

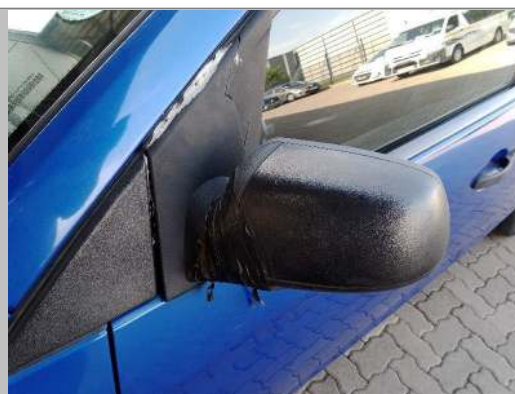
| Damage | Repair Way |
|---|---|
| Side Mirror Left Damaged | Replace |

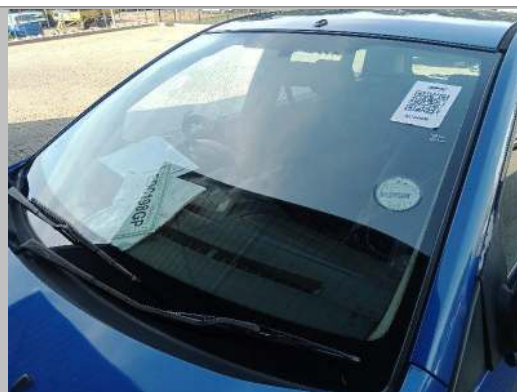
| Damage | Repair Way |
|---|---|
| Windscreen Cracked | Replace |

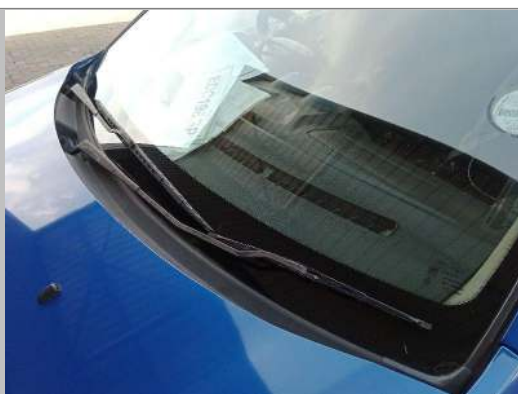
| | Damage | Repair Way |
|---|---|---|
| | Windscreen Wiper Defective | Replace |

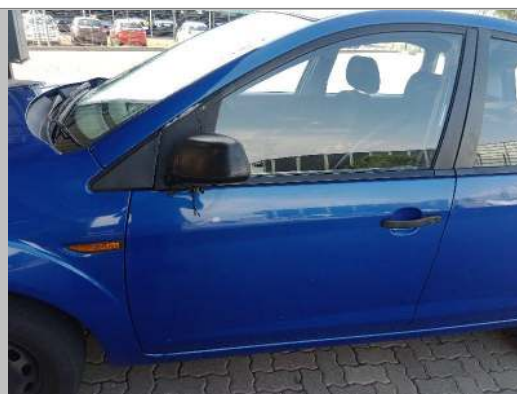
| Damage | Repair Way |
|---|---|
| Door Front Left Paintwork • Scratched | Repair |

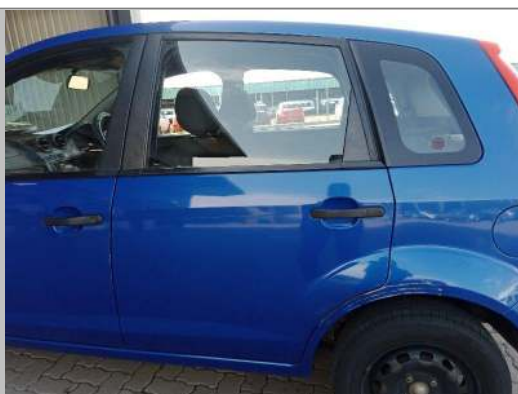
| Damage | Repair Way |
|---|---|
| Door Rear Left Damaged | Repair |

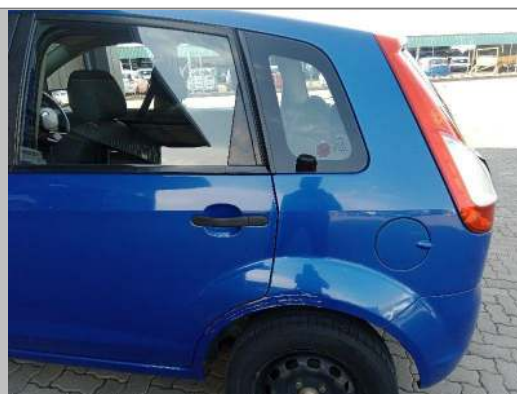
| Damage | Repair Way |
|---|---|
| Rear Fender Left Damaged | Repair |

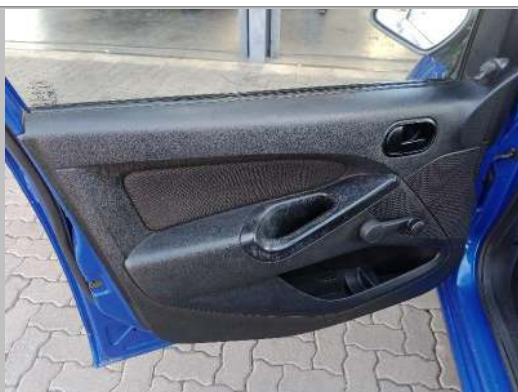
| | Damage | Repair Way |
|---|---|---|
| | Door Panel Front Left Defective | Repair |

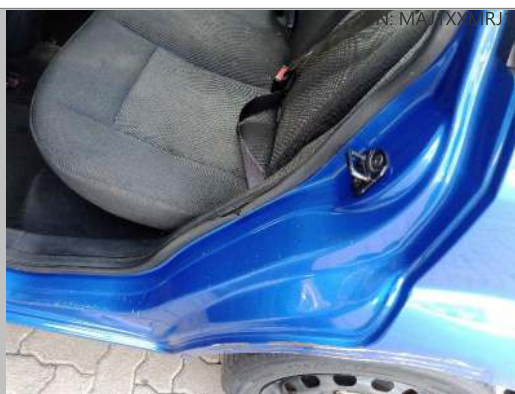
| | Damage | Repair Way |
|---|---|---|
| | Door Sealing Rubber Rear Left Damaged | Replace |

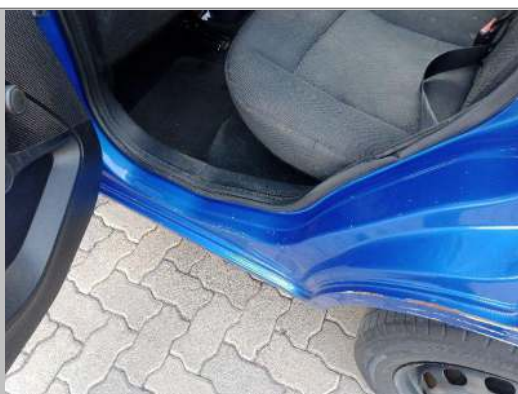
| Damage | Repair Way |
|---|---|
| Sill Panel Left Paintwork • Scratched | Repair |

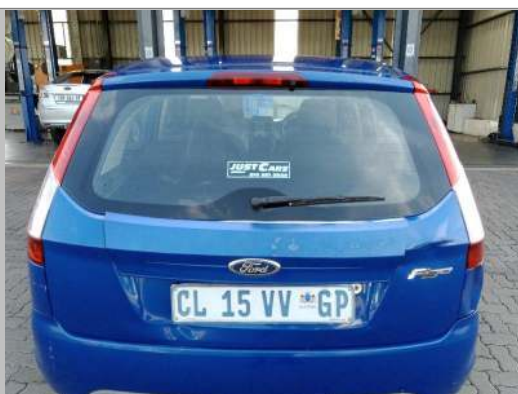
| Damage | Repair Way |
|---|---|
| Boot Lid / Hatch door Damaged | Repair |

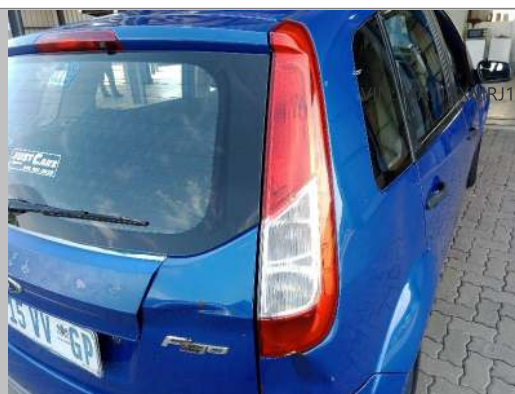
| | Damage | Repair Way |
|---|---|---|
| | Tail Light Right Cracked | Replace |

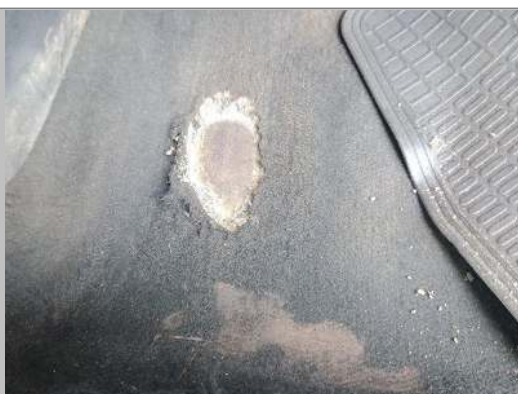
| | Damage | Repair Way |
|---|---|---|
| | Carpet Front Damaged | Repair |

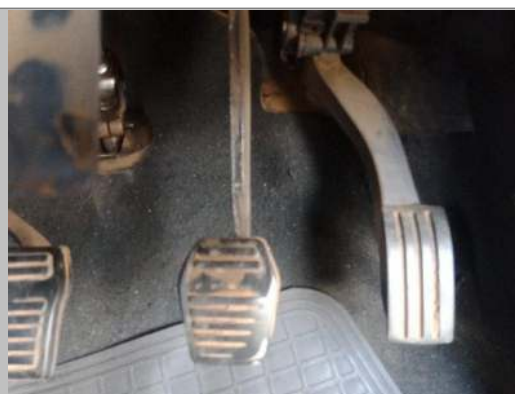
| | Damage | Repair Way |
|---|---|---|
| | Brake Pedal Rubber Damaged | Replace |

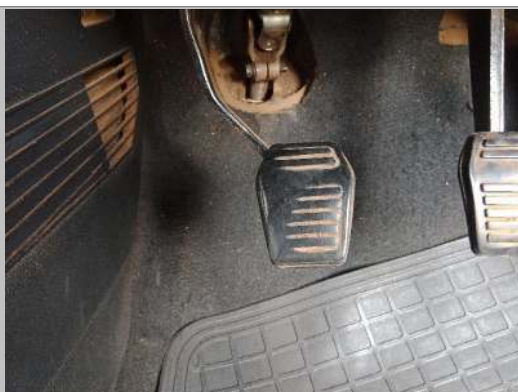
| | Damage | Repair Way |
|---|---|---|
| | Clutch Pedal Rubber Worn | Replace |

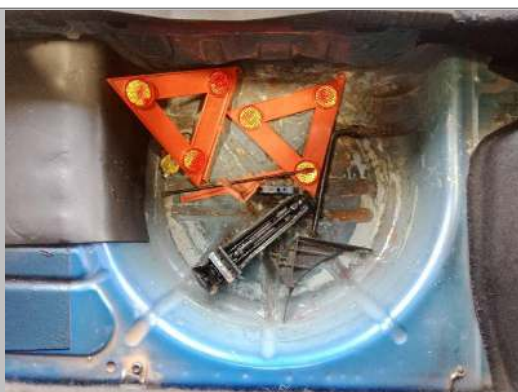
| Damage | Repair Way |
|---|---|
| Inner Boot Floor Pan and Spare Wheel Well Damaged | Repair |

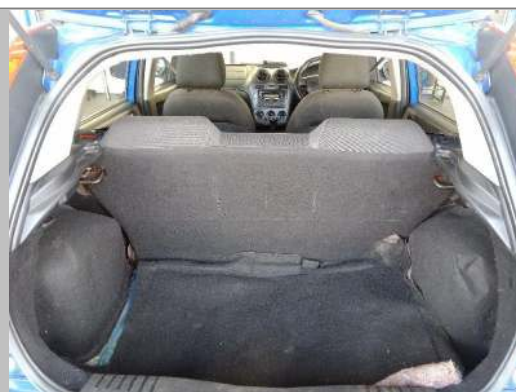
| | Damage | Repair Way |
|---|---|---|
| | Parcel Tray Missing | Replace |

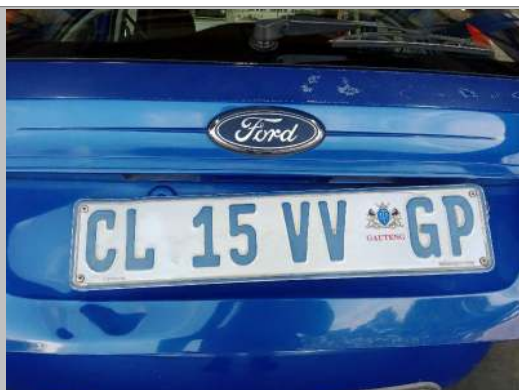
| Damage | Repair Way |
|---|---|
| Number Plate Rear Defective | Repair |

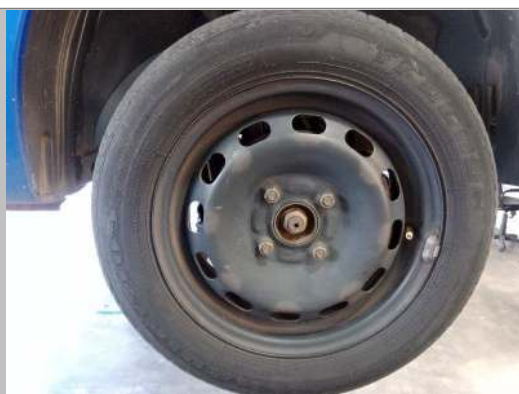
| Damage | Repair Way |
|---|---|
| Tyre Front Right Defective | Replace |

| | Size | Load/Speed Index | Manufacture | Model | Type* | Production Date | Tread Depth (mm) |
|---|---|---|---|---|---|---|---|
| Front Right | 175/65 R14 | 82H | Tracmax | Radial | V | 1419 | 0 mm |

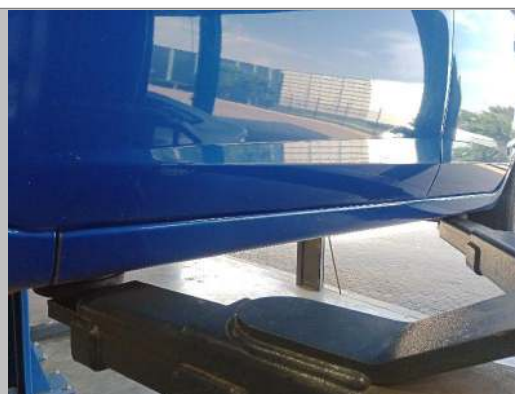
| Damage | Repair Way |
|---|---|
| Rocker Panel Left Dented | Repair |

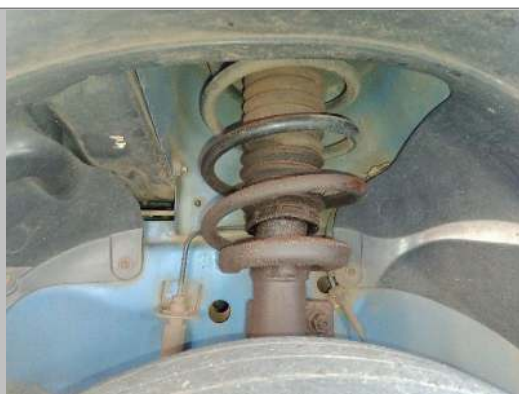
| Damage | Repair Way |
|---|---|
| Shock Absorber Front Left Leak | Replace |

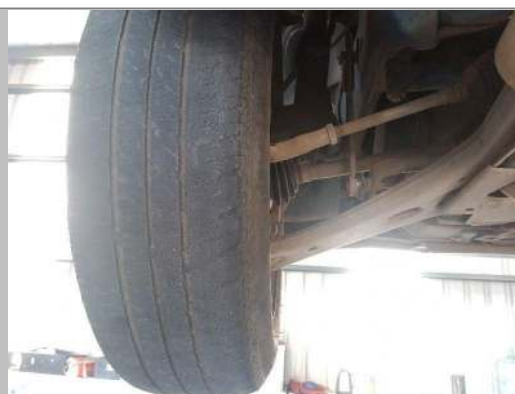
| Damage | Repair Way |
|---|---|
| Tyre Front Left Worn | Replace |

| | Size | Load/Speed Index | Manufacture | Model | Type* | Production Date | Tread Depth (mm) |
|---|---|---|---|---|---|---|---|
| Front Left | 175/65 R14 | 82H | Firestone | Touring | V | 1421 | 0 mm |

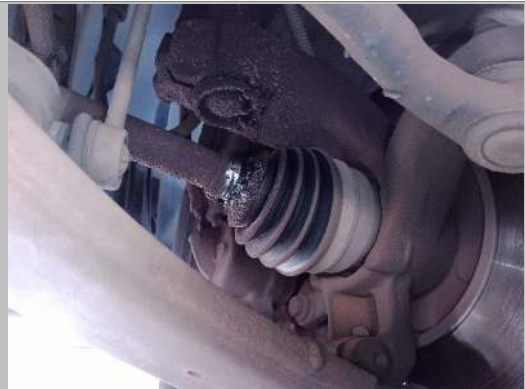
| Damage | Repair Way |
|---|---|
| CV Joint(s) Boot(s) Front Right (inner/outer) Damaged | Replace |

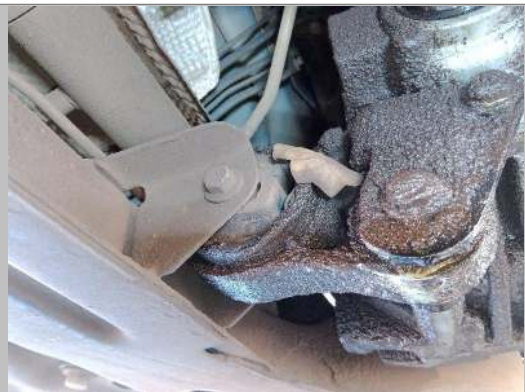
| Damage | Repair Way |
|---|---|
| Gearbox Mountings Cracked | Replace |

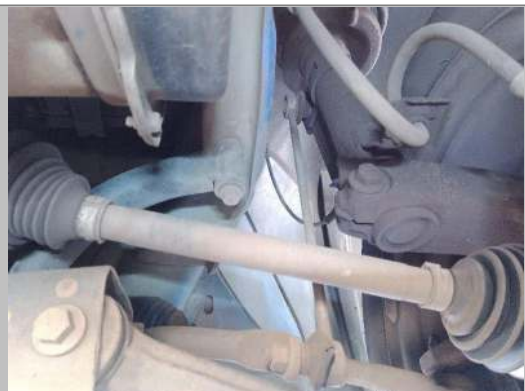
| Damage | Repair Way |
|---|---|
| Stabilizer Mounting Front Left Damaged | Replace |

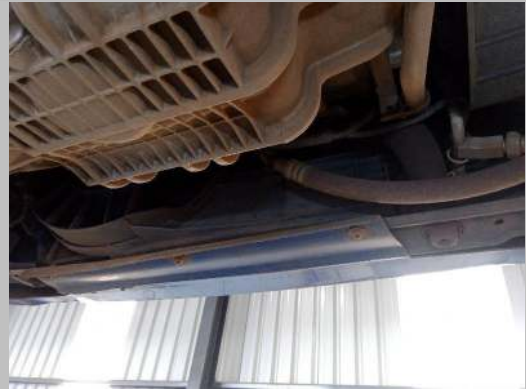
| Damage | Repair Way |
|---|---|
| Radiator Cradle Dented | Repair |

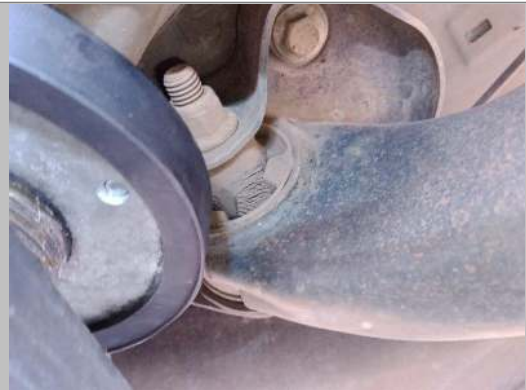
| Damage | Repair Way |
|---|---|
| Mounting Rubber(s) Rear Axle Left Cracked | Replace |

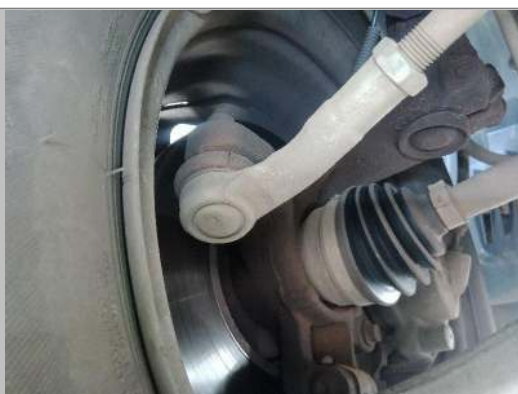
| Damage | Repair Way |
|---|---|
| Tie Rod End left Cracked | Replace |

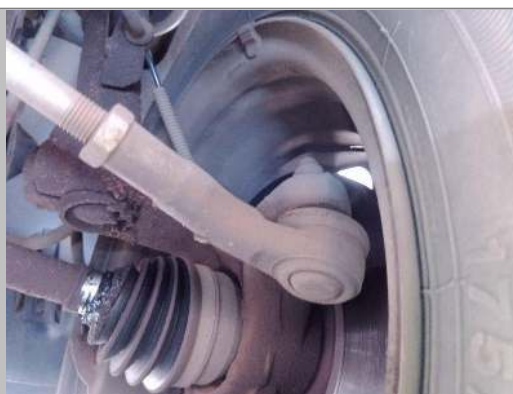
| Damage | Repair Way |
|---|---|
| Tie Rod End right Cracked | Replace |

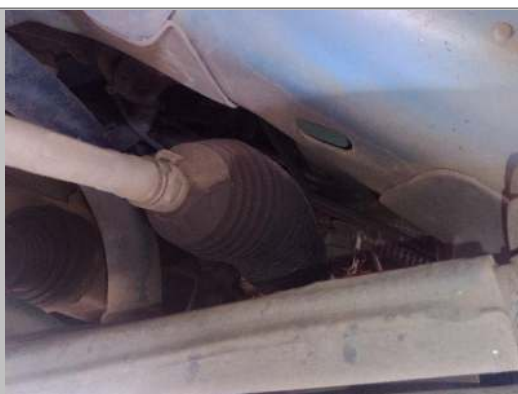
| Damage | Repair Way |
|---|---|
| Steering Rack Boot Left Leak | Replace |

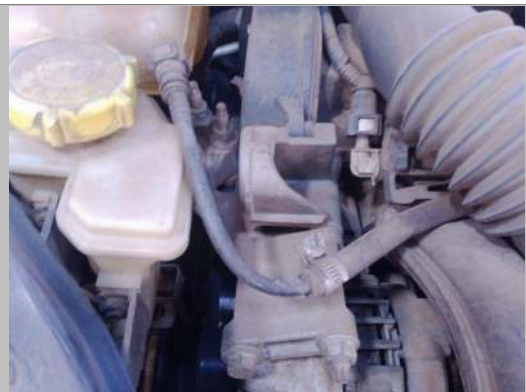
| | Damage | Repair Way |
|---|---|---|
| | Hoses Defective | Replace |

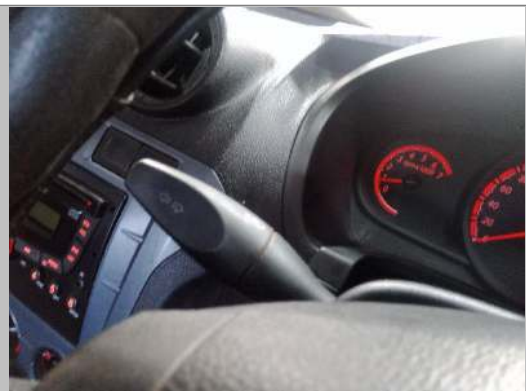
| | Damage | Repair Way |
|---|---|---|
| | Head Light Switch Damaged | Replace |

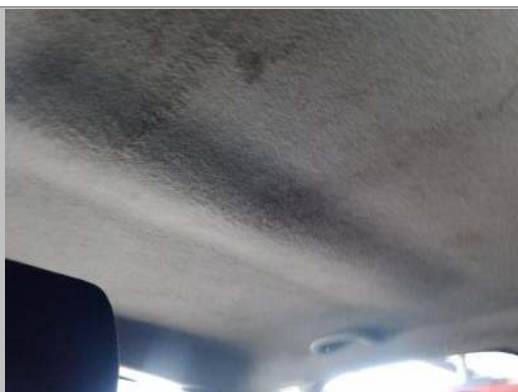
| | Damage | Repair Way |
|---|---|---|
| | Hood Lining Defective | Repair |

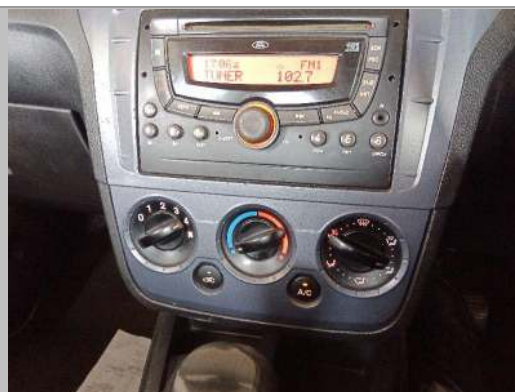
| | Damage | Repair Way |
|---|---|---|
| | Air Conditioner Insufficient | Replace |

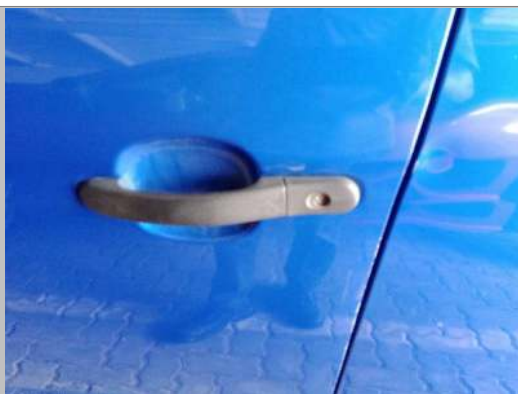
| | Damage | Repair Way |
|---|---|---|
| | Door Lock Front Left Defective | Replace |

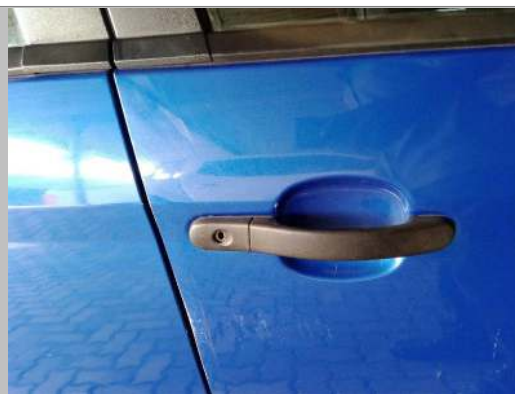
| | Damage | Repair Way |
|---|---|---|
| | Door Lock Front Right Defective | Replace |
