## CONDITION REPORT

Report No: 2016205777

MFC Auction House  
M57 Pretoria Rd, Glenmarais, KEMPTON PARK  
Gauteng

| Manufacturer | FORD | Registration Number | FB66MHGP |

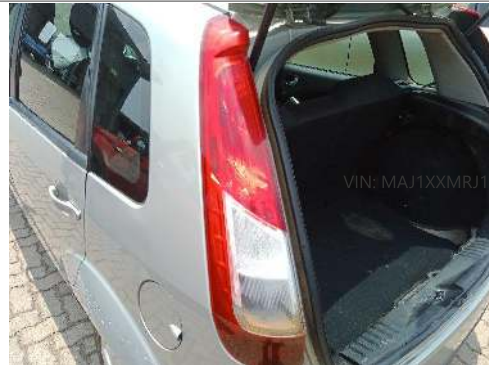
| Damage | Repair Way |
|---|---|
| Tail Light Left Damaged | Replace |

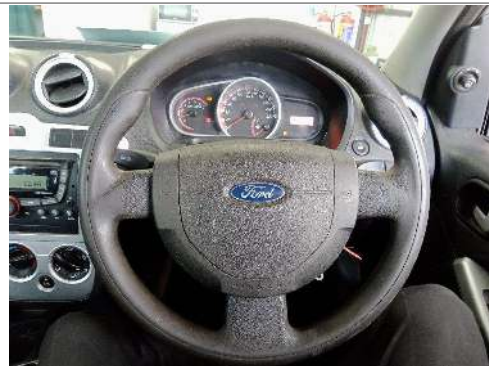
| Damage | Repair Way |
|---|---|
| Steering Wheel Trim Defective | Repair |

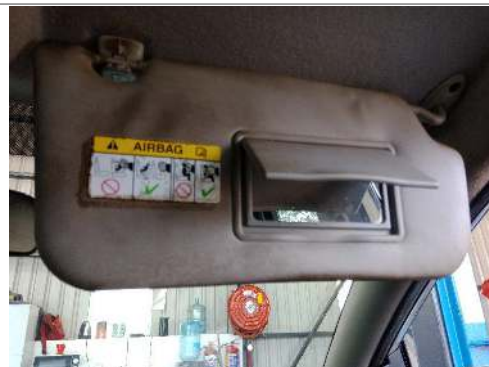
| Damage | Repair Way |
|---|---|
| Sun Visor Right Defective | Repair |

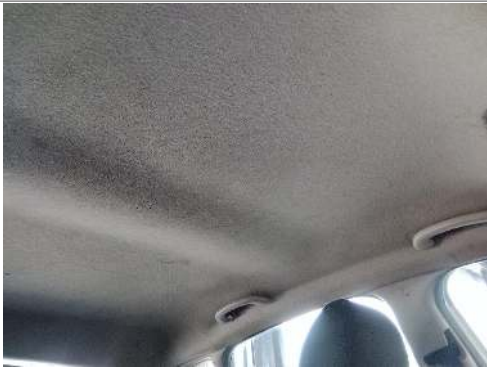
| Damage | Repair Way |
|---|---|
| Hood Lining Dirty | Repair |

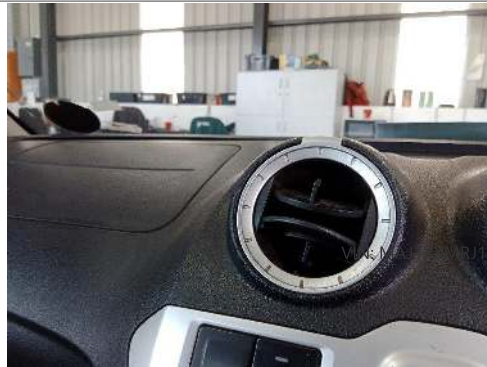
| Damage | Repair Way |
|---|---|
| Central Air Vent Damaged | Replace |

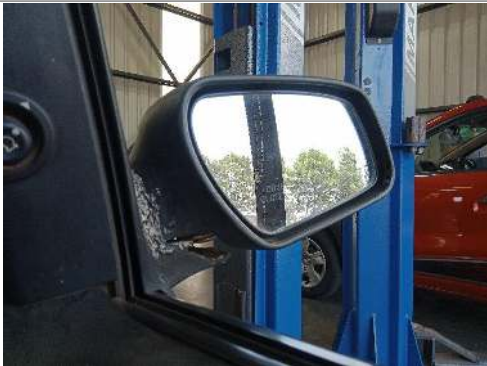
| Damage | Repair Way |
|---|---|
| Side Mirror Right Damaged | Replace |

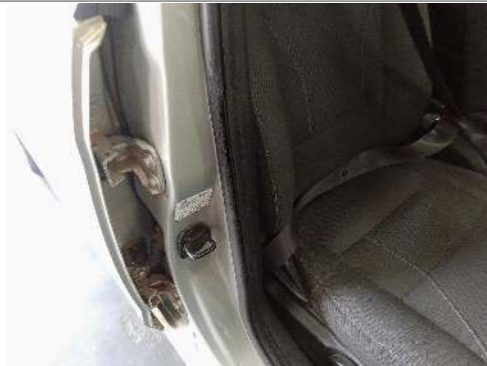
| Damage | Repair Way |
|---|---|
| Door Sealing Rubber Front Right Damaged | Replace |

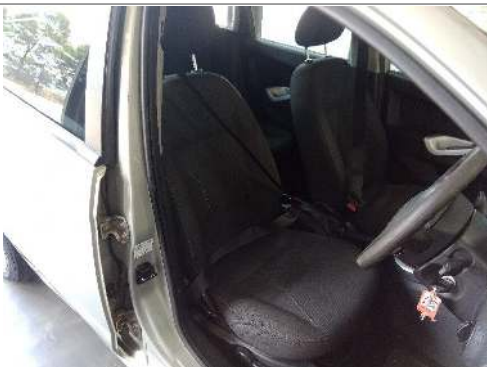
| Damage | Repair Way |
|---|---|
| Seat Front Right Dirty | Repair |

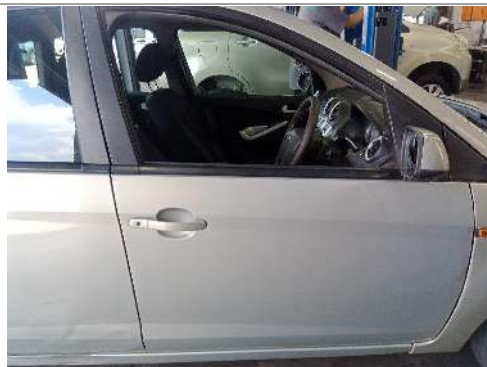
| Damage | Repair Way |
|---|---|
| Door Front Right Paintwork • Scratched | Repair |

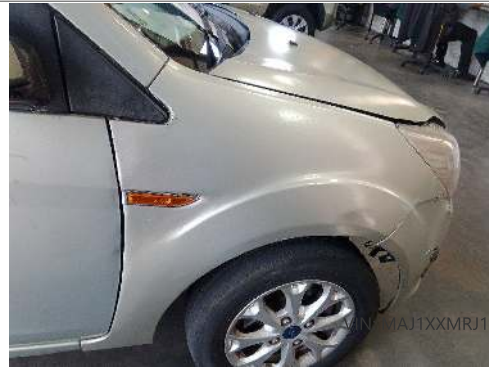
| Damage | Repair Way |
|---|---|
| Front Fender Right Residual Traces of Repair | Replace |

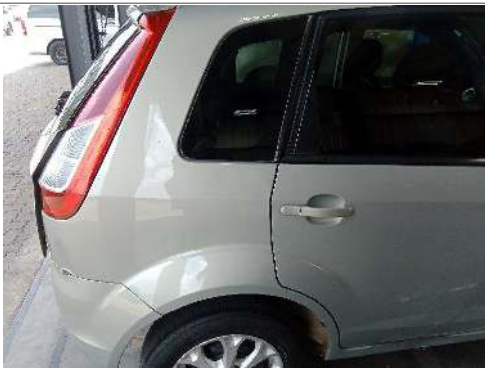
| Damage | Repair Way |
|---|---|
| Rear Fender Right Paintwork • Scratched | Repair |

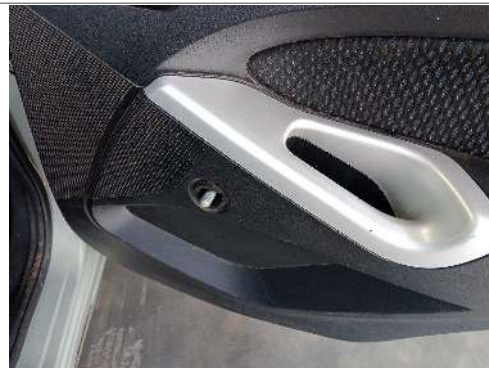
| Damage | Repair Way |
|---|---|
| Window Winder rear right Missing | Replace |

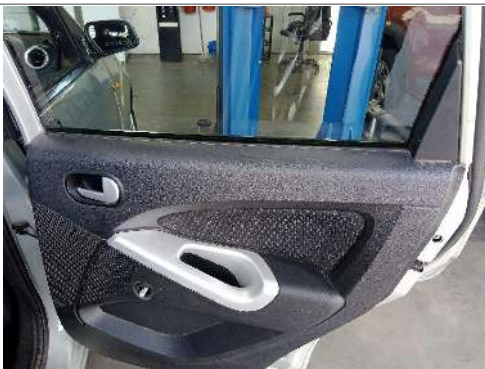
| Damage | Repair Way |
|---|---|
| Door Panel Rear Right Defective | Repair |

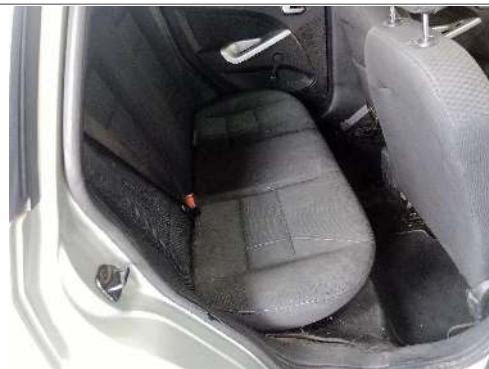
| Damage | Repair Way |
|---|---|
| Seat Rear Dirty | Repair |

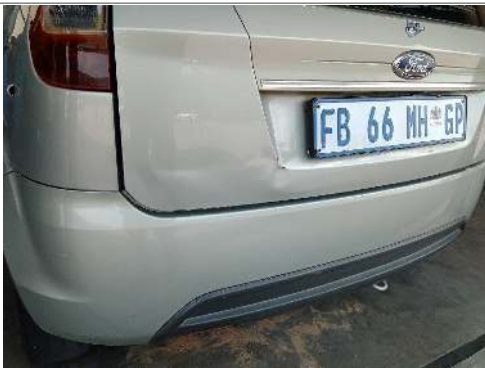
| Damage | Repair Way |
|---|---|
| Rear bumper Paintwork • Scratched | Repair |

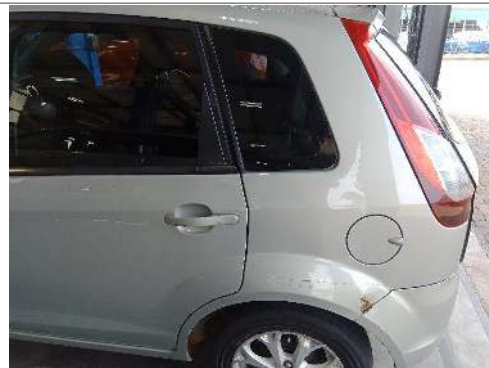
| Damage | Repair Way |
|---|---|
| Rear Fender Left Damaged | Repair |

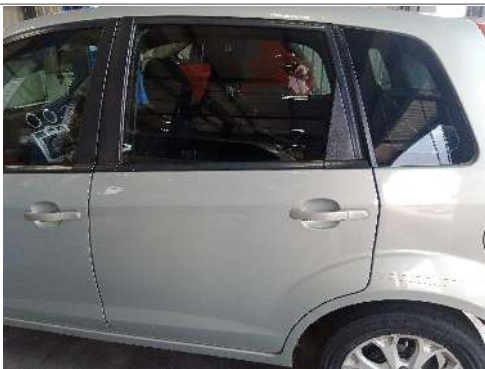
| Damage | Repair Way |
|---|---|
| Door Rear Left Paintwork • Scratched | Repair |

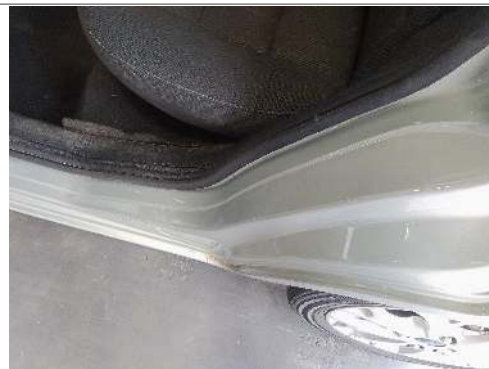
| Damage | Repair Way |
|---|---|
| C • Pillar Left Dented | Repair |

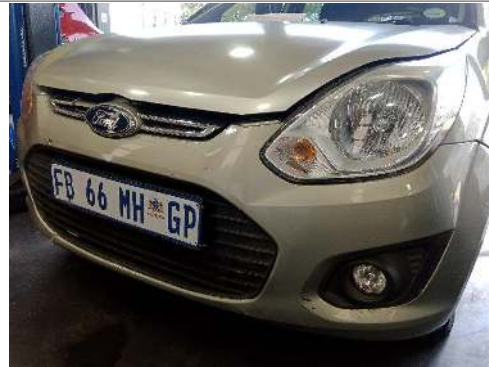
| Damage | Repair Way |
|---|---|
| Front Bumper Damaged | Replace |

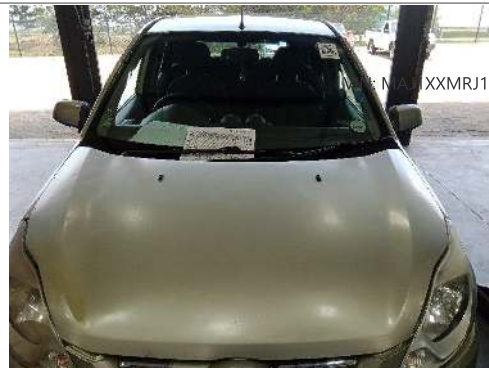
| Damage | Repair Way |
|---|---|
| Bonnet Residual Traces of Repair | Replace |

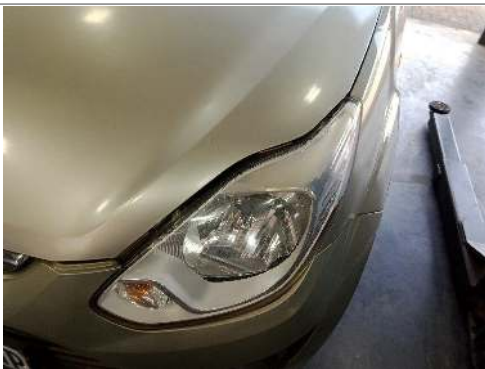
| Damage | Repair Way |
|---|---|
| Headlight Left Scratched | Repair |

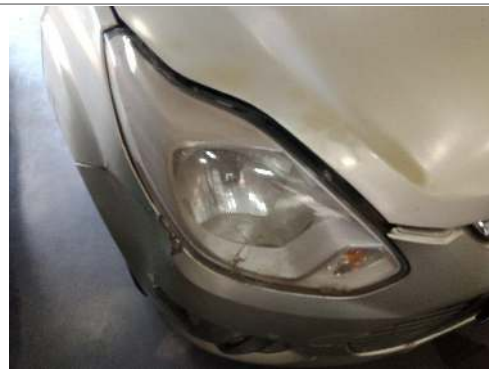
| Damage | Repair Way |
|---|---|
| Headlight Right Damaged | Replace |

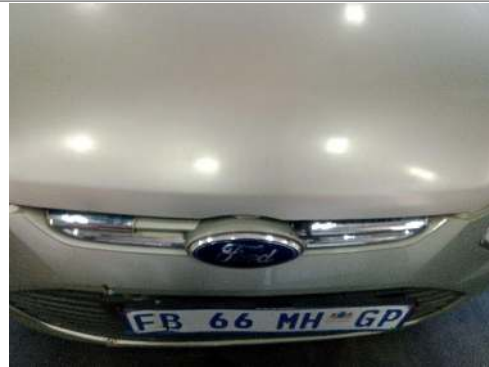
| Damage | Repair Way |
|---|---|
| Grill Broken | Replace |

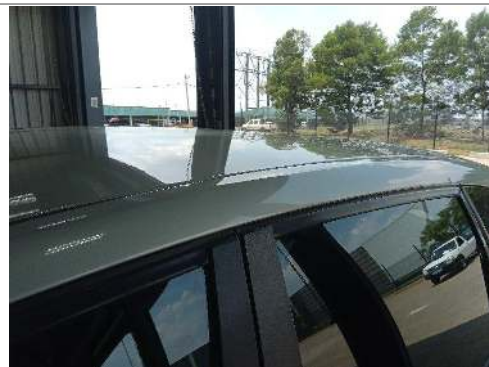
| Damage | Repair Way |
|---|---|
| B • Pillar Left Dented | Repair |

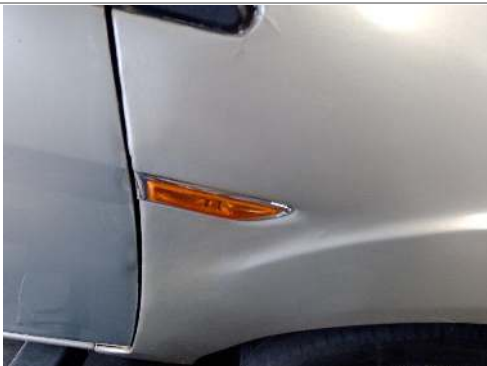
| Damage | Repair Way |
|---|---|
| Indicator Light Front Right Damaged | Replace |

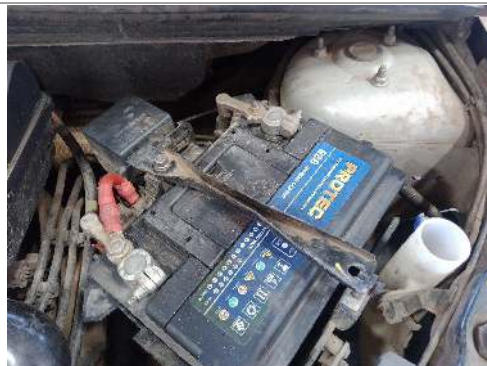
| Damage | Repair Way |
|---|---|
| Battery clamps Defective | Repair |

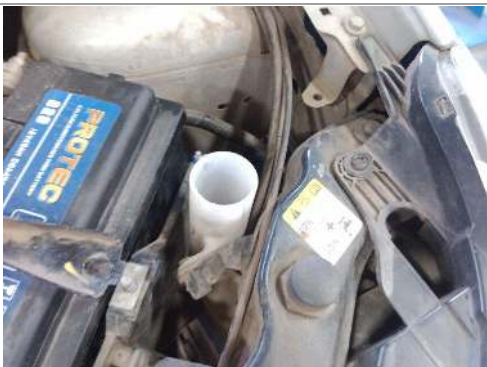
| Damage | Repair Way |
|---|---|
| Caps Missing | Replace |

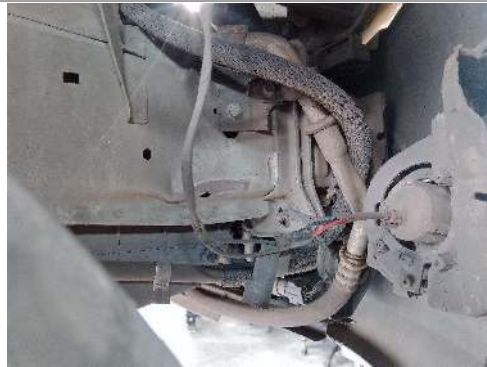
| Damage | Repair Way |
|---|---|
| Engine Wiring Defective | Repair |

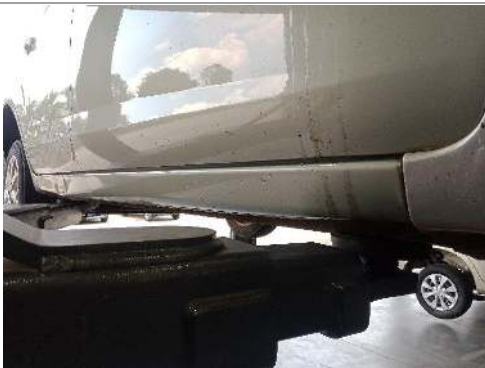
| Damage | Repair Way |
|---|---|
| Rocker Panel Right Damaged | Repair |

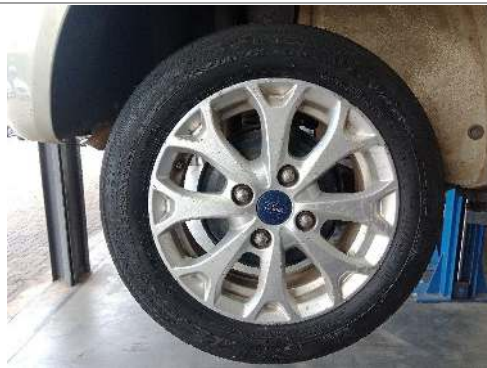
| Damage | Repair Way |
|---|---|
| Tyre Rear Right Damaged | Replace |

| | Size | Load/Speed Index | Manufacture | Model | Type* | Production Date | Tread Depth (mm) |
|---|---|---|---|---|---|---|---|
| Rear Right | 165/65 R14 | 79T | Falken | Sincera | V | 0620 | 1 mm |

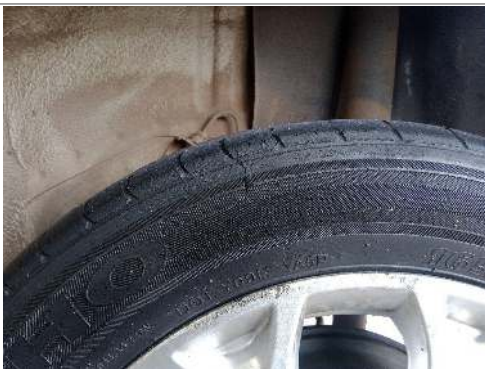
| Damage | Repair Way |
|---|---|
| Tyre Rear Left Damaged | Replace |

| | Size | Load/Speed Index | Manufacture | Model | Type* | Production Date | Tread Depth (mm) |
|---|---|---|---|---|---|---|---|
| Rear Left | 165/65 R14 | 79T | Kumho | Solus | V | 2713 | 0 mm |

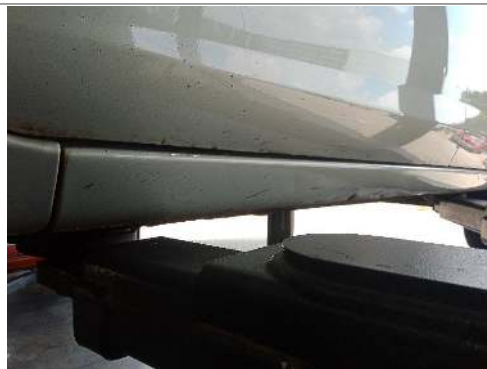
| Damage | Repair Way |
|---|---|
| Rocker Panel Left Dented | Repair |

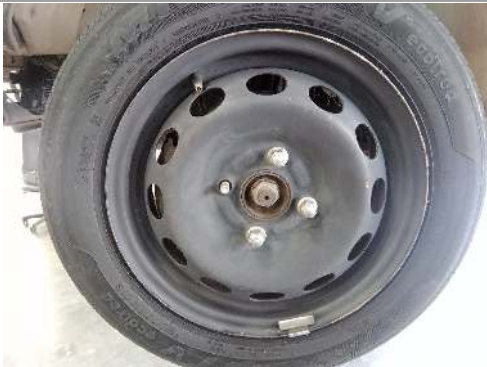
| Damage | Repair Way |
|---|---|
| Rim Front Left Scratched | Repair |

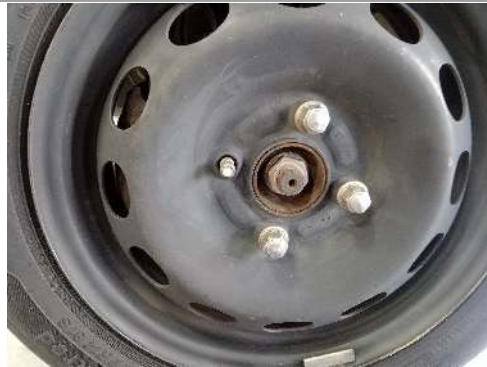
| Damage | Repair Way |
|---|---|
| Bolt(s) / Nut(s) Front Wheel Left Missing | Replace |

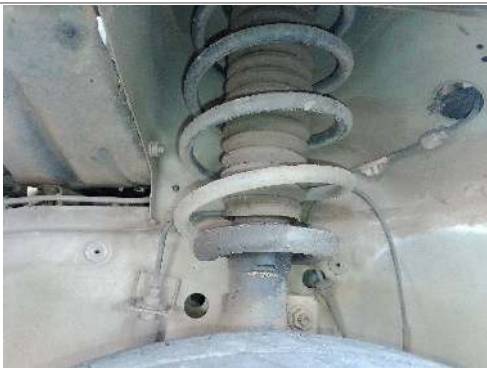
| Damage | Repair Way |
|---|---|
| Shock Absorber Front Left Sweat | Replace |

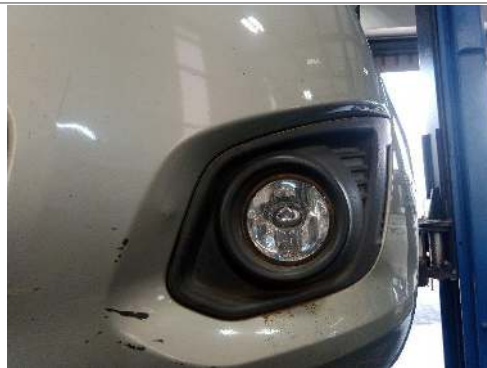
| Damage | Repair Way |
|---|---|
| Fog Light Front Left Defective | Repair |

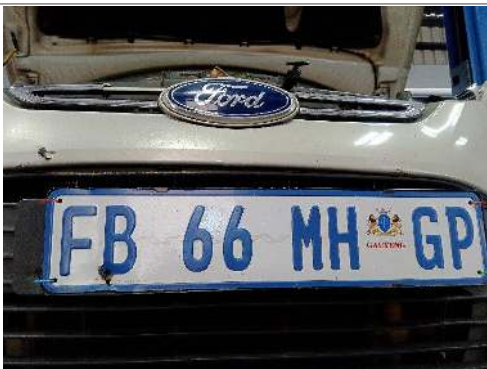
| Damage | Repair Way |
|---|---|
| Number Plate Front Damaged | Replace |

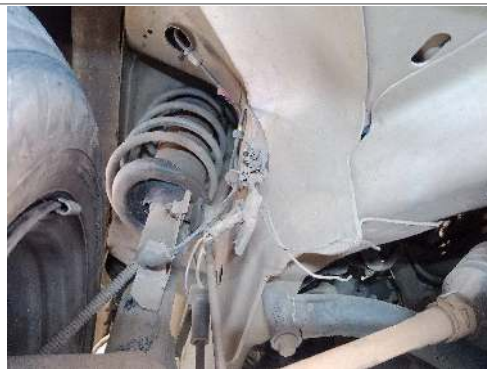
| Damage | Repair Way |
|---|---|
| Speed Sensor Damaged | Replace |

Brakes: Front left wheel binding. Front left and right speed sensors damaged. Front right brake piping loose and stay bracket missing.  
Axle and Suspension: Abnormal noise coming from front and rear suspension. Signs of vehicle grabbing.  
Tyres and Rims: Alloy rims scratched. Front left and rear right tyres have reached legal limit. Front left tyre deflated.  
Undercarriage: Vehicle undercarriage dirty.

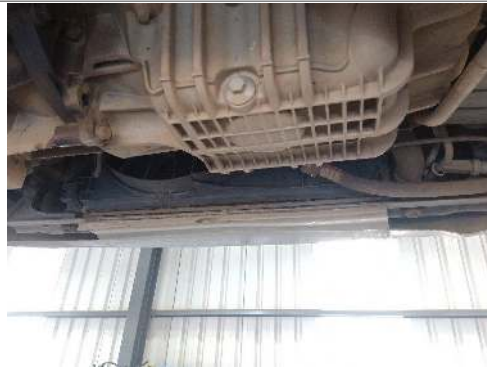
| Damage | Repair Way |
|---|---|
| Radiator Cradle Dented | Repair |

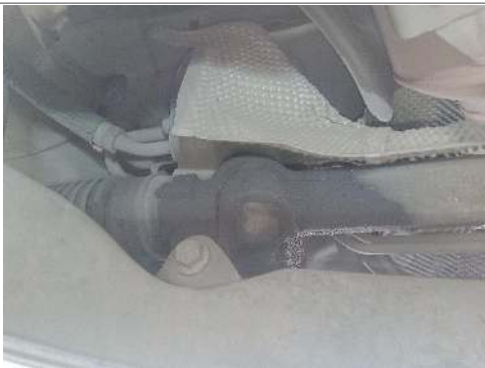
| Damage | Repair Way |
|---|---|
| Steering box Sweat | Repair |

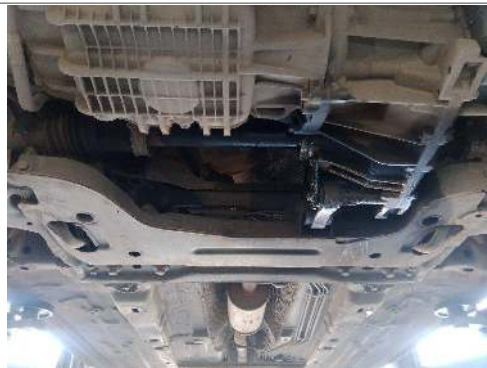
| Damage | Repair Way |
|---|---|
| Sub Frame Scratched | Repair |

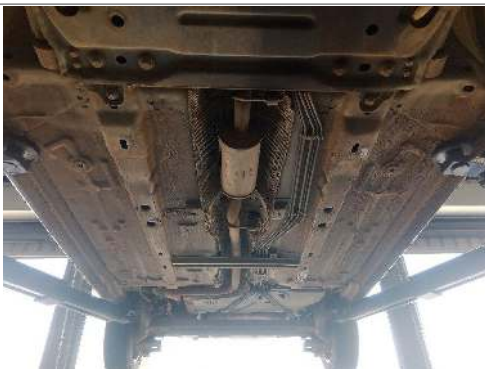
| Damage | Repair Way |
|---|---|
| Chassis Dented | Repair |

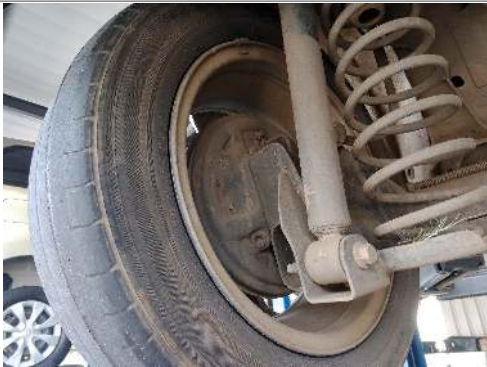
| Damage | Repair Way |
|---|---|
| Rim Rear Left Dented | Repair |

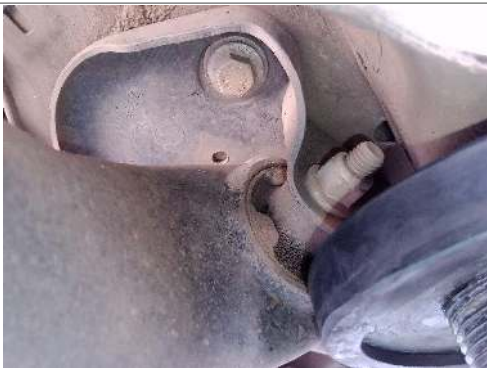
| Damage | Repair Way |
|---|---|
| Mounting Rubber(s) Rear Axle Right Cracked | Replace |

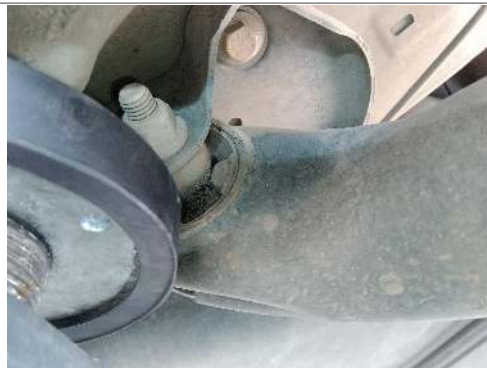
| Damage | Repair Way |
|---|---|
| Mounting Rubber(s) Rear Axle Left Cracked | Replace |

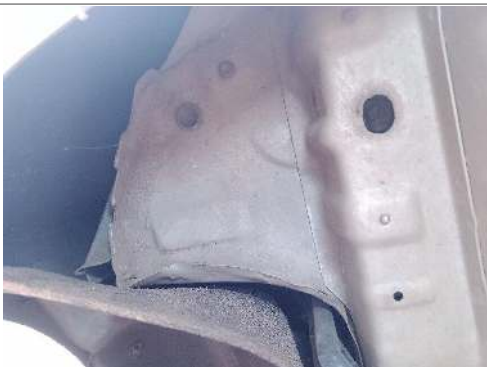
| Damage | Repair Way |
|---|---|
| Rear Fender Left / Inner Tray Dented | Repair |

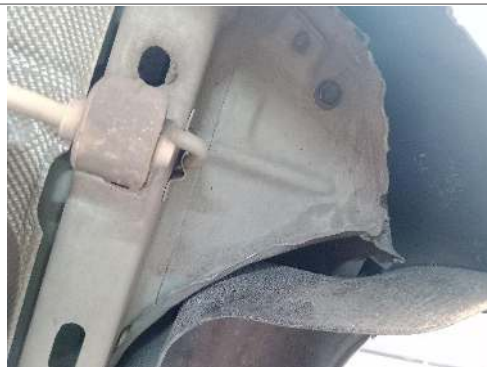
| Damage | Repair Way |
|---|---|
| Rear Fender Right / Inner Tray Dented | Repair |

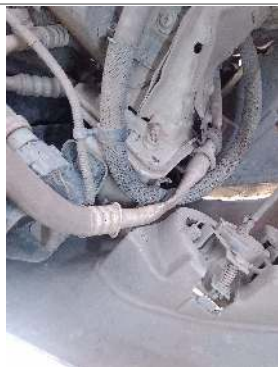
| Damage | Repair Way |
|---|---|
| Air conditioner pipes Damaged | Replace |

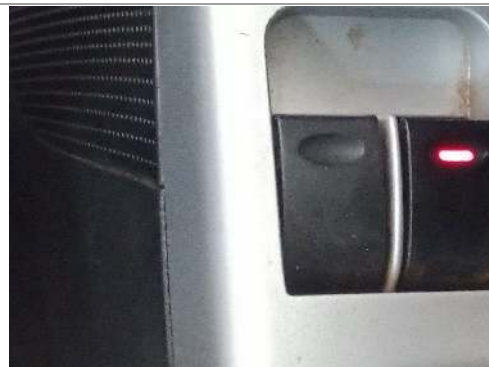
| Damage | Repair Way |
|---|---|
| Switch Electrical Window Winder front right Malfunction | Repair |
