## CONDITION REPORT

Report No:  
2016917663  
DATE  
19/06/2025

| Manufacturer | FORD | Registration Number | HG17DTGP |
| Model | FIGO 1.5 AMBIENTE [2015-2018] | Register Number | |

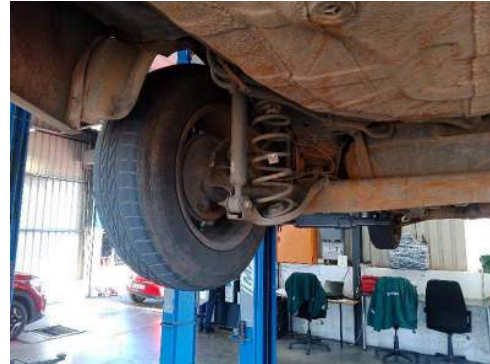
LR TYRE TREAD

| Rear tyres size differs | Replace |

| | Size | Load/Speed Index | Manufacture | Model | Type* | Production Date | Tread Depth (mm) |
|---|---|---|---|---|---|---|---|
| Rear Left | 165/80R14 | 85T | Apollo | Amazer | V | 3618 | 2 mm |

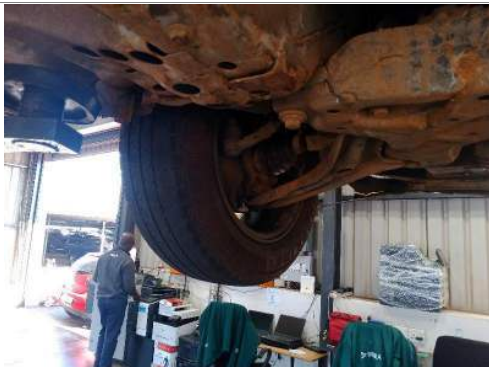
LF TYRE TREAD

| | Size | Load/Speed Index | Manufacture | Model | Type* | Production Date | Tread Depth (mm) |
|---|---|---|---|---|---|---|---|
| Front Left | 185/65R14 | 86H | Good ride | Radial Rp28 | V | 0321 | 2 mm |

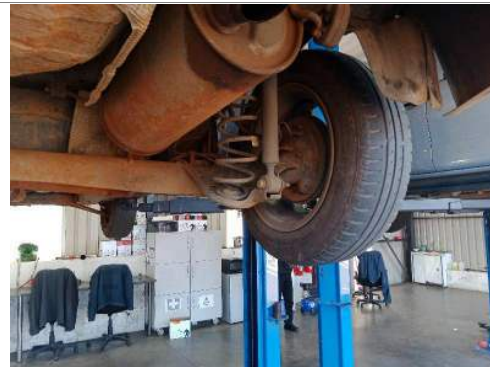
RR TYRE TREAD

| | Size | Load/Speed Index | Manufacture | Model | Type* | Production Date | Tread Depth (mm) |
|---|---|---|---|---|---|---|---|
| Rear Right | 175/65R14 | 82T | Continental | Contact | V | 4219 | 3 mm |

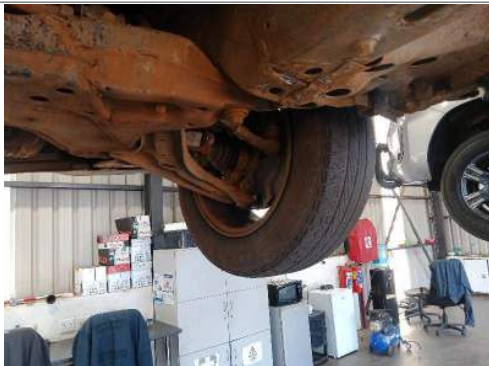
RF TYRE TREAD

| | Size | Load/Speed Index | Manufacture | Model | Type* | Production Date | Tread Depth (mm) |
|---|---|---|---|---|---|---|---|
| Front Right | 185/65R14 | 86H | Goodyear | Duragrip | V | 4317 | 2 mm |

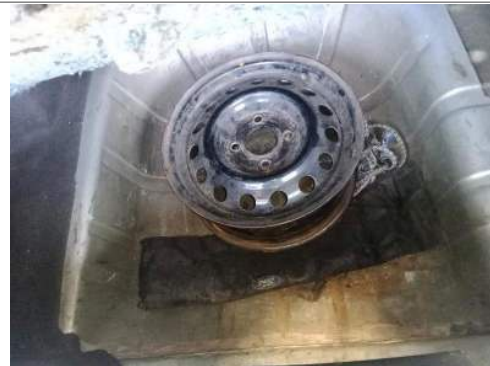
Spare rim no tire

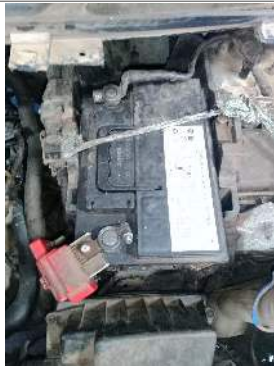
| Battery loose | Repair |

Battery loose

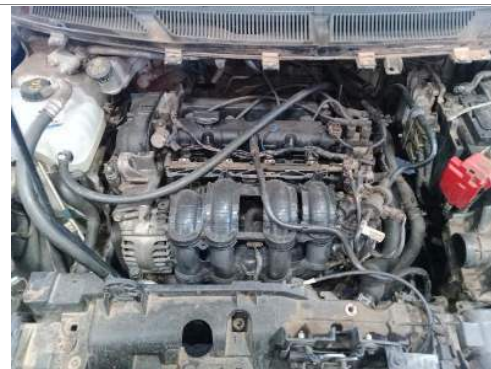
| Engine Wiring Defective | Repair |

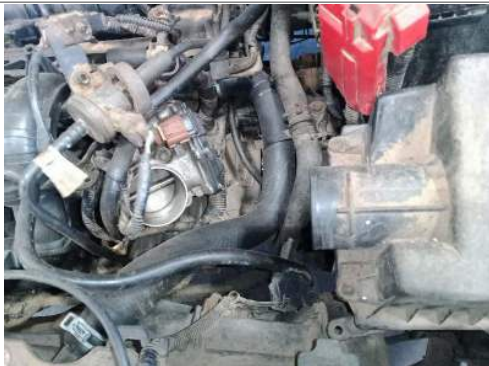
| Air cleaner Damaged | Repair |

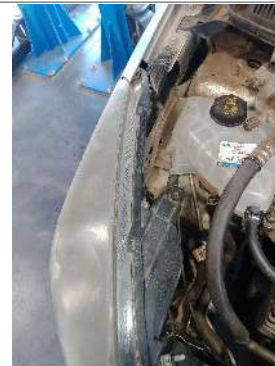
| Headlight Right Damaged | Repair |

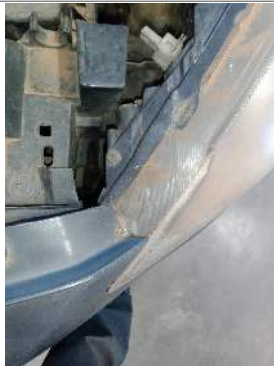
| Headlight Left Damaged | Replace |

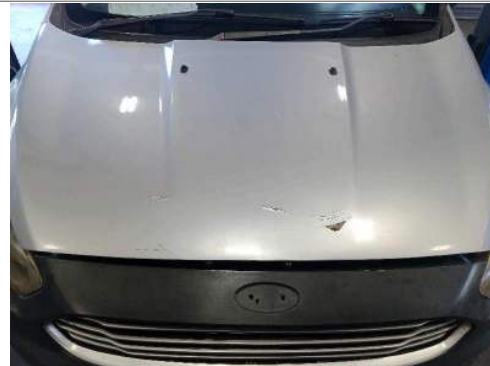
| Bonnet Paintwork • Flaking | Repair |
| Bonnet not closing properly | Repair |

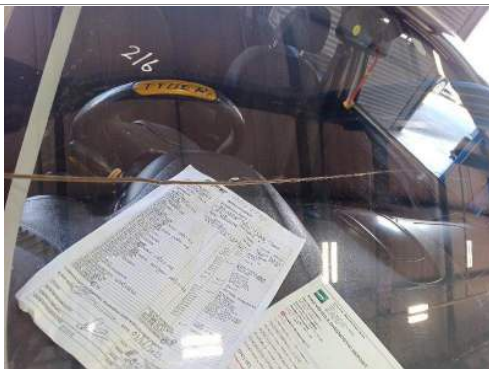
| Windscreen Cracked | Replace |

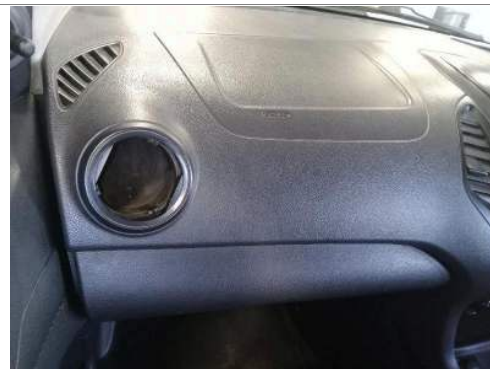
| Central Air Vent Damaged | Repair |

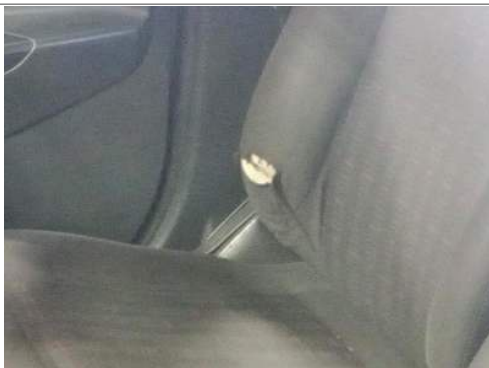
| Seat Front Right Torn / Cut | Repair |

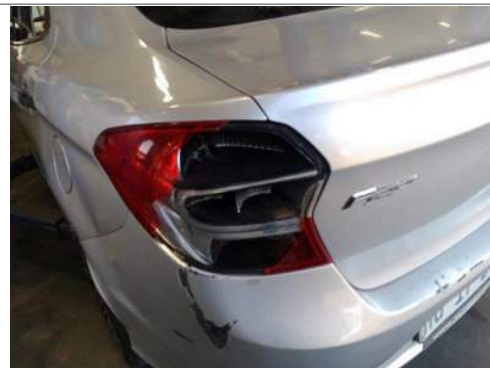
| Tail Light Left Damaged | Replace |

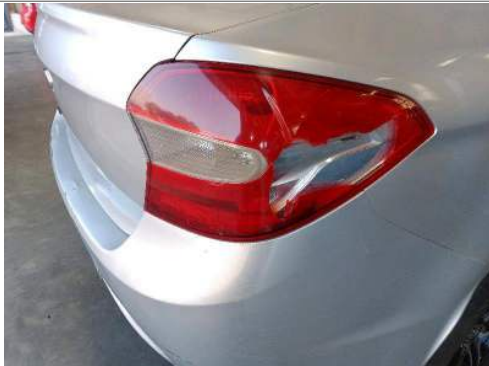
| Tail Light Right Damaged | Replace |

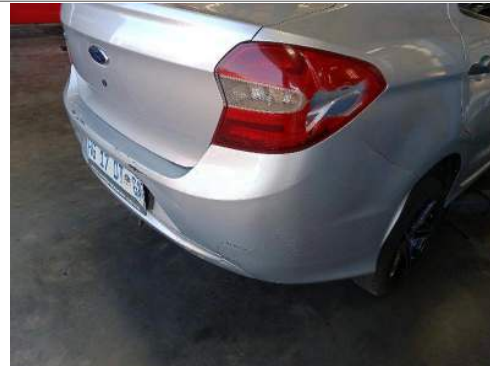
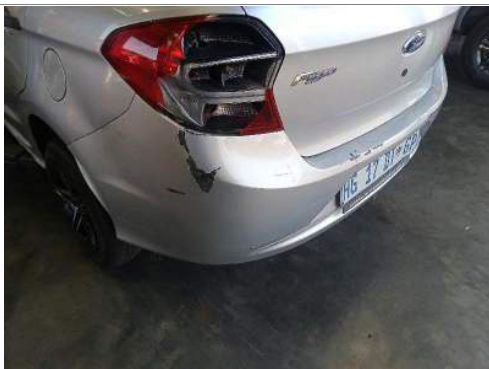
| Rear bumper Paintwork • Scratched | Repair |

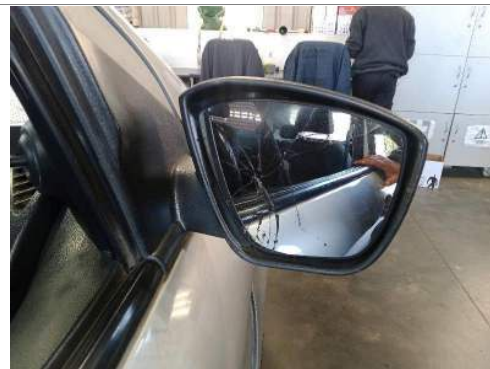
| Side Mirror Right Cracked | Replace |

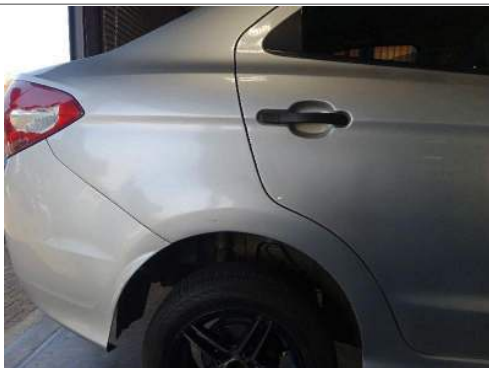
| Rear Fender Right Paintwork • Scratched | Repair |

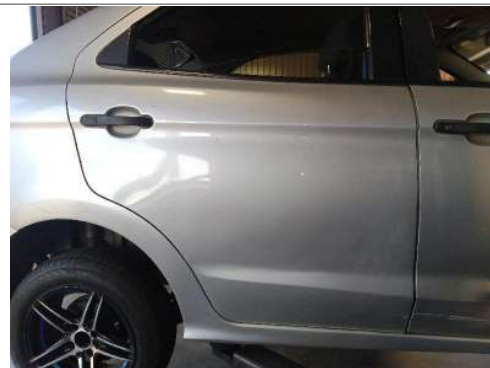
| Door Rear Right Paintwork • Scratched | Repair |

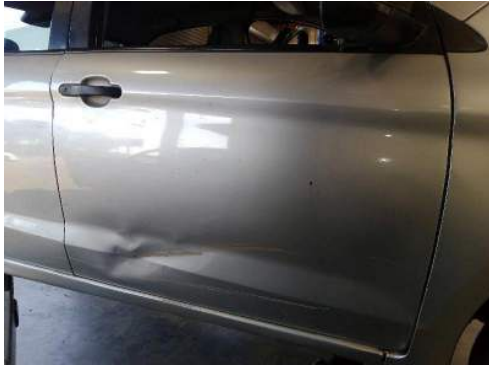
| Door Front Right Dented | Repair |

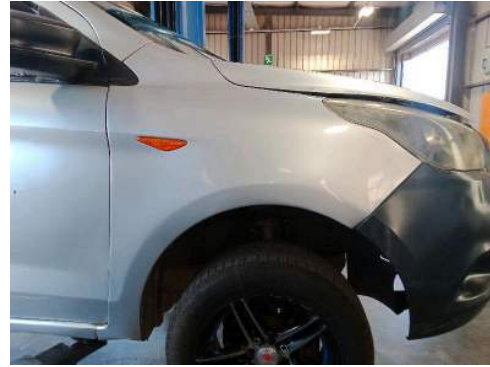
| Front Fender Right Residual Traces of Repair | Repair |

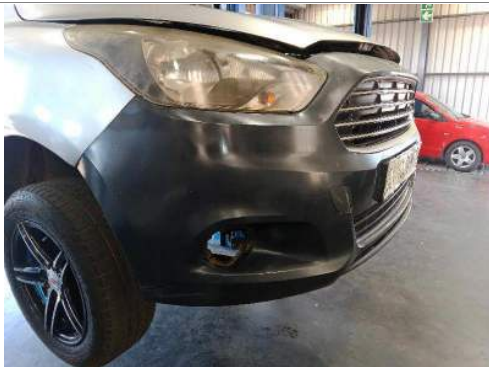
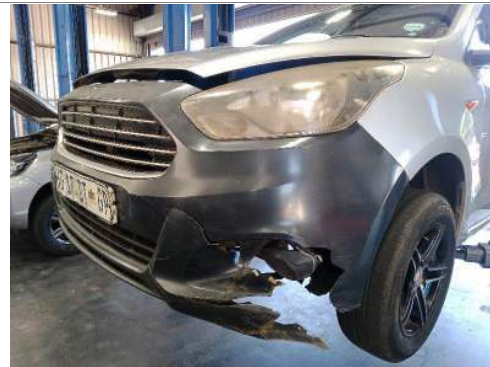
| Front Bumper Damaged | Replace |

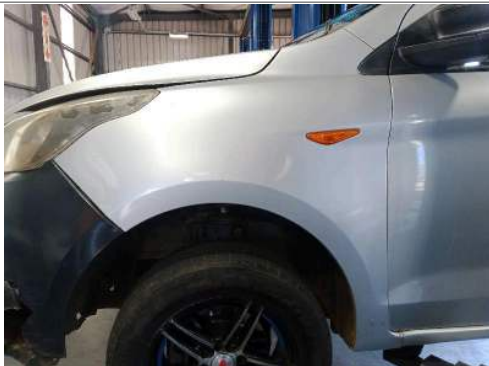
| Front Fender Left Residual Traces of Repair | Repair |

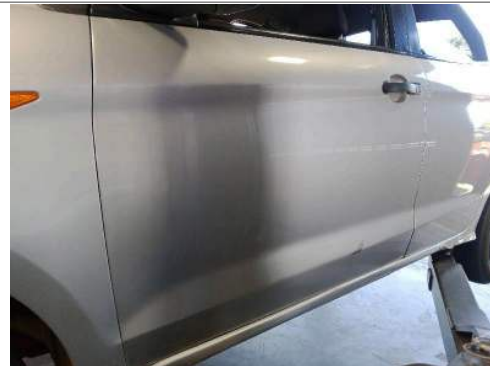
| Door Front Left Paintwork • Scratched | Repair |

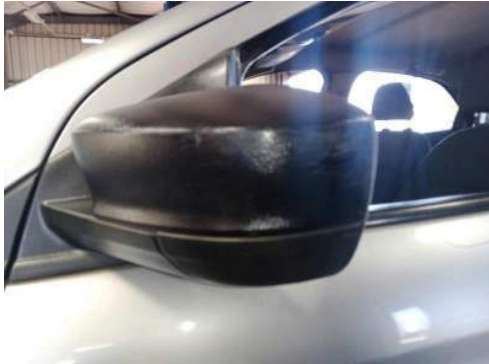
| Side Mirror Left Paintwork • Scratched | Repair |

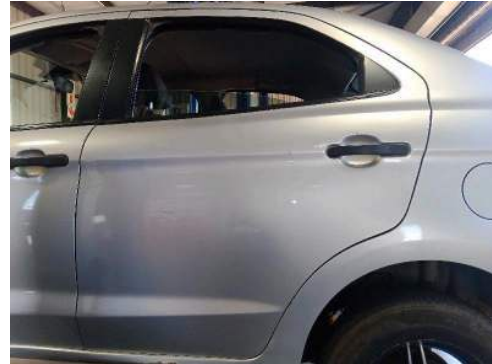
| Door Rear Left Residual Traces of Repair | Repair |

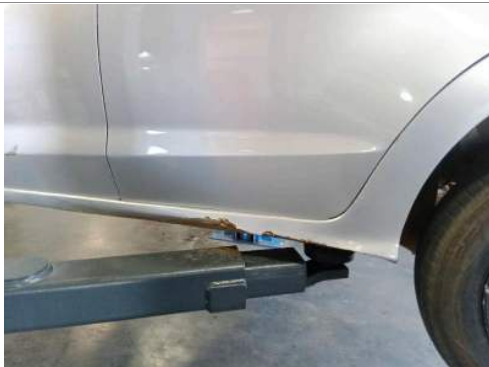
| Sill Panel Left Dented | Repair |

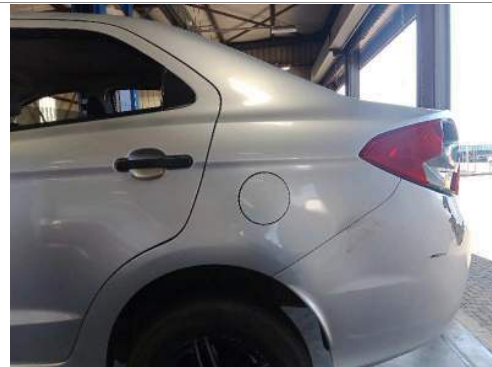
| Rear Fender Left Paintwork • Scratched | Repair |

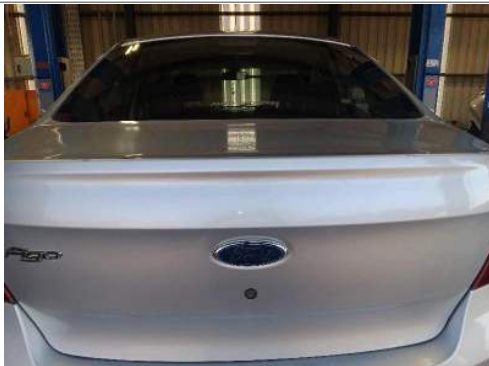
| Boot Lid / Hatch door Paintwork • Scratched | Repair |

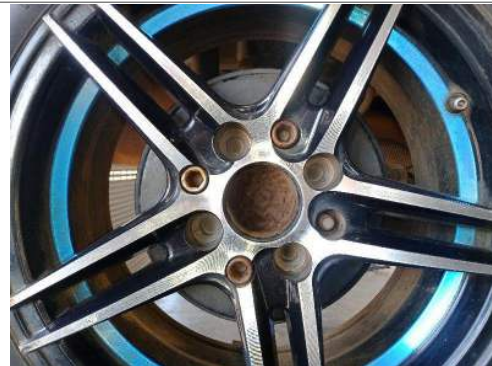
| Bolt(s) / Nut(s) Rear Wheel Right Missing | Replace |

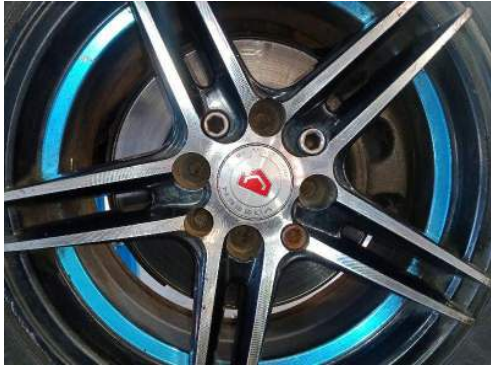
| Bolt(s) / Nut(s) Front Wheel Right Missing | Replace |

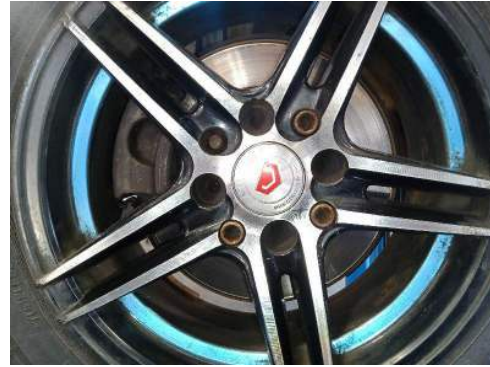
| Bolt(s) / Nut(s) Front Wheel Left Missing | Replace |

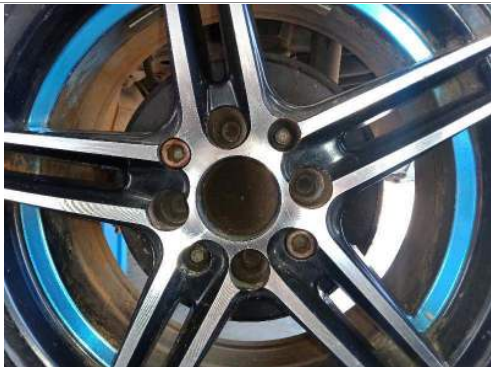
| Bolt(s) / Nut(s) Rear Wheel Left Missing | Replace |

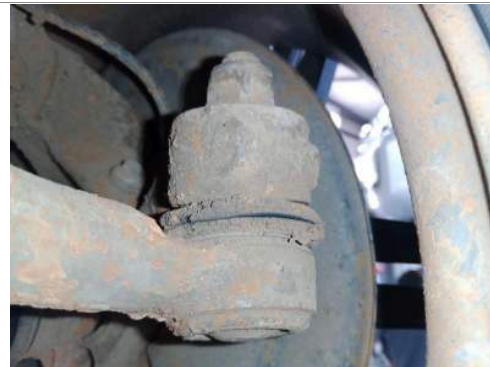
| Tie Rod End right Damaged | Replace |

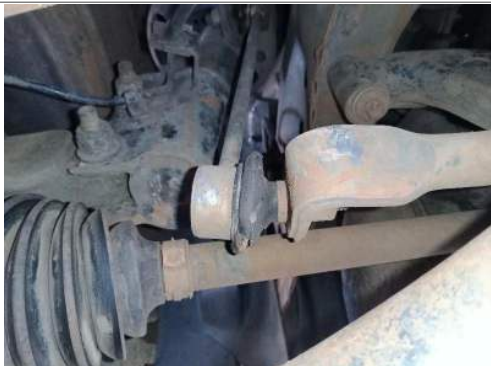
| Stabilizer Mounting Front Left Damaged | Replace |

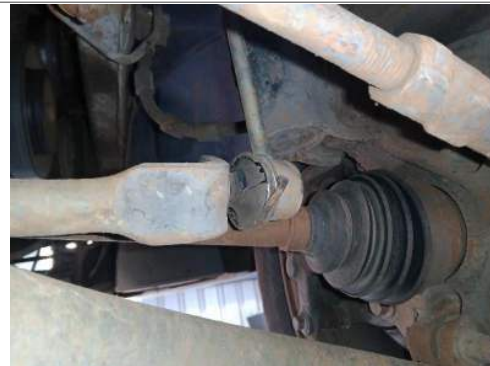
| Stabilizer Mounting Front Right Damaged | Replace |

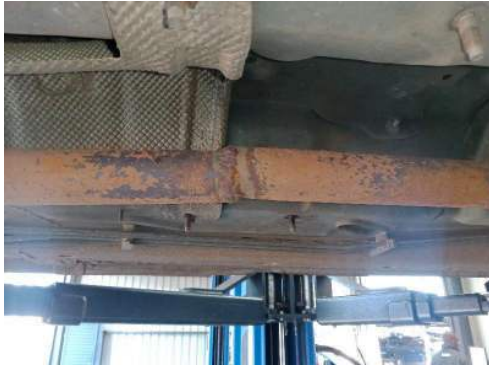
| Engine to silencer pipe Welded | Repair |

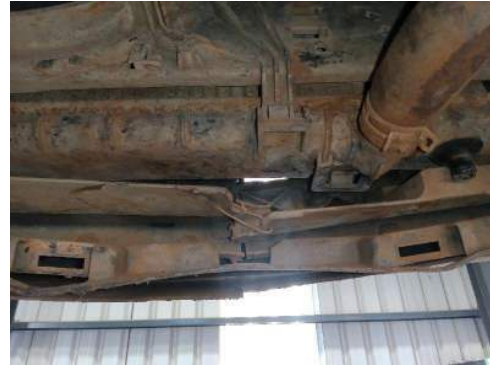
| Radiator Cradle Damaged | Replace |
