## CONDITION REPORT

Report No: 2016313096

| Manufacturer | FORD | Registration Number | JG91TYGP |
| Model | FIGO | Register Number | |

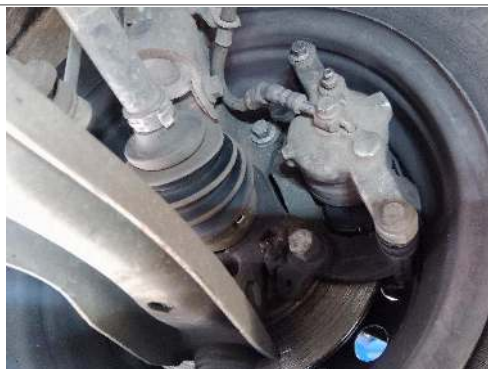
| Damage | Repair Way |
|---|---|
| Axle and suspension | Front left stub axle welded |

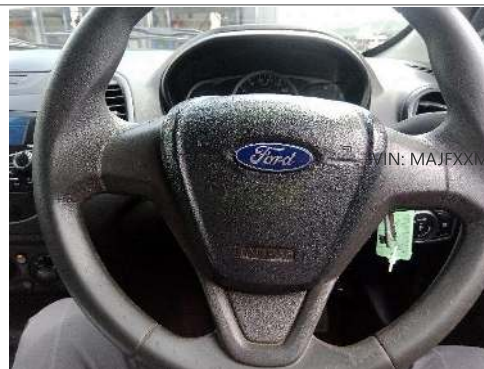
| Damage | Repair Way |
|---|---|
| Hooter Damaged | Replace |

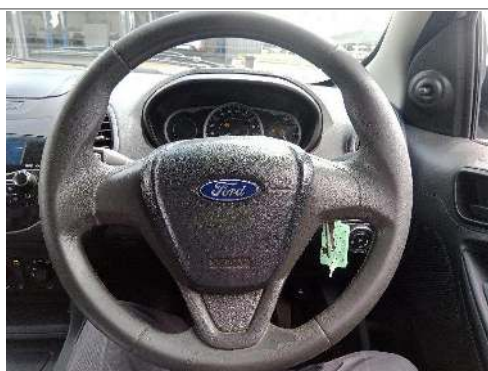
| Damage | Repair Way |
|---|---|
| Steering Wheel Trim Defective | Repair |

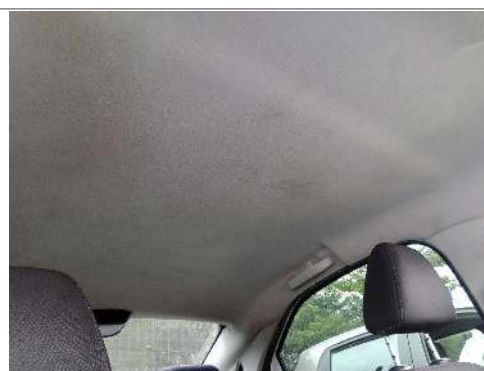
| Damage | Repair Way |
|---|---|
| Hood Lining Dirty | Repair |

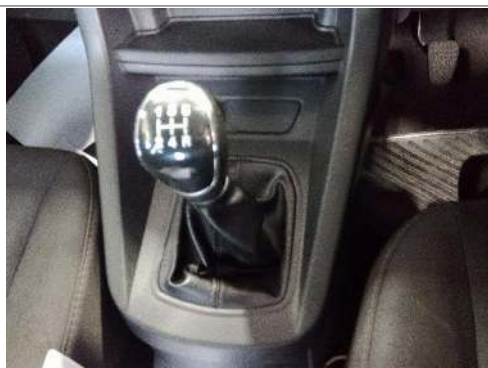
| Damage | Repair Way |
|---|---|
| Gear Selections Malfunction | Repair |

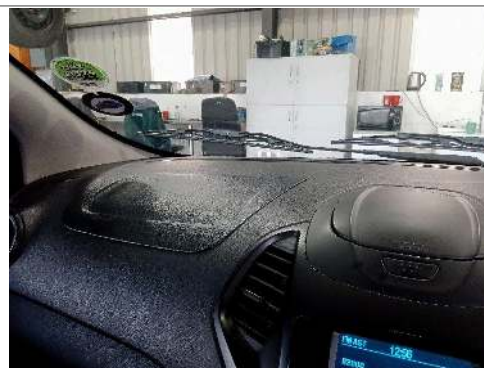
| Damage | Repair Way |
|---|---|
| Dash Padding Defective | Repair |

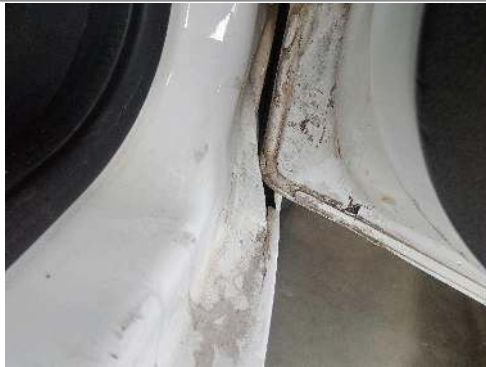
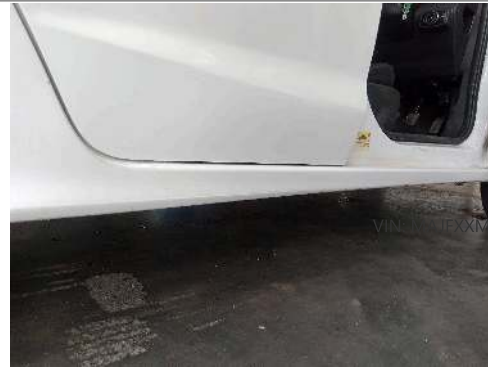
| Damage | Repair Way |
|---|---|
| Sill Panel Right Damaged | Repair |

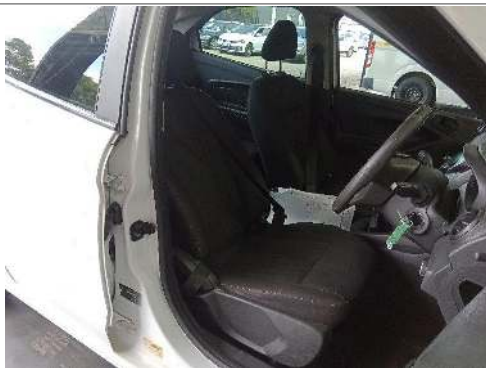
| Damage | Repair Way |
|---|---|
| Seat Front Right Torn / Cut | Repair |

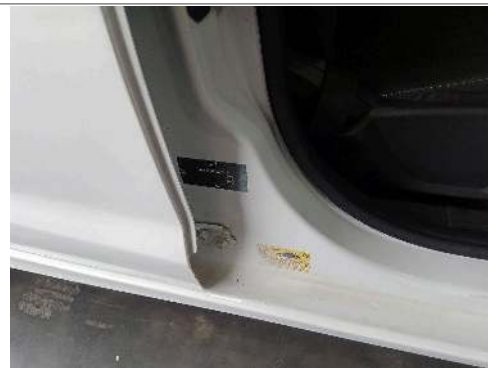
| Damage | Repair Way |
|---|---|
| B • Pillar Right Residual Traces of Repair | Repair |

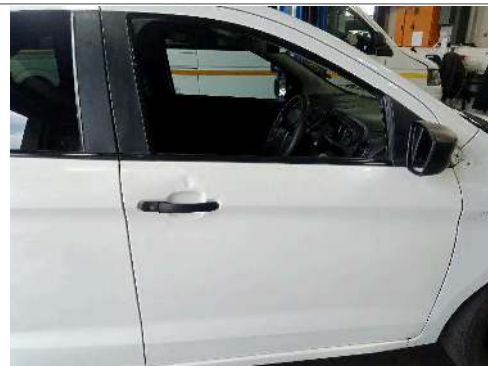
| Damage | Repair Way |
|---|---|
| Door Front Right Residual Traces of Repair | Repair |

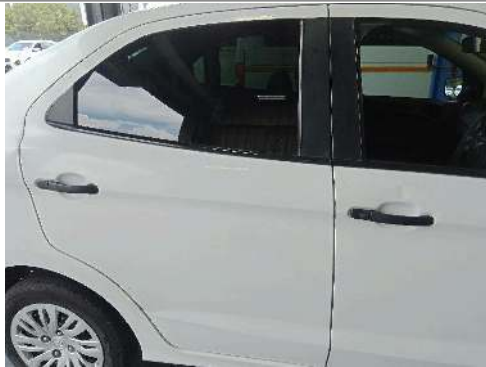
| Damage | Repair Way |
|---|---|
| Door Rear Right Residual Traces of Repair | Repair |

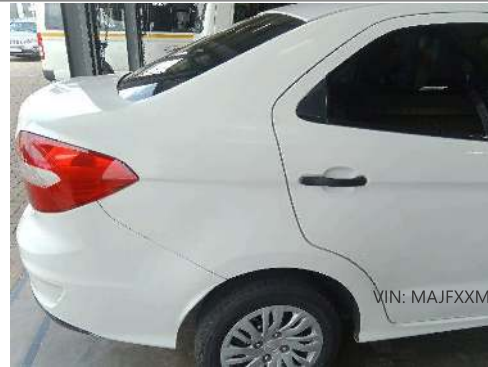
| Damage | Repair Way |
|---|---|
| Rear Fender Right Residual Traces of Repair | Repair |

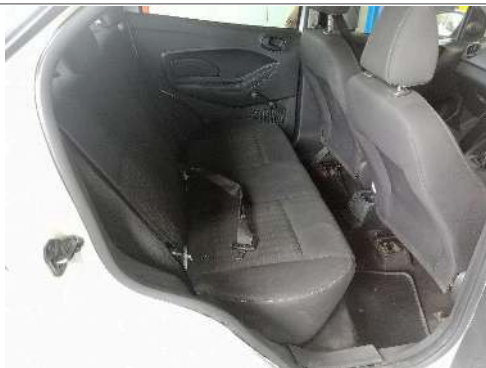
| Damage | Repair Way |
|---|---|
| Seat Rear Damaged | Repair |

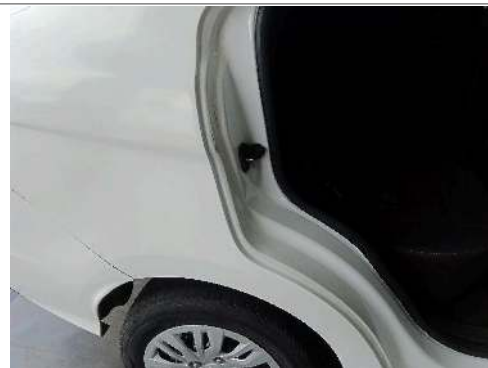
| Damage | Repair Way |
|---|---|
| C • Pillar Right Residual Traces of Repair | Repair |

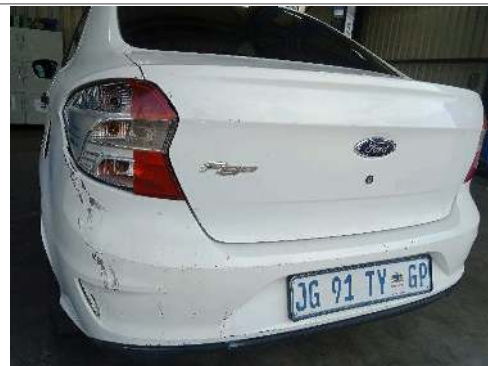
| Damage | Repair Way |
|---|---|
| Rear bumper Damaged | Replace |

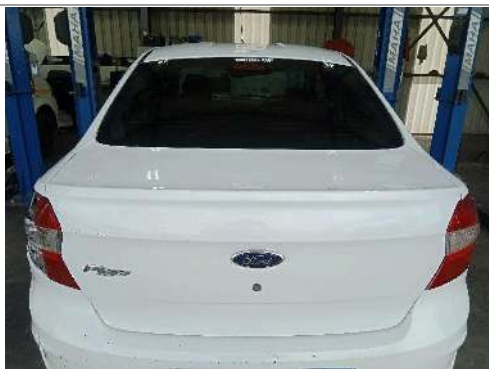
| Damage | Repair Way |
|---|---|
| Boot Lid / Hatch door Paintwork • Scratched | Repair |

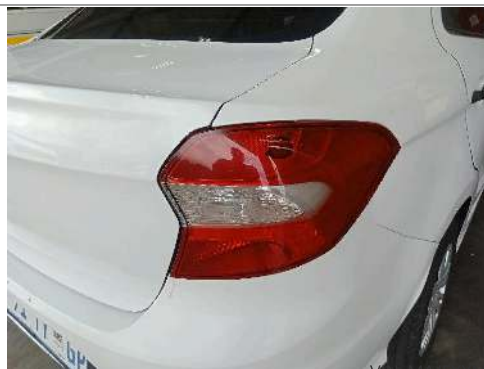
| Damage | Repair Way |
|---|---|
| Tail Light Right Defective | Replace |

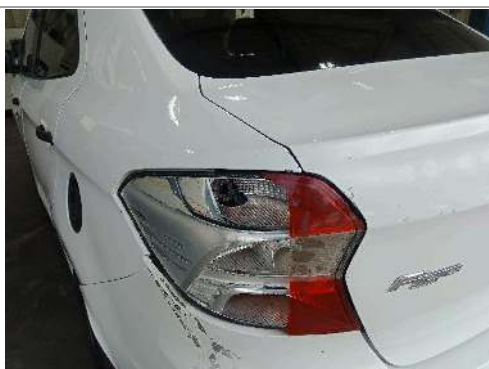
| Damage | Repair Way |
|---|---|
| Tail Light Left Damaged | Replace |

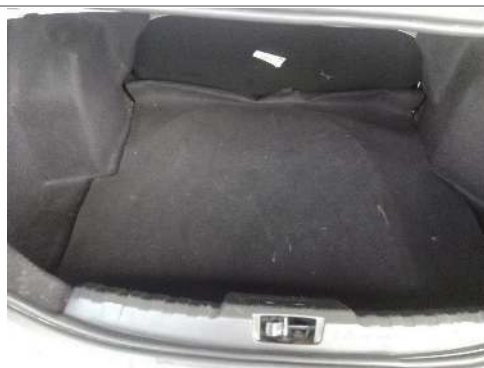
| Damage | Repair Way |
|---|---|
| Boot Carpet Damaged | Repair |

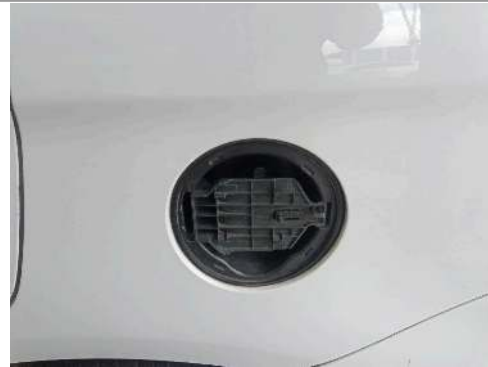
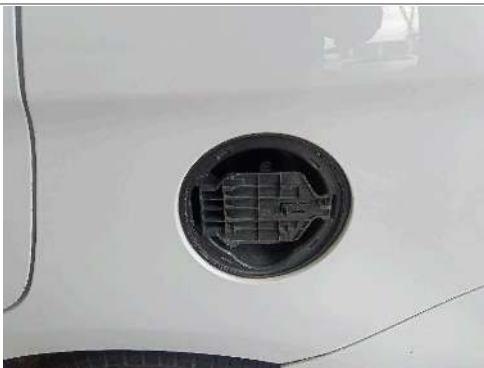
| Damage | Repair Way |
|---|---|
| Fuel Flap Defective | Replace |

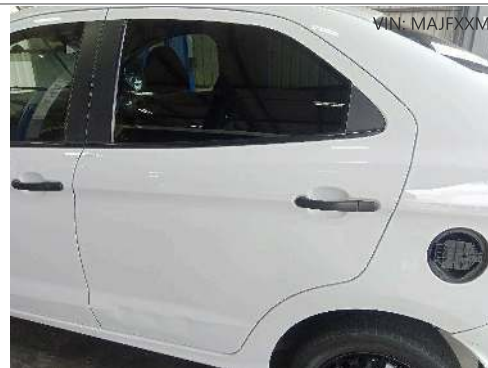
| Damage | Repair Way |
|---|---|
| Door Rear Left Damaged | Repair |

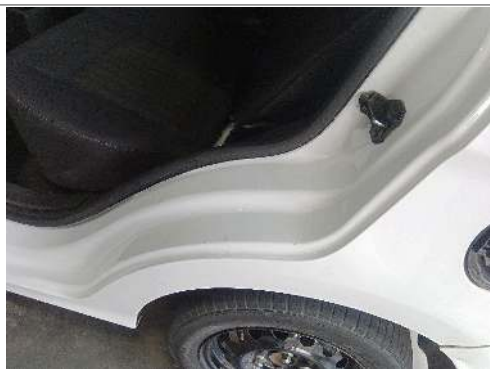
| Damage | Repair Way |
|---|---|
| C • Pillar Left Dented | Repair |

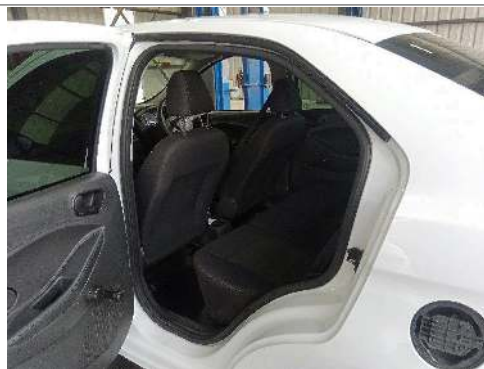
| Damage | Repair Way |
|---|---|
| Door Sealing Rubber Rear Left Damaged | Replace |

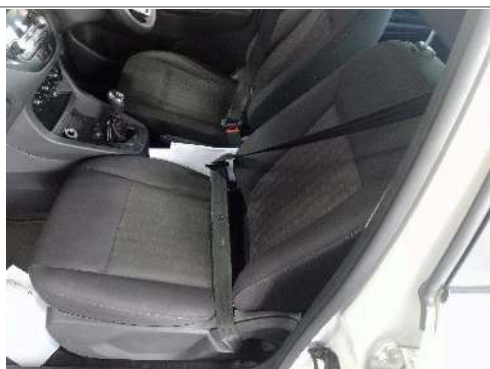
| Damage | Repair Way |
|---|---|
| Seat Front Left Dirty | Repair |

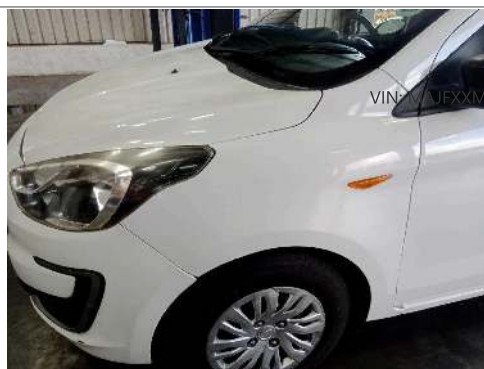
| Damage | Repair Way |
|---|---|
| Front Fender Left Dented | Repair |

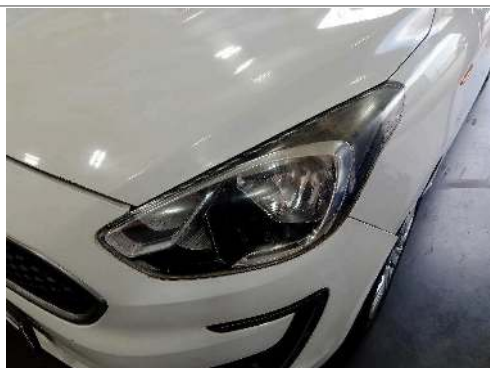
| Damage | Repair Way |
|---|---|
| Headlight Left Defective | Replace |

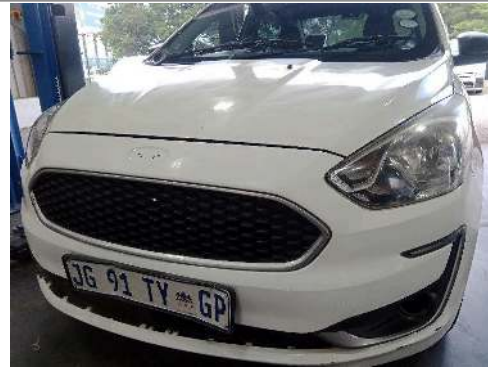
| Damage | Repair Way |
|---|---|
| Front Bumper Damaged | Replace |

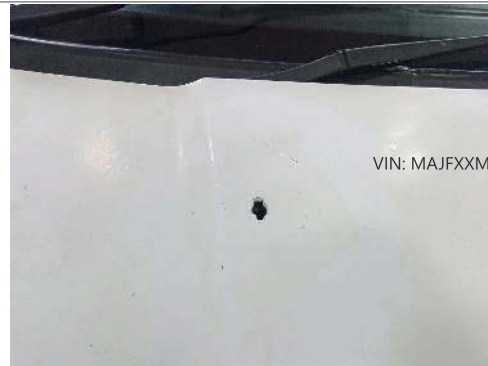
| Damage | Repair Way |
|---|---|
| Bonnet Damaged | Replace |

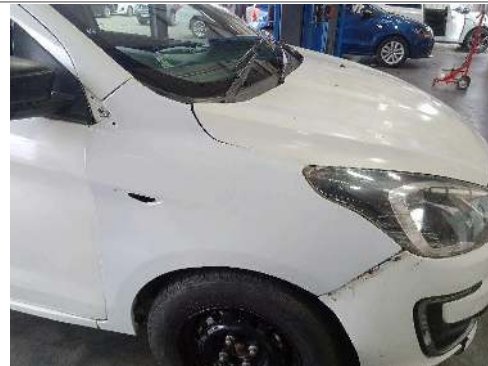
| Damage | Repair Way |
|---|---|
| Front Fender Right Damaged | Repair |

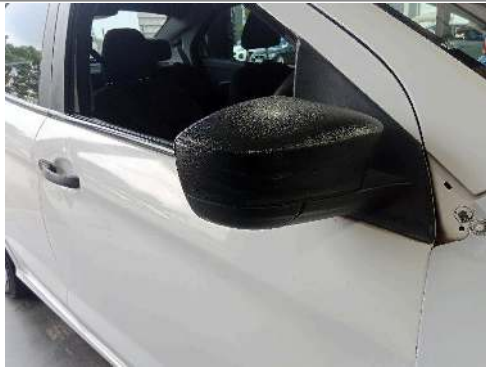
| Damage | Repair Way |
|---|---|
| Side Mirror Right Paintwork • Scratched | Repair |

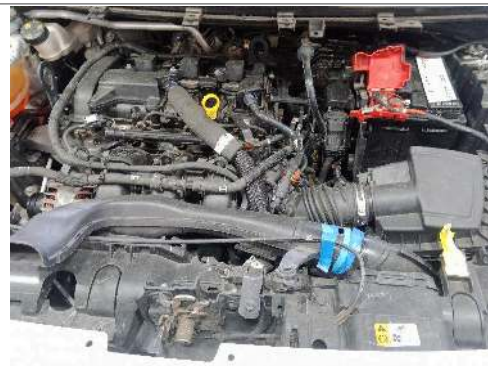
| Damage | Repair Way |
|---|---|
| Air cleaner Damaged | Replace |

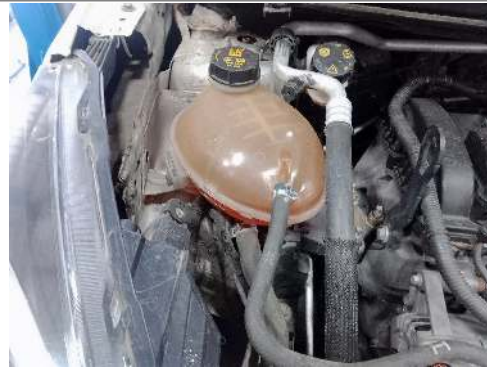
| Damage | Repair Way |
|---|---|
| Expansion Bottle Defective | Replace |

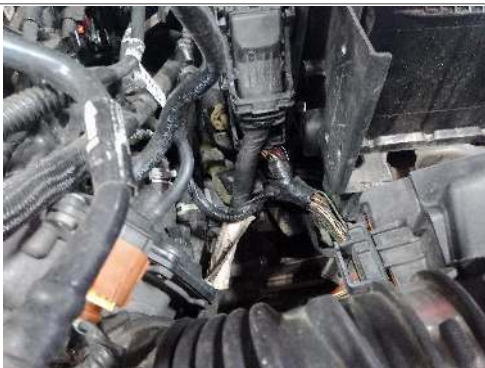
| Damage | Repair Way |
|---|---|
| Engine Wiring Defective | Repair |

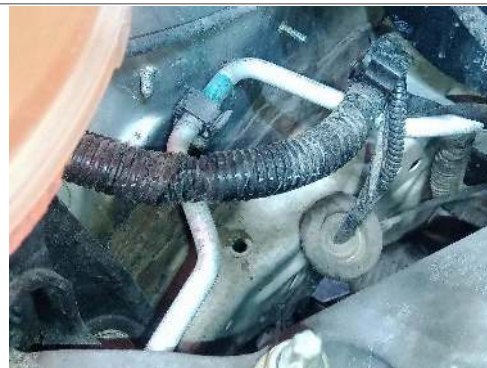
| Damage | Repair Way |
|---|---|
| Bonnet slam plate (Shock tower/ Inner tray) Welded | Repair |

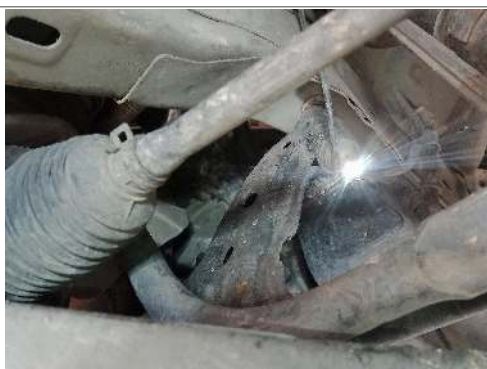
| Damage | Repair Way |
|---|---|
| Sub Frame Welded | Replace |

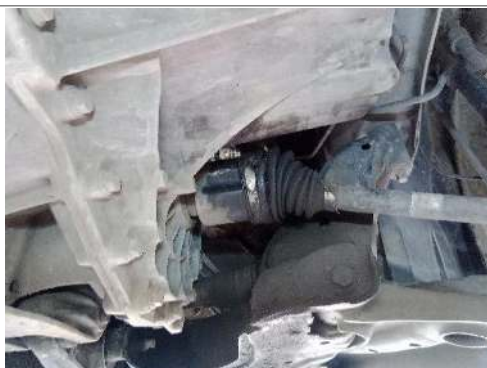
| Damage | Repair Way |
|---|---|
| CV Joint(s) Boot(s) Front Left (inner/outer) Damaged | Replace |

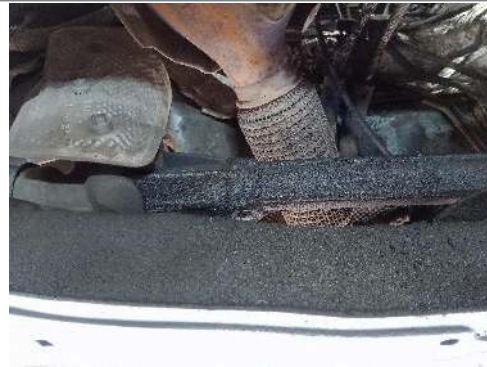
| Damage | Repair Way |
|---|---|
| Steering Rack Welded | Replace |

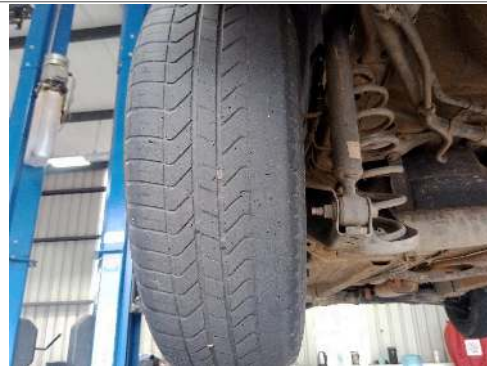
| Damage | Repair Way |
|---|---|
| Tyre Rear Left Worn | Replace |

| | Size | Load/Speed Index | Manufacture | Model | Type* | Production Date | Tread Depth (mm) |
|---|---|---|---|---|---|---|---|
| Rear Left | 175/65 R14 | 82T | Sumitomo | HTR T5 | V | 0820 | 0 mm |

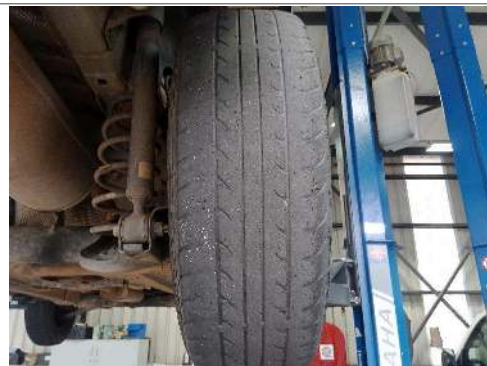
| Damage | Repair Way |
|---|---|
| Tyre Rear Right Damaged | Replace |

| | Size | Load/Speed Index | Manufacture | Model | Type* | Production Date | Tread Depth (mm) |
|---|---|---|---|---|---|---|---|
| Rear Right | 175/65 R14 | 82H | Apollo | Alnac | V | 2619 | 0 mm |

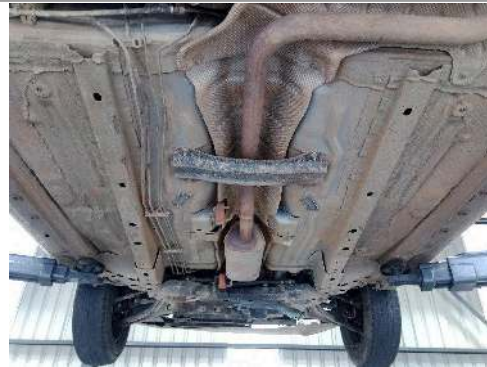
| Damage | Repair Way |
|---|---|
| Chassis Dented | Repair |

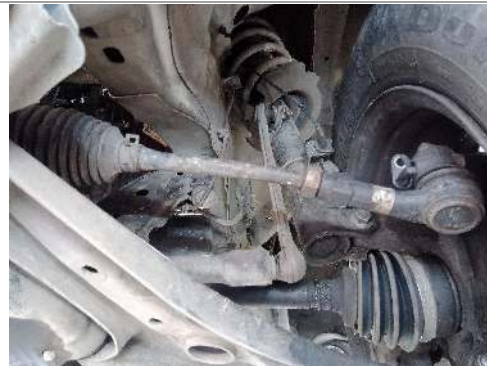
| Damage | Repair Way |
|---|---|
| Tie Rod right Damaged | Replace |

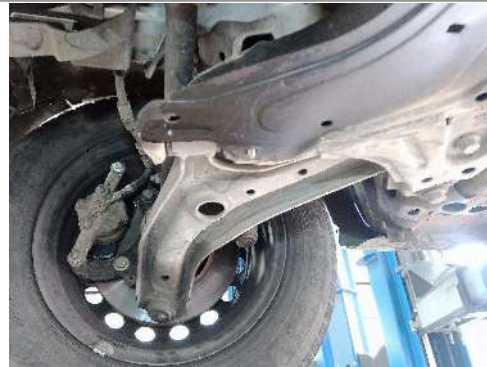
| Damage | Repair Way |
|---|---|
| Control Arm(s) Front Axle Right Damaged | Replace |

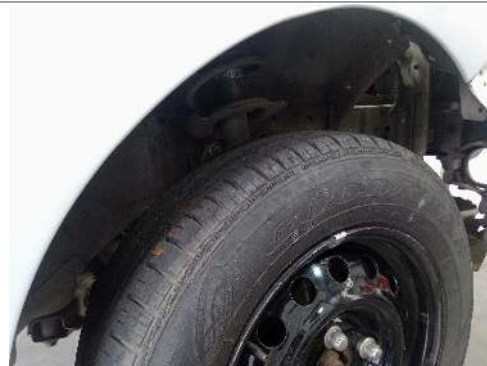
| Damage | Repair Way |
|---|---|
| Front Fender Right / Inner Tray Damaged | Replace |

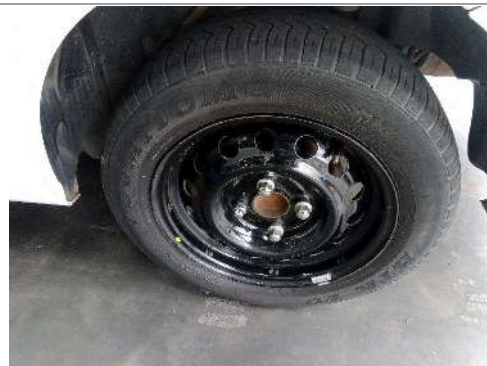
| Damage | Repair Way |
|---|---|
| Rim Rear Left Dented | Repair |

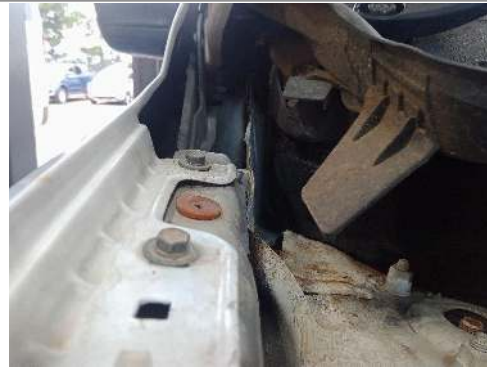
| Damage | Repair Way |
|---|---|
| A • Pillar Right Welded | Repair |
