CONDITION REPORT

Report No: 2016231716

Vehicle Type	PASSENGER VEHICLE	Registered Owner	MFC AUCTION HOUSE
Manufacturer	HYUNDAI	Registration Number	HJ97VWGP
Model	GRAND I10	Register Number	
VIN	MALA851AMJM771836	Date Of First Licensing	
Engine Number		Last COR	
Doors	5	License Expiry Date	31/08/2024
Color	WHITE	Power / Displacement	
Year Model		Paint Finish	C - COMMON
Km Reading	154,564 KM	Fuel	PETROL
Cab / Body Type	HATCHBACK	Transmission	AUTOMATIC

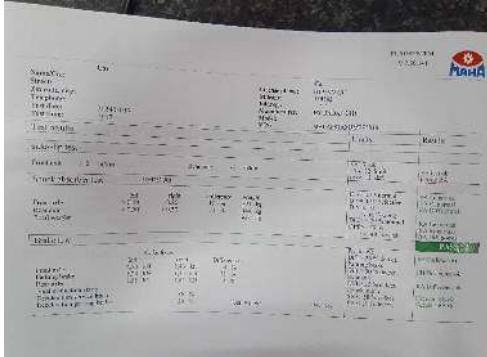
Shock and brake report

Brake Test Results

Left	Right		
	Braking Force [kN]	Braking Force [kN]	Axle Weight [kg]	Deceleration [m/s ²]
Front	2.3	2.4	-	
Rear	1.5	1.6	-	
Emergency / Parking	1.2	1.4	-

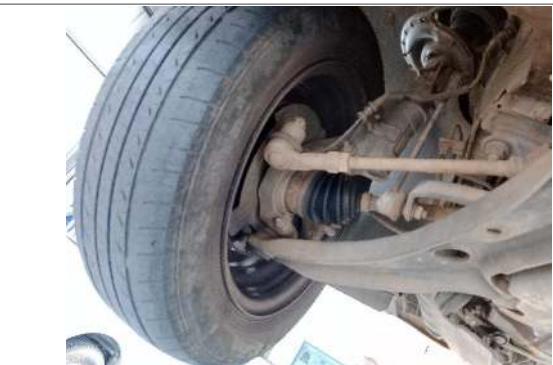
LF TYRE TREAD

Size	Load/Speed Index	Manufacture	Model	Type*	Production Date	Tread Depth (mm)
Front Left	165/65R14	79T	Fullrun	Frun one	V	0121	1 mm
Front Right	165/65R14	79T	Fullrun	Frun one	V	0121	1 mm
Rear Left	165/65R14	79T	Fullrun	Frun one	V	0121	5 mm
Rear Right	165/65R14	79T	Fullrun	Frun one	V		0 mm

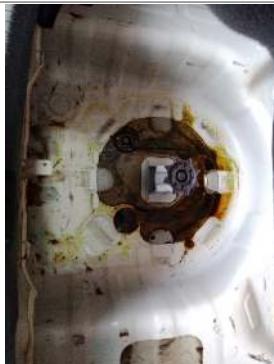
No sparewheel

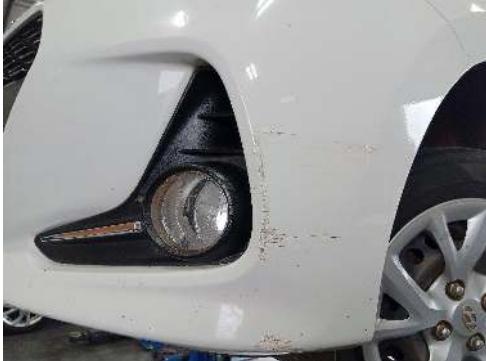
Damage	Repair Way
Dim Light Left Defective	Repair
Fog Light Front Left Defective	Repair
Fog Light Front Right Defective	Repair
Front Bumper Paintwork • Scratched	Repair
Roof Dented	Repair
Gearbox Oil Leak	Repair
Radiator Cradle Damaged	Replace
