CONDITION REPORT

Report No: 2016289146

MFC Auction House
M57 Pretoria Rd, Glenmarais, KEMPTON PARK
Gauteng

| Manufacturer | HYUNDAI | Registration Number | FG67RCGP |

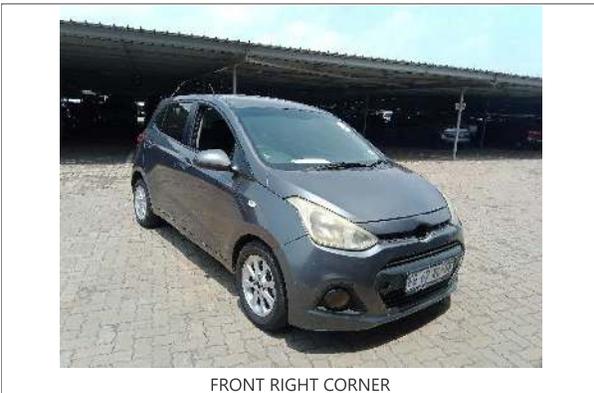
FRONT RIGHT CORNER

| Damage | Repair Way |
|--|--|
| Body and Exterior | Signs of impact damage to front of vehicle |

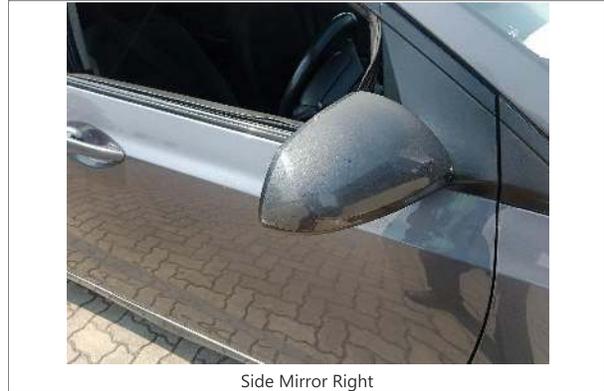
| Damage | Repair Way |
|---|---|
| Side Mirror Right Paintwork • Scratched | Repair |

Side Mirror Right

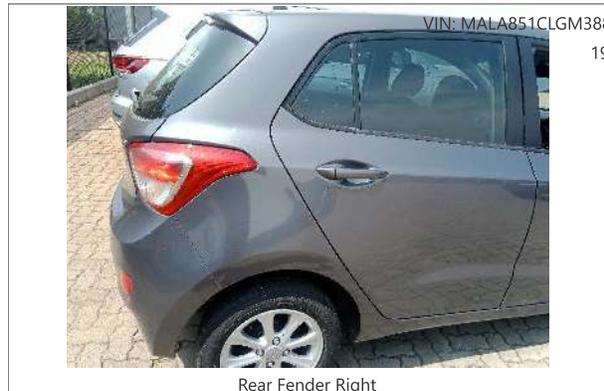
| Damage | Repair Way |
|---|---|
| Rear Fender Right Paintwork • Scratched | Repair |

Rear Fender Right

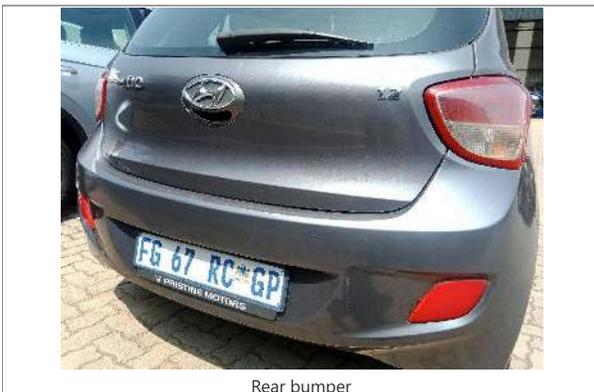
| Damage | Repair Way |
|---|---|
| Rear bumper Damaged | Repair |

Rear bumper

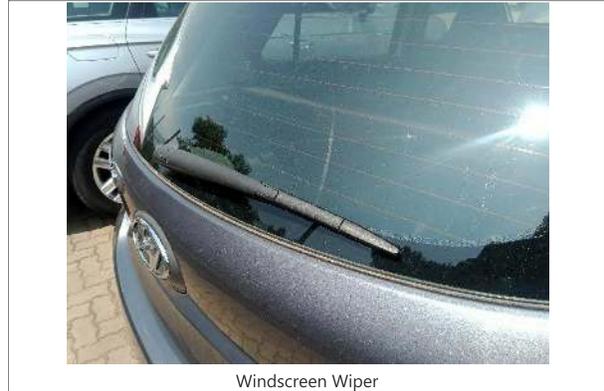
| Damage | Repair Way |
|---|---|
| Windscreen Wiper Damaged | Replace |

Windscreen Wiper

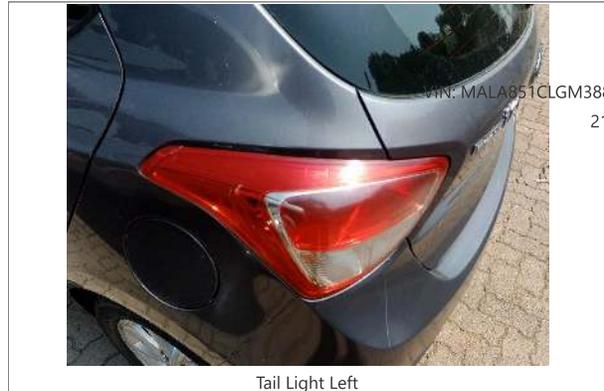
| Damage | Repair Way |
|---|---|
| Tail Light Left Damaged | Replace |

Tail Light Left

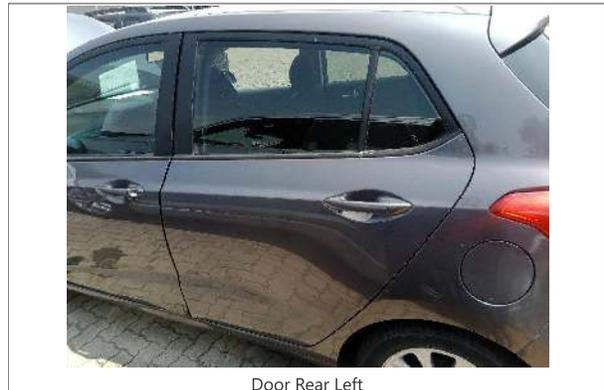
| Damage | Repair Way |
|---|---|
| Door Rear Left Paintwork • Scratched | Repair |

Door Rear Left

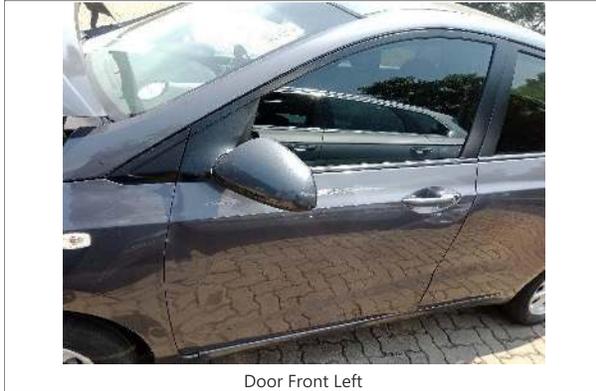
| Damage | Repair Way |
|---|---|
| Door Front Left Damaged | Repair |

Door Front Left

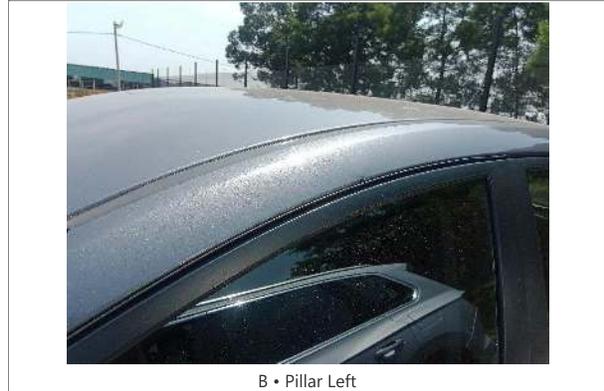
| Damage | Repair Way |
|---|---|
| B • Pillar Left Dented | Repair |

B • Pillar Left

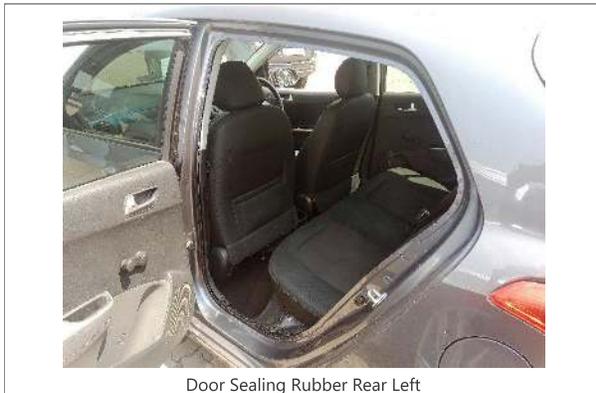
| Damage | Repair Way |
|---|---|
| Door Sealing Rubber Rear Left Missing | Replace |

Door Sealing Rubber Rear Left

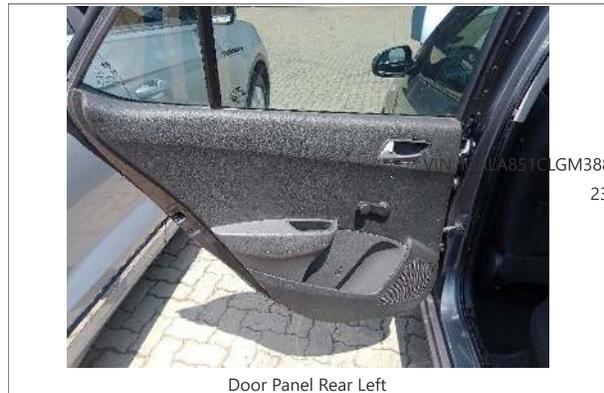
| Damage | Repair Way |
|---|---|
| Door Panel Rear Left Defective | Repair |

Door Panel Rear Left

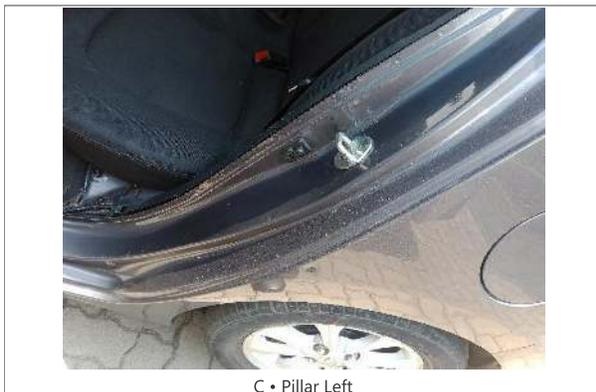
| Damage | Repair Way |
|---|---|
| C • Pillar Left Dented | Repair |

C • Pillar Left

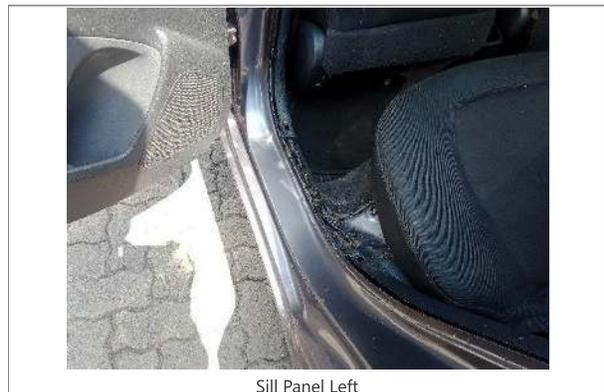
| Damage | Repair Way |
|---|---|
| Sill Panel Left Paintwork • Scratched | Repair |

Sill Panel Left

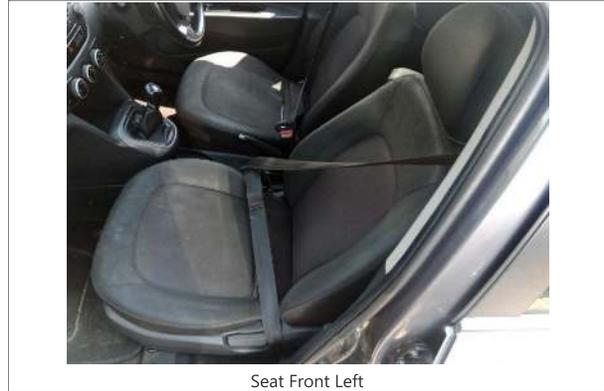
| Damage | Repair Way |
|---|---|
| Seat Front Left Dirty | Repair |

Seat Front Left

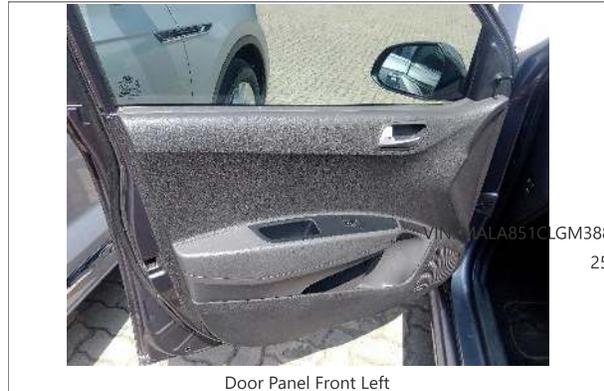
| Damage | Repair Way |
|---|---|
| Door Panel Front Left Defective | Repair |

Door Panel Front Left

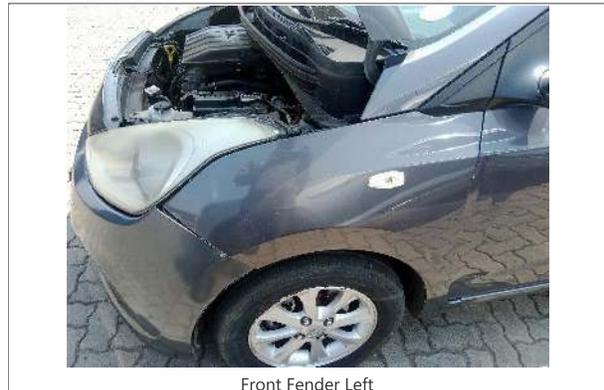
| Damage | Repair Way |
|---|---|
| Front Fender Left Dented | Repair |

Front Fender Left

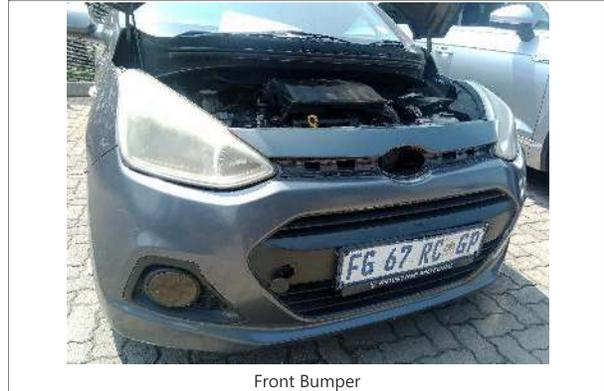
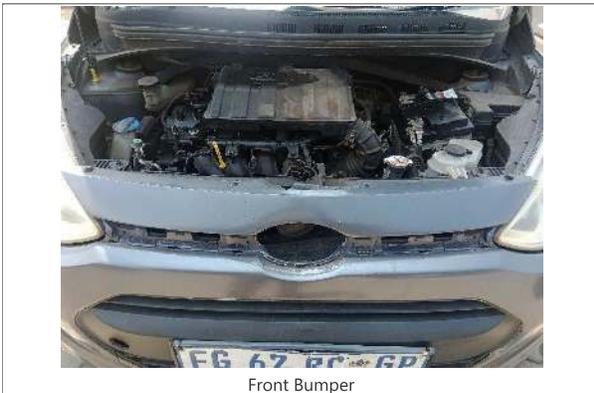
| Damage | Repair Way |
|---|---|
| Front Bumper Damaged | Replace |

Front Bumper

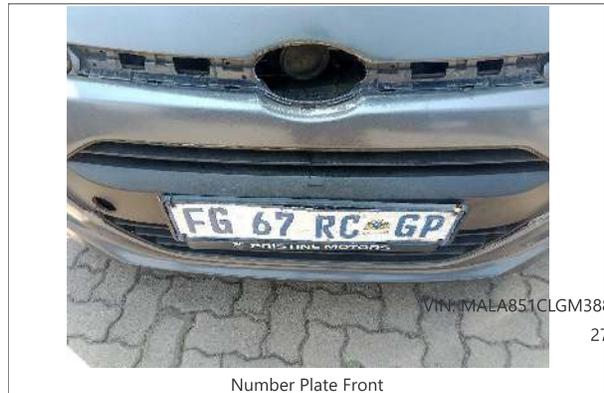
| Damage | Repair Way |
|---|---|
| Number Plate Front Damaged | Replace |

Number Plate Front

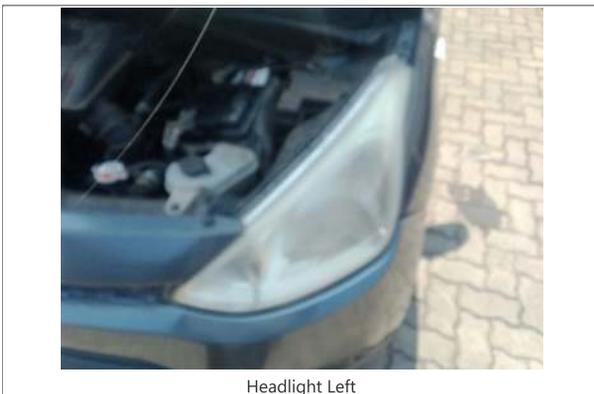
| Damage | Repair Way |
|---|---|
| Headlight Left Defective | Replace |

Headlight Left

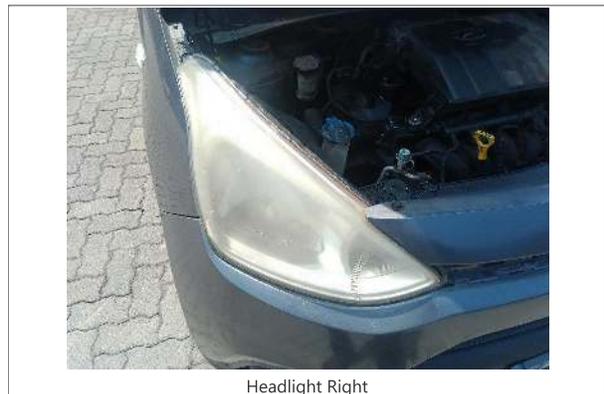
| Damage | Repair Way |
|---|---|
| Headlight Right Defective | Replace |

Headlight Right

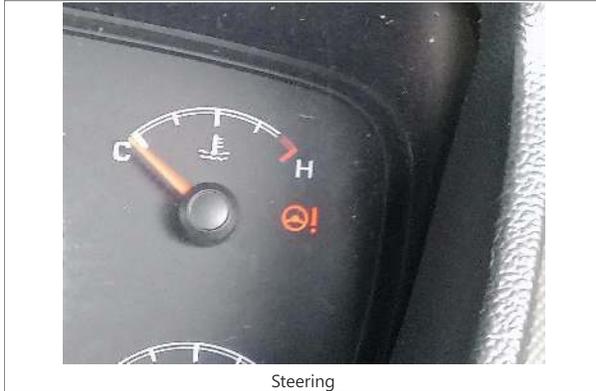
| Damage | Repair Way |
|--|--|
| Steering Malfunction | Repair |

Steering

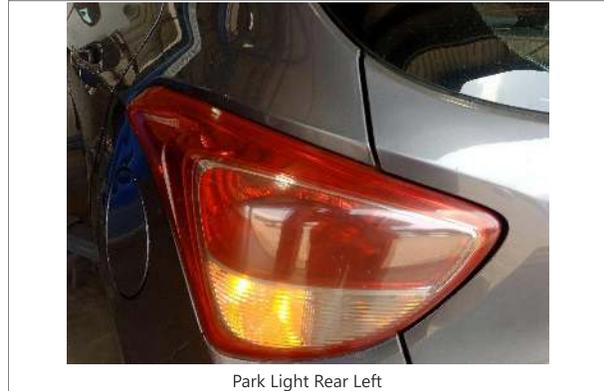
| Damage | Repair Way |
|---|---|
| Park Light Rear Left Defective | Repair |

Park Light Rear Left

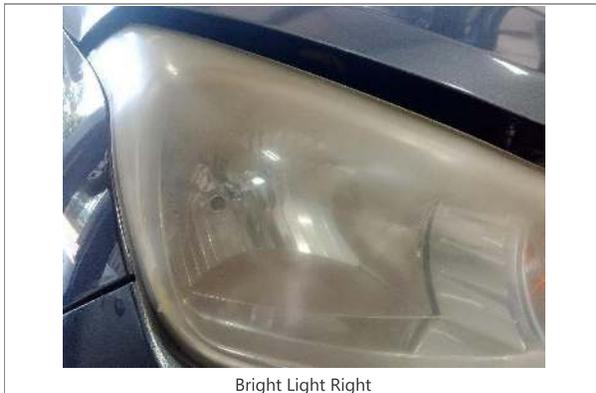
| Damage | Repair Way |
|---|---|
| Bright Light Right Damaged | Replace |

Bright Light Right

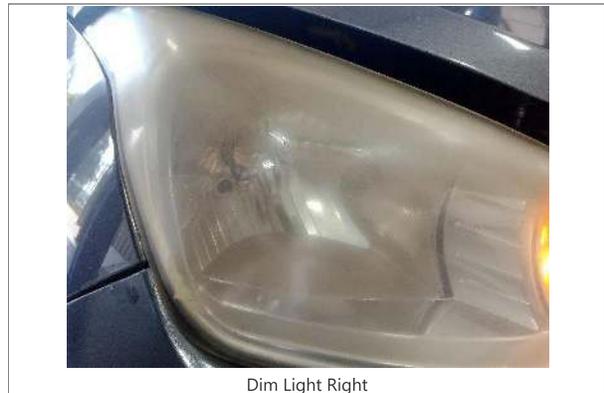
| Damage | Repair Way |
|---|---|
| Dim Light Right Damaged | Replace |

Dim Light Right

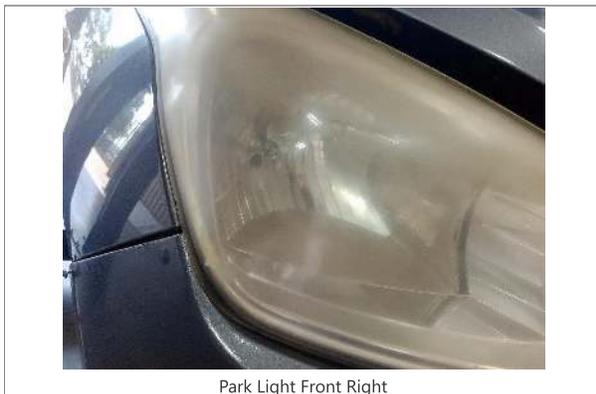
| Damage | Repair Way |
|---|---|
| Park Light Front Right Damaged | Replace |

Park Light Front Right

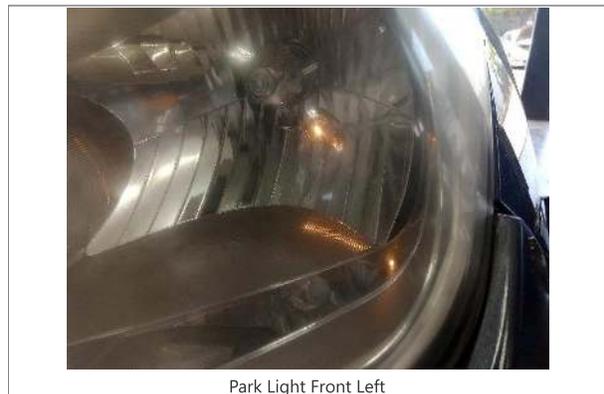
| Damage | Repair Way |
|---|---|
| Park Light Front Left Malfunction | Replace |

Park Light Front Left

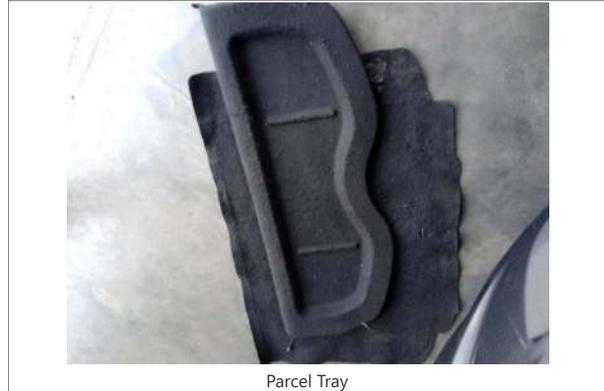
| Damage | Repair Way |
|---|---|
| Parcel Tray Damaged | Repair |

Parcel Tray

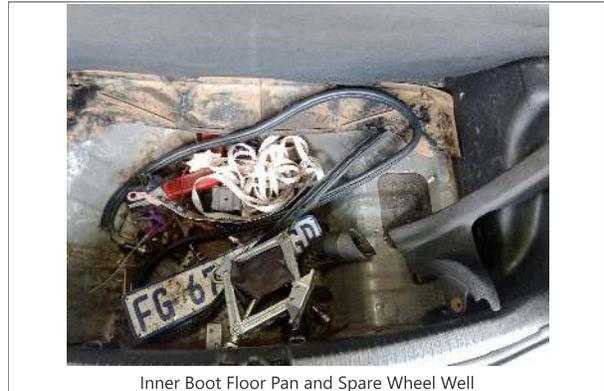
| Damage | Repair Way |
|---|---|
| Inner Boot Floor Pan and Spare Wheel Well Dented | Repair |

Inner Boot Floor Pan and Spare Wheel Well

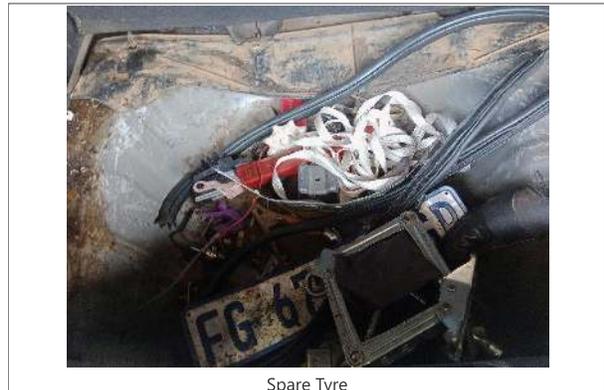
| Damage | Repair Way |
|---|---|
| Spare Tyre Defective | Replace |

Spare Tyre

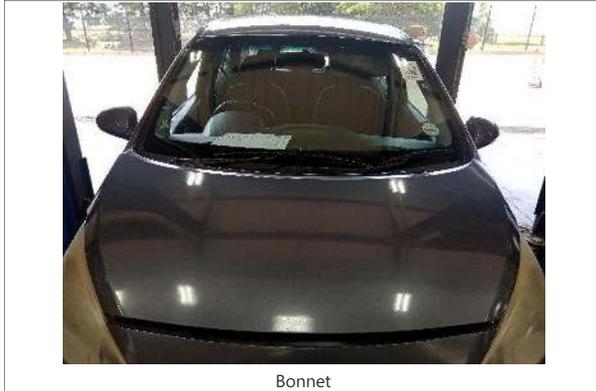
| Damage | Repair Way |
|---|---|
| Bonnet Paintwork • Scratched | Repair |

Bonnet

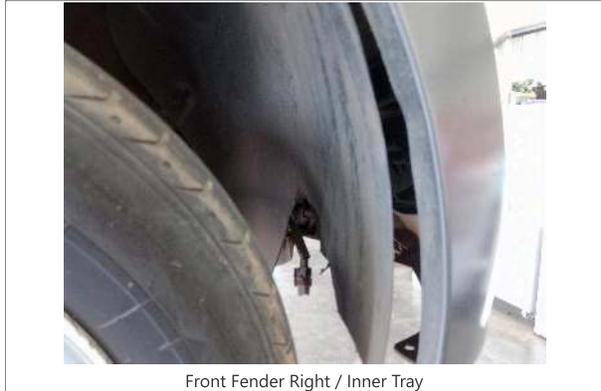
| Damage | Repair Way |
|---|---|
| Front Fender Right / Inner Tray Damaged | Replace |

Front Fender Right / Inner Tray

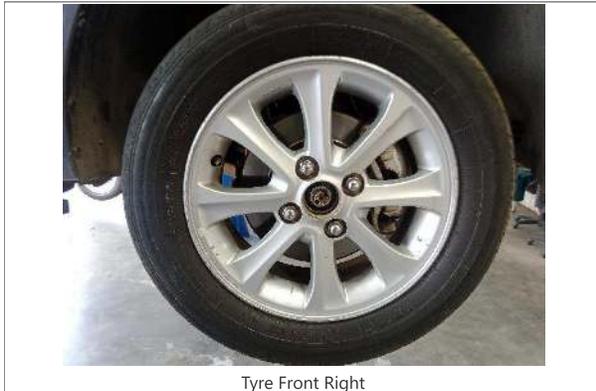
| Damage | Repair Way |
|---|---|
| Tyre Front Right Damaged | Replace |

| | Size | Load/Speed Index | Manufacture | Model | Type* | Production Date | Tread Depth (mm) |
|---|---|---|---|---|---|---|---|
| Front Right | 175/65 R14 | 82H | Autogrip | Grip200 | V | 0222 | 0 mm |

Tyre Front Right

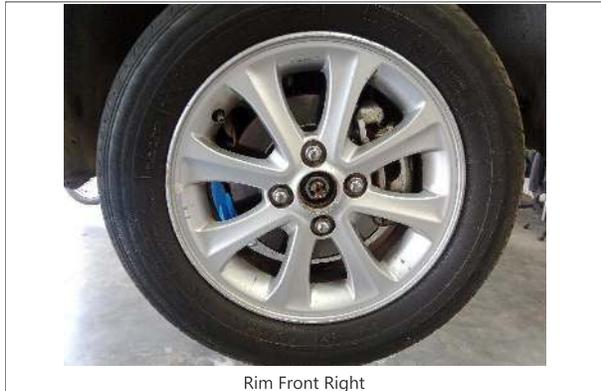
| Damage | Repair Way |
|---|---|
| Rim Front Right Scratched | Repair |

Rim Front Right

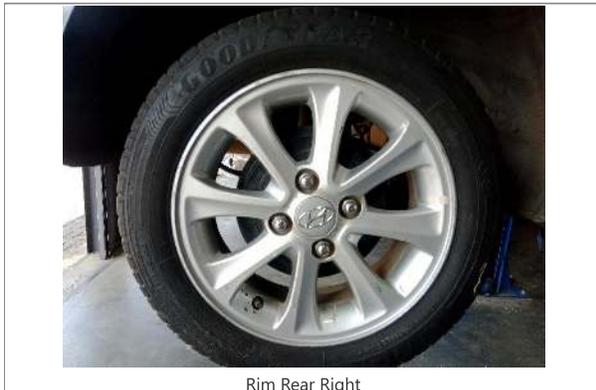
| Damage | Repair Way |
|---|---|
| Rim Rear Right Scratched | Repair |

Rim Rear Right

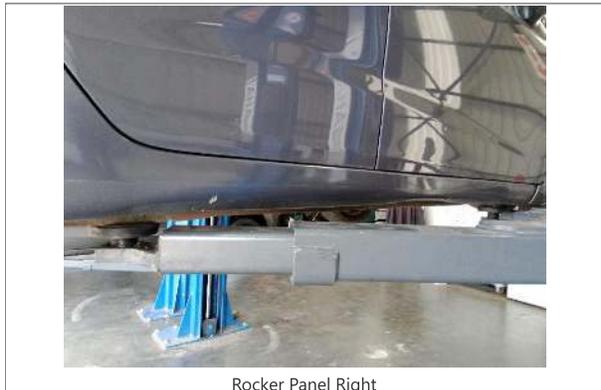
| Damage | Repair Way |
|---|---|
| Rocker Panel Right Damaged | Repair |

Rocker Panel Right
