## CONDITION REPORT

Report No: 2016852390

| Manufacturer | HYUNDAI | Registration Number | FL74VPGP |
| Model | GRAND I10 1.25 FLUID 5-DR [2014-2017] | Register Number | |

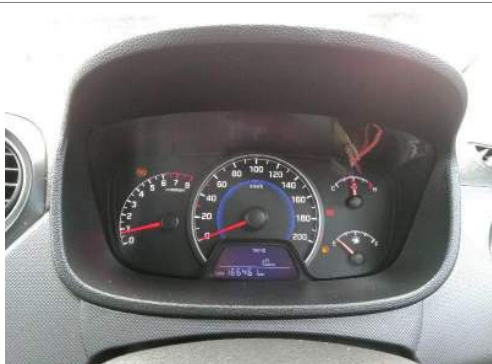
| Damage | Repair Way |
|---|---|
| Warning lights illuminated on dashboard | Repair |

| No | System | Code | Description | Status |
|---|---|---|---|---|
| 1 | AB(AIRBAG) | B1102:00 | BATTERY VOLTAGE LOW | |

DASHBOARD (W/ ENGINE RUNNING)

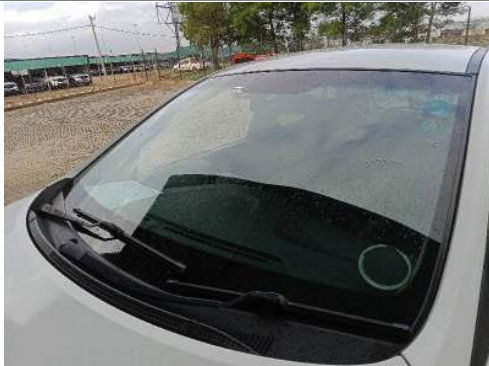
LICENSE DISC

| Damage | Repair Way |
|---|---|
| Body and Exterior | Vehicle license disk missing |

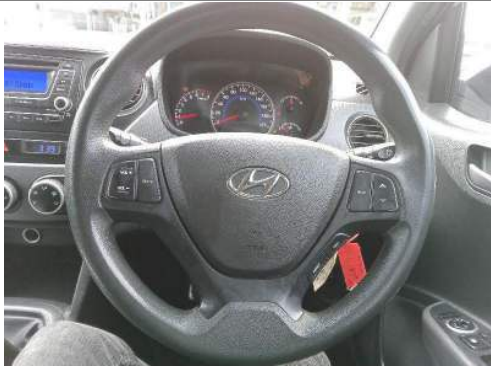
| Damage | Repair Way |
|---|---|
| Steering Wheel Trim Defective | Repair |

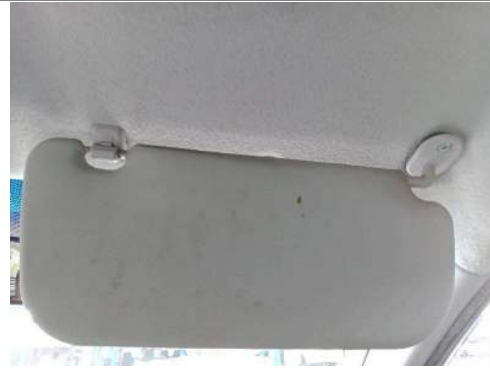
| Damage | Repair Way |
|---|---|
| Sun Visor Right Damaged | Repair |

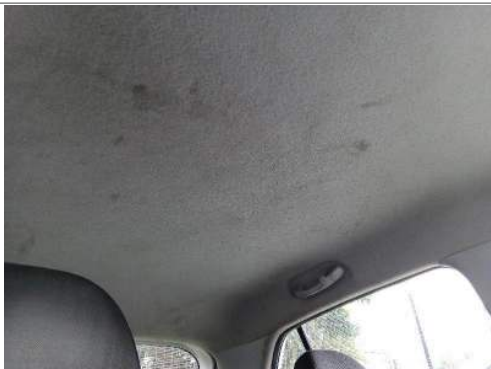
| Damage | Repair Way |
|---|---|
| Hood Lining Dirty | Repair |

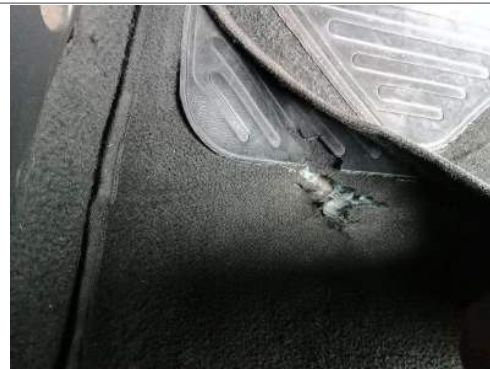
| Damage | Repair Way |
|---|---|
| Carpet Front Damaged | Repair |

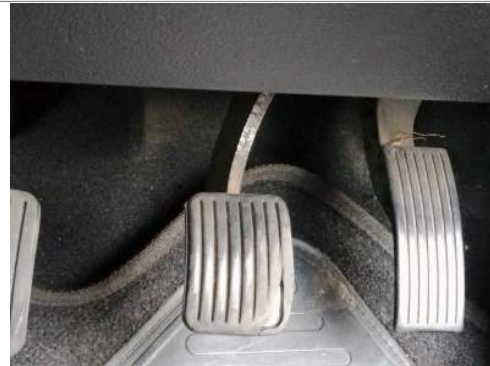
| Damage | Repair Way |
|---|---|
| Clutch Pedal Rubber Damaged | Replace |

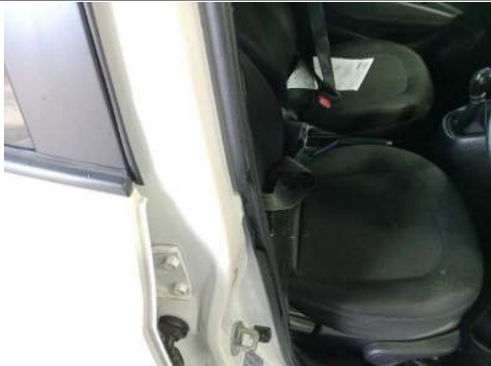
| Damage | Repair Way |
|---|---|
| Door Sealing Rubber Front Right Damaged | Replace |

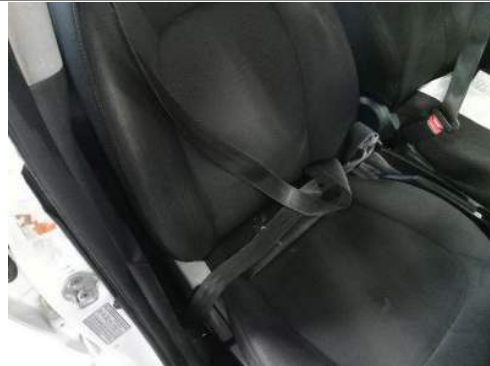
| Damage | Repair Way |
|---|---|
| Seat Belt Front Right Damaged | Replace |

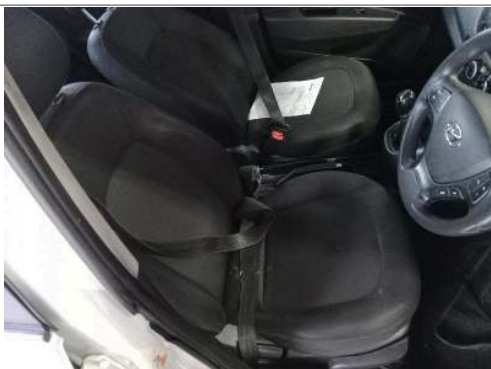
| Damage | Repair Way |
|---|---|
| Seat Front Right Defective | Repair |

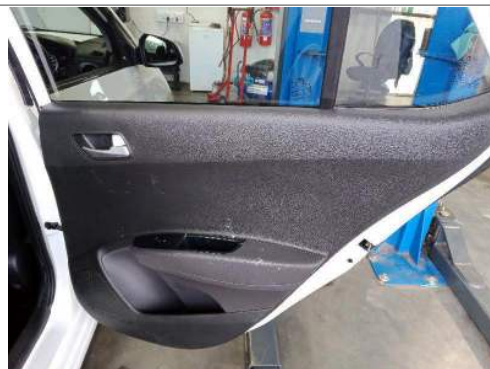
| Damage | Repair Way |
|---|---|
| Door Panel Rear Right Defective | Repair |

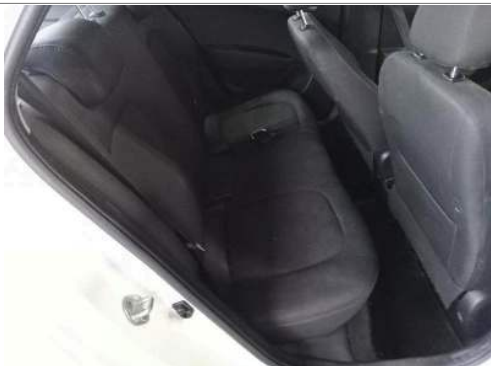
| Damage | Repair Way |
|---|---|
| Seat Rear Torn / Cut | Repair |

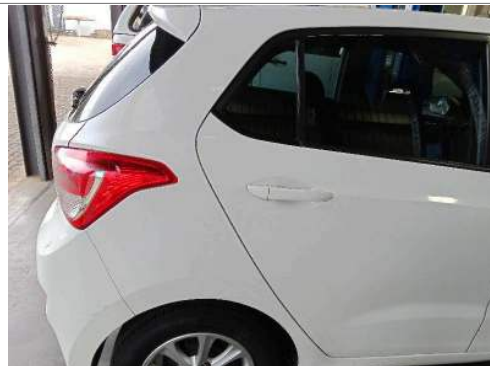
| Damage | Repair Way |
|---|---|
| Rear Fender Right Paintwork • Scratched | Repair |

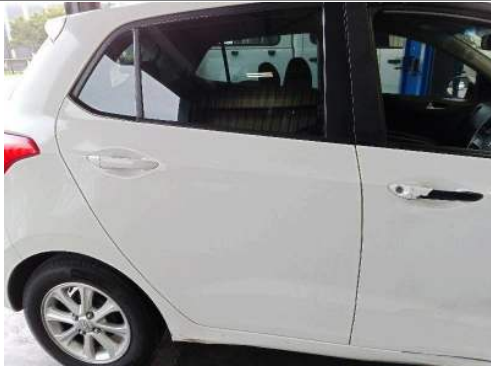
| Damage | Repair Way |
|---|---|
| Door Rear Right Residual Traces of Repair | Repair |

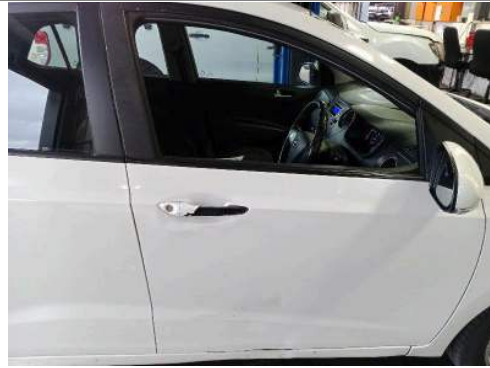
| Damage | Repair Way |
|---|---|
| Door Front Right Damaged | Repair |

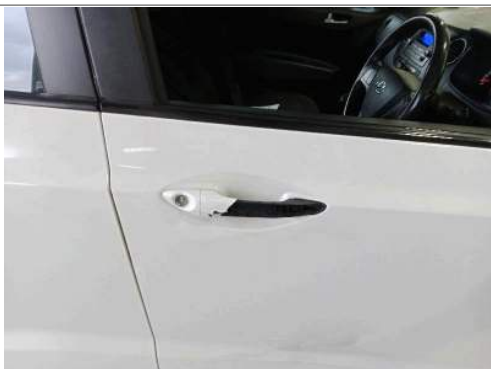
| Damage | Repair Way |
|---|---|
| Door Handle Front Right Damaged | Replace |

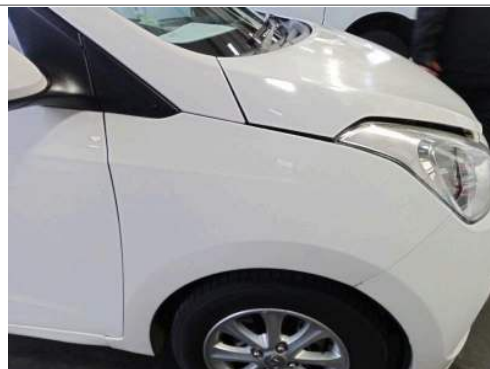
| Damage | Repair Way |
|---|---|
| Front Fender Right Residual Traces of Repair | Repair |

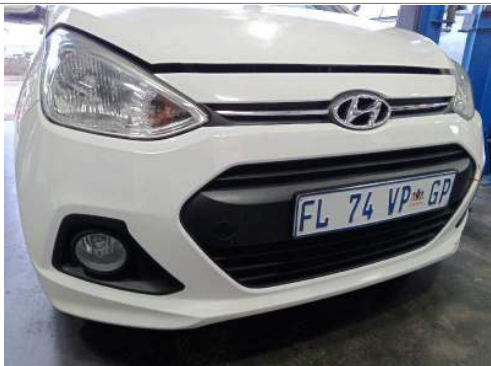
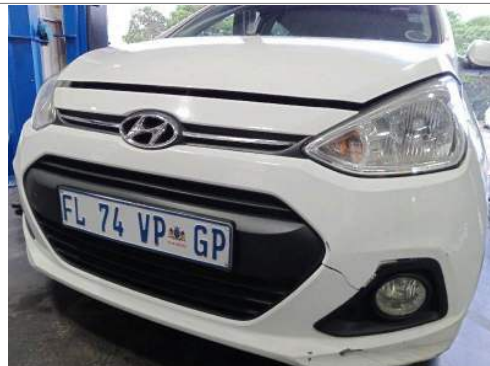
| Damage | Repair Way |
|---|---|
| Front Bumper Damaged | Repair |

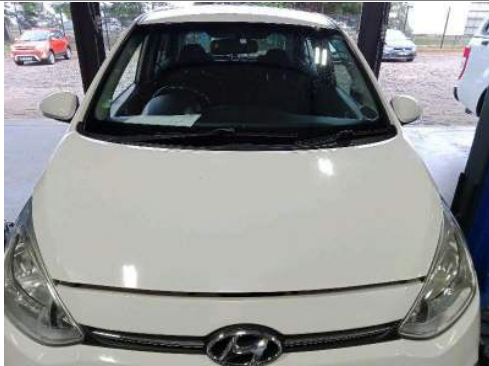
| Damage | Repair Way |
|---|---|
| Bonnet Paintwork • Chipmarks | Repair |

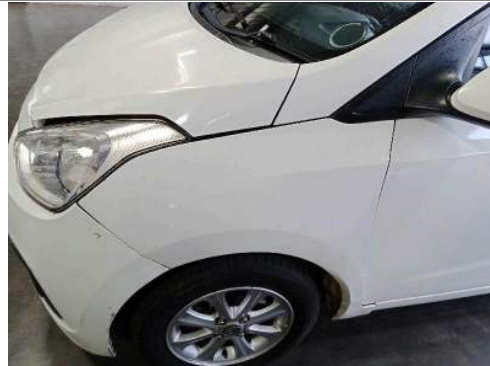
| Damage | Repair Way |
|---|---|
| Front Fender Left Damaged | Repair |

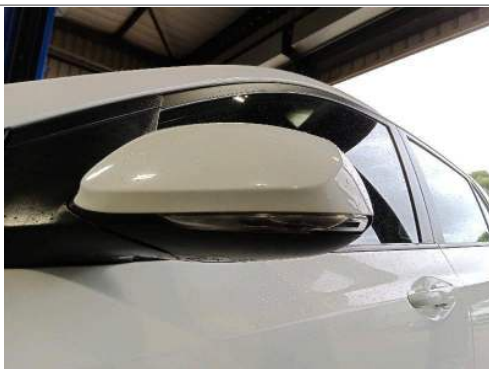
| Damage | Repair Way |
|---|---|
| Indicator Light Front Left Damaged | Replace |

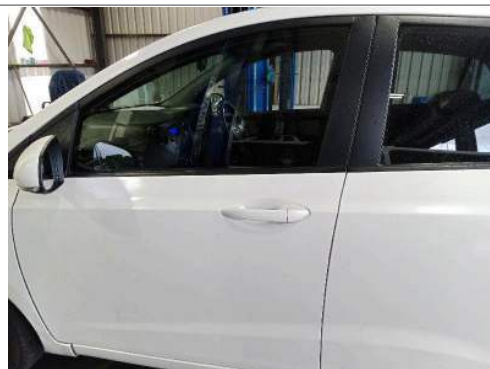
| Damage | Repair Way |
|---|---|
| Door Front Left Damaged | Repair |

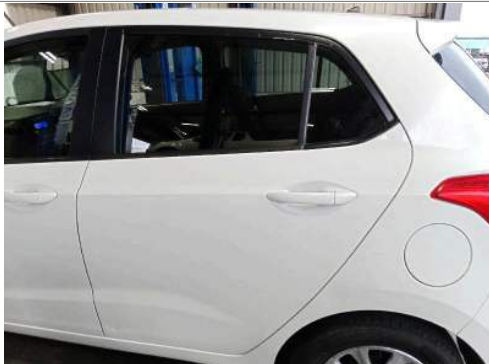
| Damage | Repair Way |
|---|---|
| Door Rear Left Damaged | Repair |

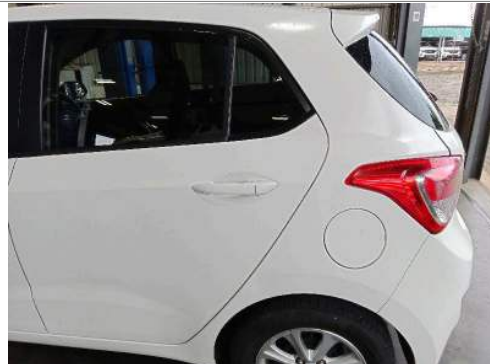
| Damage | Repair Way |
|---|---|
| Rear Fender Left Damaged | Repair |

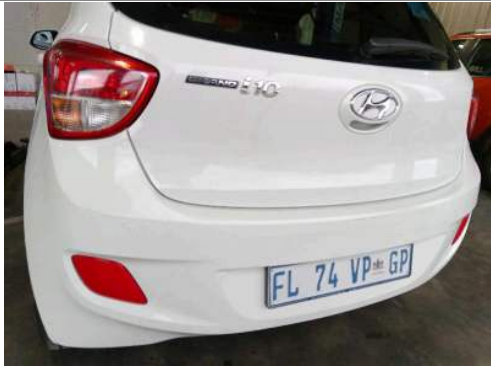
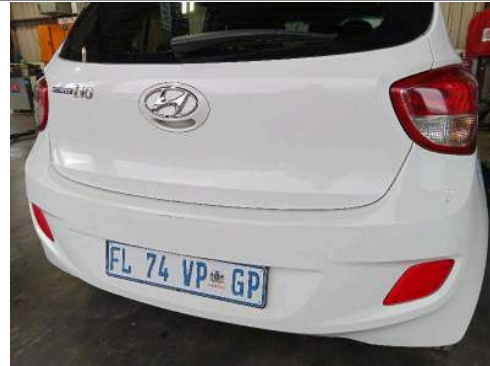
| Damage | Repair Way |
|---|---|
| Rear bumper Paintwork • Scratched | Repair |

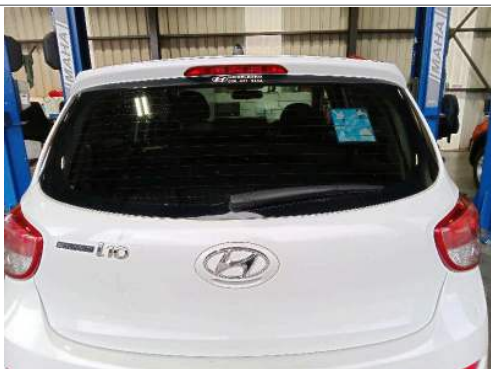
| Damage | Repair Way |
|---|---|
| Boot Lid / Hatch door Paintwork • Scratched | Repair |

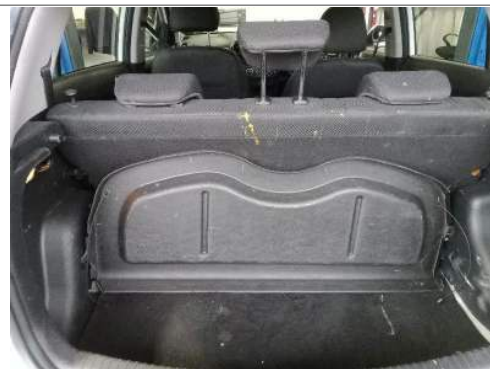
| Damage | Repair Way |
|---|---|
| Parcel Tray Damaged | Replace |

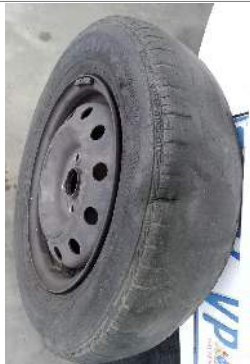
| Damage | Repair Way |
|---|---|
| Spare Tyre Damaged | Replace |

| | Size | Load/Speed Index | Manufacture | Model | Type* | Production Date | Tread Depth (mm) |
|---|---|---|---|---|---|---|---|
| Spare | 165/80 R14 | 85T | Goodyear | Duraplus | V | 1917 | 0 mm |

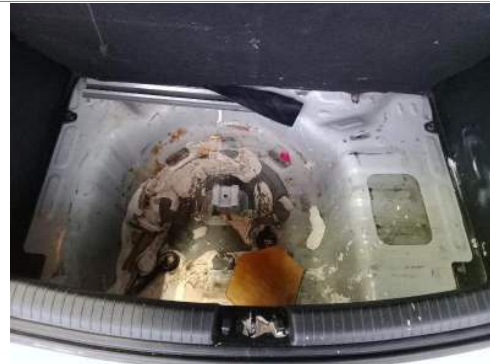
| Damage | Repair Way |
|---|---|
| Inner Boot Floor Pan and Spare Wheel Well Damaged | Repair |

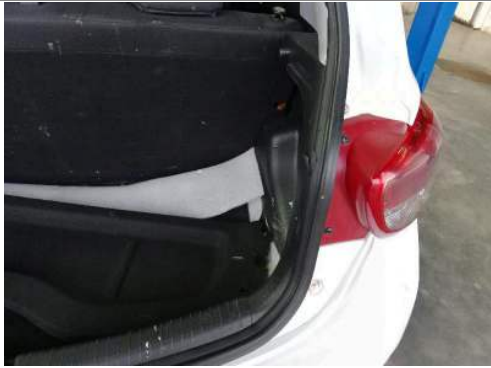
| Damage | Repair Way |
|---|---|
| Boot Lid / Hatch Door Rubbers Damaged | Replace |

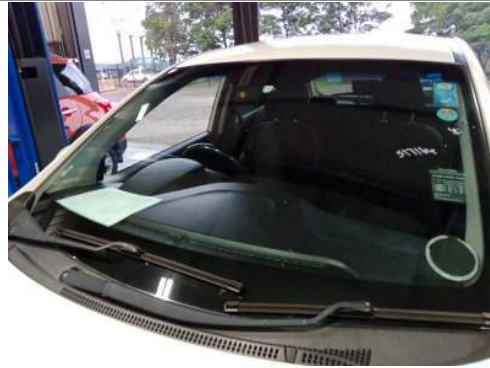
| Damage | Repair Way |
|---|---|
| Windscreen Chipped | Replace |

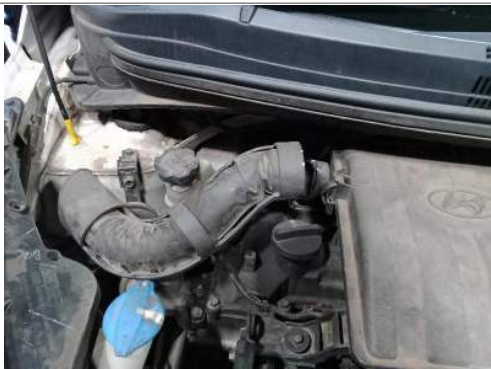
| Damage | Repair Way |
|---|---|
| Air cleaner Damaged | Replace |

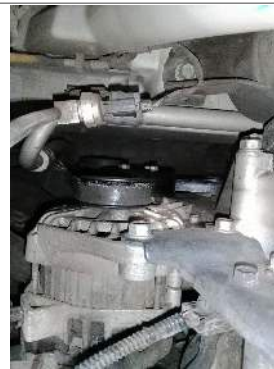
| Damage | Repair Way |
|---|---|
| Fan Belt Damaged | Replace |

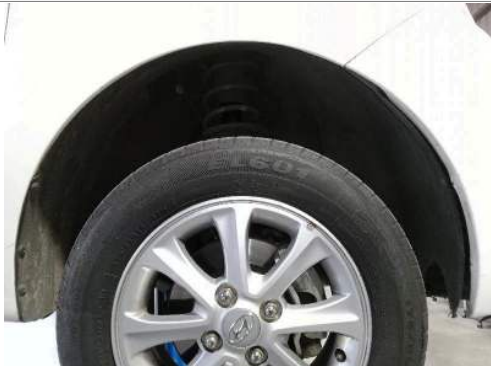
| Damage | Repair Way |
|---|---|
| Front Fender Right / Inner Tray Damaged | Repair |

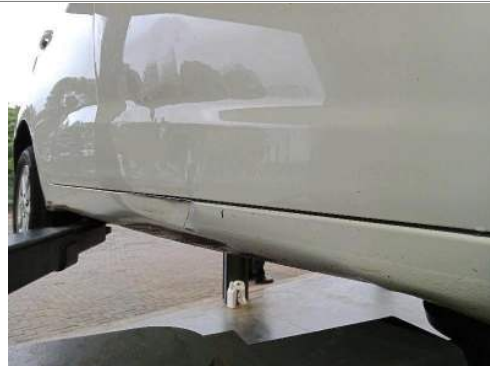
| Damage | Repair Way |
|---|---|
| Sill Panel Right Damaged | Repair |

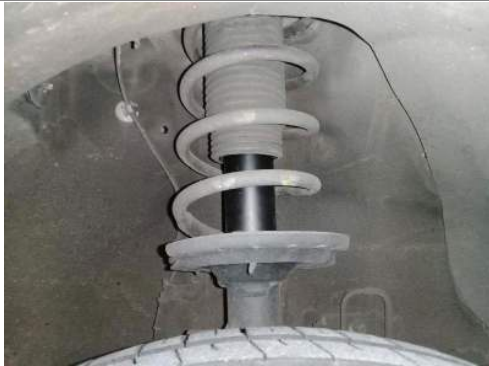
| Damage | Repair Way |
|---|---|
| Shock Absorber Front Right Sweat | Replace |

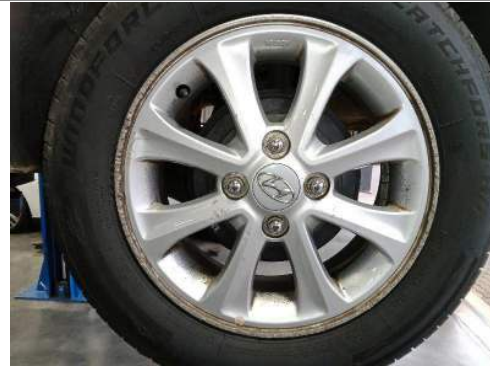
| Damage | Repair Way |
|---|---|
| Rim Rear Left Scratched | Repair |

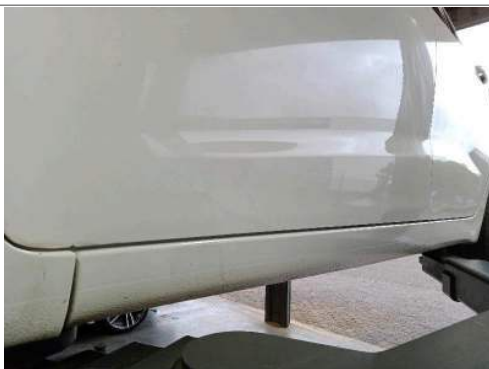
| Damage | Repair Way |
|---|---|
| Sill Panel Left Dented | Repair |

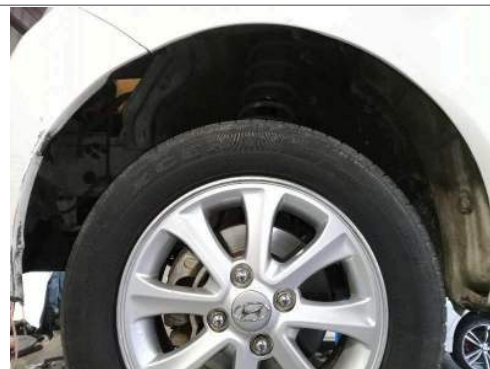
| Damage | Repair Way |
|---|---|
| Front Fender Left / Inner Tray Defective | Repair |

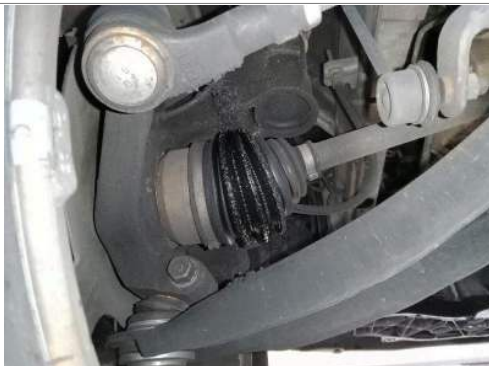
| Damage | Repair Way |
|---|---|
| CV Joint(s) Boot(s) Front Left (inner/outer) Damaged | Replace |

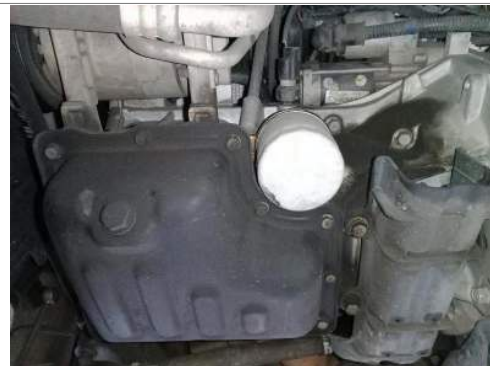
| Damage | Repair Way |
|---|---|
| Engine Oil Sweat | Repair |

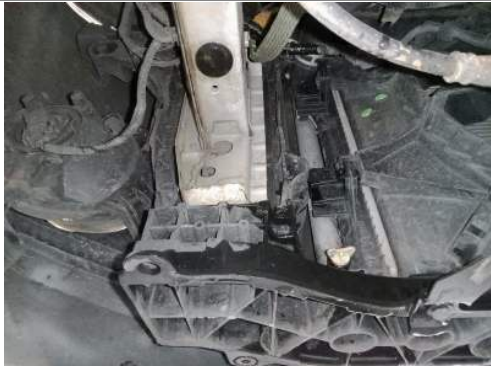
| Damage | Repair Way |
|---|---|
| Radiator Cradle Damaged | Replace |

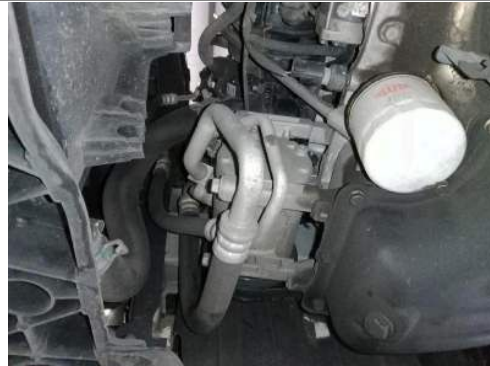
| Damage | Repair Way |
|---|---|
| Air conditioner pipes Defective | Repair |

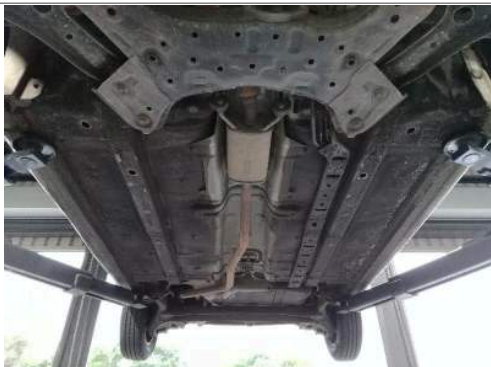
| Damage | Repair Way |
|---|---|
| Chassis Dented | Repair |
