MFC Auction House  
M57 Pretoria Rd, Glenmarais, KEMPTON PARK  
Gauteng

## CONDITION REPORT

Report No: 2016377847

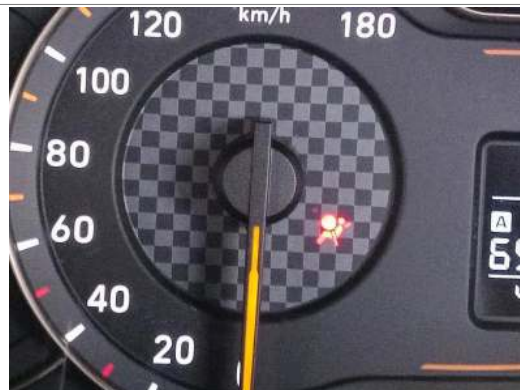
| Damage | Repair Way |
|---|---|
| Airbag warning lights illuminated | Repair. |

Airbag warning lights illumina

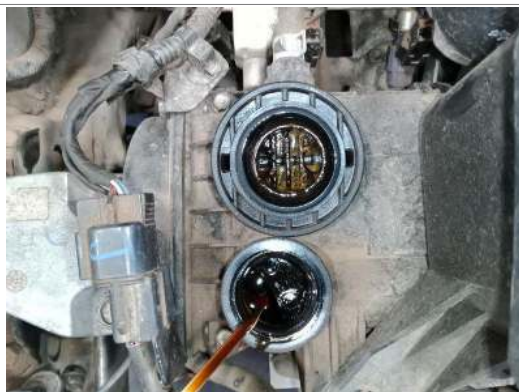
Oil cap and dipstick

| Damage | Repair Way |
|---|---|
| Foreign substance on oil cap see additional 10 | Repair |

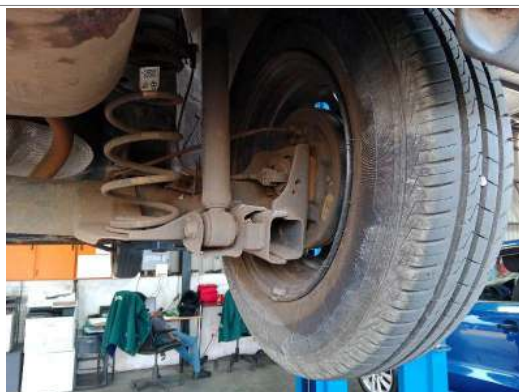
RR TYRE TREAD

| Damage | Repair Way |
|---|---|
| Rear tyre size differs | Replace |

| | Size | Load/Speed Index | Manufacture | Model | Type* | Production Date | Tread Depth (mm) |
|---|---|---|---|---|---|---|---|
| Rear Right | 155/80R13 | 79T | Hankook | Kinergy | V | 6820 | 5 mm |

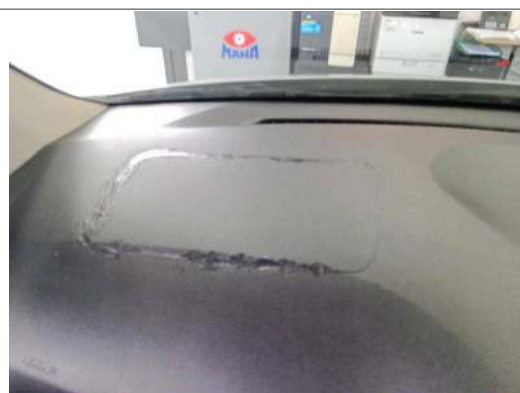
## Dash Padding

| Damage | Repair Way |
|---|---|
| Dash Padding Damaged | Repair |

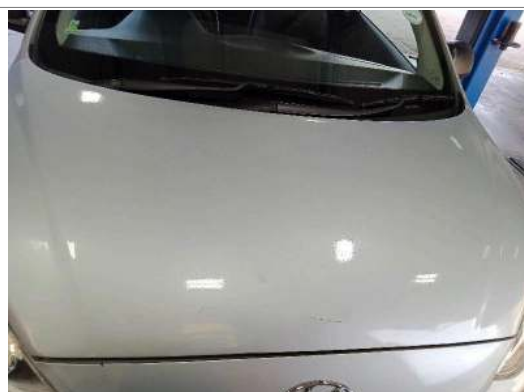
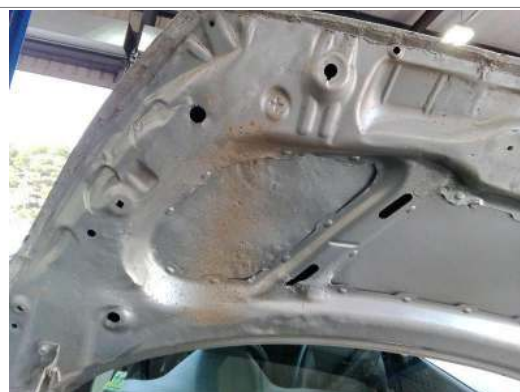
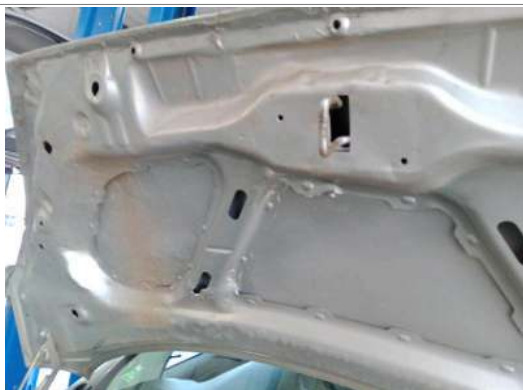
| Damage | Repair Way |
|---|---|
| Bonnet Residual Traces of Repair | Replace |

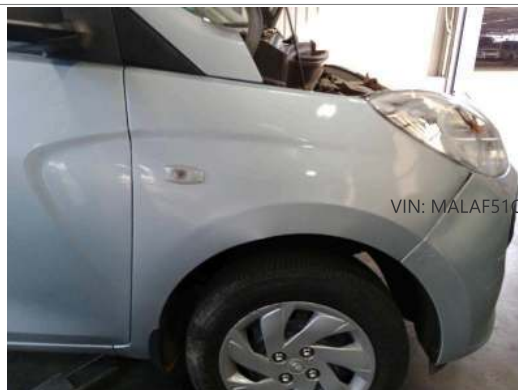
| Damage | Repair Way |
|---|---|
| Front Fender Right Residual Traces of Repair | Repair |

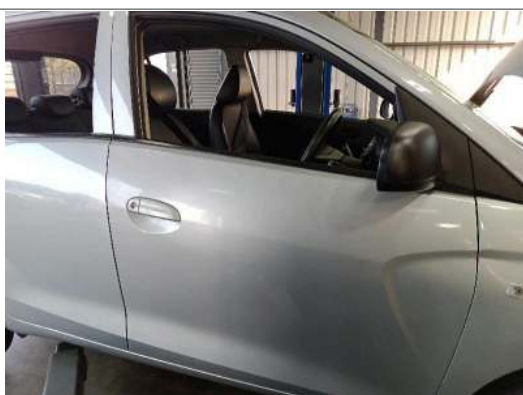
| Damage | Repair Way |
|---|---|
| Door Front Right Residual Traces of Repair | Repair |

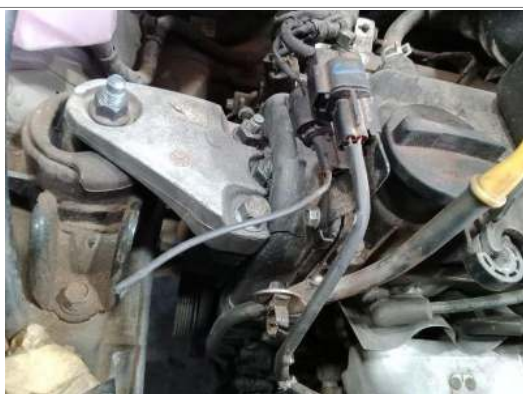
| Damage | Repair Way |
|---|---|
| Engine Wiring Defective | Repair |

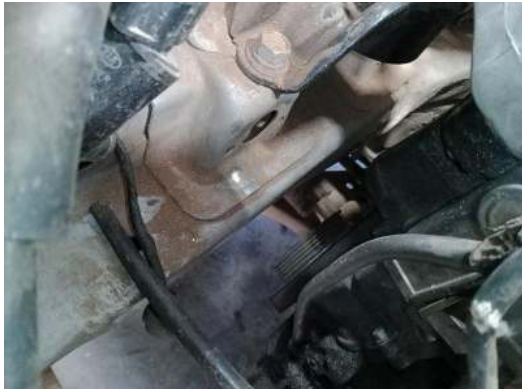
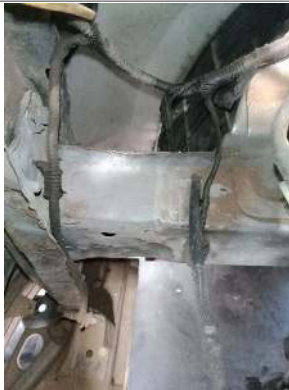
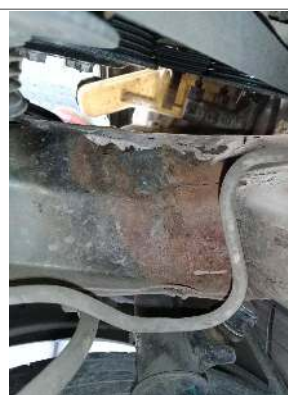
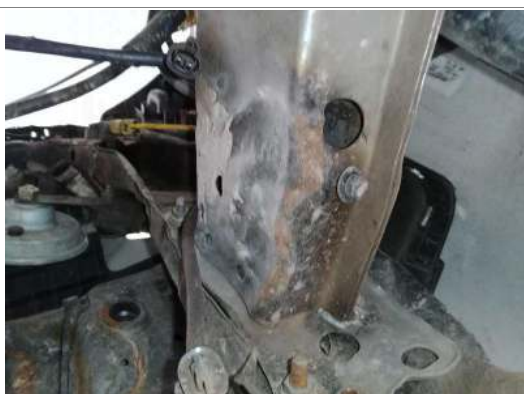
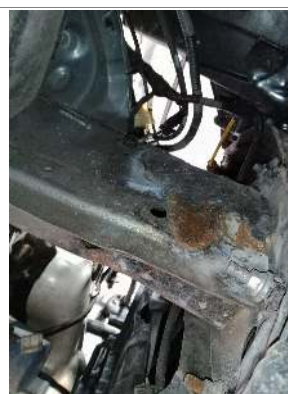
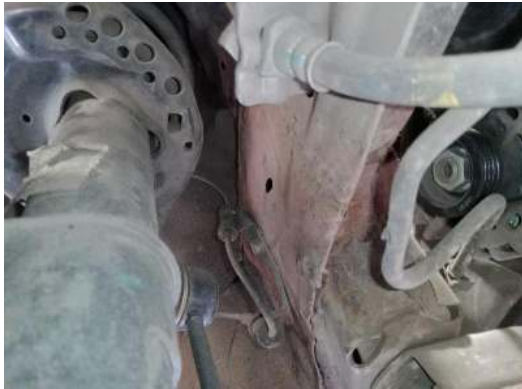
| Damage | Repair Way |
|---|---|
| Main Beam Right Residual Traces of Repair | Repair |
| Signs of cut and joint on main beams | Replace. |

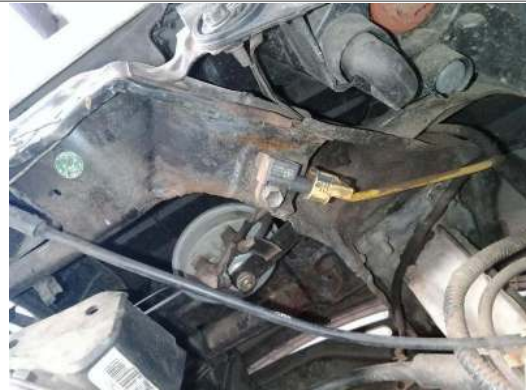
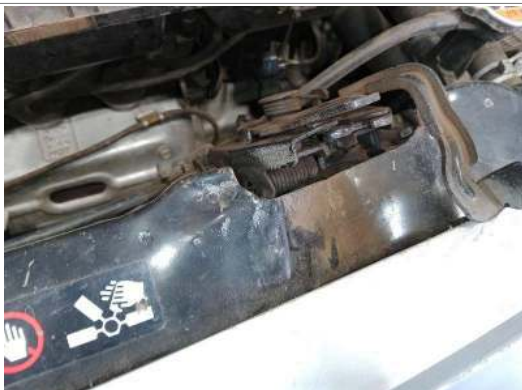
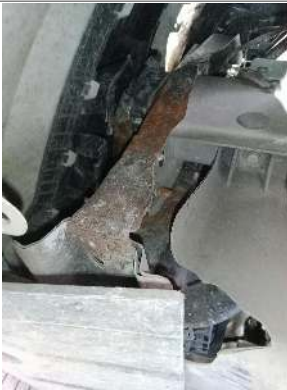
| Damage | Repair Way |
|---|---|
| Radiator Cradle Damaged | Replace |

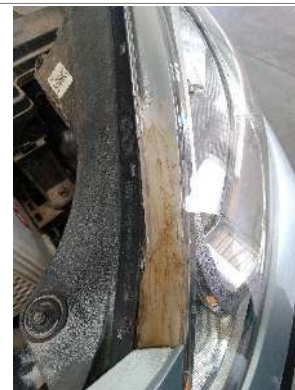
| Damage | Repair Way |
|---|---|
| Headlight Left Damaged | Replace |

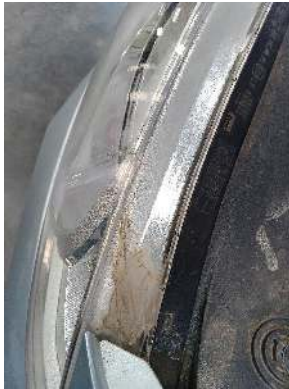
| Damage | Repair Way |
|---|---|
| Headlight Right Damaged | Replace |

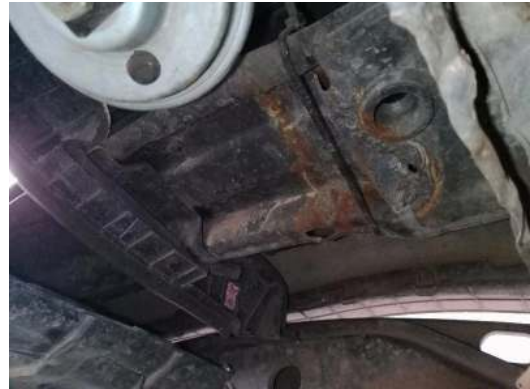
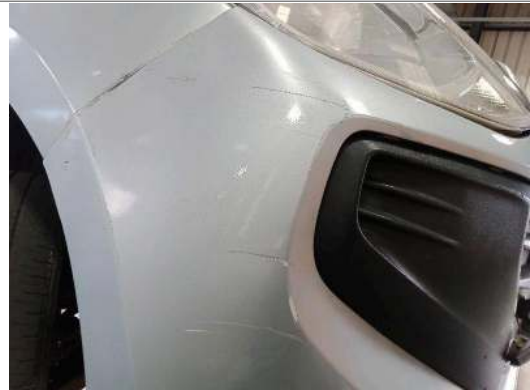
| Damage | Repair Way |
|---|---|
| Front Bumper Damaged | Replace |

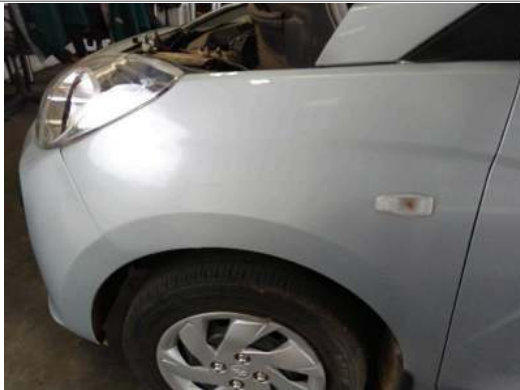
| Damage | Repair Way |
|---|---|
| Front Fender Left Residual Traces of Repair | Repair |

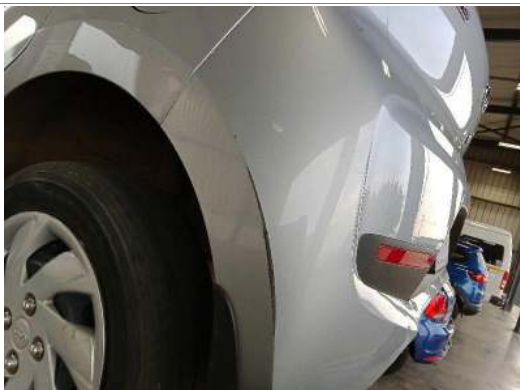
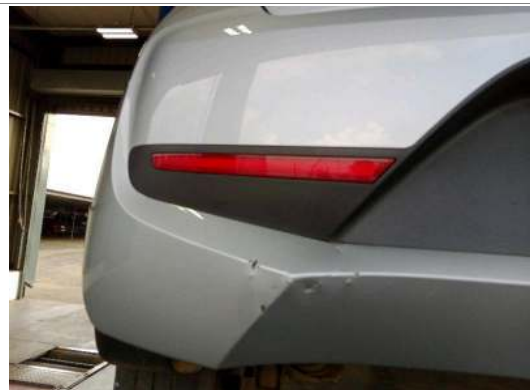
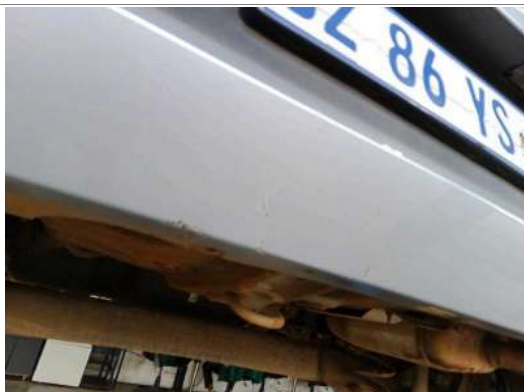
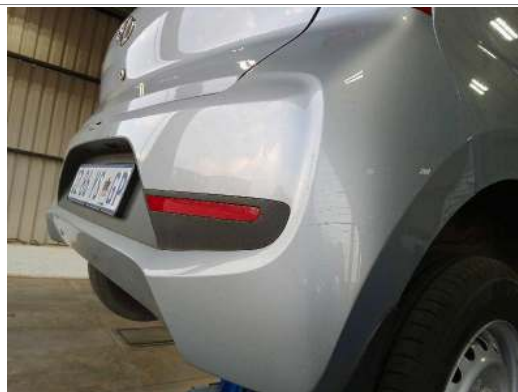
| Damage | Repair Way |
|---|---|
| Rear bumper Paintwork • Scratched | Repair |

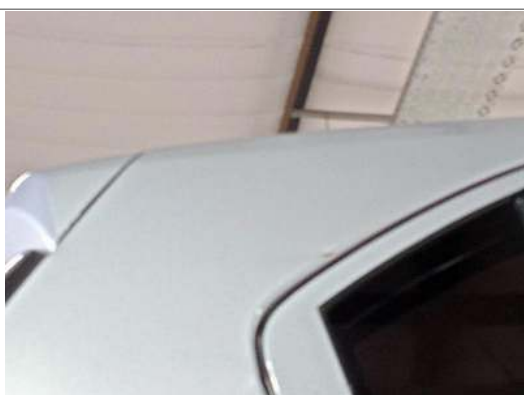
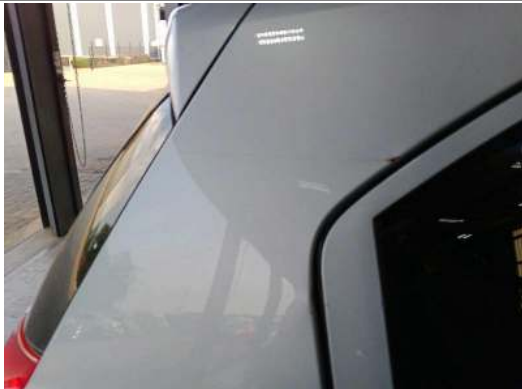
| Damage | Repair Way |
|---|---|
| Rear Fender Right Damaged | Repair |

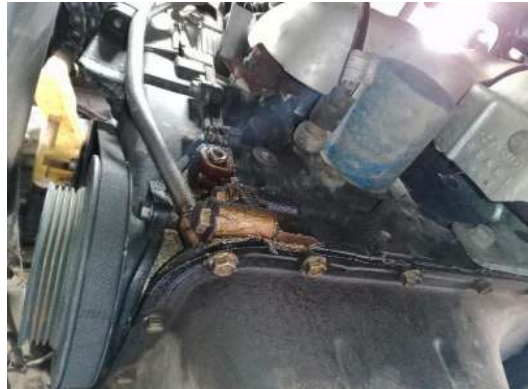
| Damage | Repair Way |
|---|---|
| Engine Oil Leak | Repair |
| Engine Noise Excessive | Repair |

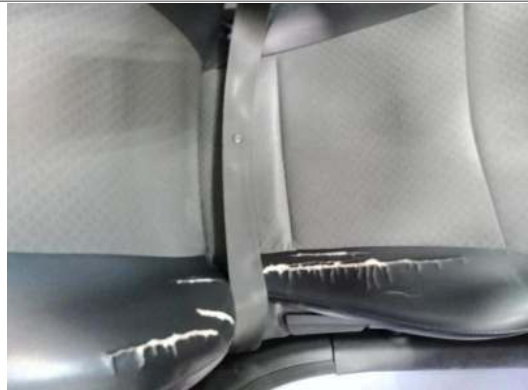
| Damage | Repair Way |
|---|---|
| Seat Front Right Torn / Cut | Repair |
