## CONDITION REPORT

Report No: 2016213106

MFC Auction House  
M57 Pretoria Rd, Glenmarais, KEMPTON PARK  
Gauteng

| Manufacturer | HYUNDAI | Registration Number | KB66NXGP |

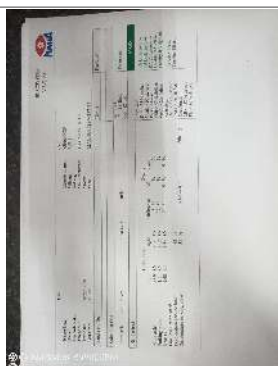
Brake report

| | Left | Right | | |
|---|---|---|---|---|
| Front | 2.0 | 2.2 | - | |
| Rear | 1.4 | 1.1 | - | |
| Emergency / Parking | 1.1 | 1.5 | - | |

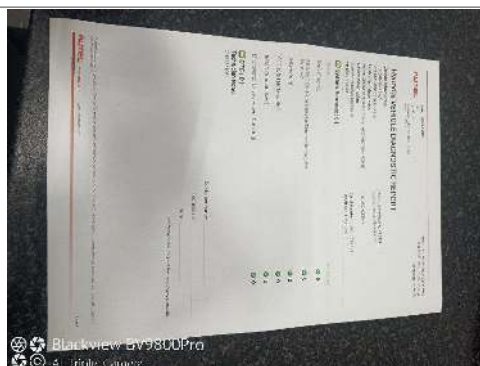
Diagnostic report

During the diagnostic no active error messages were detected. (See also attached Diagnostic Report. For more information regarding the Fault Codes (DTC) and the recommended rectifications please contact the workshops of the vehicle manufacture).

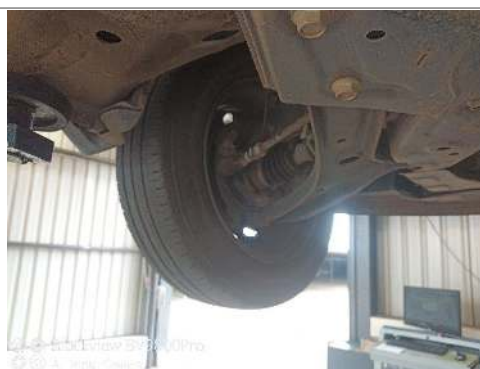
LF TYRE TREAD

| | Size | Load/Speed Index | Manufacture | Model | Type* | Production Date | Tread Depth (mm) |
|---|---|---|---|---|---|---|---|
| Front Left | 165/70R14 | 81T | MRF | Zvts | V | 0621 | 3 mm |

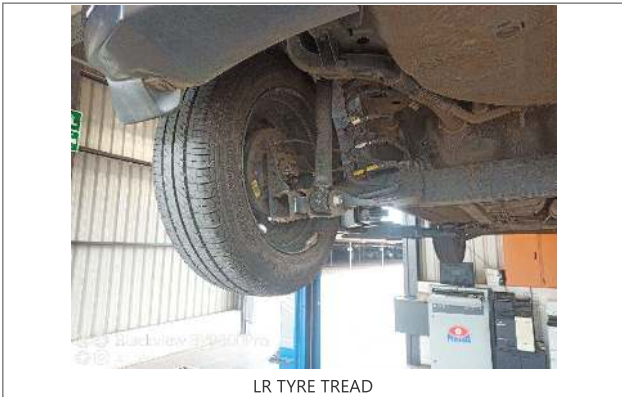
LR TYRE TREAD

| | Size | Load/Speed Index | Manufacture | Model | Type* | Production Date | Tread Depth (mm) |
|---|---|---|---|---|---|---|---|
| Rear Left | 165/70R14 | 81T | MRF | Zvts | V | 0821 | 3 mm |

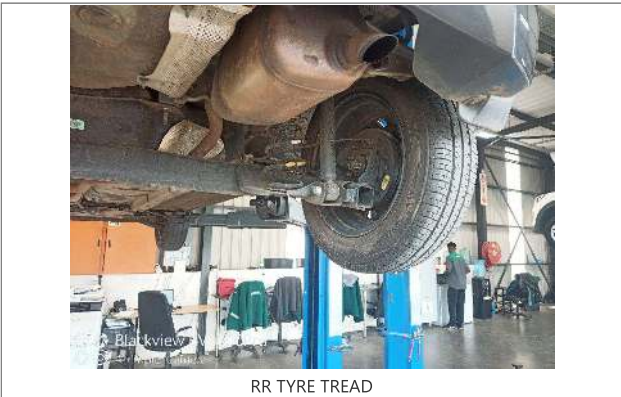
RR TYRE TREAD

| | Size | Load/Speed Index | Manufacture | Model | Type* | Production Date | Tread Depth (mm) |
|---|---|---|---|---|---|---|---|
| Rear Right | 165/70R14 | 81T | MRF | Zvts | V | 0821 | 3 mm |

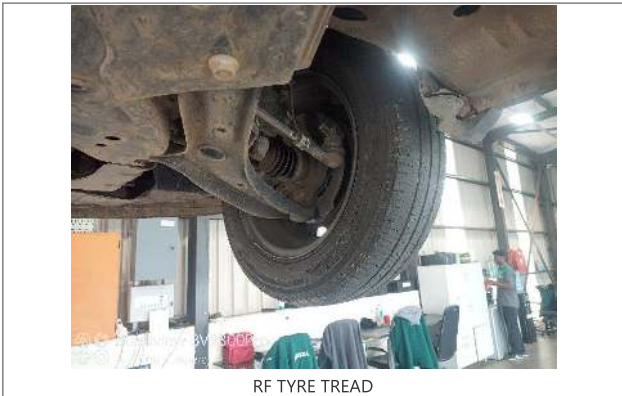
RF TYRE TREAD

| | Size | Load/Speed Index | Manufacture | Model | Type* | Production Date | Tread Depth (mm) |
|---|---|---|---|---|---|---|---|
| Front Right | 165/70R14 | 81T | MRF | Zvts | V | 0621 | 3 mm |

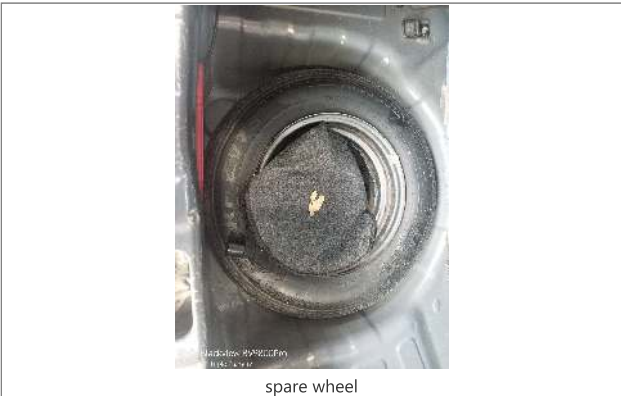
spare wheel

| | Size | Load/Speed Index | Manufacture | Model | Type* | Production Date | Tread Depth (mm) |
|---|---|---|---|---|---|---|---|
| Spare | 155/80R13 | 79T | MRF | Zvts | V | //// | 4 mm |

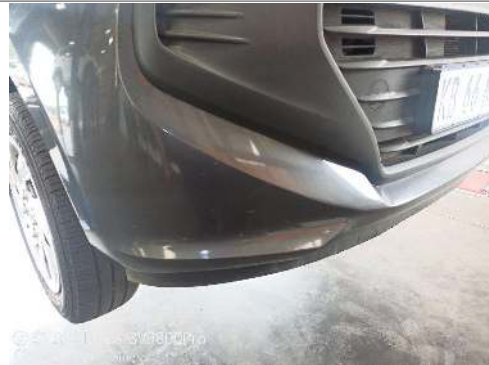
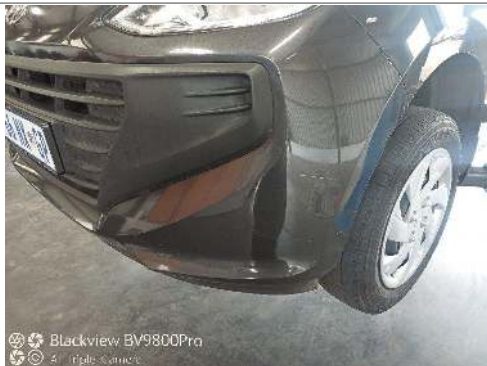
| Damage | Repair Way |
|---|---|
| Front Bumper Paintwork • Scratched | Repair |

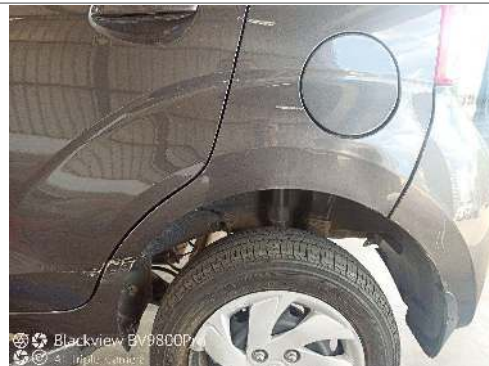
| Damage | Repair Way |
|---|---|
| Rear Fender Left Dented | Repair |

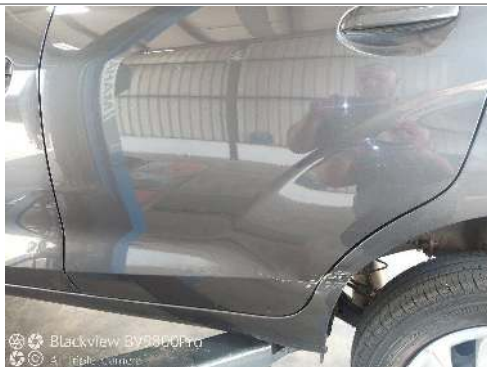
| Damage | Repair Way |
|---|---|
| Door Rear Left Paintwork • Scratched | Repair |

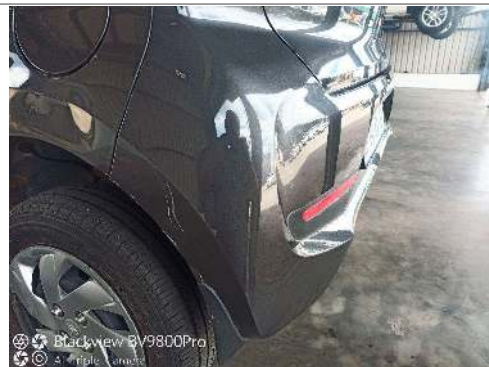
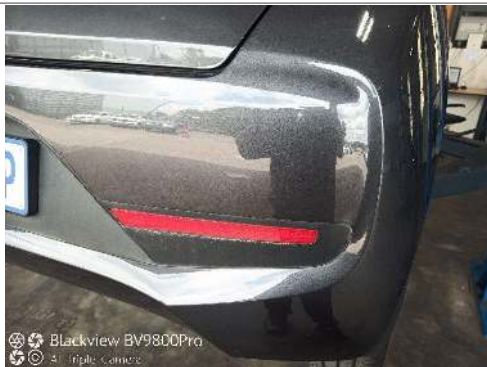
| Damage | Repair Way |
|---|---|
| Rear bumper Paintwork • Scratched | Repair |

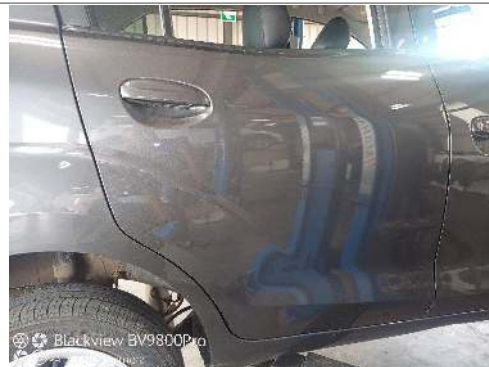
| Damage | Repair Way |
|---|---|
| Door Rear Right Paintwork • Scratched | Repair |

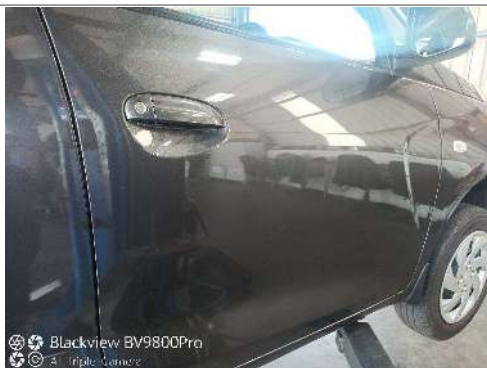
| Damage | Repair Way |
|---|---|
| Door Front Right Paintwork • Scratched | Repair |
