CONDITION REPORT

Report No: 2016867824

| Manufacturer | HYUNDAI | Registration Number | KL18YJGP |
| Model | ATOS 1.1 50KW MOTION 5-DR AMT [2021-2024] | Register Number | |

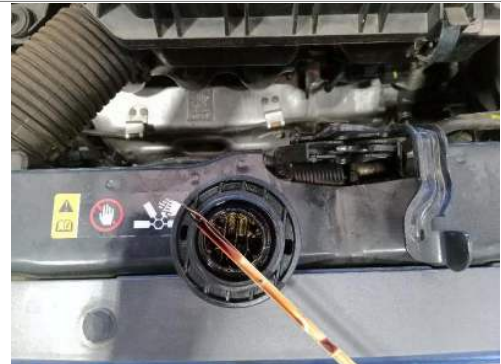
Oil cap and dipstick

| Damage | Repair Way |
|---|---|
| Engine | Foreign substance on oil cap |

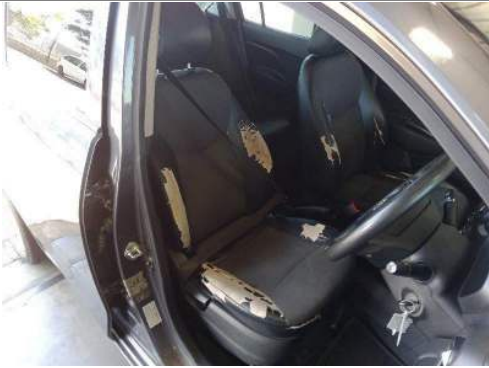
| Damage | Repair Way |
|---|---|
| Seat Front Right Damaged | Repair |

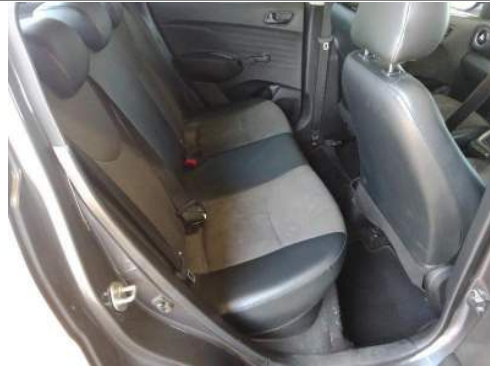
| Damage | Repair Way |
|---|---|
| Seat Rear Defective | Repair |

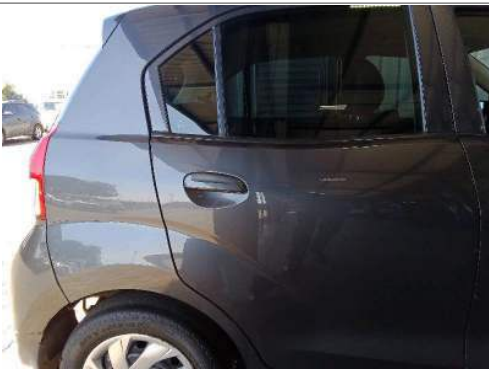
| Damage | Repair Way |
|---|---|
| Rear Fender Right Paintwork • Scratched | Repair |

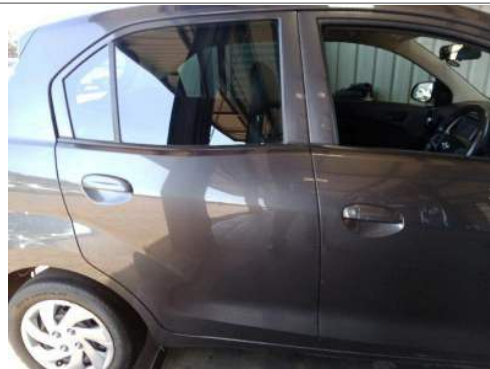
| Damage | Repair Way |
|---|---|
| Door Rear Right Paintwork • Scratched | Repair |

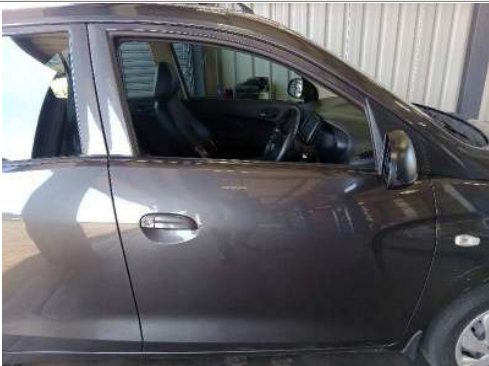
| Damage | Repair Way |
|---|---|
| Door Front Right Dented | Repair |

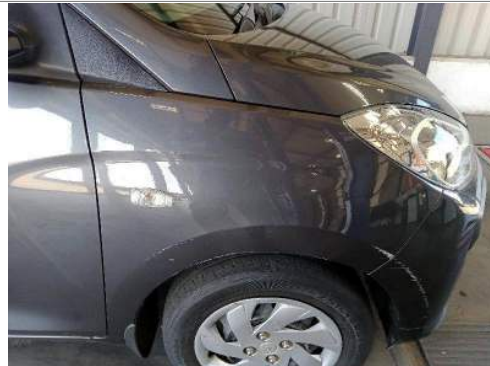
| Damage | Repair Way |
|---|---|
| Front Fender Right Damaged | Repair |

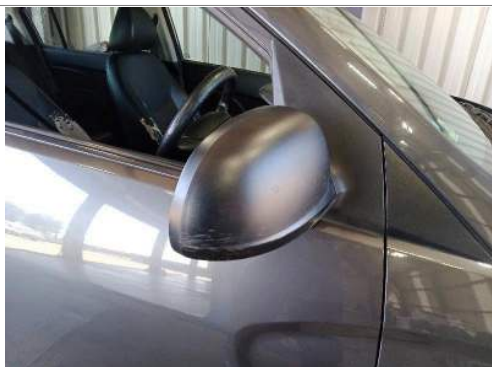
| Damage | Repair Way |
|---|---|
| Side Mirror Right Paintwork • Scratched | Repair |

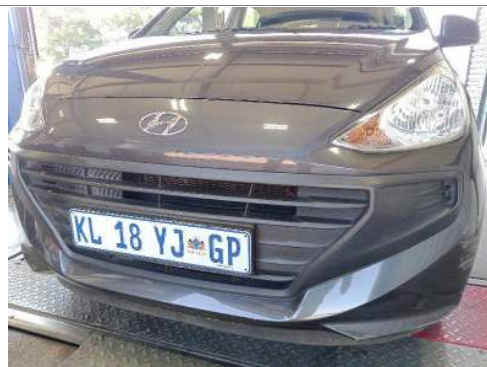
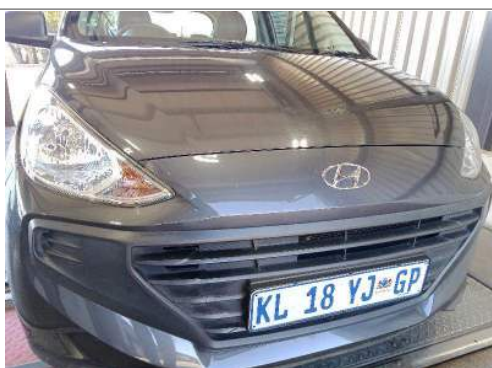
| Damage | Repair Way |
|---|---|
| Front Bumper Damaged | Repair |

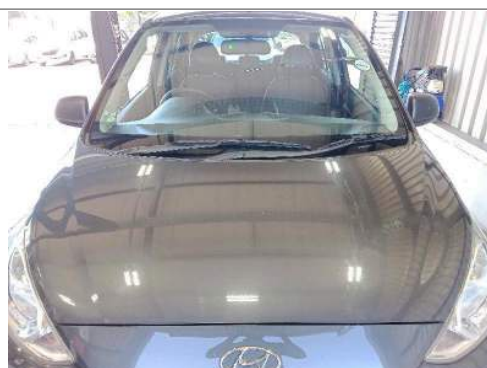
| Damage | Repair Way |
|---|---|
| Bonnet Paintwork • Scratched | Repair |

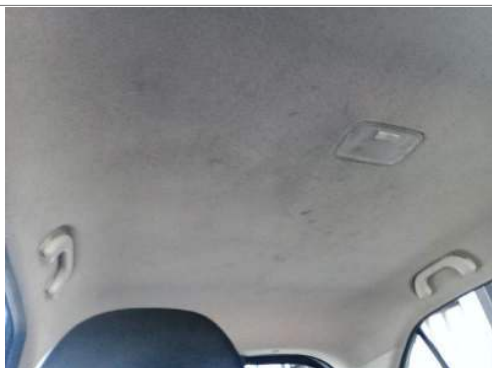
| Damage | Repair Way |
|---|---|
| Hood Lining Damaged | Repair |

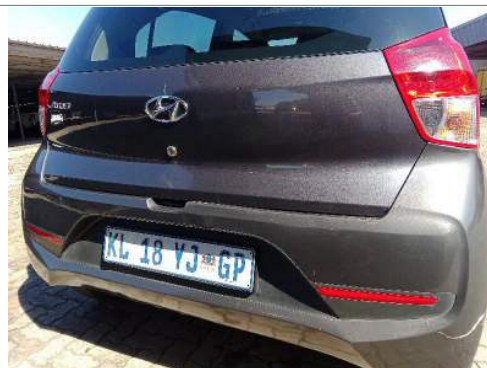
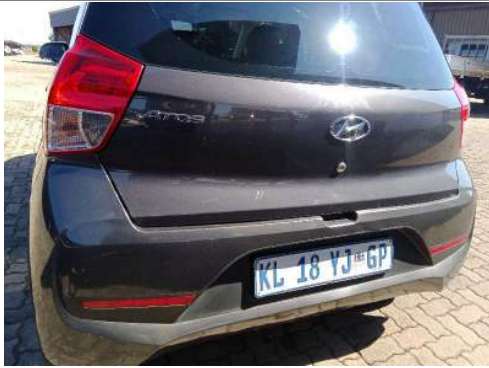
| Damage | Repair Way |
|---|---|
| Rear bumper Damaged | Repair |

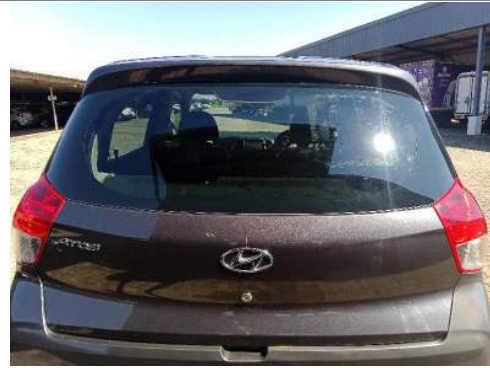
| Damage | Repair Way |
|---|---|
| Boot Lid / Hatch door Paintwork • Scratched | Repair |

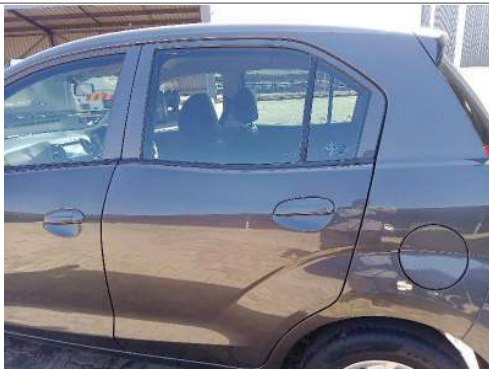
| Damage | Repair Way |
|---|---|
| Door Rear Left Paintwork • Scratched | Repair |

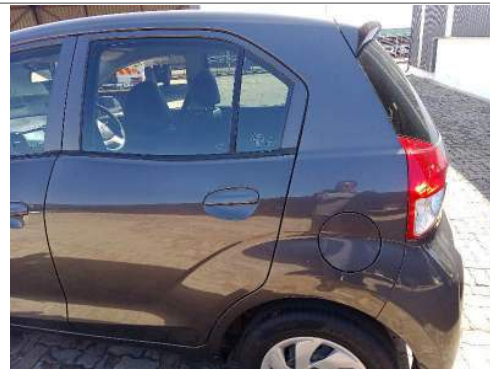
| Damage | Repair Way |
|---|---|
| Rear Fender Left Paintwork • Scratched | Repair |

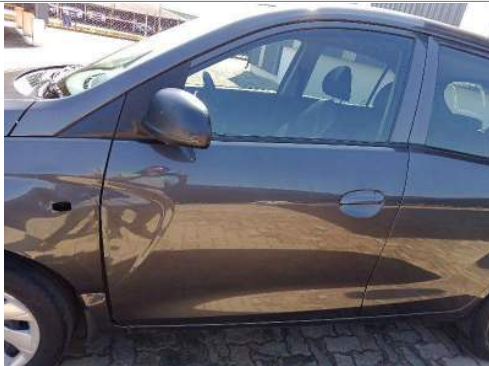
| Damage | Repair Way |
|---|---|
| Door Front Left Damaged | Repair |

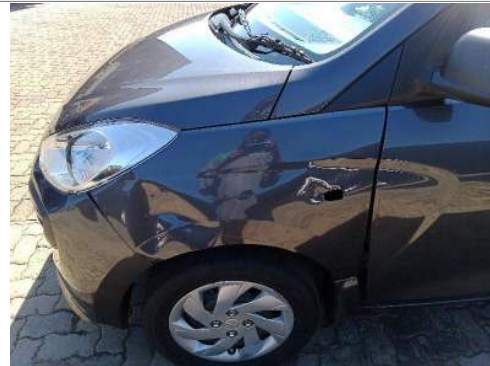
| Damage | Repair Way |
|---|---|
| Front Fender Left Damaged | Repair |

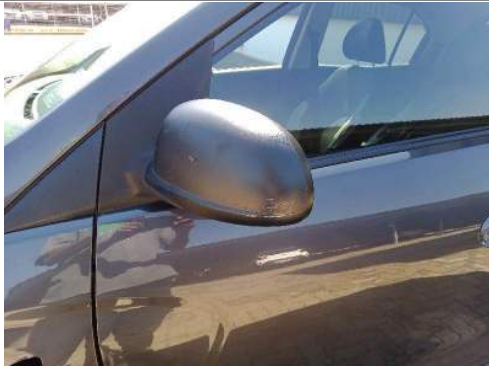
| Damage | Repair Way |
|---|---|
| Side Mirror Left Paintwork • Scratched | Repair |

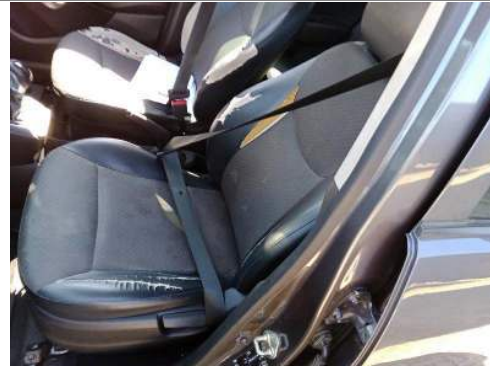
| Damage | Repair Way |
|---|---|
| Seat Front Left Damaged | Repair |

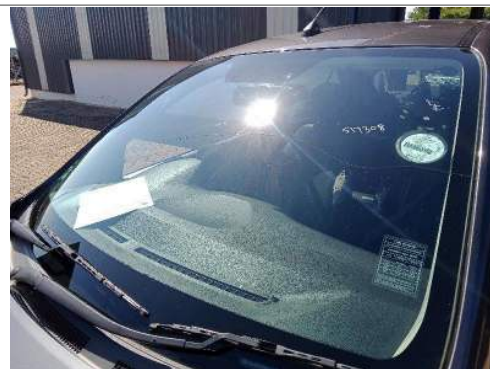
| Damage | Repair Way |
|---|---|
| Windscreen Cracked | Replace |

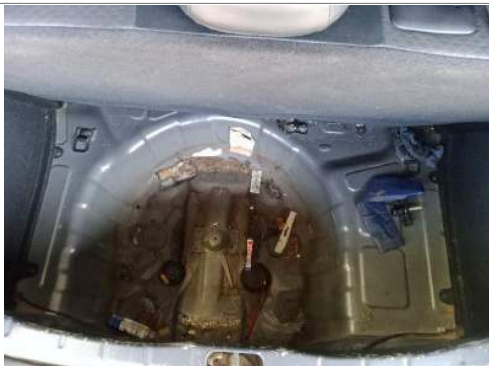
| Damage | Repair Way |
|---|---|
| Inner Boot Floor Pan and Spare Wheel Well Dented | Repair |

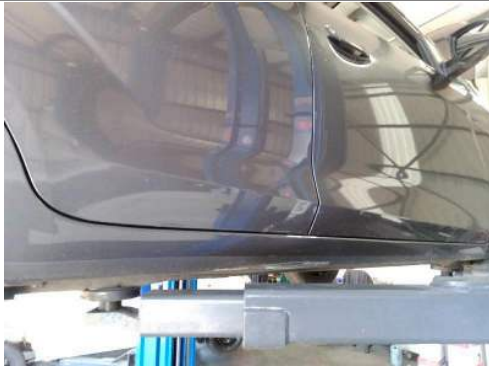
| Damage | Repair Way |
|---|---|
| Sill Panel Right Dented | Repair |

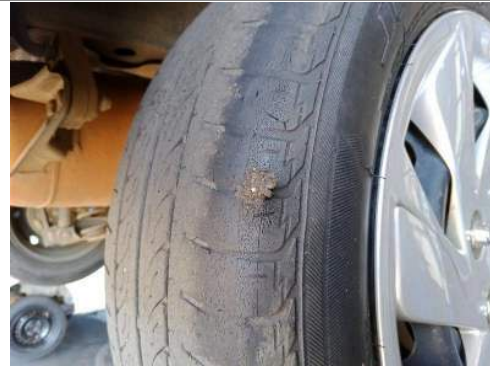
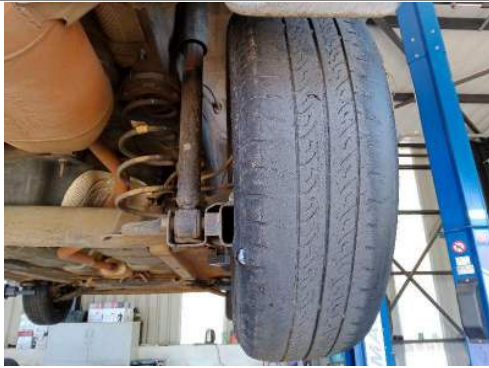
| Damage | Repair Way |
|---|---|
| Tyre Rear Right Damaged | Replace |

| | Size | Load/Speed Index | Manufacture | Model | Type* | Production Date | Tread Depth (mm) |
|---|---|---|---|---|---|---|---|
| Rear Right | 175/65 R14 | 82H | Joyroad | Tour | V | 1422 | 0 mm |

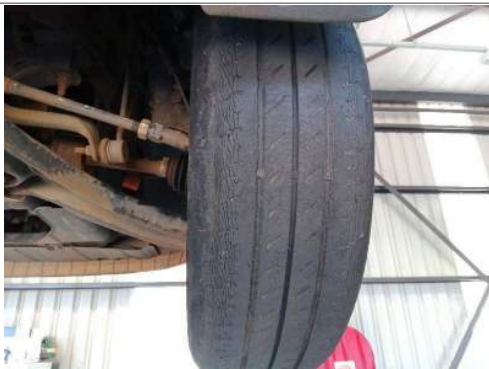
| Damage | Repair Way |
|---|---|
| Tyre Front Right Worn | Replace |

| | Size | Load/Speed Index | Manufacture | Model | Type* | Production Date | Tread Depth (mm) |
|---|---|---|---|---|---|---|---|
| Front Right | 175/65 R14 | 82T | Silverstone | Radial | V | 5117 | 0 mm |

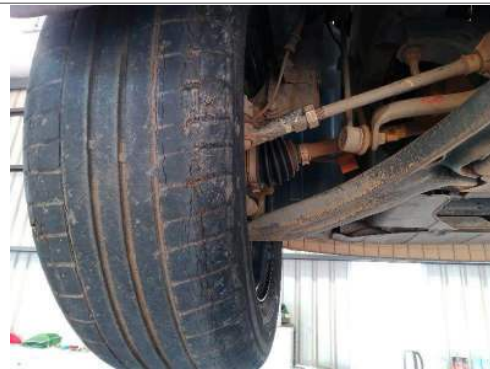
| Damage | Repair Way |
|---|---|
| Tyre Front Left Damaged | Replace |

| | Size | Load/Speed Index | Manufacture | Model | Type* | Production Date | Tread Depth (mm) |
|---|---|---|---|---|---|---|---|
| Front Left | 185/60 R14 | 82H | Habilead | Comfort | V | 0113 | 0 mm |

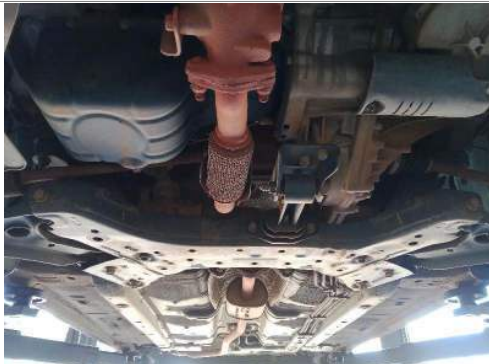
| Damage | Repair Way |
|---|---|
| Sub Frame Dented | Repair |

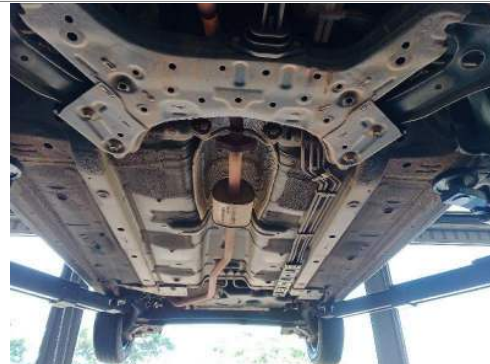
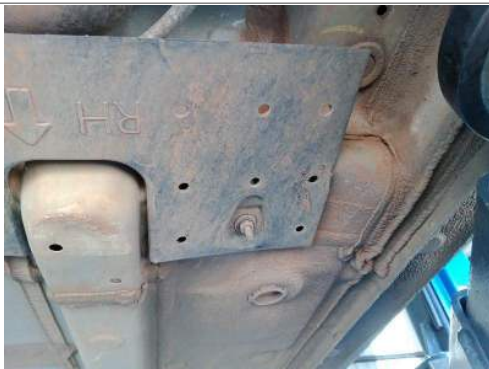
| Damage | Repair Way |
|---|---|
| Chassis Damaged | Repair |

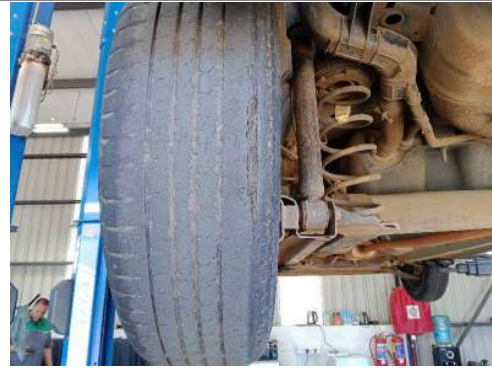
| Damage | Repair Way |
|---|---|
| Tyre Rear Left Damaged | Replace |

| | Size | Load/Speed Index | Manufacture | Model | Type* | Production Date | Tread Depth (mm) |
|---|---|---|---|---|---|---|---|
| Rear Left | 175/70 R14 | 84T | Winrun | R330 | V | 2323 | 0 mm |

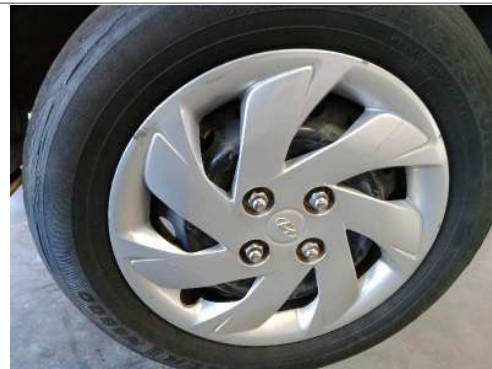
| Damage | Repair Way |
|---|---|
| Rim Front Right Scratched | Repair |
