## CONDITION REPORT

Report No:  
2016906734  
DATE  
09/06/2025

| Manufacturer | HYUNDAI | Registration Number | JW70VHGP |
| Model | I10 1.1 MOTION 5-DR [2011-2018] | Register Number | |

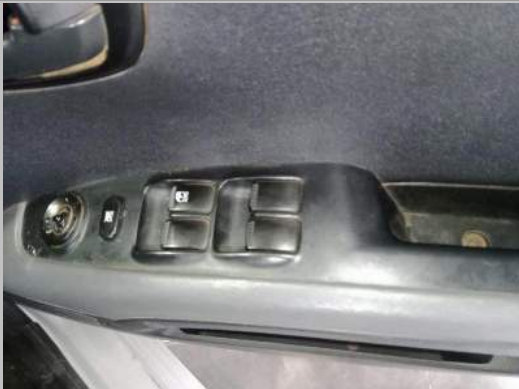
| Damage | Repair Way |
|---|---|
| Switch Electrical Window Winder rear left Malfunction | Repair |

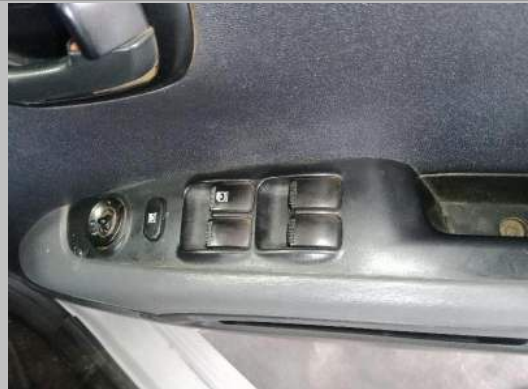
| Damage | Repair Way |
|---|---|
| Switch Electrical Window Winder rear right Malfunction | Repair |

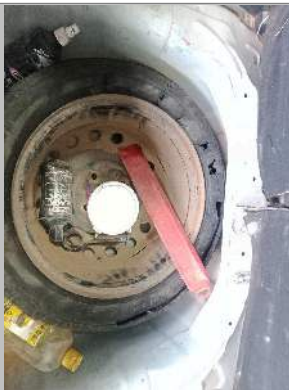
| Damage | Repair Way |
|---|---|
| Spare Tyre Damaged | Replace |

| | Size | Load/Speed Index | Manufacture | Model | Type* | Production Date | Tread Depth (mm) |
|---|---|---|---|---|---|---|---|
| Spare | 165/60R14 | 75H | Dunlop | Sp sport | V | 0000 | 2 mm |

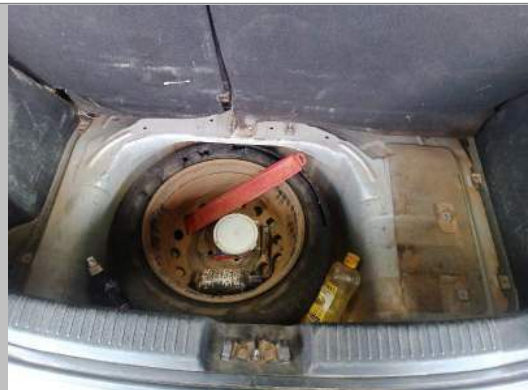
| Damage | Repair Way |
|---|---|
| Boot Carpet Missing | Replace |

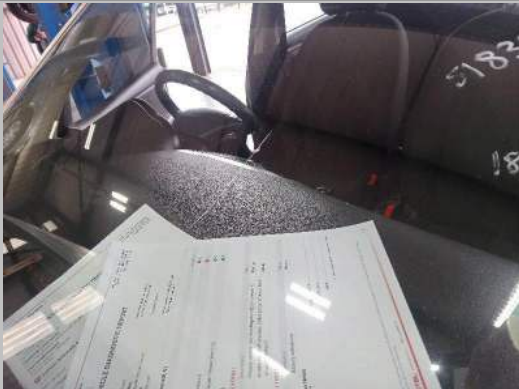
| Damage | Repair Way |
|---|---|
| Windscreen Cracked | Replace |

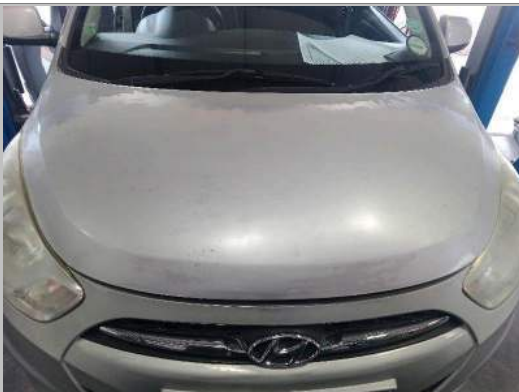
| Damage | Repair Way |
|---|---|
| Bonnet Paintwork • Discoloured | Repair |

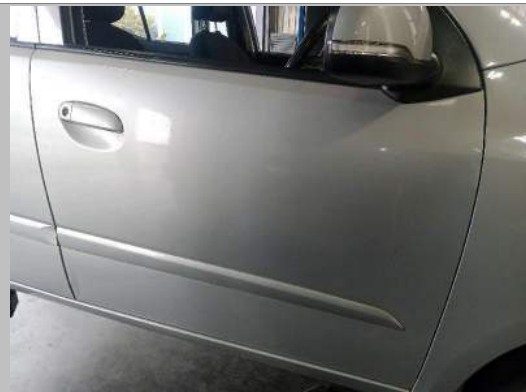
| Damage | Repair Way |
|---|---|
| Door Front Right Dented | Repair |

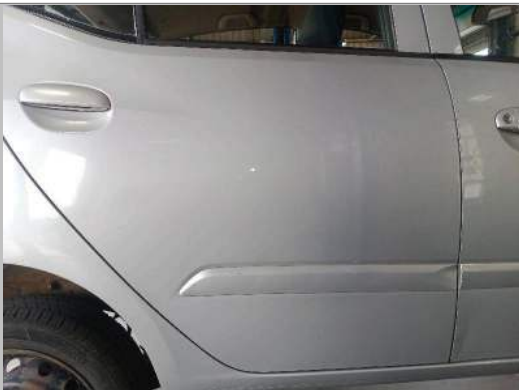
| Damage | Repair Way |
|---|---|
| Door Rear Right Paintwork • Scratched | Repair |

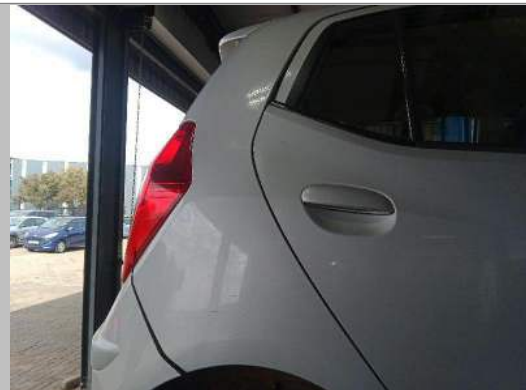
| Damage | Repair Way |
|---|---|
| Rear Fender Right Dented | Repair |

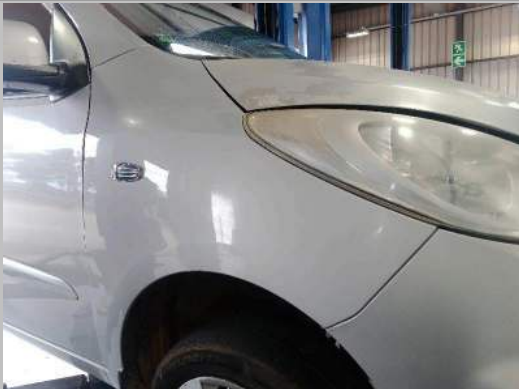
| Damage | Repair Way |
|---|---|
| Front Fender Right Paintwork • Scratched | Repair |

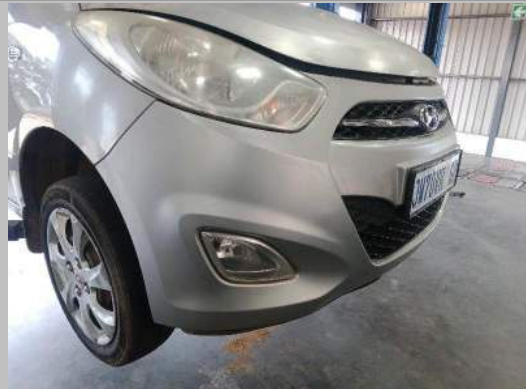
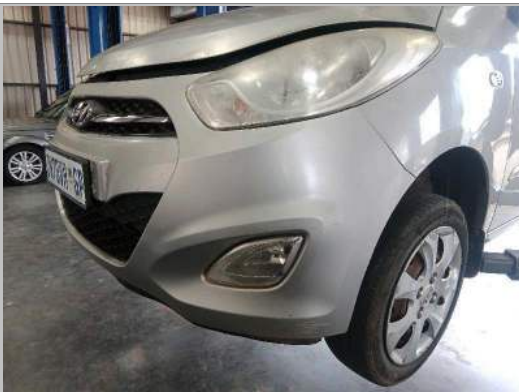
| Damage | Repair Way |
|---|---|
| Front Bumper Paintwork • Discoloured | Repair |

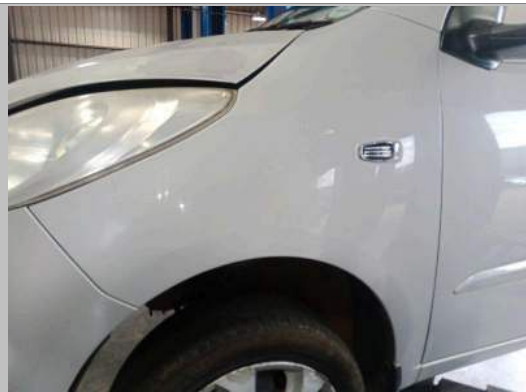
| Damage | Repair Way |
|---|---|
| Front Fender Left Paintwork • Scratched | Repair |

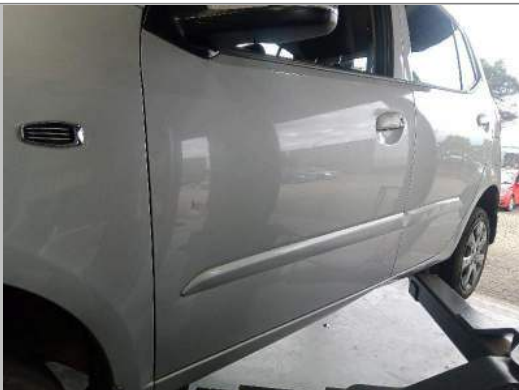
| Damage | Repair Way |
|---|---|
| Door Front Left Dented | Repair |

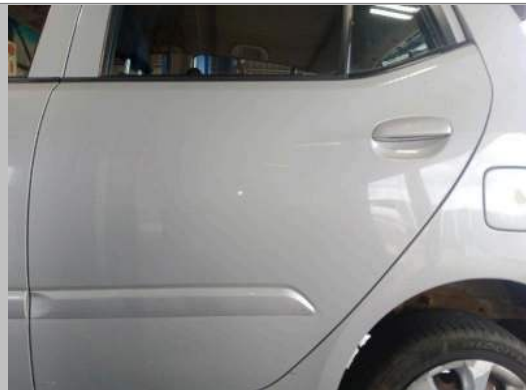
| Damage | Repair Way |
|---|---|
| Door Rear Left Paintwork • Scratched | Repair |

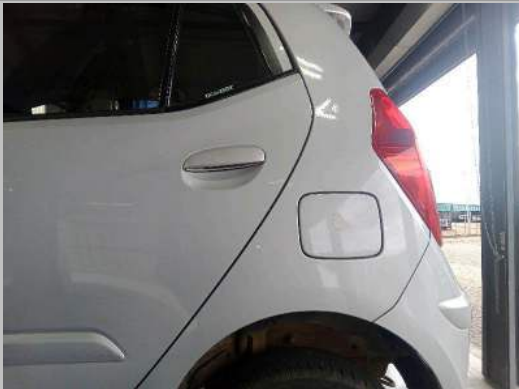
| Damage | Repair Way |
|---|---|
| Rear Fender Left Paintwork • Scratched | Repair |

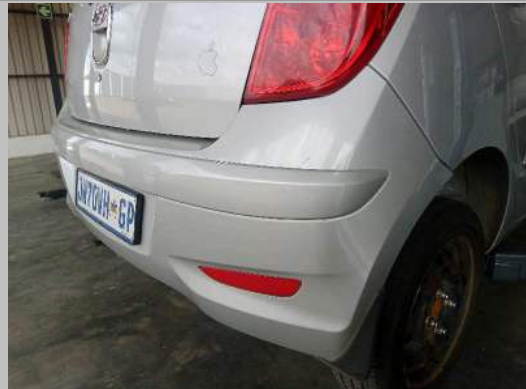
| Damage | Repair Way |
|---|---|
| Rear bumper Paintwork • Scratched | Repair |

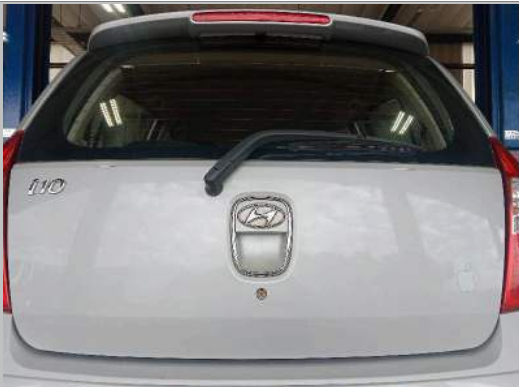
| Damage | Repair Way |
|---|---|
| Boot Lid / Hatch door Paintwork • Scratched | Repair |

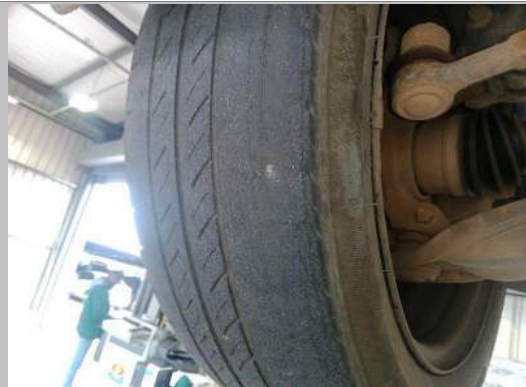
| Damage | Repair Way |
|---|---|
| Tyre Front Left Smooth | Replace |

| | Size | Load/Speed Index | Manufacture | Model | Type* | Production Date | Tread Depth (mm) |
|---|---|---|---|---|---|---|---|
| Front Left | 165/60R14 | 75H | Velocity | Rota -eco | V | 5023 | 0 mm |

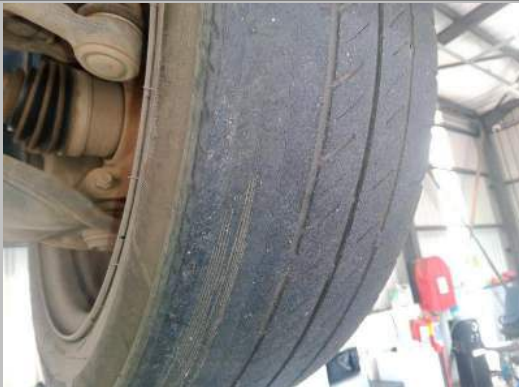
| Damage | Repair Way |
|---|---|
| Tyre Front Right Damaged | Replace |

| | Size | Load/Speed Index | Manufacture | Model | Type* | Production Date | Tread Depth (mm) |
|---|---|---|---|---|---|---|---|
| Front Right | 165/60R14 | 75H | Velocity | Rota -eco | V | 5023 | 0 mm |

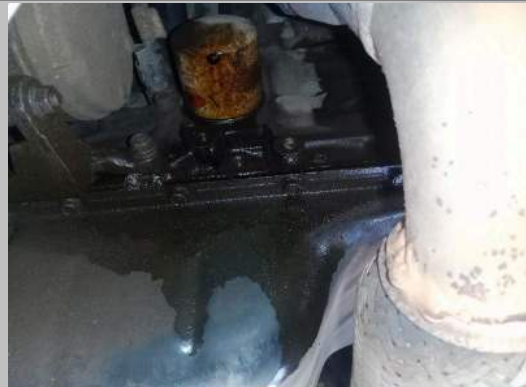
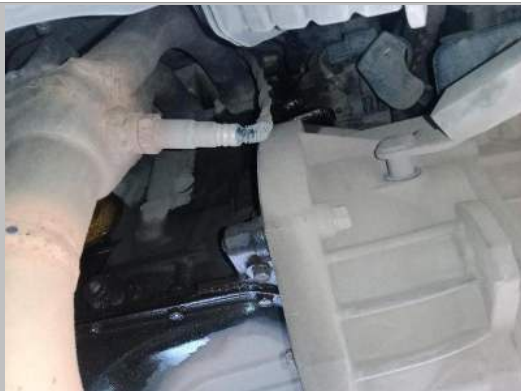
| Damage | Repair Way |
|---|---|
| Engine Oil Leak | Repair |

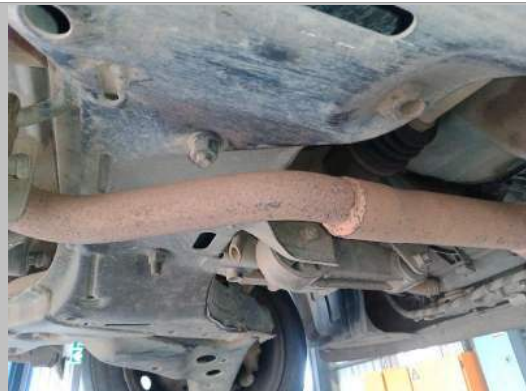
| Damage | Repair Way |
|---|---|
| Engine to silencer pipe Welded | Repair |

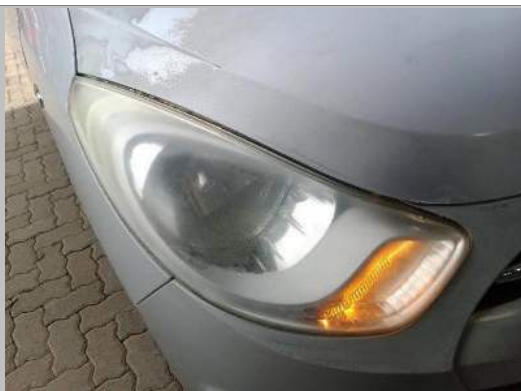
| Damage | Repair Way |
|---|---|
| Dim and Bright Indicator Light Malfunction | Repair |

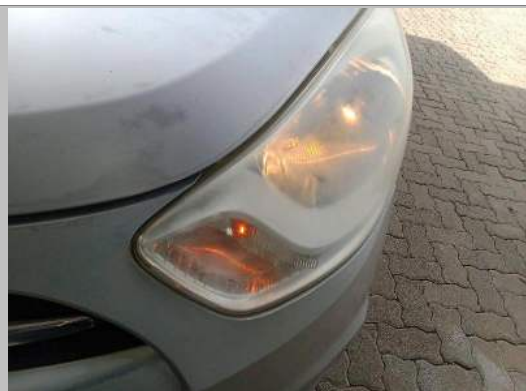
| Damage | Repair Way |
|---|---|
| Dim Light Left Malfunction | Repair |
