MFC Auction House  
M57 Pretoria Rd, Glenmarais, KEMPTON PARK  
Gauteng

| Vehicle Type | PASSENGER VEHICLE | Registered Owner | MFC |

## CONDITION REPORT

Report No: 2016214157

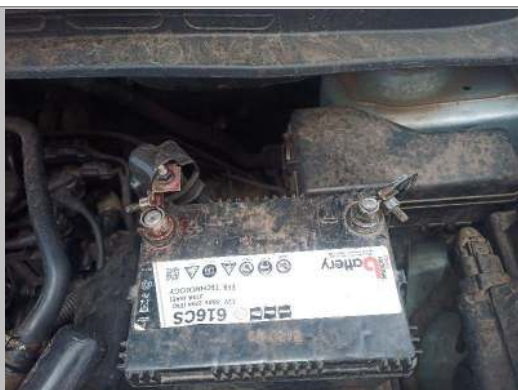
| Damage | Repair Way |
|---|---|
| Battery clamps Defective | Replace |

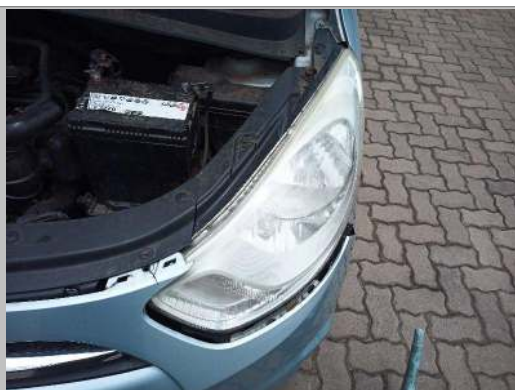
| Damage | Repair Way |
|---|---|
| Headlight Left Damaged | Replace |

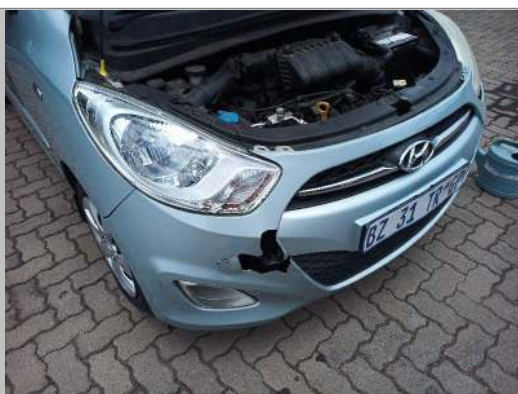
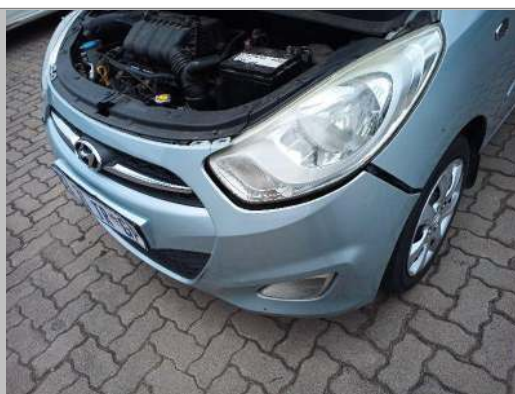
| Damage | Repair Way |
|---|---|
| Front Bumper Damaged | Replace |

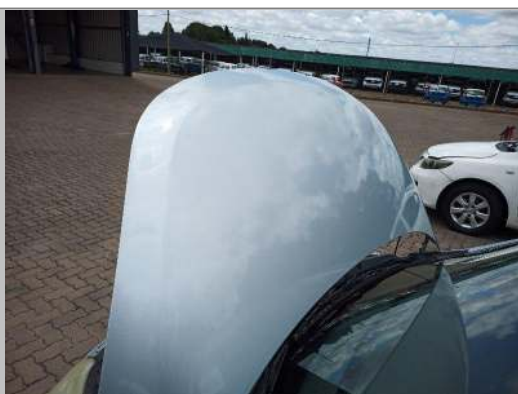
| Damage | Repair Way |
|---|---|
| Bonnet Damaged | Repair |

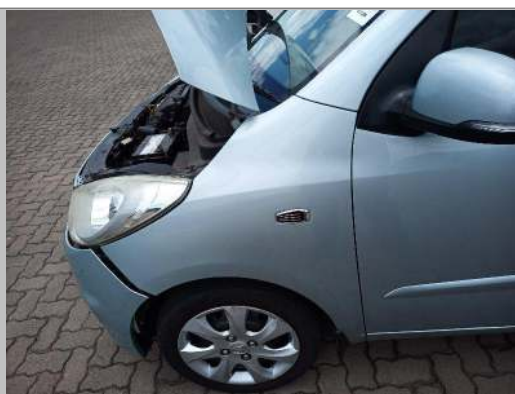
| Damage | Repair Way |
|---|---|
| Front Fender Left Damaged | Repair |

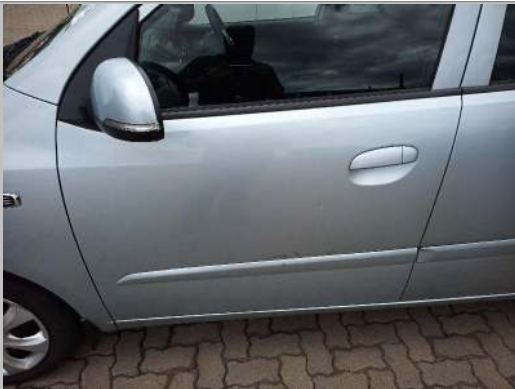
| Damage | Repair Way |
|---|---|
| Door Front Left Damaged | Repair |

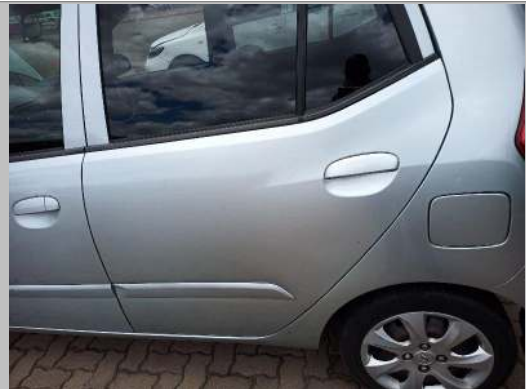
| Damage | Repair Way |
|---|---|
| Door Rear Left Damaged | Repair |

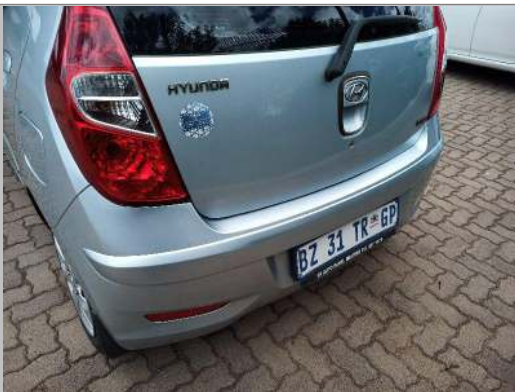
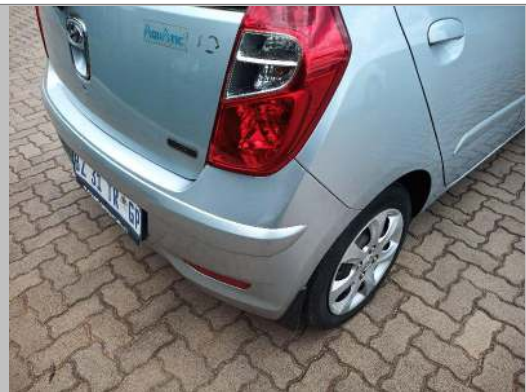
| Damage | Repair Way |
|---|---|
| Rear bumper Damaged | Repair |

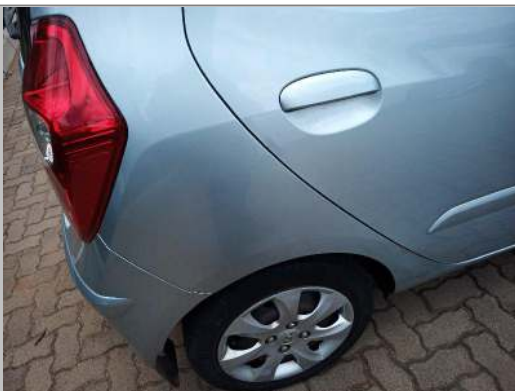
| Damage | Repair Way |
|---|---|
| Rear Fender Right Damaged | Repair |

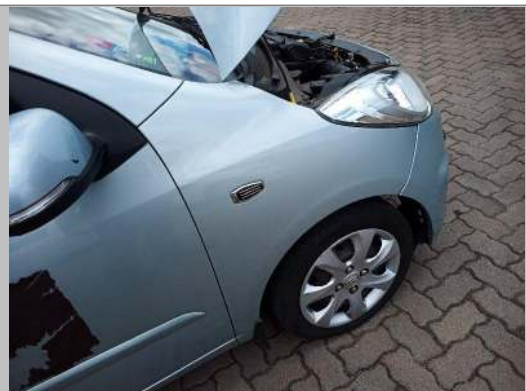
| Damage | Repair Way |
|---|---|
| Front Fender Right Damaged | Repair |

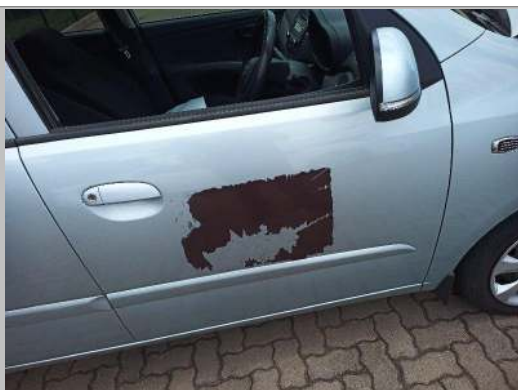
| Damage | Repair Way |
|---|---|
| Door Front Right Damaged | Repair |

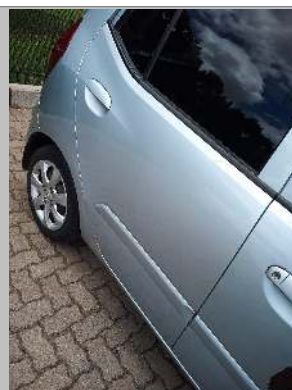
| Damage | Repair Way |
|---|---|
| Door Rear Right Damaged | Repair |

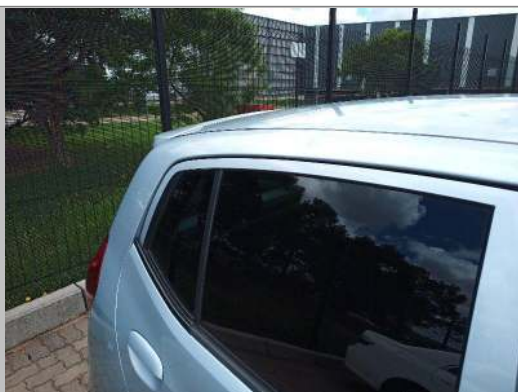
| Damage | Repair Way |
|---|---|
| C • Pillar Left Damaged | Repair |

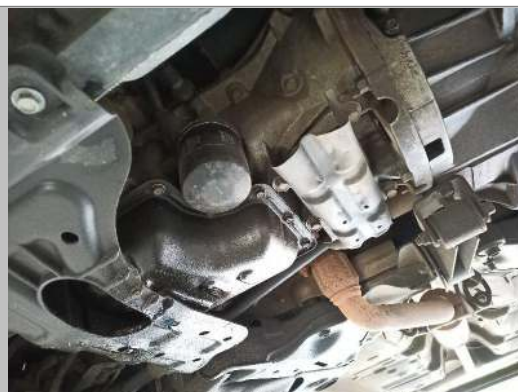
| Damage | Repair Way |
|---|---|
| Engine Oil Leak | Repair |

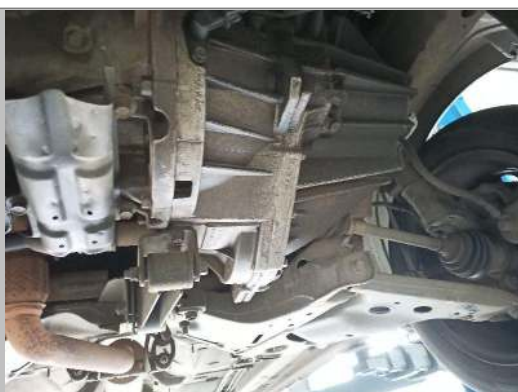
| Damage | Repair Way |
|---|---|
| Gearbox Oil Leak | Repair |

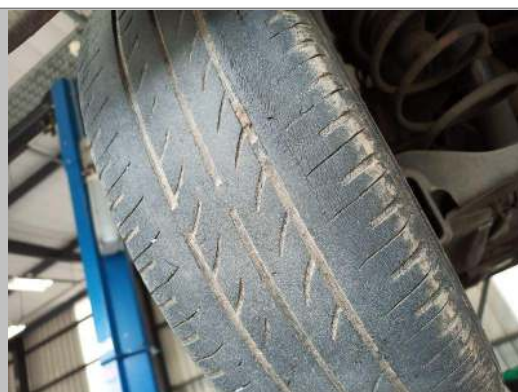
| Damage | Repair Way |
|---|---|
| Tyre Rear Left Worn | Replace |

| | Size | Load/Speed Index | Manufacture | Model | Type* | Production Date | Tread Depth (mm) |
|---|---|---|---|---|---|---|---|
| Rear Left | 165/60R14 | 75T | Goodride | Radial | V | 3913 | 0 mm |

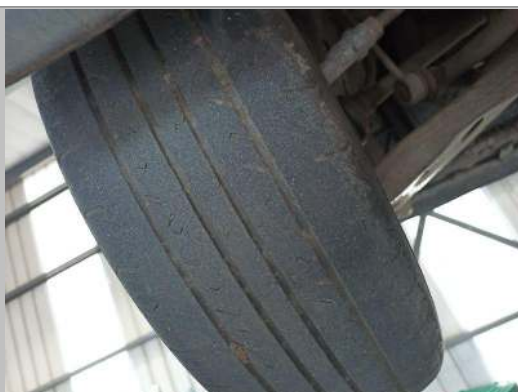
| Damage | Repair Way |
|---|---|
| Tyre Front Left Worn | Replace |

| | Size | Load/Speed Index | Manufacture | Model | Type* | Production Date | Tread Depth (mm) |
|---|---|---|---|---|---|---|---|
| Front Left | 165/60R14 | 75H | Rapid | Radial | V | 3119 | 0 mm |

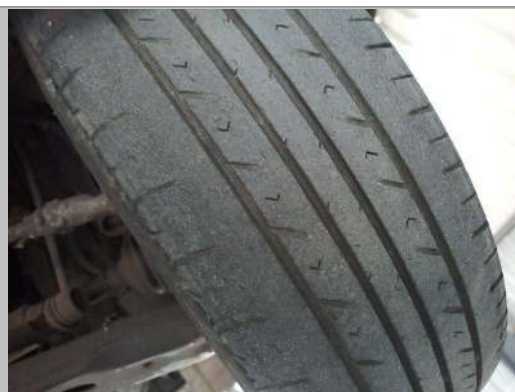
| Damage | Repair Way |
|---|---|
| Tyre Front Right Worn | Repair |

| | Size | Load/Speed Index | Manufacture | Model | Type* | Production Date | Tread Depth (mm) |
|---|---|---|---|---|---|---|---|
| Front Right | 165/60R14 | 75H | Rapid | Radial | V | 3119 | 0 mm |
