MFC Auction House
M57 Pretoria Rd, Glenmarais, KEMPTON PARK
Gauteng

DEKRA MFC
M57 Pretoria Rd - 1619
KEMPTON PARK - GT
08610 33572

VEHICLE INSPECTION

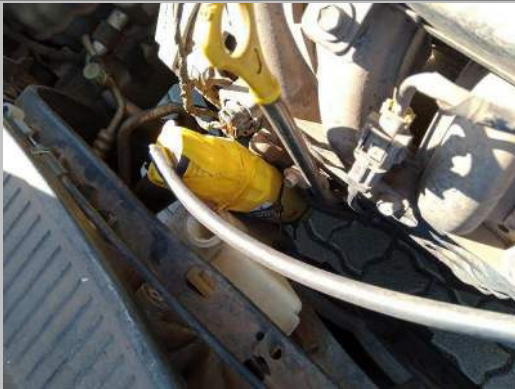
Damage	Repair Way
Expansion Bottle Damaged	Replace
Headlight Left Damaged	Replace
Headlight Right Damaged	Replace
Front Bumper Damaged	Repair
Bonnet Damaged	Repair
A • Pillar Left Damaged	Replace
A • Pillar Right Damaged	Repair
Front Fender Left Damaged	Repair
Front Fender Right Damaged	Repair
Rear Fender Right Damaged	Repair
Door Front Left Damaged	Repair
Door Front Right Damaged	Repair
Door Rear Left Damaged	Repair
Door Rear Right Damaged	Repair
Boot Lid / Hatch door Damaged	Repair
Rear bumper Damaged	Repair
Roof Damaged	Repair
Windscreen Damaged	Replace
Tyre Front Left Worn	Replace
Tyre Front Right Worn	Replace
Tyre Rear Right Worn	Replace
Gearbox Oil Leak	Repair
Radiator Cradle Damaged	Replace

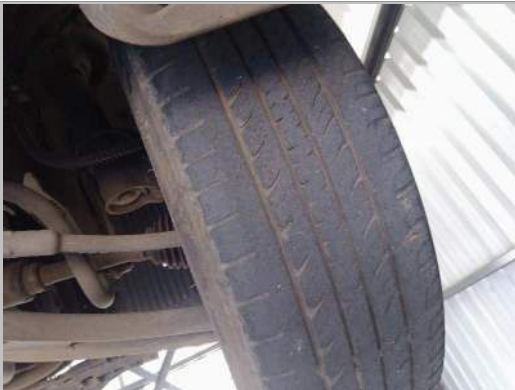
Tyre Front Right

Size	Load/Speed Index	Manufacture	Model	Type*	Production Date	Tread Depth (mm)
Front Left	175/70R14	84T	Durun	Radial	V	1918	0 mm
Front Right	175/70R14	84T	Durun	Radial	V	1918	0 mm
Rear Left	175/70R14	84H	Royal black	Radial	V	4517	2 mm
Rear Right	175/70R14	84T	Durun	Radial	V	1918	0 mm
