CONDITION REPORT

Report No: 2016204818

MFC Auction House  
M57 Pretoria Rd, Glenmarais, KEMPTON PARK  
Gauteng

Vehicle Type	PASSENGER VEHICLE	Registered Owner	MFC
Manufacturer	HYUNDAI	Registration Number	KD67WKGP
Model	I20	Register Number	
VIN	MALBG512LNM069070	Date Of First Licensing	
Engine Number		Last COR	
Doors	5	License Expiry Date	29/02/2024
Color	BLUE	Power / Displacement	
Year Model		Paint Finish	M - METALLIC
Km Reading	75,827 KM	Fuel	PETROL
Cab / Body Type	HATCHBACK	Transmission	MANUAL

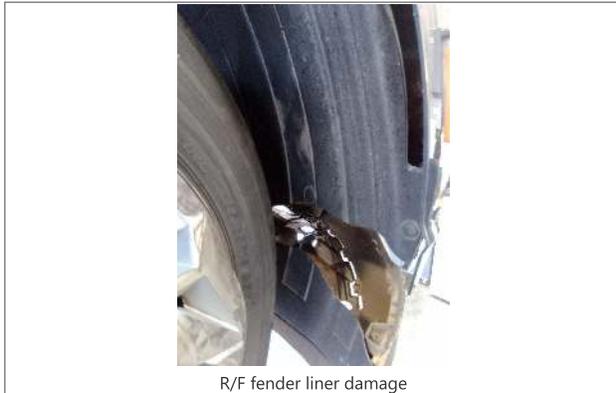
R/F fender liner damage

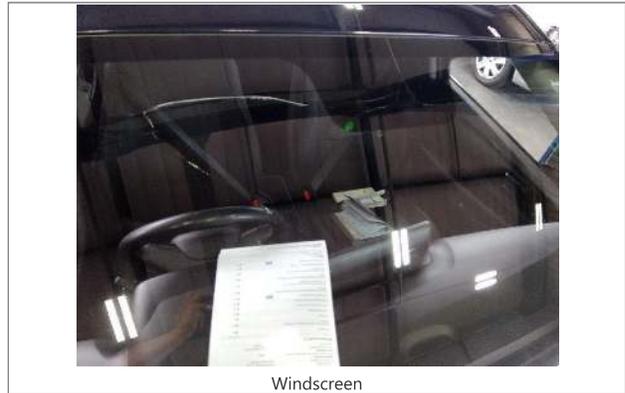
Damage	Repair Way
Indicator Light Front Right Broken	Replace
Fog Light Front Right Defective	Repair
Side Mirror Right Damaged	Replace
Front Bumper Damaged	Replace
Front Fender Right Dented	Repair
Rear Fender Right Damaged	Replace
Door Front Right Damaged	Replace
Door Rear Right Damaged	Replace
Rear bumper Damaged	Replace
Windscreen Cracked	Replace
