## CONDITION REPORT

Report No: 2016880319

| Manufacturer | HYUNDAI | Registration Number | HN50CWGP |
| Model | I20 | Register Number | |

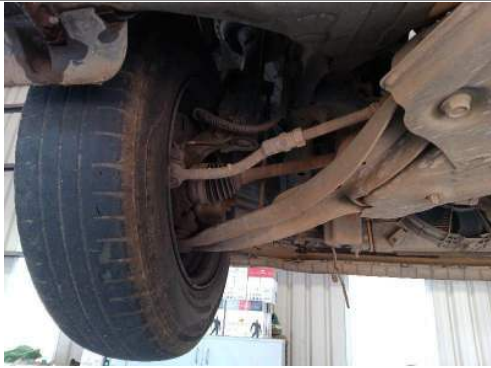
LF TYRE TREAD

| | Size | Load/Speed Index | Manufacture | Model | Type* | Production Date | Tread Depth (mm) |
|---|---|---|---|---|---|---|---|
| Front Left | 165/80 R14 | 85T | Apollo | Amazer | V | 3122 | 0 mm |

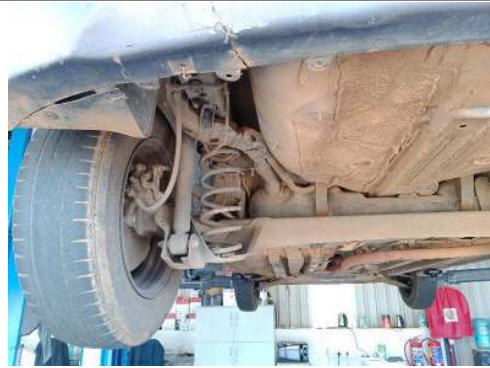
LR TYRE TREAD

| | Size | Load/Speed Index | Manufacture | Model | Type* | Production Date | Tread Depth (mm) |
|---|---|---|---|---|---|---|---|
| Rear Left | 165/80 R14 | 85T | Goodyear | Assurance | V | 2317 | 1 mm |

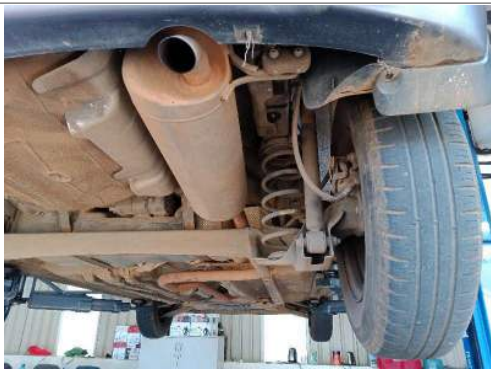
RR TYRE TREAD

| | Size | Load/Speed Index | Manufacture | Model | Type* | Production Date | Tread Depth (mm) |
|---|---|---|---|---|---|---|---|
| Rear Right | 165/80 R14 | 85T | Apollo | Amazer | V | 3821 | 1 mm |

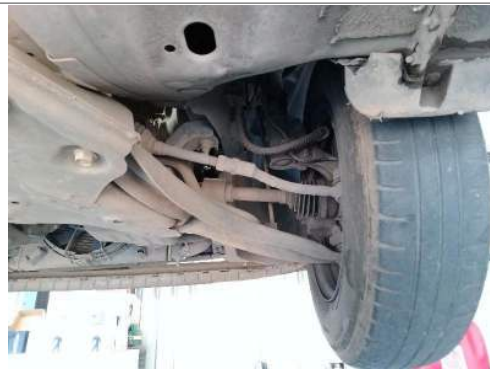
RF TYRE TREAD

| | Size | Load/Speed Index | Manufacture | Model | Type* | Production Date | Tread Depth (mm) |
|---|---|---|---|---|---|---|---|
| Front Right | 165/80 R14 | 85T | Apollo | Amazer | V | 3122 | 0 mm |

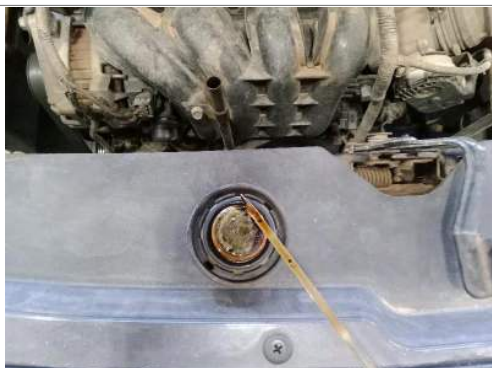
Oil cap and dipstick

| Damage | Repair Way |
|---|---|
| Engine | Foreign substance on oil cap |

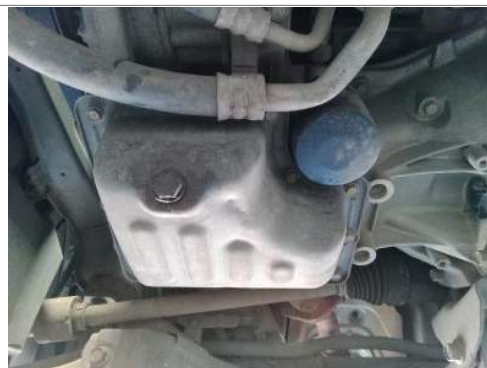
| Damage | Repair Way |
|---|---|
| Engine | Engine oil sump dented |

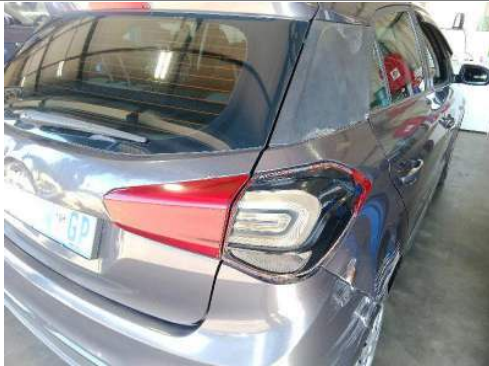
| Damage | Repair Way |
|---|---|
| Tail Light Right Damaged | Replace |

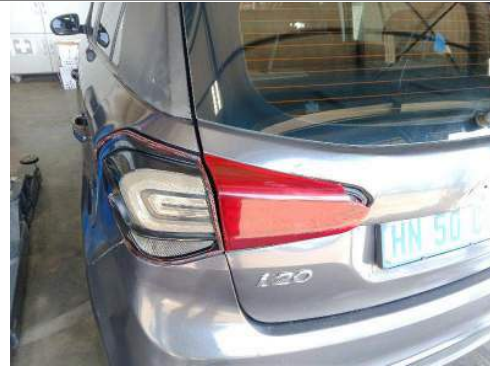
| Damage | Repair Way |
|---|---|
| Tail Light Left Damaged | Replace |

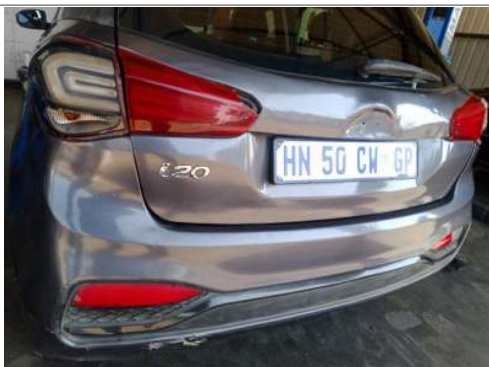
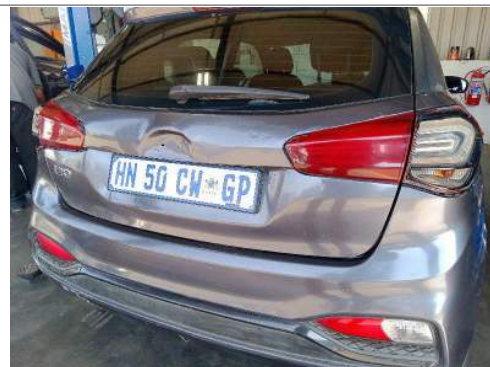
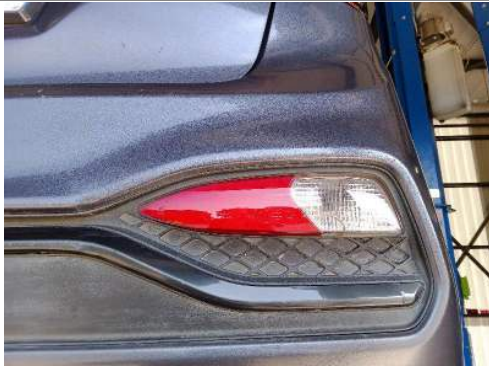
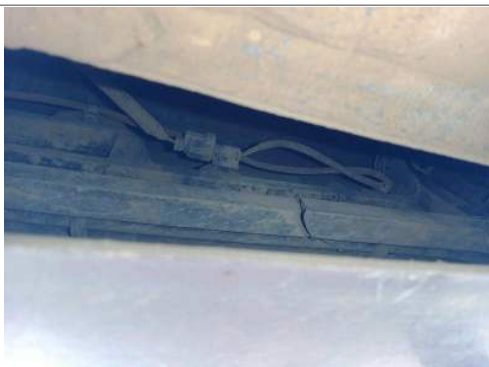
| Damage | Repair Way |
|---|---|
| Rear bumper Damaged | Repair |

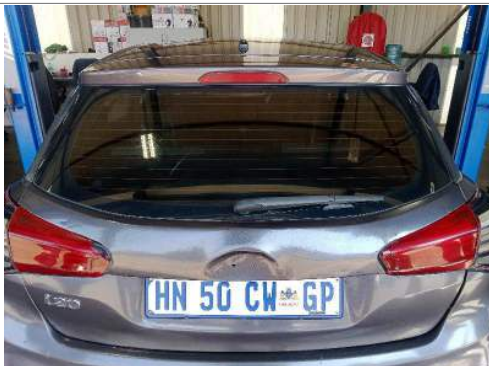
| Damage | Repair Way |
|---|---|
| Boot Lid / Hatch door Damaged | Replace |

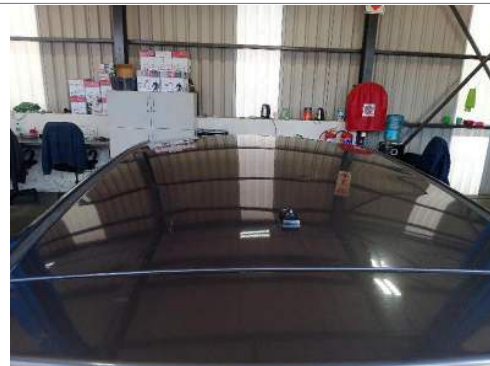
| Damage | Repair Way |
|---|---|
| Roof Dented | Repair |

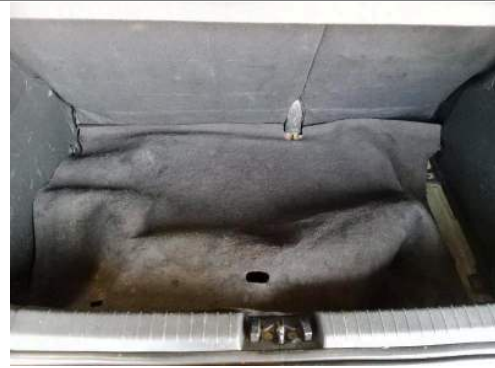
| Damage | Repair Way |
|---|---|
| Boot Carpet Damaged | Replace |

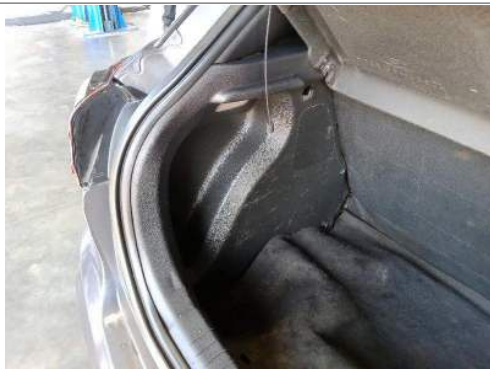
| Damage | Repair Way |
|---|---|
| Boot Panel Left Damaged | Repair |

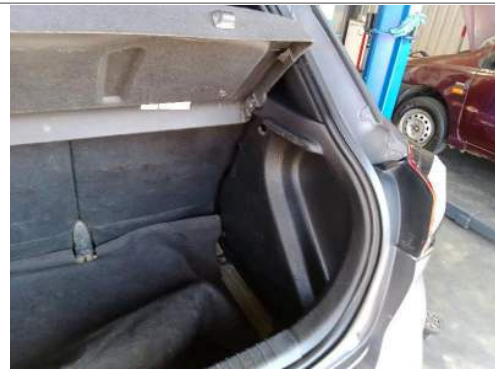
| Damage | Repair Way |
|---|---|
| Boot Panel Right Damaged | Repair |

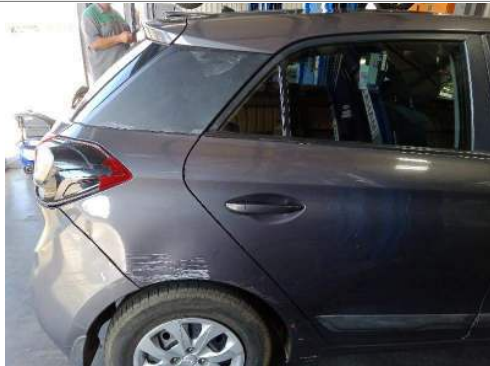
| Damage | Repair Way |
|---|---|
| Rear Fender Right Damaged | Repair |

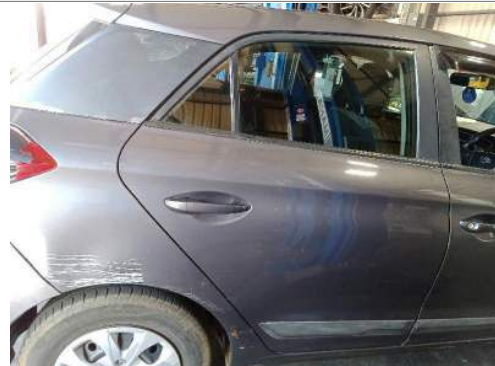
| Damage | Repair Way |
|---|---|
| Door Rear Right Paintwork • Scratched | Repair |

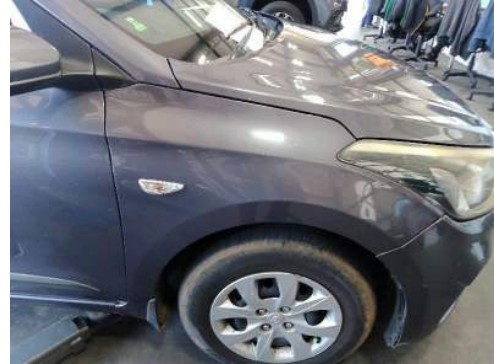
| Damage | Repair Way |
|---|---|
| Front Fender Right Dented | Repair |

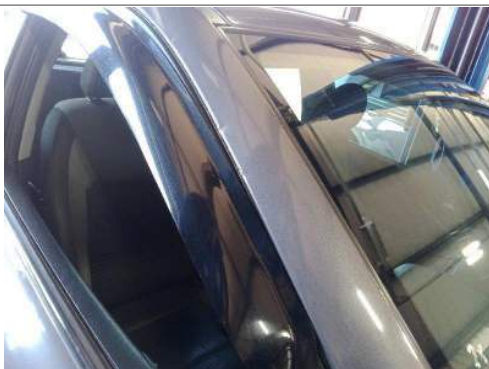
| Damage | Repair Way |
|---|---|
| A • Pillar Right Damaged | Repair |

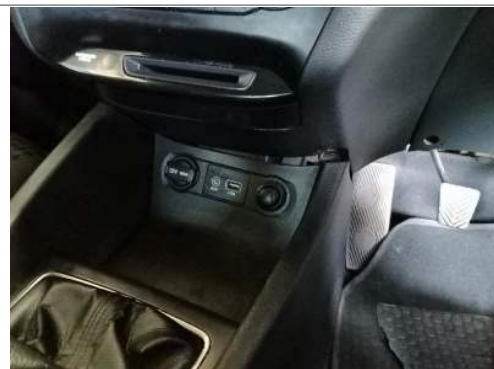
| Damage | Repair Way |
|---|---|
| Center Console / Cubbyhole + Lid Damaged | Repair |

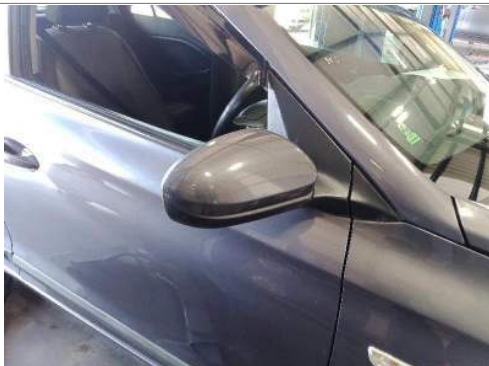
| Damage | Repair Way |
|---|---|
| Side Mirror Right Paintwork • Scratched | Repair |

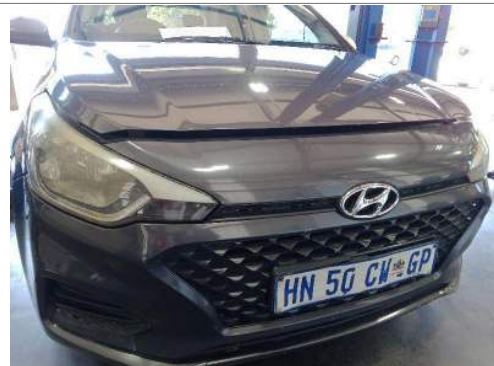
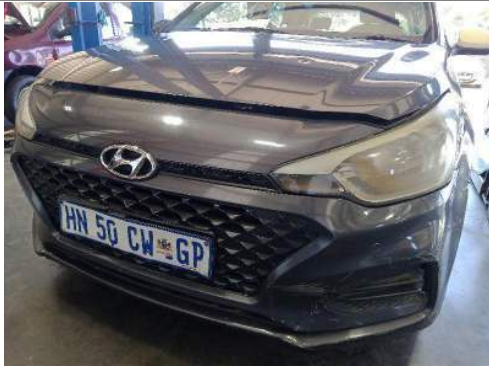
| Damage | Repair Way |
|---|---|
| Front Bumper Damaged | Repair |

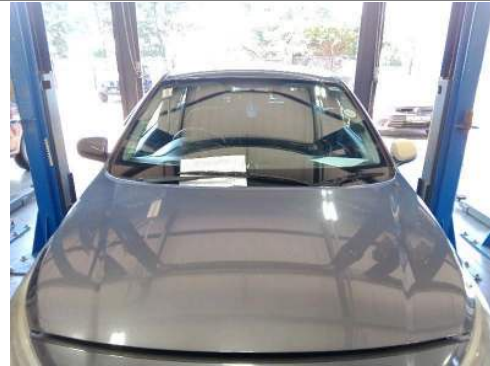
| Damage | Repair Way |
|---|---|
| Bonnet Damaged | Repair |

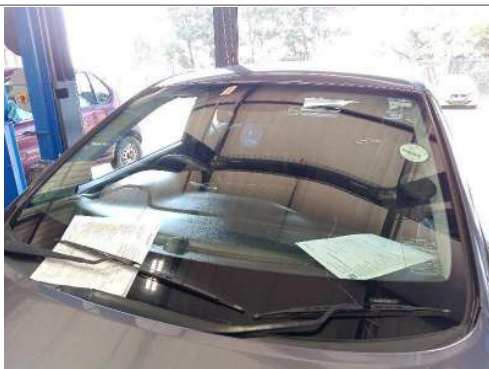
| Damage | Repair Way |
|---|---|
| Windscreen Cracked | Replace |

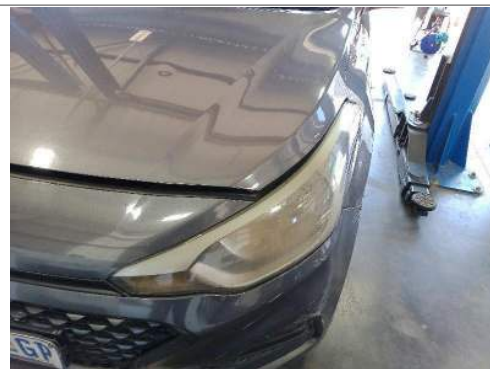
| Damage | Repair Way |
|---|---|
| Headlight Left Damaged | Replace |

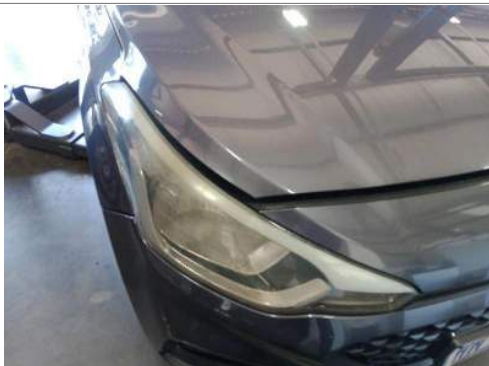
| Damage | Repair Way |
|---|---|
| Headlight Right Damaged | Replace |

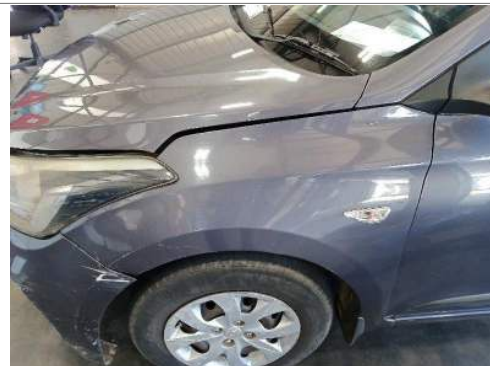
| Damage | Repair Way |
|---|---|
| Front Fender Left Damaged | Repair |

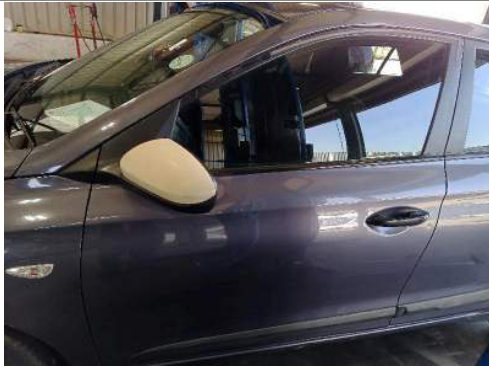
| Damage | Repair Way |
|---|---|
| Door Front Left Dented | Repair |

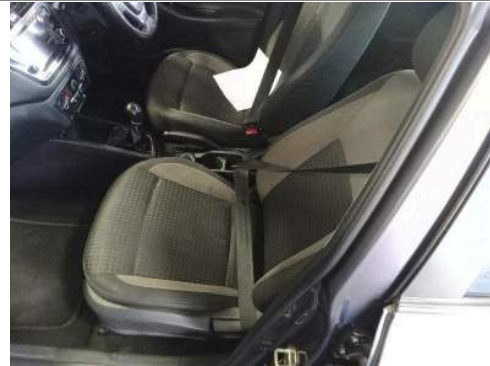
| Damage | Repair Way |
|---|---|
| Seat Front Left Dirty | Repair |

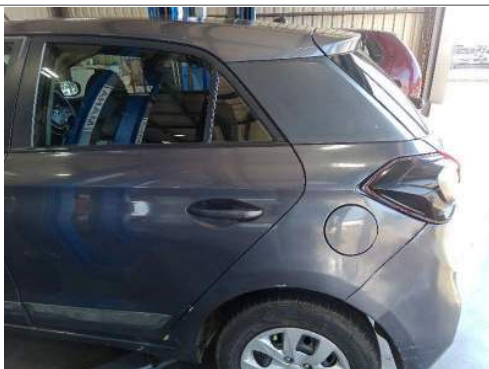
| Damage | Repair Way |
|---|---|
| Rear Fender Left Residual Traces of Repair | Repair |

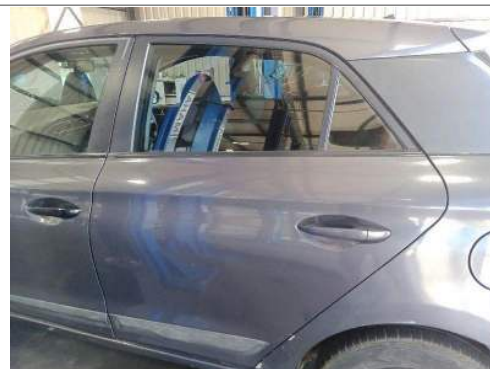
| Damage | Repair Way |
|---|---|
| Door Rear Left Damaged | Repair |

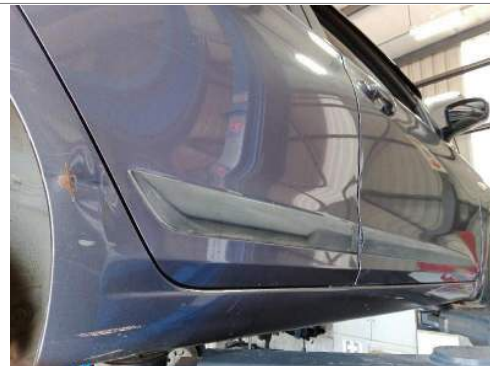
| Damage | Repair Way |
|---|---|
| Sill Panel Right Dented | Repair |

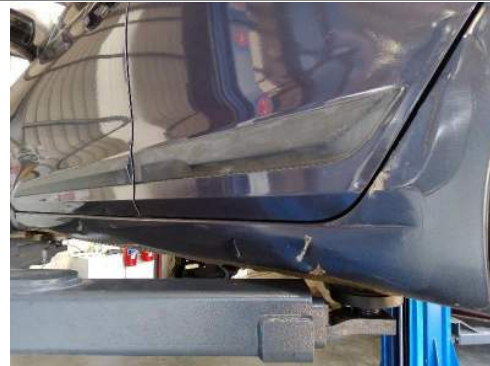
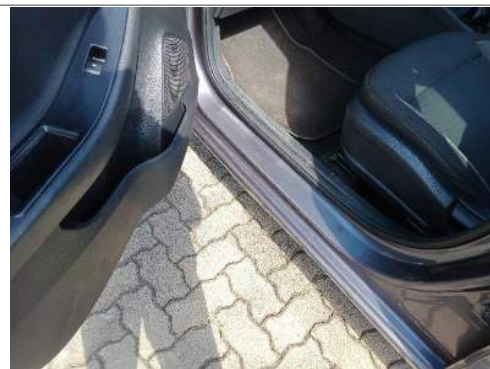
| Damage | Repair Way |
|---|---|
| Sill Panel Left Damaged | Repair |

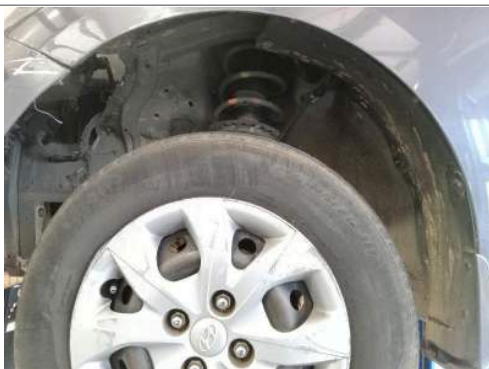
| Damage | Repair Way |
|---|---|
| Front Fender Left / Inner Tray Damaged | Replace |

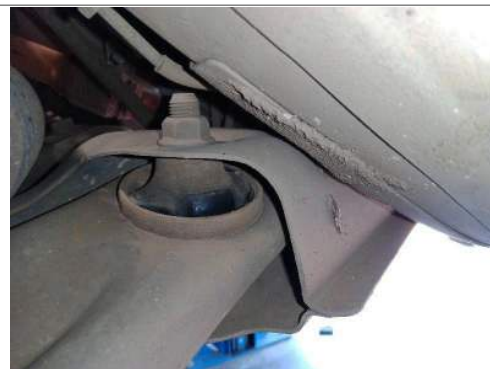
| Damage | Repair Way |
|---|---|
| Control Arm Bush(es) Front Axle Left Cracked | Replace |

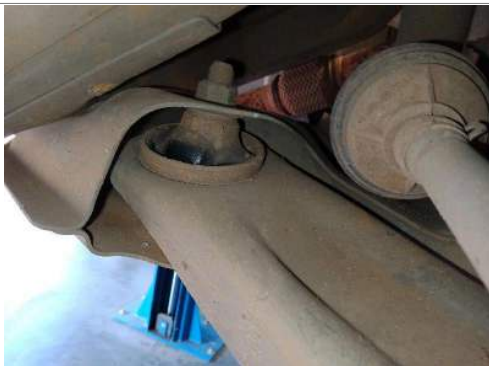
| Damage | Repair Way |
|---|---|
| Control Arm Bush(es) Front Axle Right Cracked | Replace |

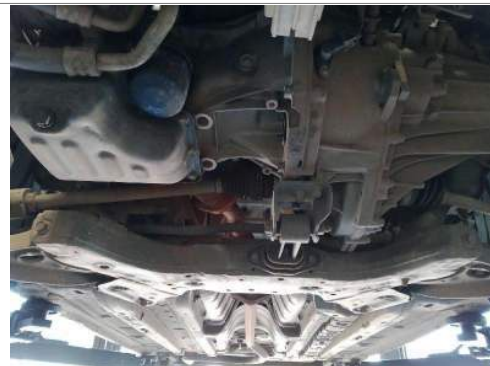
| Damage | Repair Way |
|---|---|
| Sub Frame Damaged | Repair |

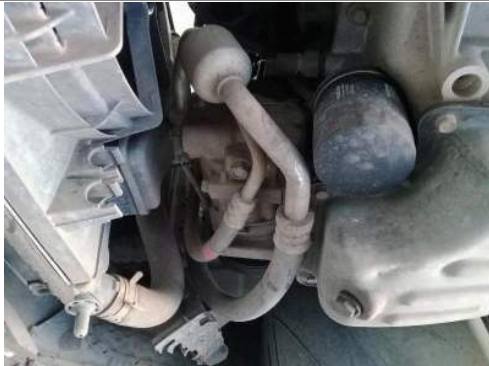
| Damage | Repair Way |
|---|---|
| Air conditioner pipes Damaged | Replace |

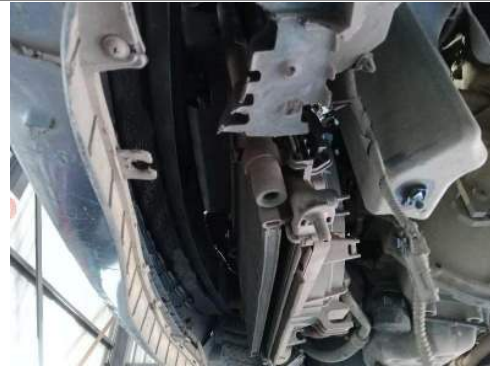
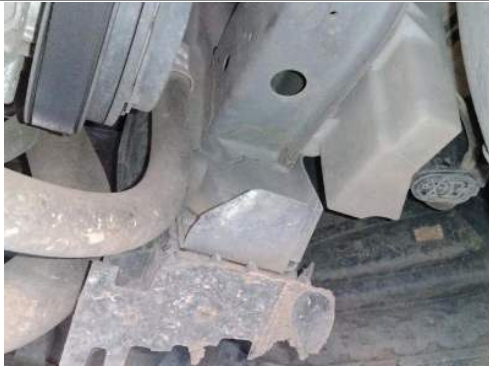
| Damage | Repair Way |
|---|---|
| Radiator Cradle Damaged | Replace |

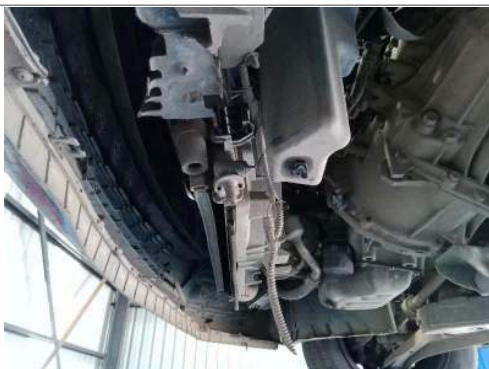
| Damage | Repair Way |
|---|---|
| Engine Wiring Defective | Repair |

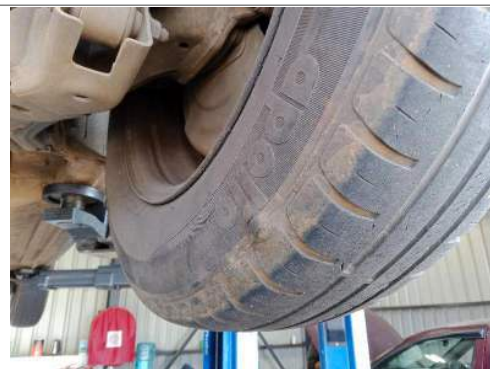
| Damage | Repair Way |
|---|---|
| Tyre Rear Right Damaged | Replace |

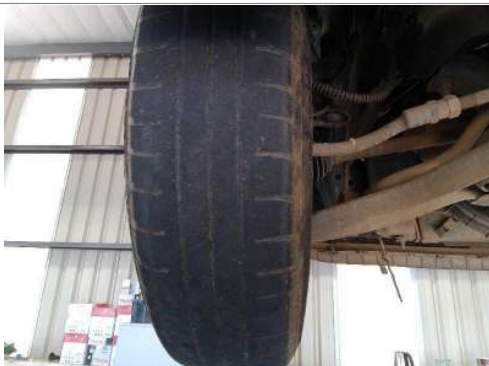
| Damage | Repair Way |
|---|---|
| Tyre Front Left Worn | Replace |

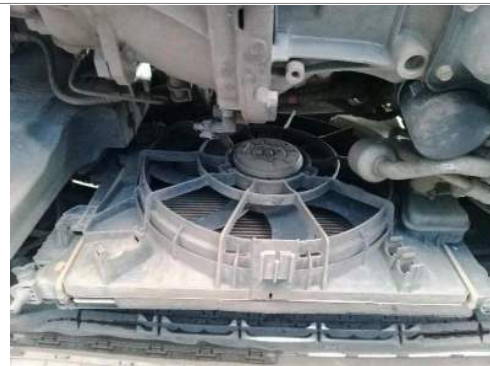
| Damage | Repair Way |
|---|---|
| Radiator Defective | Repair |

| Damage | Repair Way |
|---|---|
| Engine | Radiator and Aircon condenser loose |

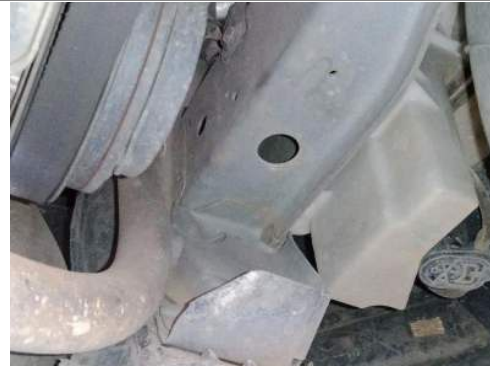
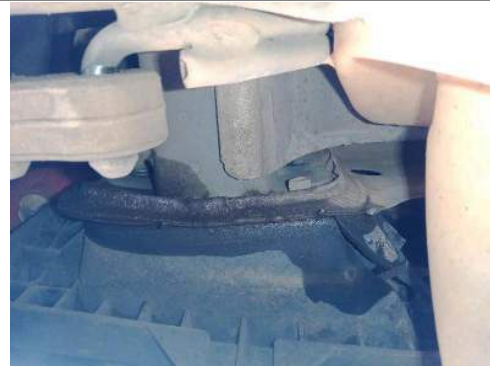
| Damage | Repair Way |
|---|---|
| Main Beam Right Dented | Repair |

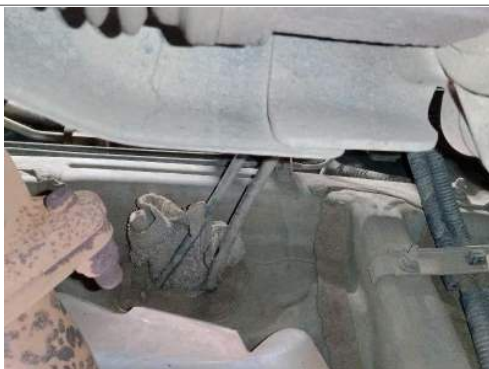
| Damage | Repair Way |
|---|---|
| Firewall Defective | Repair |

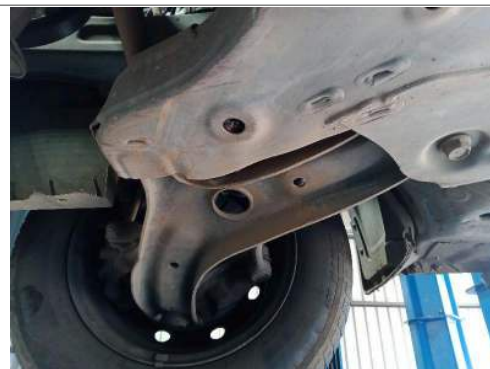
| Damage | Repair Way |
|---|---|
| Control Arm(s) Front Axle Right Damaged | Replace |

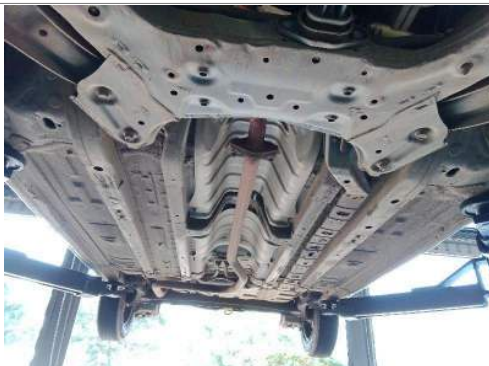
| Damage | Repair Way |
|---|---|
| Chassis Dented | Repair |

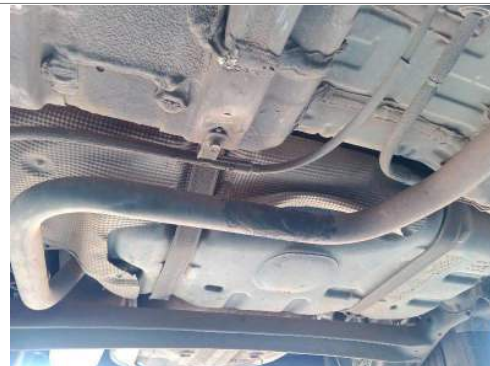
| Damage | Repair Way |
|---|---|
| Fuel Tank Defective | Repair |

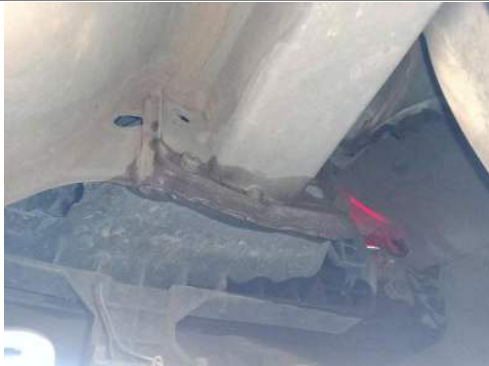
| Damage | Repair Way |
|---|---|
| Main Beam Left Dented | Repair |

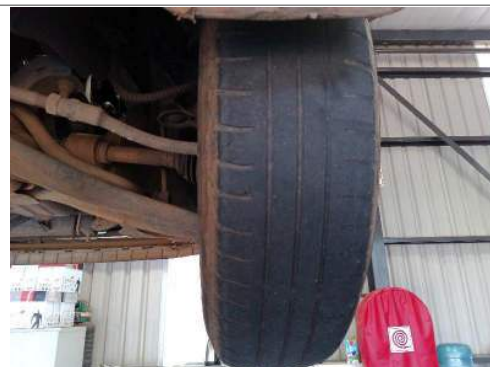
| Damage | Repair Way |
|---|---|
| Tyre Front Right Worn | Replace |

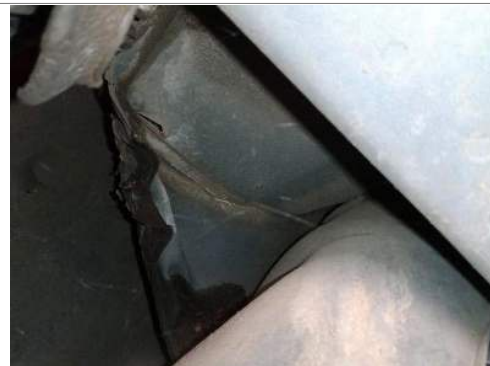
| Damage | Repair Way |
|---|---|
| Rear Fender Left / Inner Tray Damaged | Repair |

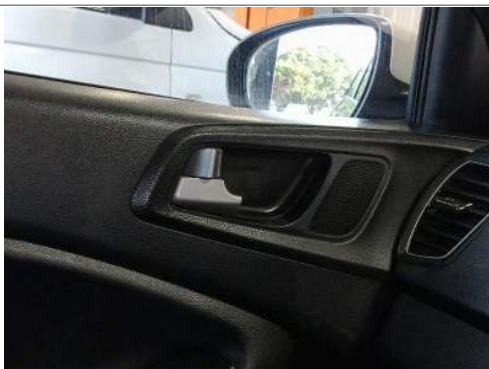
| Damage | Repair Way |
|---|---|
| Door Handle Front Left Damaged | Replace |
