MFC Auction House  
M57 Pretoria Rd, Glenmarais, KEMPTON PARK  
Gauteng

| Manufacturer | HYUNDAI | Registration Number | KMD460NW |

## CONDITION REPORT

Report No: 2016309753

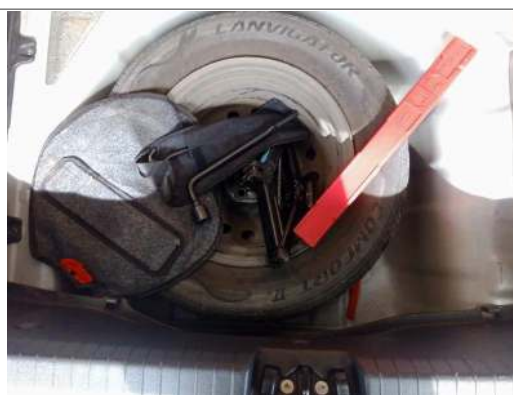
Sparewheel

| | Size | Load/Speed Index | Manufacture | Model | Type* | Production Date | Tread Depth (mm) |
|---|---|---|---|---|---|---|---|
| Spare | 185/70R14 | 88H | Lanvigator | Comfort | V | 0000 | 1 mm |

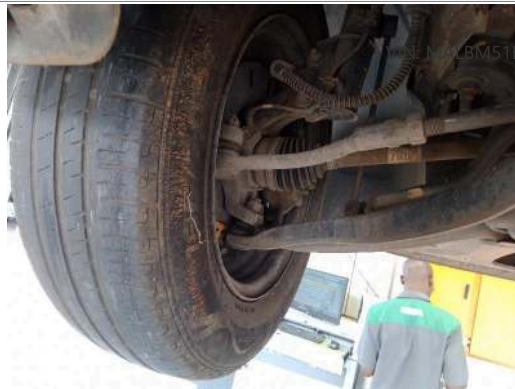
LF TYRE TREAD

| | Size | Load/Speed Index | Manufacture | Model | Type* | Production Date | Tread Depth (mm) |
|---|---|---|---|---|---|---|---|
| Front Left | 185/70R14 | 88H | Lanvigator | Comfort | V | 0321 | 1 mm |

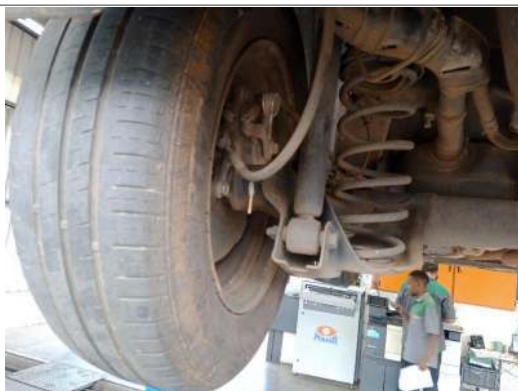
LR TYRE TREAD

| | Size | Load/Speed Index | Manufacture | Model | Type* | Production Date | Tread Depth (mm) |
|---|---|---|---|---|---|---|---|
| Rear Left | 185/70R14 | 88H | Lanvigator | Comfort | V | 0321 | 1 mm |

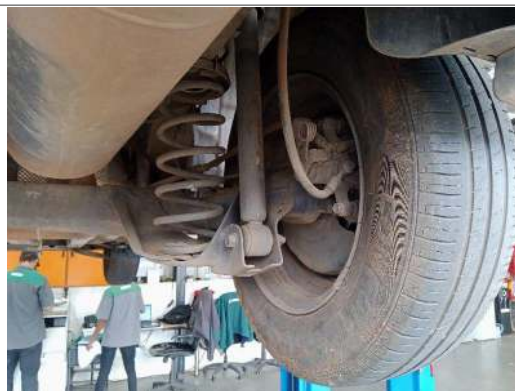
RR TYRE TREAD

| | Size | Load/Speed Index | Manufacture | Model | Type* | Production Date | Tread Depth (mm) |
|---|---|---|---|---|---|---|---|
| Rear Right | 185/70R14 | 88H | Lanvigator | Comfort | V | 0321 | 5 mm |

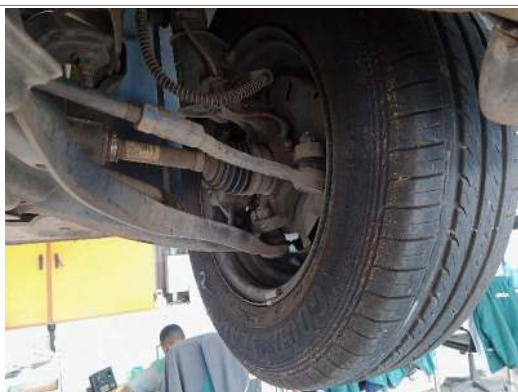
RF TYRE TREAD

| | Size | Load/Speed Index | Manufacture | Model | Type* | Production Date | Tread Depth (mm) |
|---|---|---|---|---|---|---|---|
| Front Right | 185/70R14 | 88T | Goodyear | Assurance | V | 1819 | 6 mm |

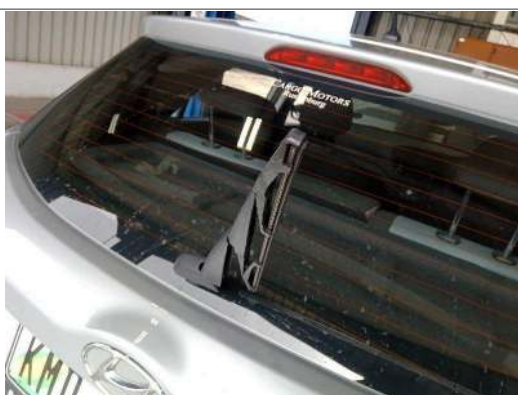
| Damage | Repair Way |
|---|---|
| Windscreen Wiper Missing | Replace |

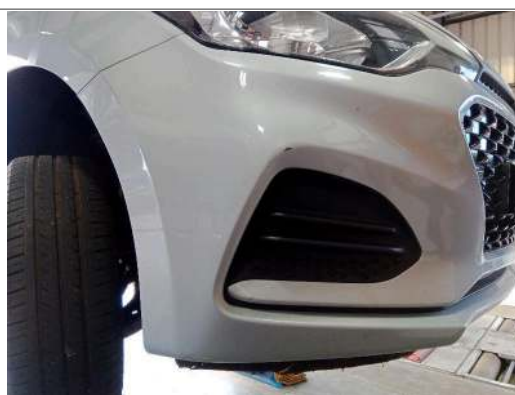
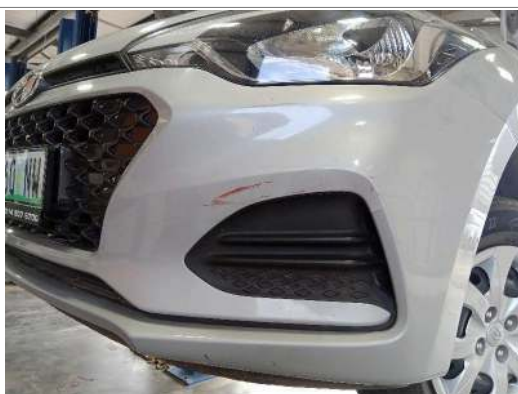
| Damage | Repair Way |
|---|---|
| Front Bumper Paintwork • Scratched | Repair |

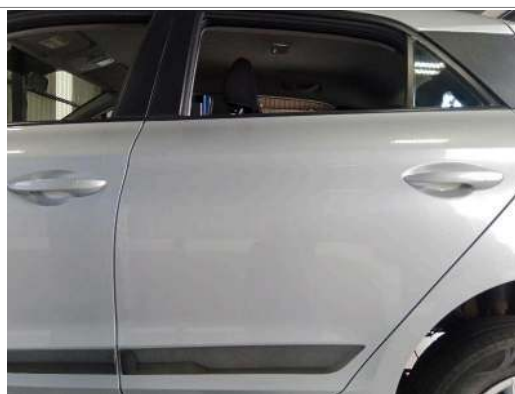
| Damage | Repair Way |
|---|---|
| Door Rear Left Paintwork • Scratched | Repair |

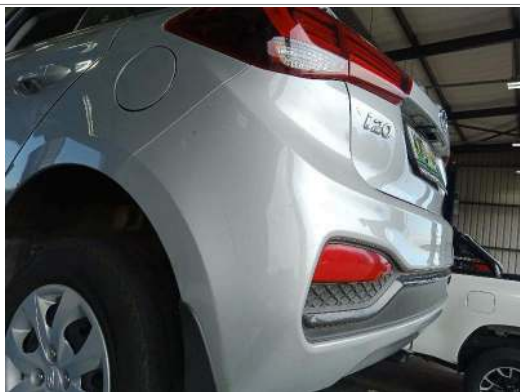
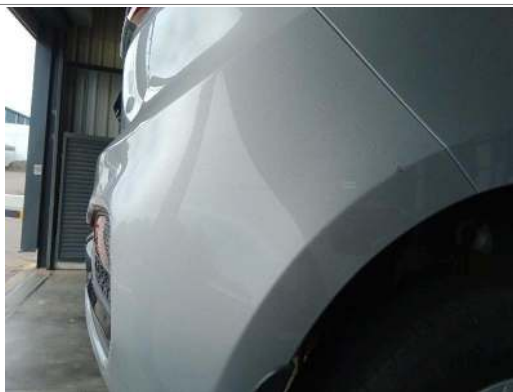
| Damage | Repair Way |
|---|---|
| Rear bumper Paintwork • Scratched | Repair |

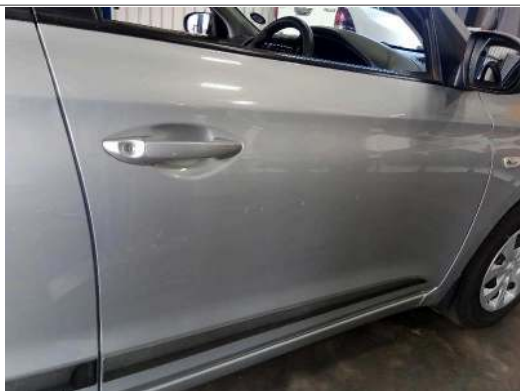
| Damage | Repair Way |
|---|---|
| Door Front Right Paintwork • Scratched | Repair |

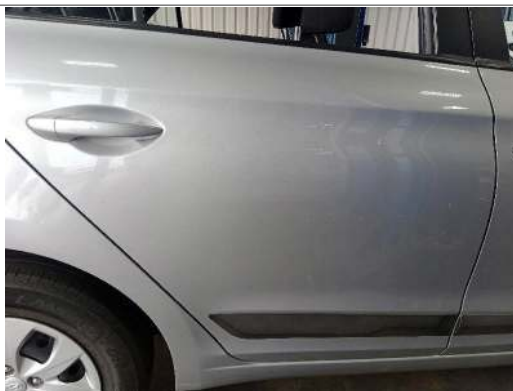
| Damage | Repair Way |
|---|---|
| Door Rear Right Paintwork • Scratched | Repair |

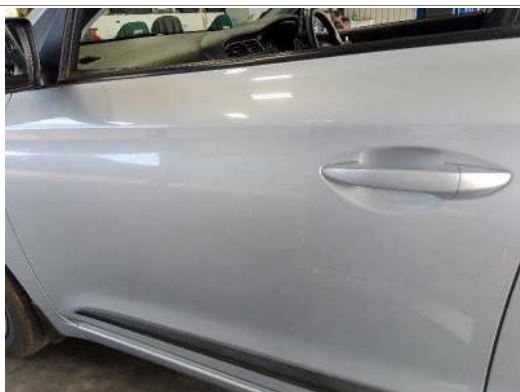
| Damage | Repair Way |
|---|---|
| Door Front Left Paintwork • Scratched | Repair |
