MFC Auction House  
M57 Pretoria Rd, Glenmarais, KEMPTON PARK  
Gauteng

## CONDITION REPORT

Report No: 2016325199

VIN: MALFC81ALMM169834

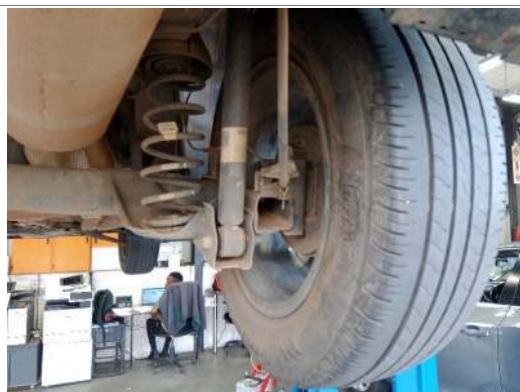
RR TYRE TREAD

| | Size | Load/Speed Index | Manufacture | Model | Type* | Production Date | Tread Depth (mm) |
|---|---|---|---|---|---|---|---|
| Rear Right | 215/60R16 | 95H | MRF | Wanderer | V | 0421 | 5 mm |

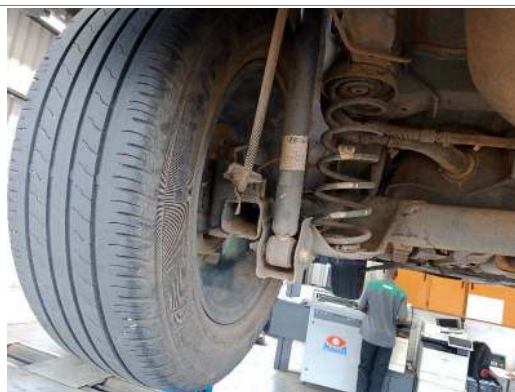
LR TYRE TREAD

| | Size | Load/Speed Index | Manufacture | Model | Type* | Production Date | Tread Depth (mm) |
|---|---|---|---|---|---|---|---|
| Rear Left | 215/60R16 | 95H | MRF | Wanderer | V | 0421 | 6 mm |

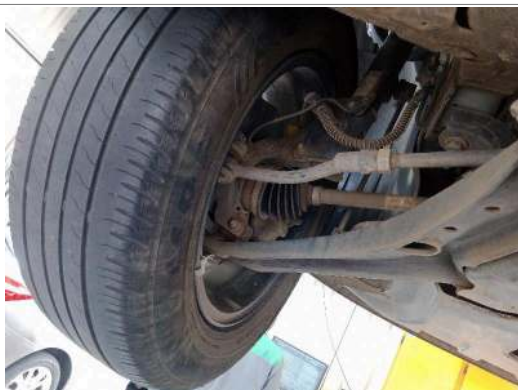
LF TYRE TREAD

| | Size | Load/Speed Index | Manufacture | Model | Type* | Production Date | Tread Depth (mm) |
|---|---|---|---|---|---|---|---|
| Front Left | 215/60R16 | 95H | MRF | Wanderer | V | 0421 | 5 mm |

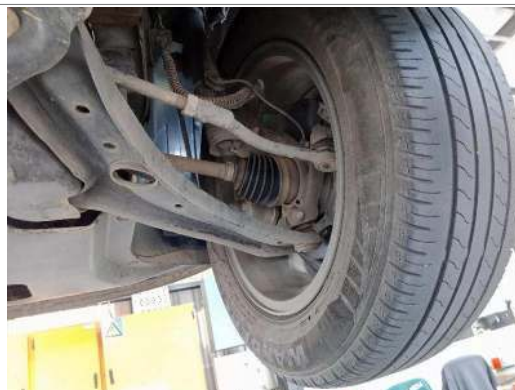
RF TYRE TREAD

| | Size | Load/Speed Index | Manufacture | Model | Type* | Production Date | Tread Depth (mm) |
|---|---|---|---|---|---|---|---|
| Front Right | 215/60R16 | 95H | MRF | Wanderer | V | 0421 | 4 mm |

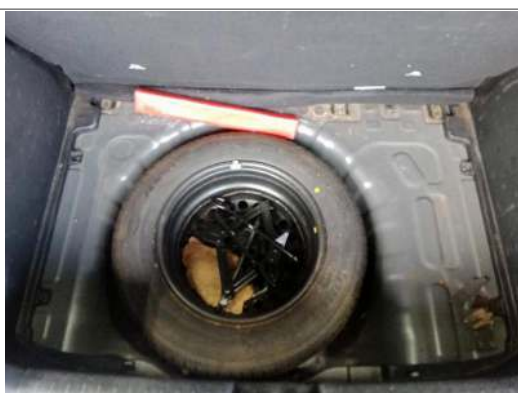
Sparewheel

| | Size | Load/Speed Index | Manufacture | Model | Type* | Production Date | Tread Depth (mm) |
|---|---|---|---|---|---|---|---|
| Spare | 195/65R15 | 91H | Goodyear | Assurance | V | 0000 | 3 mm |

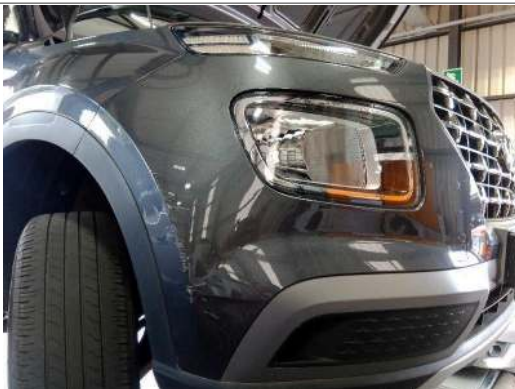
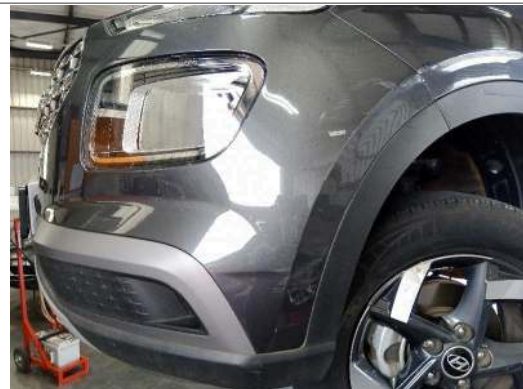
Front Bumper Paintwork • Scratched  
Front Fender Left Dented  
Rear Fender Left Paintwork • Scratched  
Door Front Left Paintwork • Scratched  
Door Rear Left Paintwork • Scratched  
Rear bumper Paintwork • Scratched

Repair  
Repair  
Repair  
Repair  
Repair  
Repair
