## CONDITION REPORT

Report No:  
2016925114  
DATE  
25/06/2025

MFC Auction House  
M57 Pretoria Rd, Glenmarais, KEMPTON PARK  
Gauteng

Vehicle Type	PASSENGER VEHICLE	Registered Owner	MFC
Manufacturer	HYUNDAI	Registration Number	JZ89RRGP
Model	VENUE 1.0 88KW TGDI FLUID AT [2019-2023]	Register Number	
VIN	MALFC81AVMM169346	Date Of First Licensing	
Engine Number		Last COR	
Doors	5	License Expiry Date	31/07/2025
Color	GREY	Power / Displacement	
Year Model	2021	Paint Finish	M - METALLIC
Km Reading	66,949 KM	Fuel	PETROL
Cab / Body Type	HATCHBACK	Transmission	AUTOMATIC

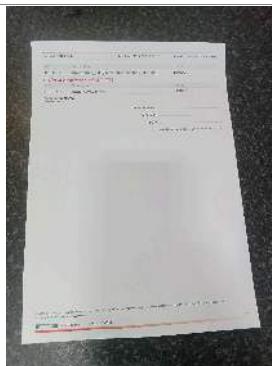
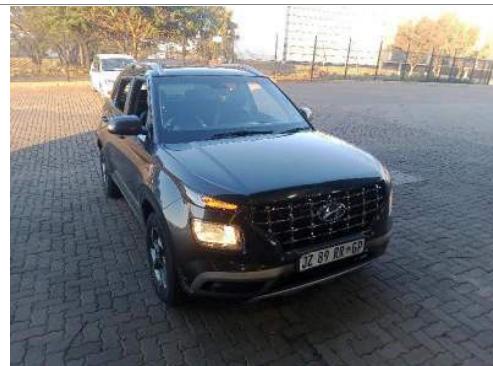
Diagnostic report

No	System	Code	Description	Status
1	HISTORY	B1346.00	DRIVER AIRBAG (DAB) RESISTANCE TOO HIGH (1ST STAGE)

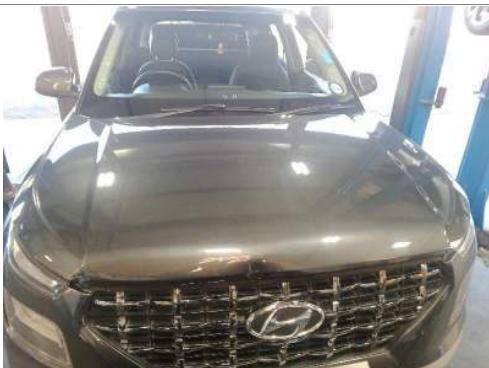
Hooter Defective	Repair
Headlight Left Scratched	Repair
Headlight Right Cracked	Repair
Front Bumper Paintwork • Scratched	Repair
Bonnet Dented	Repair
Rear Fender Right Paintwork • Scratched	Repair
Door Front Left Dented	Repair
Door Front Right Paintwork • Scratched	Repair
Door Rear Left Dented	Repair
Door Rear Right Paintwork • Scratched	Repair
Boot Lid / Hatch door Dented	Repair
