## CONDITION REPORT

Report No:  
2016994558  
DATE  
28/08/2025

| Manufacturer | HYUNDAI | Registration Number | NONE |
| Model | CRETA 1.5 PREMIUM [2020-2022] | Register Number | |

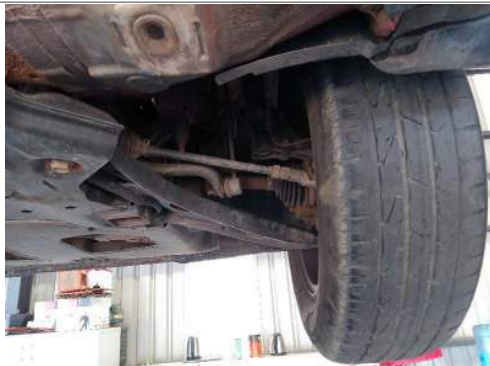
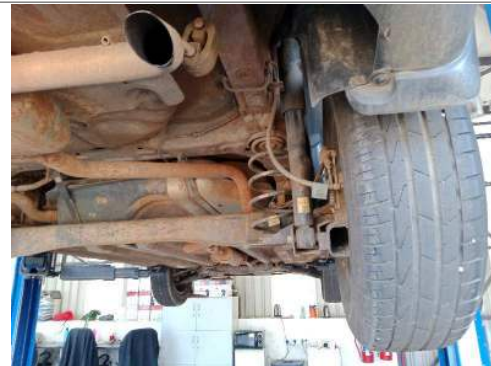
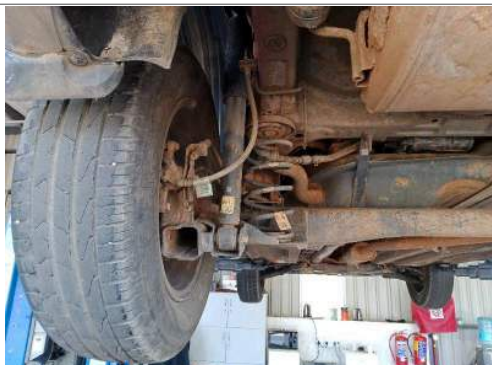
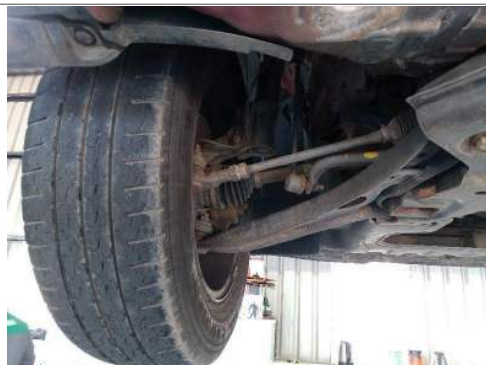
| | Size | Load/Speed Index | Manufacture | Model | Type* | Production Date | Tread Depth (mm) |
|---|---|---|---|---|---|---|---|
| Front Left | 205/65 R16C | 107T | Pirelli | Carrier | V | 0716 | 2 mm |
| Front Right | 205/65 R16 | 95W | Hankook | Ventus | V | 4323 | 2 mm |
| Rear Left | 205/65 R16 | 95W | Hankook | Ventus | V | 2223 | 3 mm |
| Rear Right | 205/65 R16 | 95W | Hankook | Ventus | V | 2223 | 3 mm |

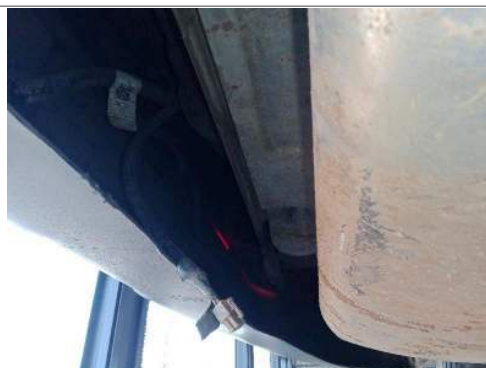
| | Damage | Repair Way |
|--|---|---|
| | Loose wiring on rear of vehicle | Repair |

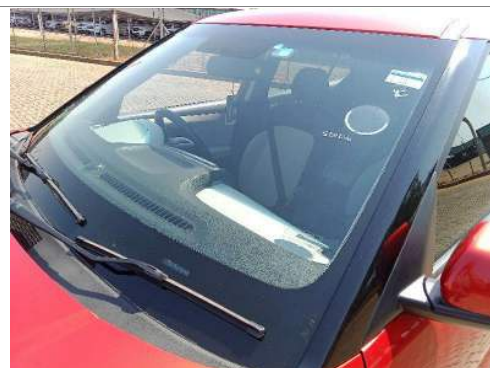
| | Damage | Repair Way |
|--|---|---|
| | License disc missing | Replace |

LICENSE DISC MISSING

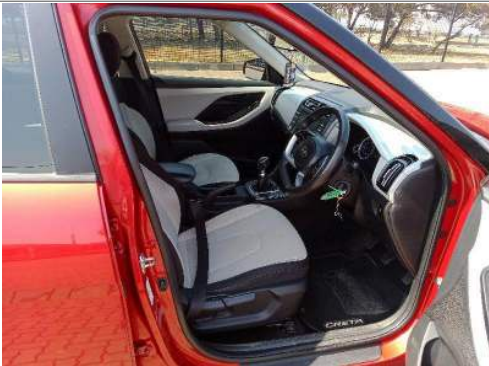
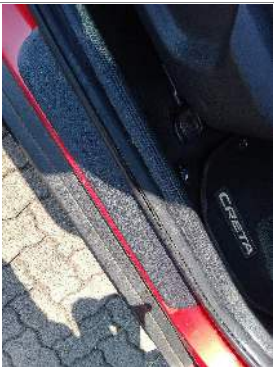
| | Damage | Repair Way |
|--|---|---|
| | Door Sealing Rubber Front Right Damaged | Replace |

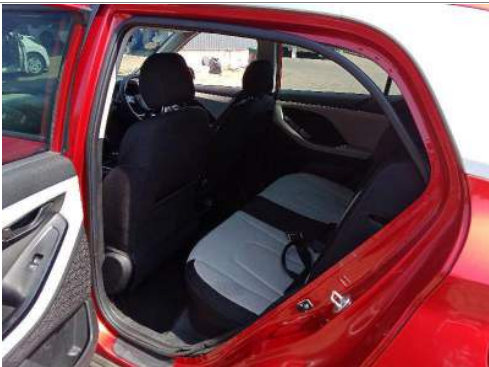
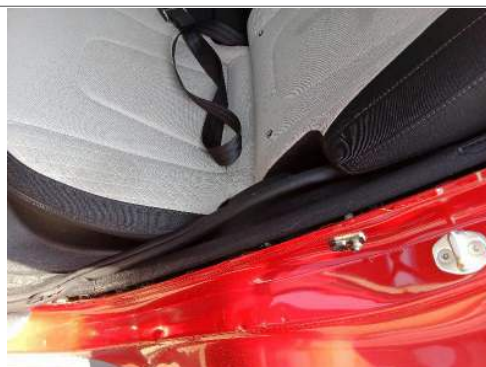
| | Damage | Repair Way |
|--|---|---|
| | Door Sealing Rubber Rear Left Damaged | Replace |

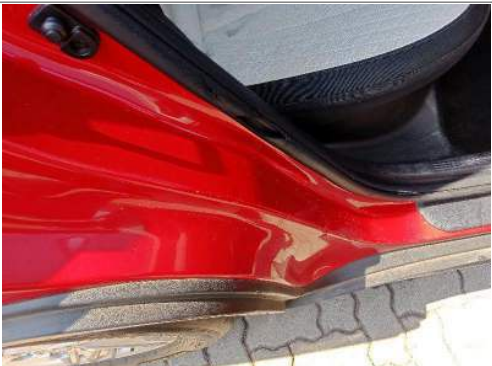
| | Damage | Repair Way |
|--|---|---|
| | C • Pillar Right Dented | Repair |

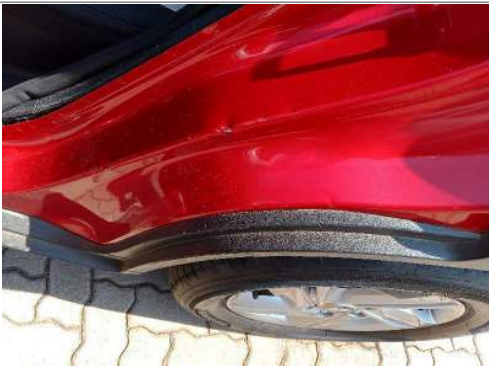
| | Damage | Repair Way |
|--|---|---|
| | C • Pillar Left Dented | Repair |

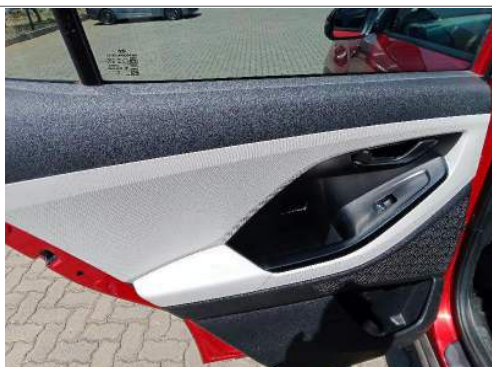
| | Damage | Repair Way |
|--|---|---|
| | Door Panel Rear Left Defective | Repair |

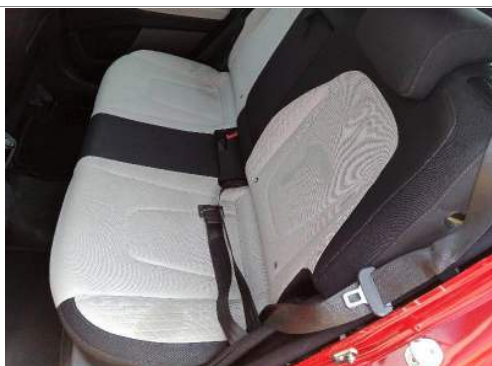
| | Damage | Repair Way |
|--|---|---|
| | Seat Rear Dirty | Repair |

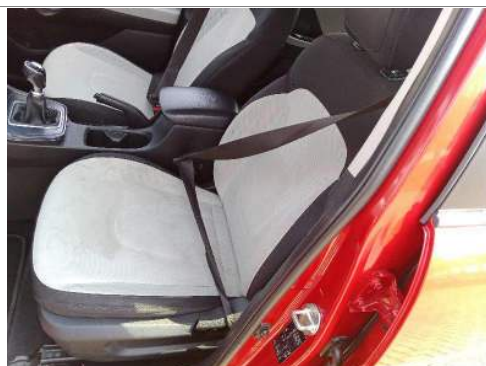
| | Damage | Repair Way |
|--|---|---|
| | Seat Front Left Dirty | Repair |

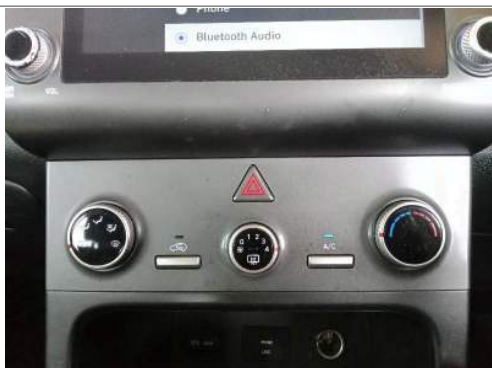
| | Damage | Repair Way |
|--|---|---|
| | Air Conditioner Insufficient | Replace |

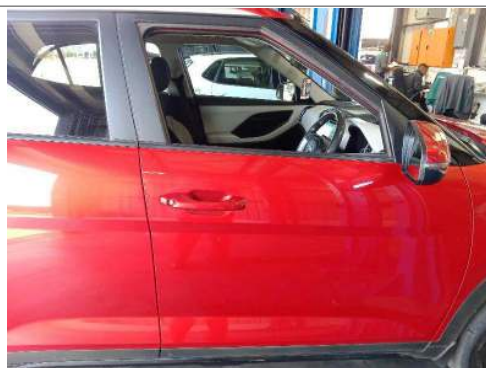
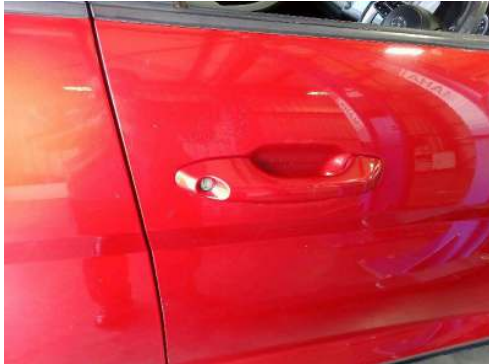
| | Damage | Repair Way |
|--|---|---|
| | Door Front Right Paintwork • Scratched | Repair |

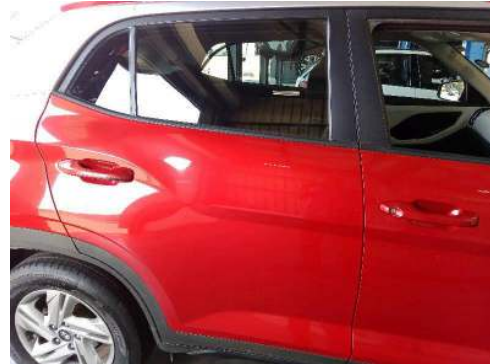
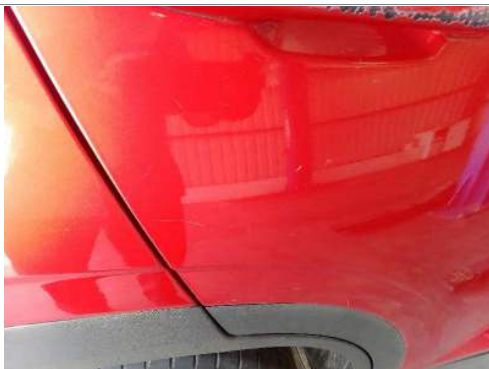
| | Damage | Repair Way |
|--|---|---|
| | Door Rear Right Paintwork • Scratched | Repair |

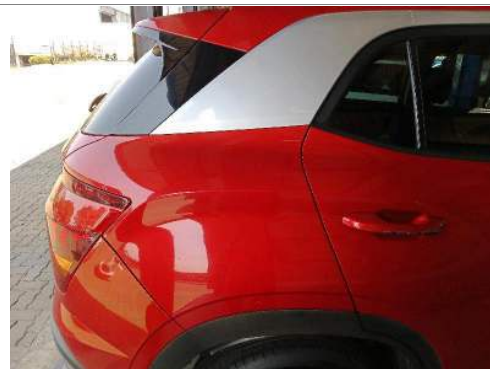
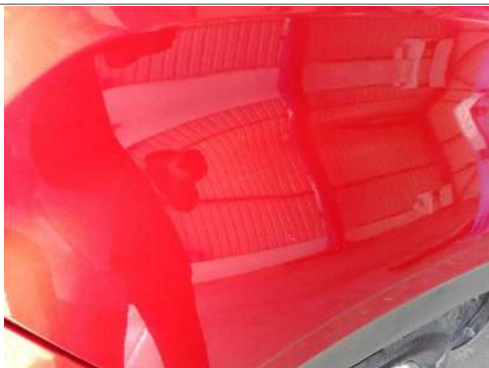
| | Damage | Repair Way |
|--|---|---|
| | Rear Fender Right Paintwork • Scratched | Repair |

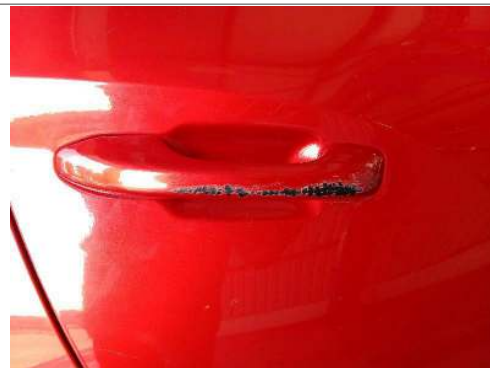
| | Damage | Repair Way |
|--|---|---|
| | Door Handle Rear Right Damaged | Repair |

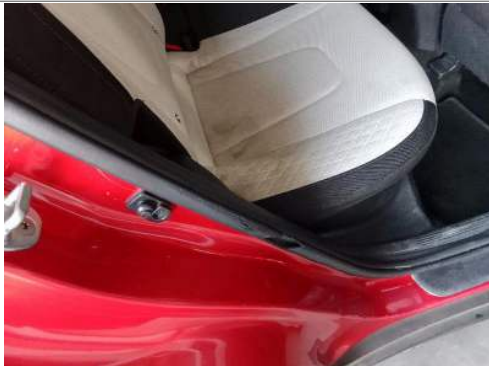
| | Damage | Repair Way |
|--|---|---|
| | Door Sealing Rubber Rear Right Damaged | Replace |

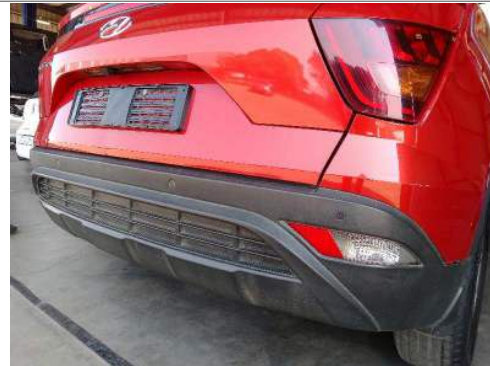
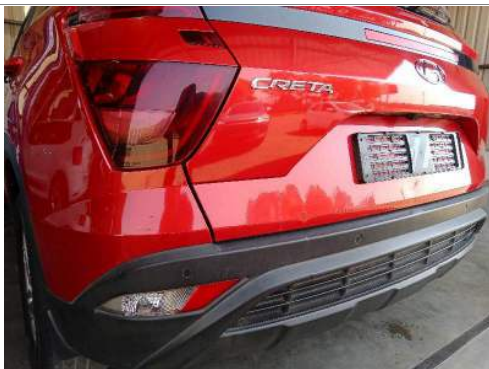
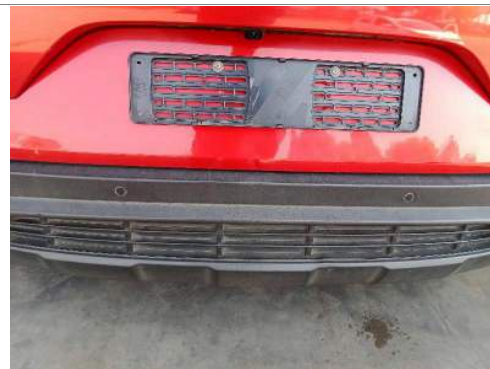
| | Damage | Repair Way |
|--|---|---|
| | Rear bumper Damaged | Repair |
| | Body and Exterior | Signs of impact damage to rear of vehicle |

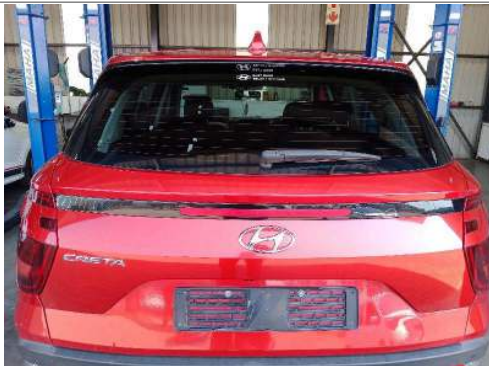
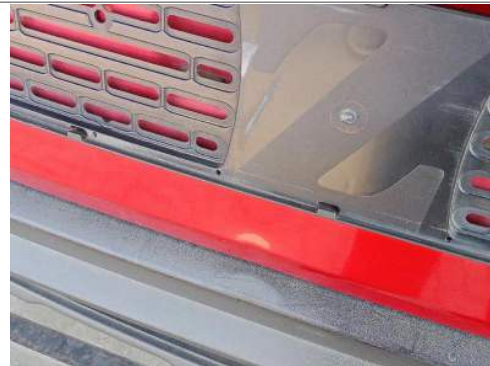
| | Damage | Repair Way |
|--|---|---|
| | Boot Lid / Hatch door Dented | Repair |

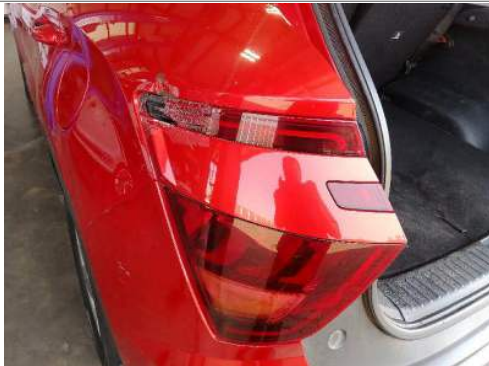
| | Damage | Repair Way |
|--|---|---|
| | Tail Light Left Damaged | Replace |

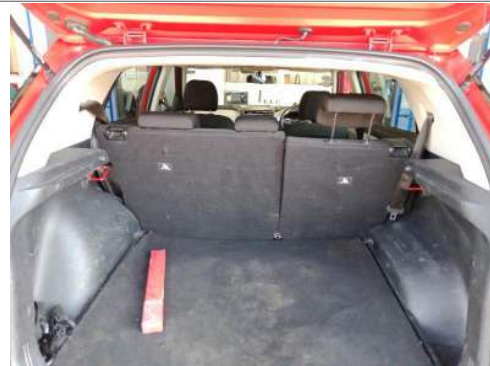
| | Damage | Repair Way |
|--|---|---|
| | Parcel Tray Missing | Replace |

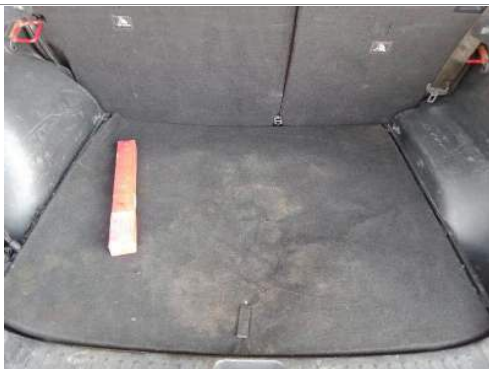
| | Damage | Repair Way |
|--|---|---|
| | Boot Carpet Damaged | Replace |

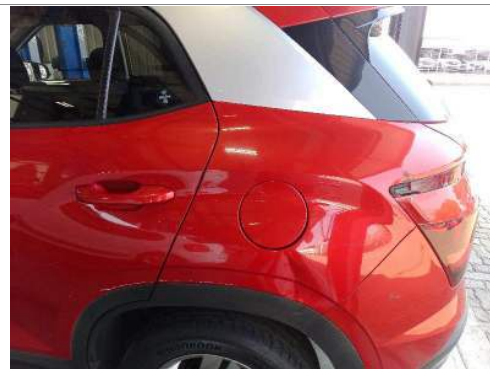
| | Damage | Repair Way |
|--|---|---|
| | Rear Fender Left Damaged | Repair |

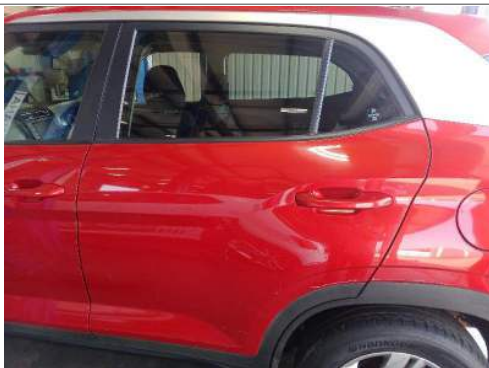
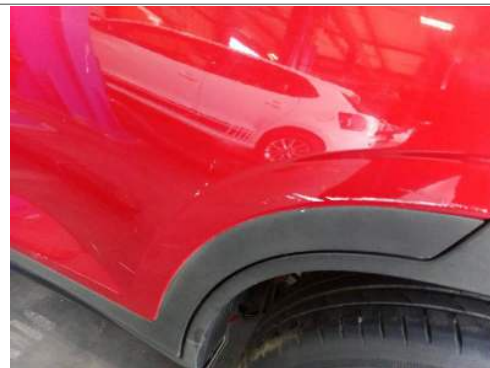
| | Damage | Repair Way |
|--|---|---|
| | Door Rear Left Paintwork • Scratched | Repair |

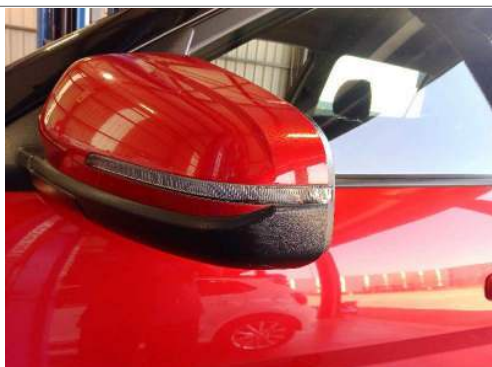
| | Damage | Repair Way |
|--|---|---|
| | Side Mirror Left Paintwork • Scratched | Repair |

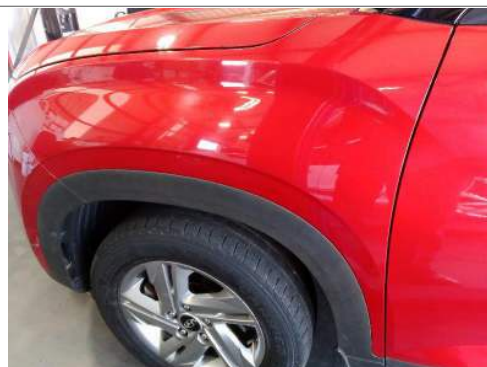
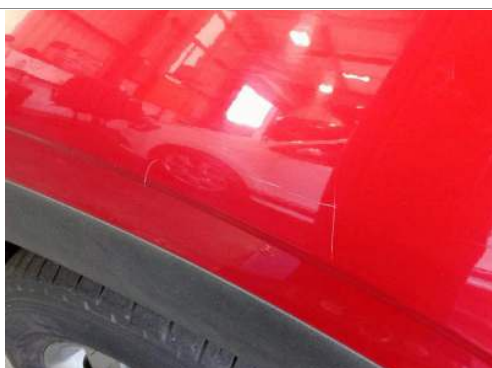
| | Damage | Repair Way |
|--|---|---|
| | Front Fender Left Paintwork • Scratched | Repair |

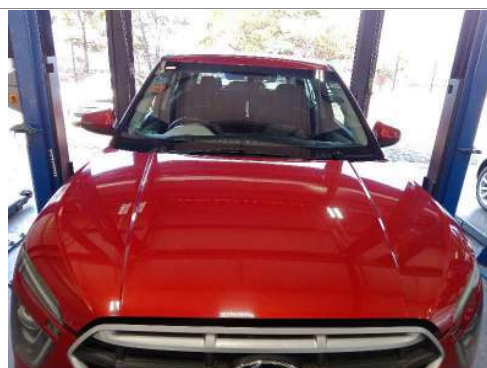
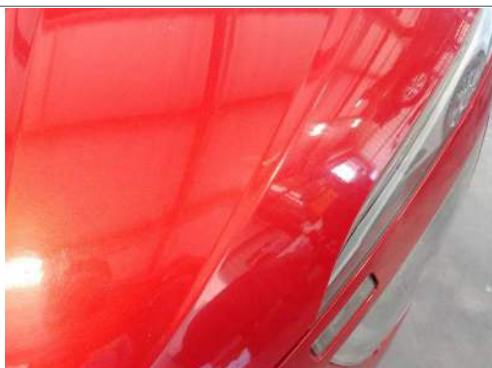
| | Damage | Repair Way |
|--|---|---|
| | Bonnet Paintwork • Scratched | Repair |

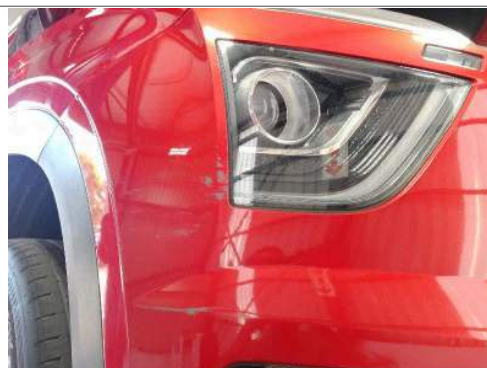
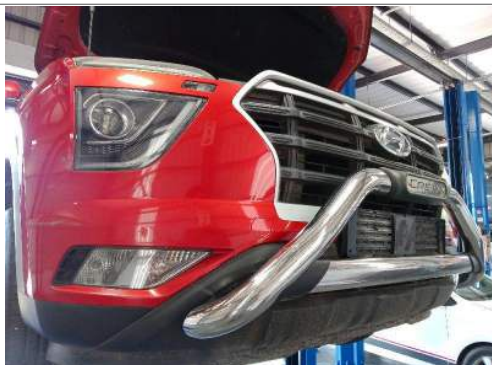
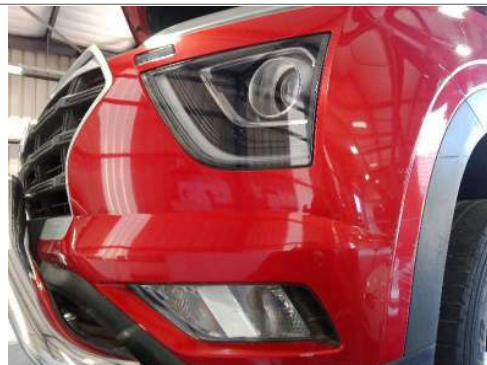
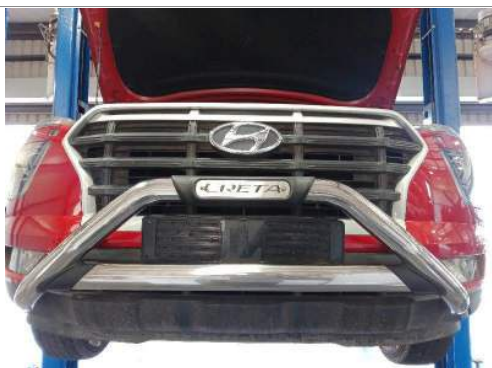
| | Damage | Repair Way |
|--|---|---|
| | Front Bumper Paintwork • Scratched | Repair |

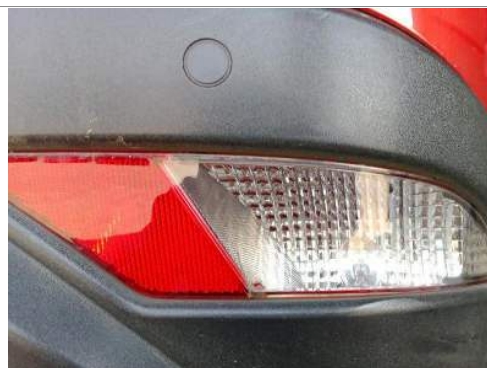
| | Damage | Repair Way |
|--|---|---|
| | Fog Light Rear Right Cracked | Replace |

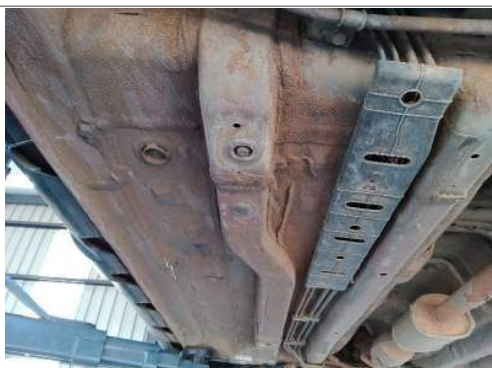
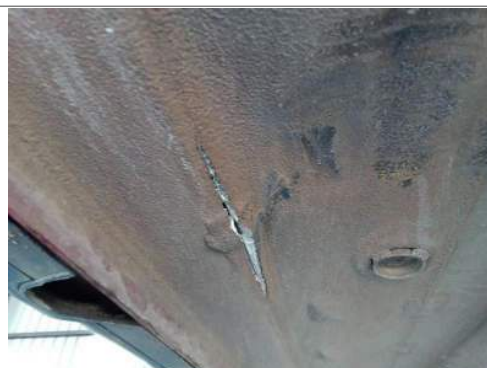
| | Damage | Repair Way |
|--|---|---|
| | Chassis Damaged | Repair |

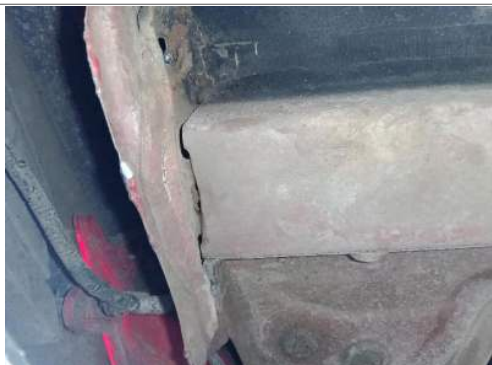
| | Damage | Repair Way |
|--|---|---|
| | Main Beam Left Dented | Repair |

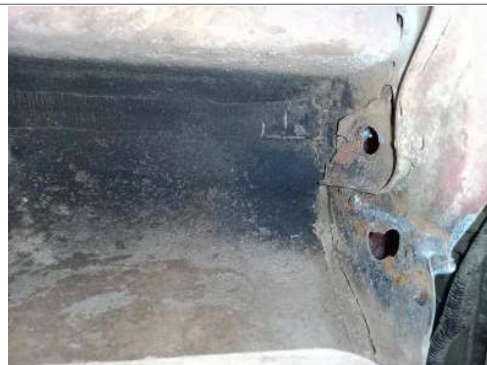
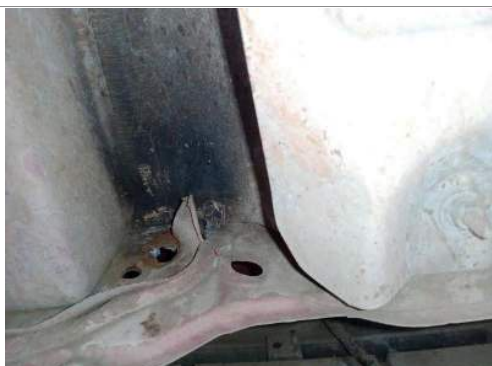
| | Damage | Repair Way |
|--|---|---|
| | Inner Boot Floor Pan and Spare Wheel Well Welded | Repair |
