## CONDITION REPORT

Report No: 2016295086

| Manufacturer | TATA | Registration Number | DH46FYGP |
| Model | INDICA | Register Number | |

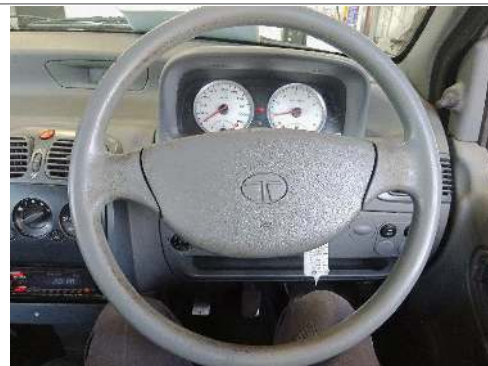
| Damage | Repair Way |
|---|---|
| Steering Wheel Trim Defective | Repair |

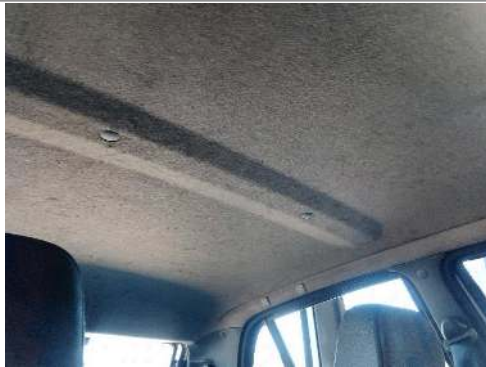
| Damage | Repair Way |
|---|---|
| Hood Lining Dirty | Repair |

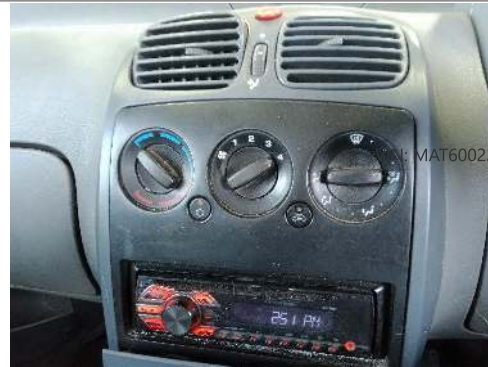
| Damage | Repair Way |
|---|---|
| Air Conditioner Insufficient | Replace |

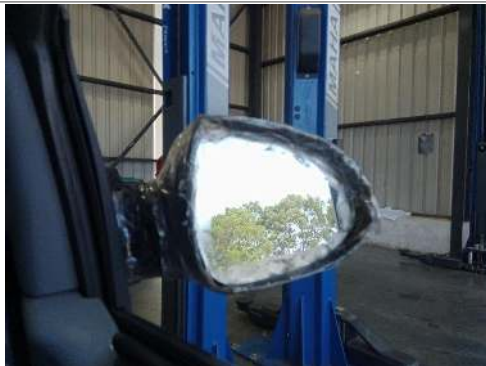
| Damage | Repair Way |
|---|---|
| Side Mirror Right Damaged | Replace |

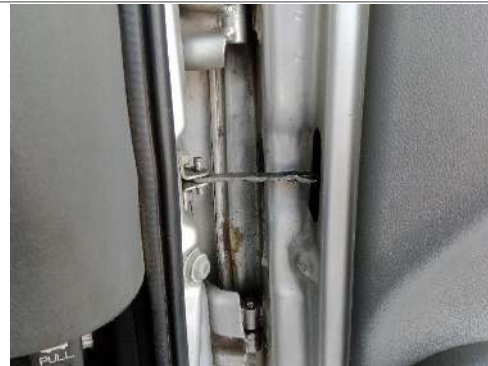
| Damage | Repair Way |
|---|---|
| Doorstopper Front Right Damaged | Replace |

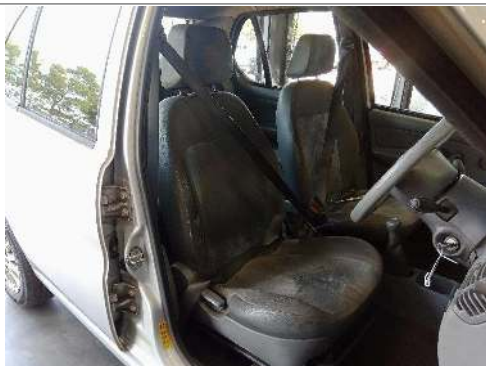
| Damage | Repair Way |
|---|---|
| Seat Front Right Damaged | Repair |

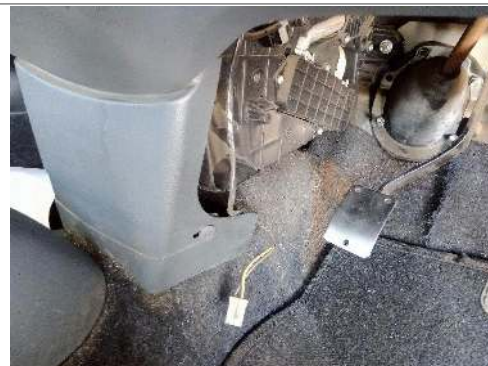
| Damage | Repair Way |
|---|---|
| Clutch Pedal Rubber Missing | Replace |

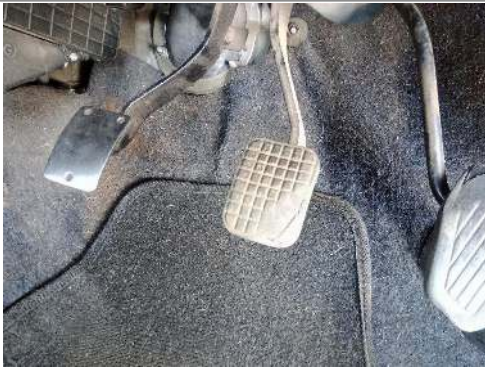
| Damage | Repair Way |
|---|---|
| Brake Pedal Rubber Damaged | Replace |

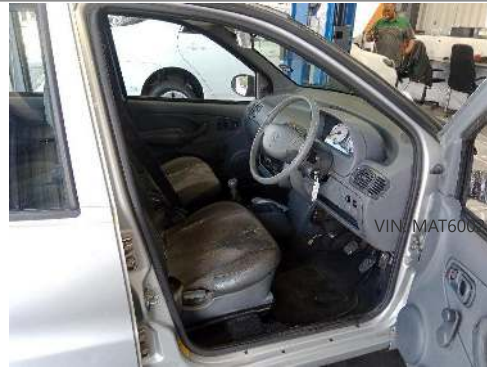
| Damage | Repair Way |
|---|---|
| Door Sealing Rubber Front Right Damaged | Replace |

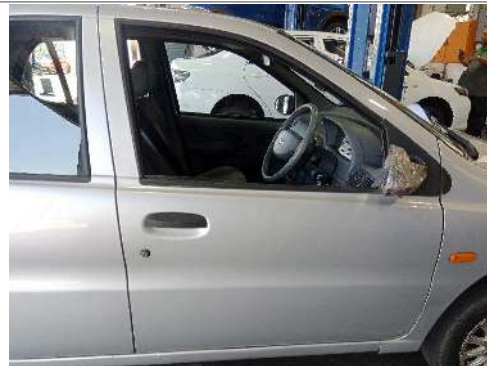
| Damage | Repair Way |
|---|---|
| Door Front Right Paintwork • Scratched | Repair |

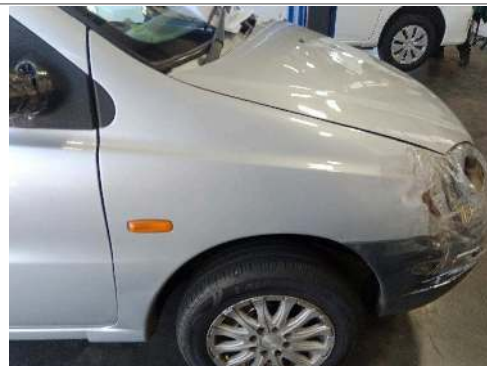
| Damage | Repair Way |
|---|---|
| Front Fender Right Damaged | Repair |

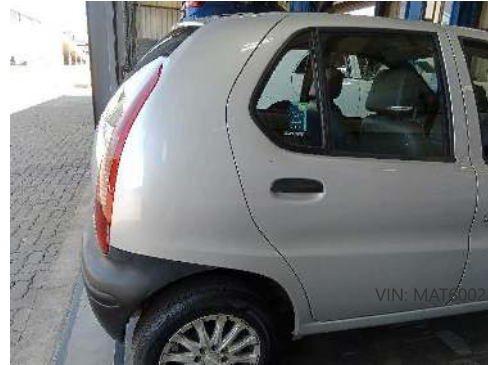
| Damage | Repair Way |
|---|---|
| Rear Fender Right Paintwork • Scratched | Repair |

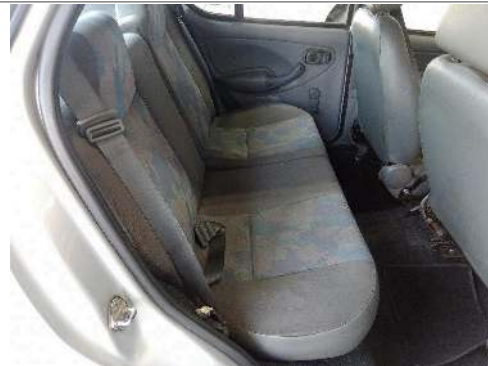
| Damage | Repair Way |
|---|---|
| Seat Rear Defective | Repair |

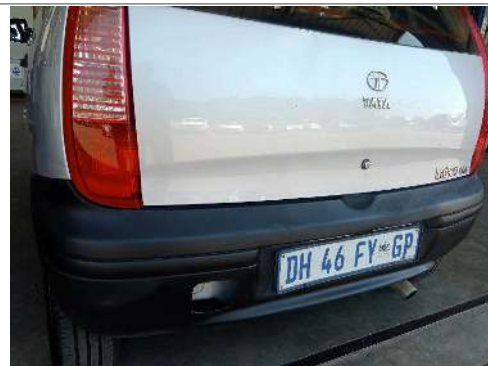
| Damage | Repair Way |
|---|---|
| Rear bumper Paintwork • Scratched | Repair |

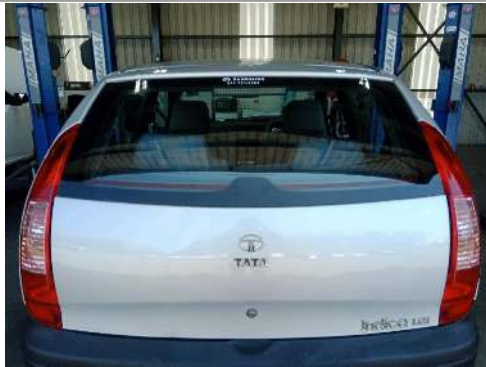
| Damage | Repair Way |
|---|---|
| Boot Lid / Hatch door Dented | Repair |

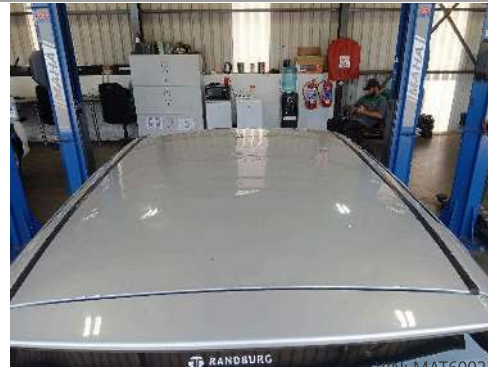
| Damage | Repair Way |
|---|---|
| Roof Damaged | Repair |

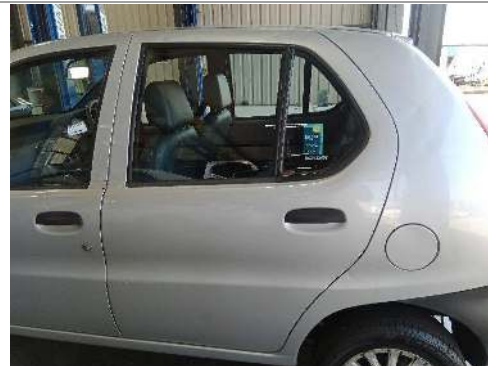
| Damage | Repair Way |
|---|---|
| Door Rear Left Dented | Repair |

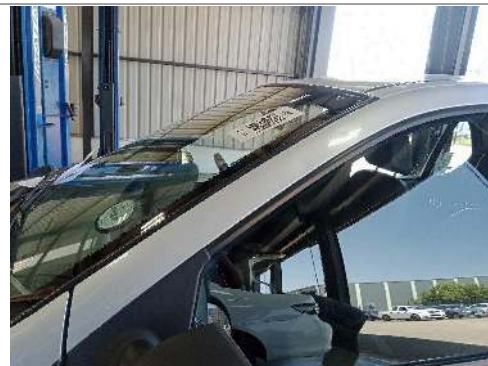
| Damage | Repair Way |
|---|---|
| A • Pillar Left Dented | Repair |

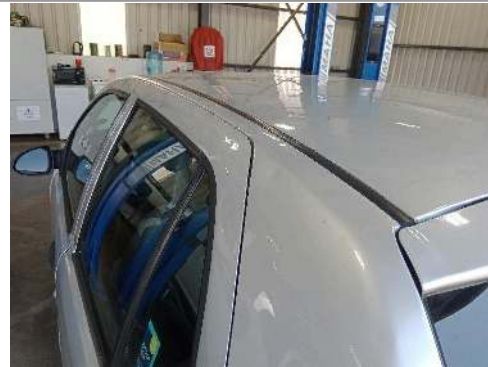
| Damage | Repair Way |
|---|---|
| C • Pillar Left Dented | Repair |

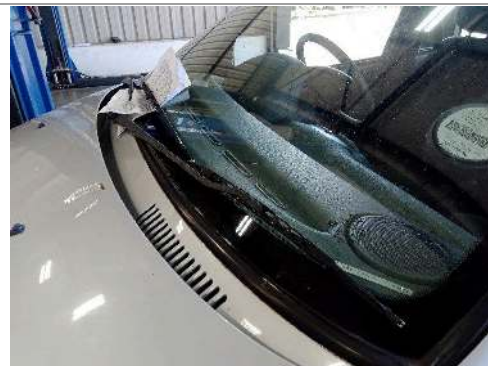
| Damage | Repair Way |
|---|---|
| Windscreen Wiper Damaged | Replace |

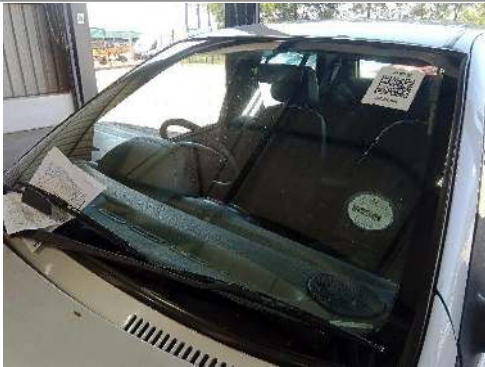
| Damage | Repair Way |
|---|---|
| Windscreen Cracked | Replace |

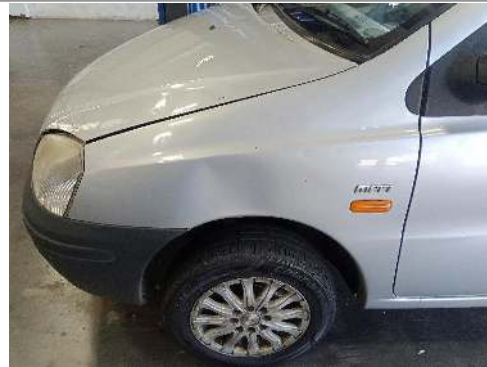
| Damage | Repair Way |
|---|---|
| Front Fender Left Damaged | Repair |

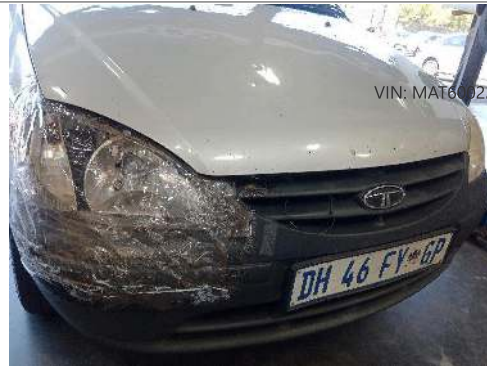
| Damage | Repair Way |
|---|---|
| Front Bumper Damaged | Repair |

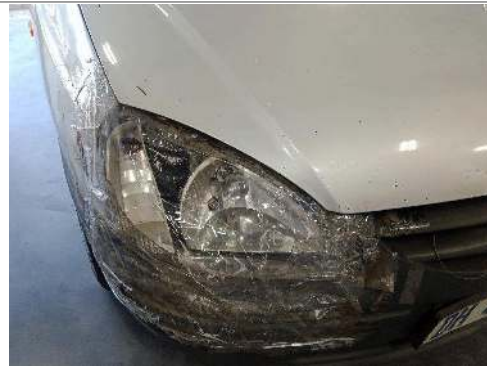
| Damage | Repair Way |
|---|---|
| Headlight Right Damaged | Replace |

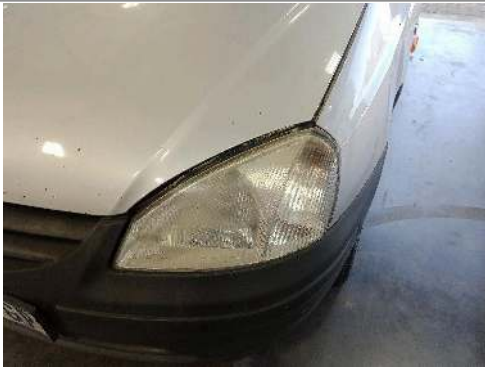
| Damage | Repair Way |
|---|---|
| Headlight Left Defective | Repair |

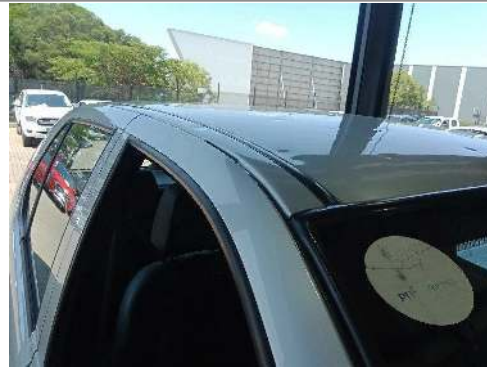
| Damage | Repair Way |
|---|---|
| A • Pillar Right Dented | Repair |

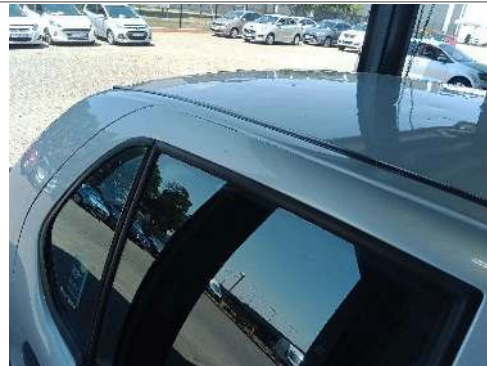
| Damage | Repair Way |
|---|---|
| C • Pillar Right Dented | Repair |

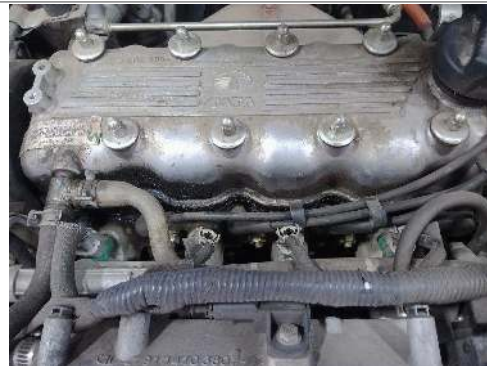
| Damage | Repair Way |
|---|---|
| Engine Oil Leak | Repair |

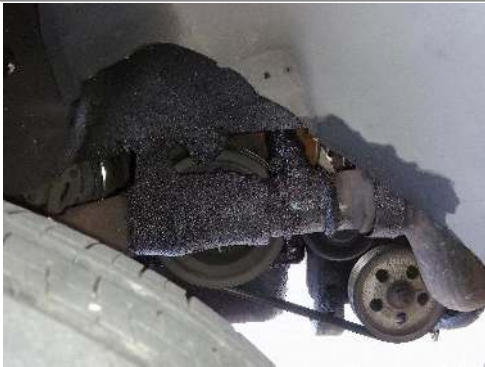
| Damage | Repair Way |
|---|---|
| Hoses Oil Leak | Repair |

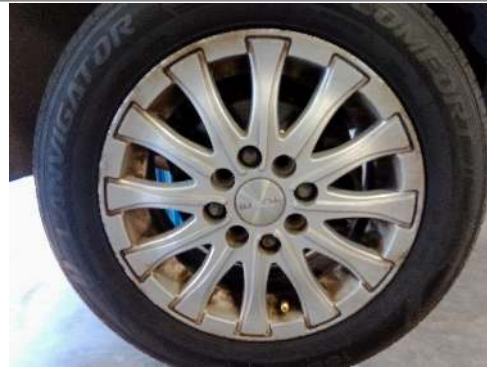
| Damage | Repair Way |
|---|---|
| Rim Front Right Scratched | Repair |

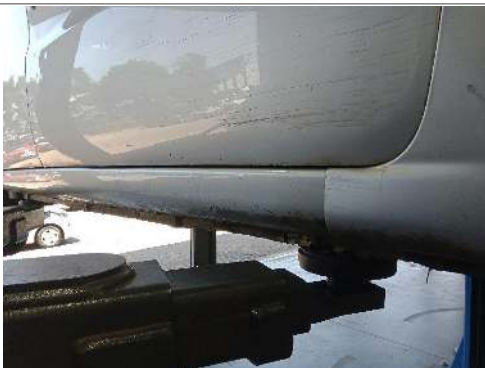
| Damage | Repair Way |
|---|---|
| Rocker Panel Right Damaged | Repair |

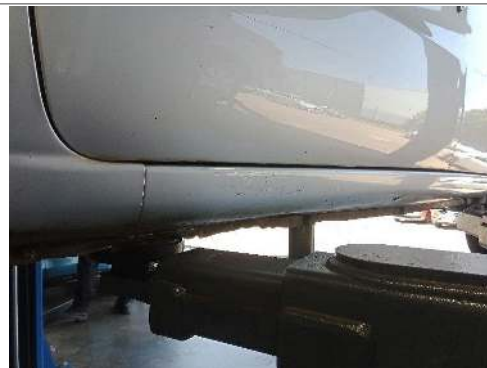
| Damage | Repair Way |
|---|---|
| Rocker Panel Left Damaged | Repair |

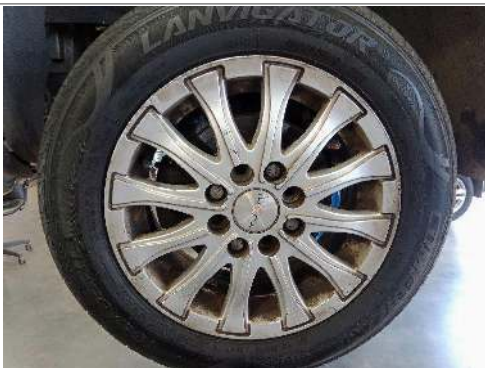
| Damage | Repair Way |
|---|---|
| Rim Front Left Scratched | Repair |

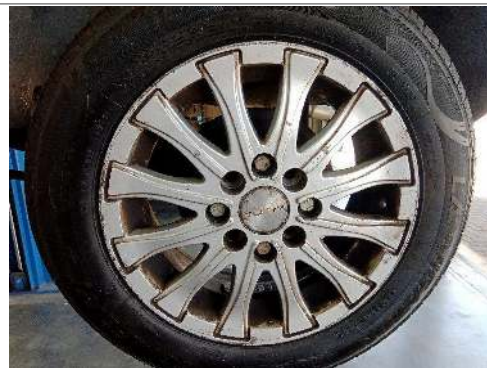
| Damage | Repair Way |
|---|---|
| Rim Rear Left Scratched | Repair |

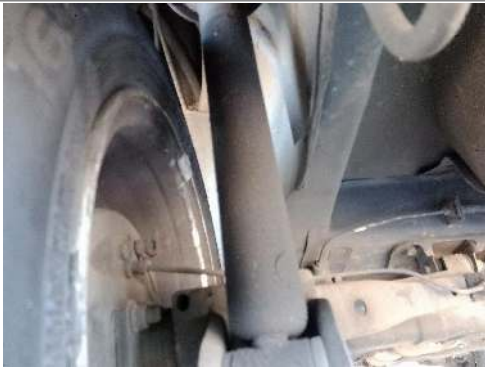
| Damage | Repair Way |
|---|---|
| Shock Absorber Rear Left Leak | Replace |

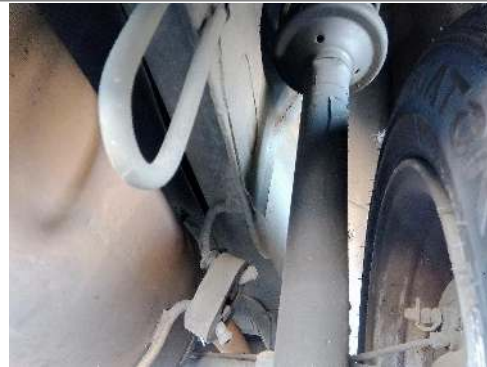
| Damage | Repair Way |
|---|---|
| Shock Absorber Rear Right Leak | Replace |

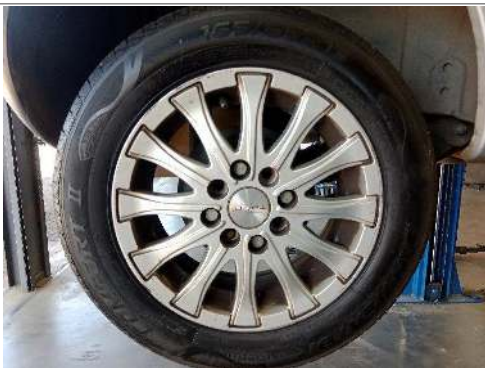
| Damage | Repair Way |
|---|---|
| Rim Rear Right Scratched | Repair |

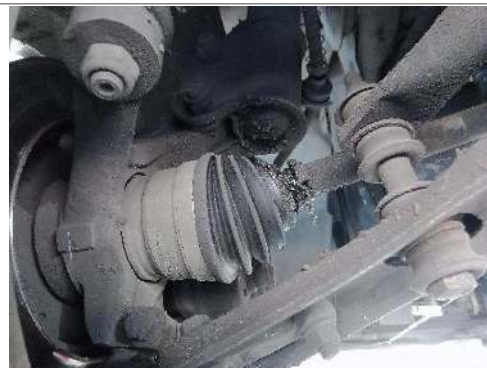
| Damage | Repair Way |
|---|---|
| CV Joint(s) Boot(s) Front Left (inner/outer) Damaged | Replace |

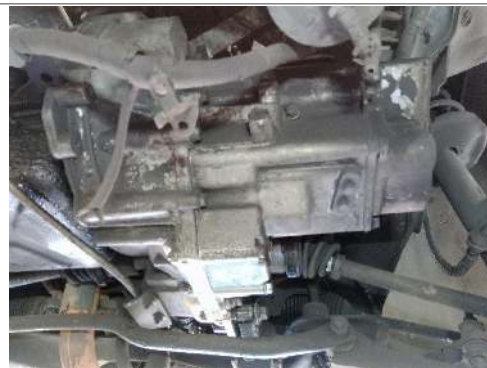
| Damage | Repair Way |
|---|---|
| Gearbox Oil Leak | Repair |

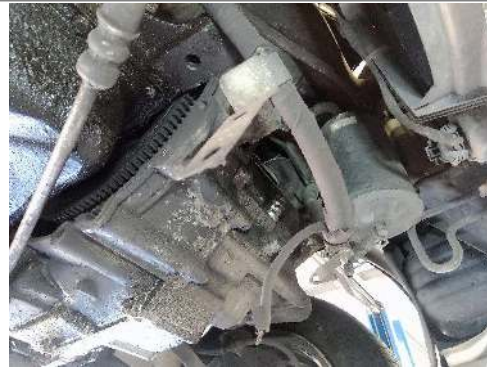
| Damage | Repair Way |
|---|---|
| Engine Wiring Defective | Repair |

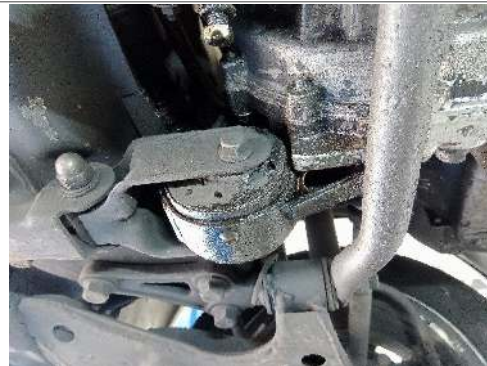
| Damage | Repair Way |
|---|---|
| Gearbox Mountings Defective | Replace |

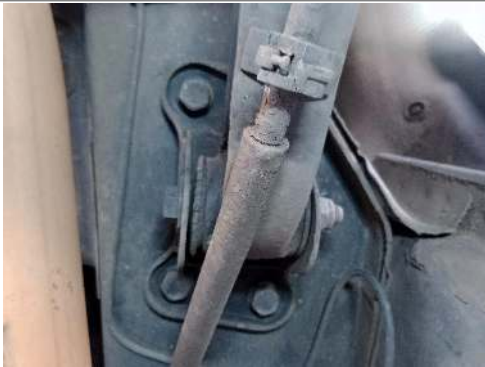
| Damage | Repair Way |
|---|---|
| Mounting Rubber(s) Rear Axle Right Cracked | Replace |

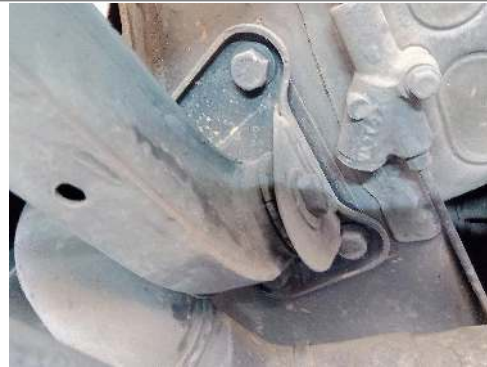
| Damage | Repair Way |
|---|---|
| Mounting Rubber(s) Rear Axle Left Cracked | Replace |

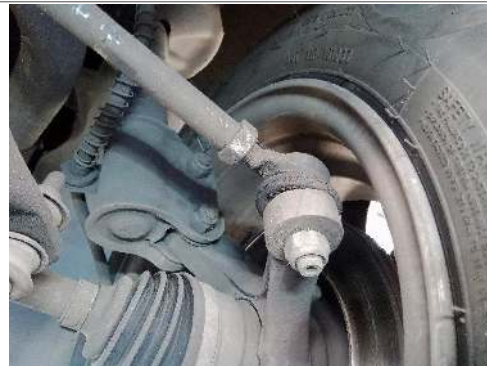
| Damage | Repair Way |
|---|---|
| Tie Rod End right Cracked | Replace |

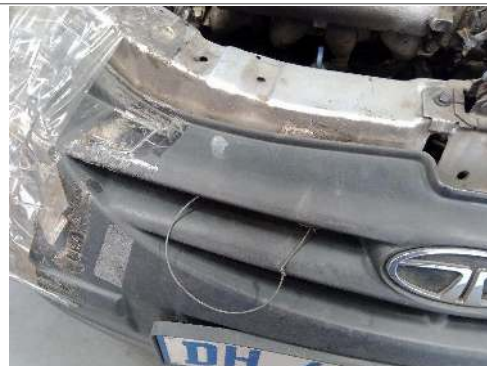
| Damage | Repair Way |
|---|---|
| Bonnet cable Missing | Replace |

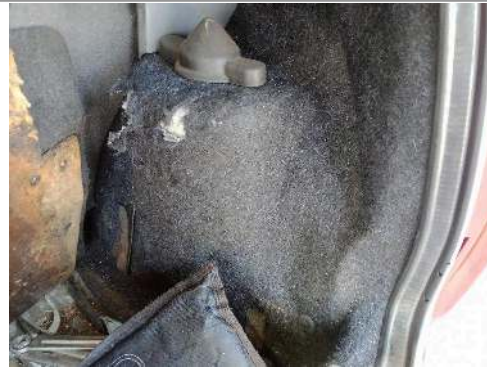
| Damage | Repair Way |
|---|---|
| Boot Panel Right Damaged | Replace |

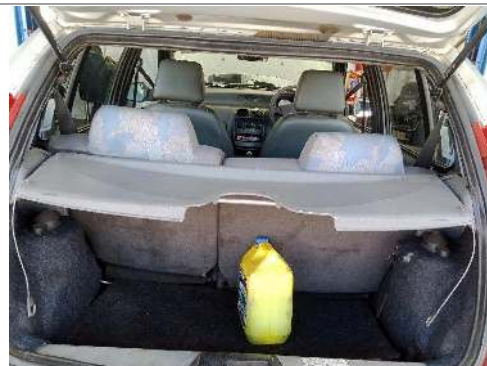
| Damage | Repair Way |
|---|---|
| Parcel Tray Defective | Repair |
