CONDITION REPORT

Report No:
2016996304
DATE
29/08/2025

| Manufacturer | SUZUKI | Registration Number | HFP348L |
| Model | SWIFT 1.2I GL 5-DR [2021-2025] | Register Number | |

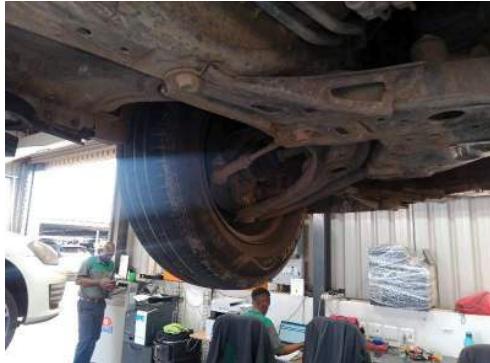
LF TYRE TREAD

| | Size | Load/Speed Index | Manufacture | Model | Type* | Production Date | Tread Depth (mm) |
|---|---|---|---|---|---|---|---|
| Front Left | 185/70R14 | 88H | Royal black | Royal mile | V | 2723 | 3 mm |

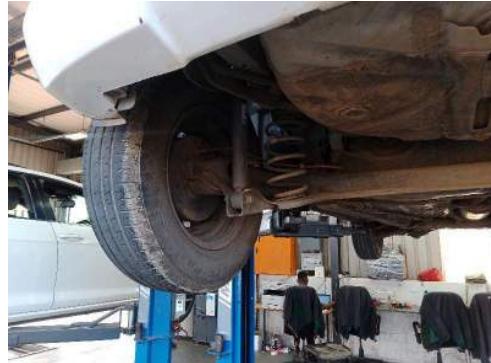
LR TYRE TREAD

| | Size | Load/Speed Index | Manufacture | Model | Type* | Production Date | Tread Depth (mm) |
|---|---|---|---|---|---|---|---|
| Rear Left | 185/70R14 | 88H | Royal black | Royal mile | V | 2723 | 3 mm |

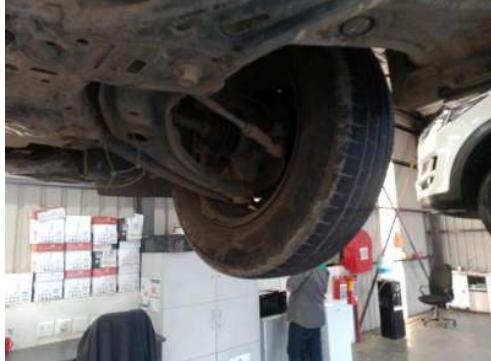
RF TYRE TREAD

| | Size | Load/Speed Index | Manufacture | Model | Type* | Production Date | Tread Depth (mm) |
|---|---|---|---|---|---|---|---|
| Front Right | 185/70R14 | 88H | Royal black | Royal mile | V | 2723 | 3 mm |

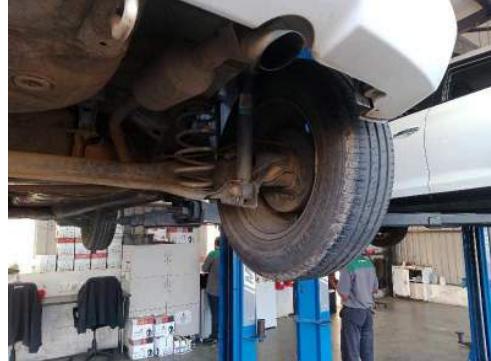
RR TYRE TREAD

| | Size | Load/Speed Index | Manufacture | Model | Type* | Production Date | Tread Depth (mm) |
|---|---|---|---|---|---|---|---|
| Rear Right | 185/70R14 | 88H | Royal black | Royal mile | V | 2723 | 3 mm |

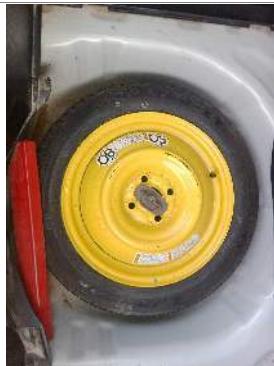
Spare wheel

| | Size | Load/Speed Index | Manufacture | Model | Type* | Production Date | Tread Depth (mm) |
|---|---|---|---|---|---|---|---|
| Spare | T135/70R15 | 99M | Jk tyre | Temporary | V | 0000 | 4 mm |

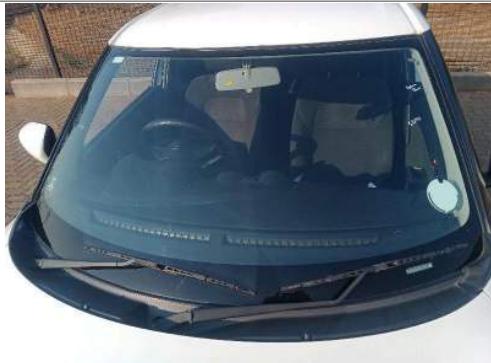
| Damage | Repair Way |
|--|---|
| License disc missing | Replace |

LICENSE DISC MISSING

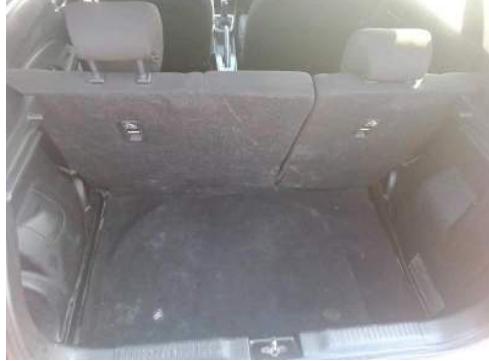
| Damage | Repair Way |
|--|---|
| Parcel Tray Missing | Replace |

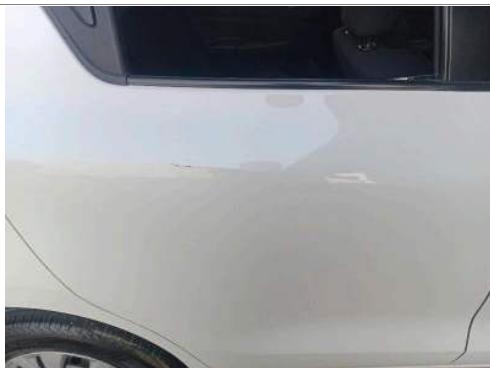
| Damage | Repair Way |
|--|---|
| Door Rear Right Paintwork • Scratched | Repair |

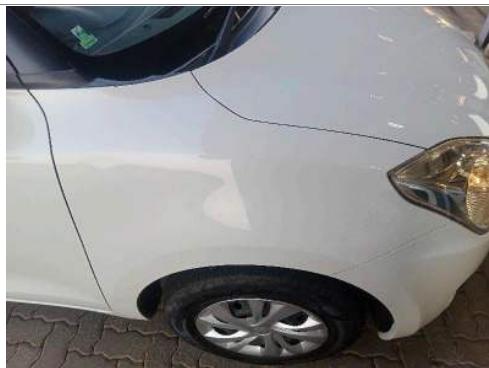
| Damage | Repair Way |
|--|---|
| Door Front Right Dented | Repair |

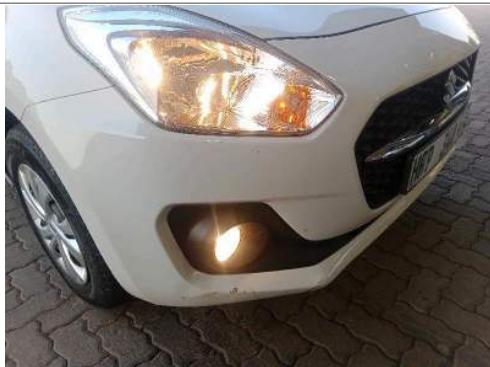
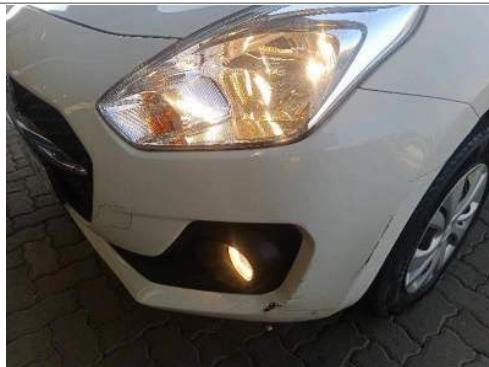
| Damage | Repair Way |
|--|---|
| Front Bumper Paintwork • Scratched | Repair |

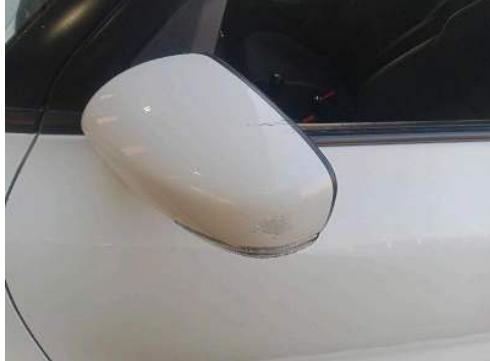
| Damage | Repair Way |
|--|---|
| Side Mirror Left Paintwork • Scratched | Repair |

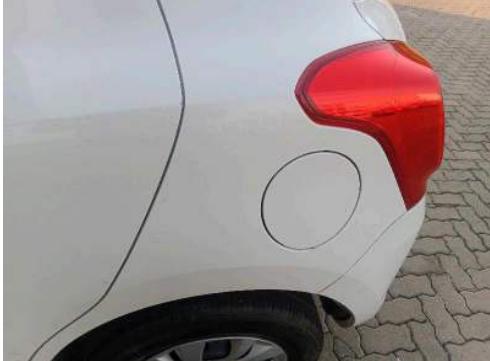
| Damage | Repair Way |
|--|---|
| Rear Fender Left Paintwork • Scratched | Repair |

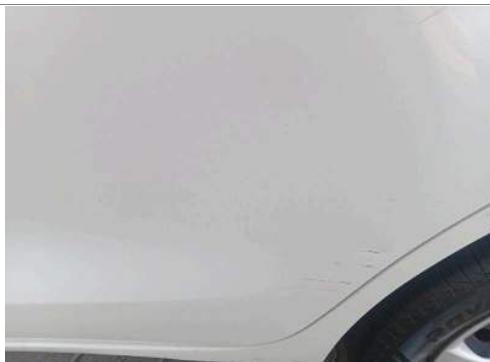
| Damage | Repair Way |
|--|---|
| Door Rear Left Paintwork • Scratched | Repair |

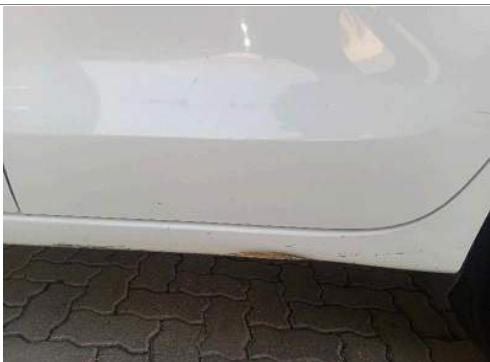
| Damage | Repair Way |
|--|---|
| Sill Panel Left Dented | Repair |

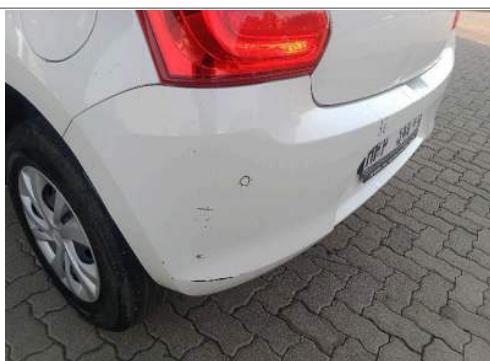
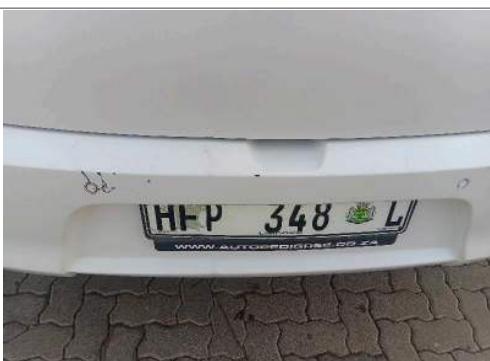
| Damage | Repair Way |
|--|---|
| Rear bumper Paintwork • Scratched | Repair |

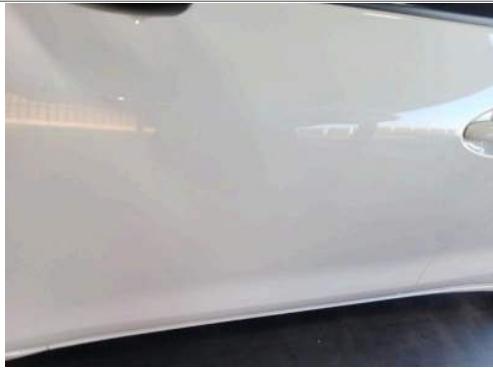
| Damage | Repair Way |
|--|---|
| Door Front Left Paintwork • Scratched | Repair |
