MFC Auction House  
M57 Pretoria Rd, Glenmarais, KEMPTON PARK  
Gauteng

Vehicle Type	PASSENGER VEHICLE	Registered Owner	
Manufacturer	TOYOTA	Registration Number	KF28RDGP
Model	ETIOS SD 1.5 XS [2015-2016]	Register Number	
VIN	MBJB29BT300101377	Date Of First Licensing	
Engine Number		Last COR	
Doors	4	License Expiry Date	
Color	WHITE	Power / Displacement	
Year Model	2015	Paint Finish	TWO COAT UNI
Km Reading	282,091 KM	Fuel	PETROL
Cab / Body Type	SEDAN	Transmission	MANUAL

VEHICLE INSPECTION

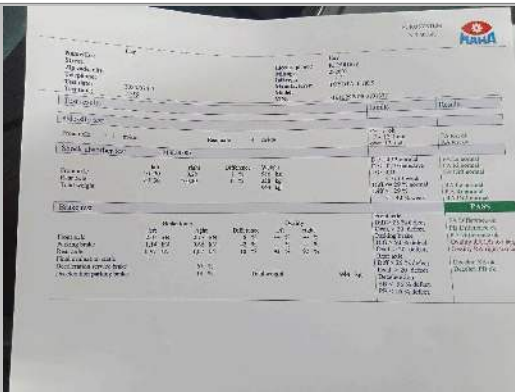
BRAKE AND SHOCK TEST REPORT

Left	Right	Axle Weight [KG]	Deceleration [m/s <sup>2</sup> ]
	Braking Force [KN]	Braking Force [KN]		
Front	2.01	2.17	-	
Rear	0.97	1.07	-	
Emergency / Parking	1.14	0.66	-

General Comments: ACCORDING TO THE AGE AND MILEAGE OF THE VEHICLE, NORMAL WEAR AND TEAR MARKS ON THE BODY, INTERIOR, EXTERIOR, AND MECHANICAL PARTS. Interior: Signs of the vehicle's airbags being deployed.  
Body • Exterior: Minor dents, scratches, and stone chips to some body panels. Signs of repair work done to some body panels. The vehicle's body was in poor condition. Signs of impact damage to the front of the vehicle. Poor alignment of some body panels. Repair work done on the vehicle was below standard. The vehicle was a cut-and-join.  
Brakes: The vehicle's brakes were extremely hard to depress.

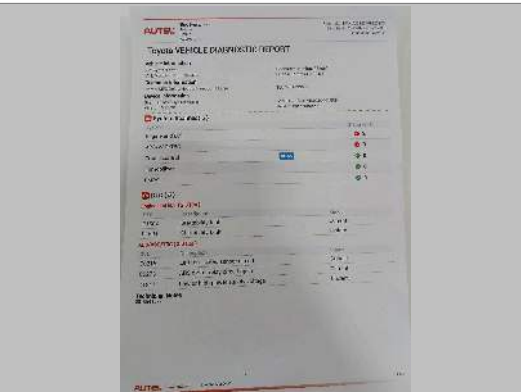
DIAGNOSTIC TEST REPORT

No	System	Code	Description	Status
1	ENGINE	P1604	STARTABILITY FAULT	
2	ABS/VSC/TRC	C0215	LEFT REAR SPEED SENSOR CIRCUIT	
3	ABS/VSC/TRC	C0273	ABS MOTOR RELAY CIRCUIT OPEN	
4	ABS/VSC/TRC	C1241	LOW OR HIGH POWER SUPPLY VOLTAGE

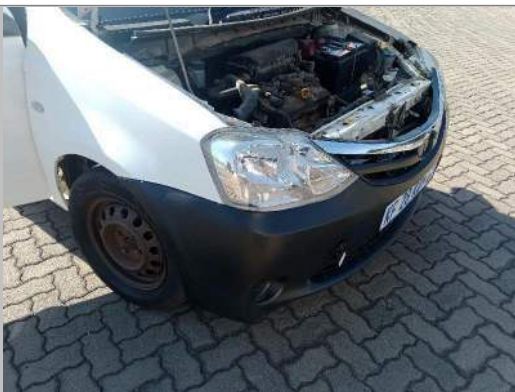
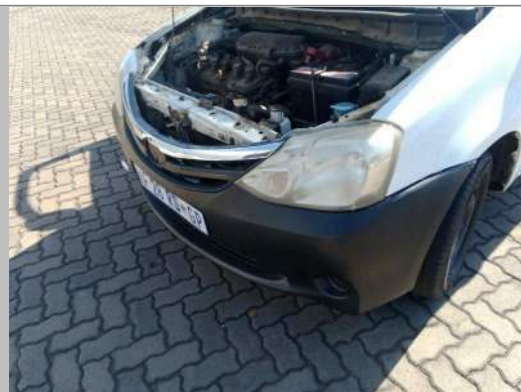
Damage	Repair Way
Engine Oil Leak	Repair
Engine Management Lights Set	Repair
Headlight Left Damaged	Replace
Headlight Right Damaged	Replace
Dash Padding Damaged	Replace
Front Bumper Damaged	Repair
Bonnet Damaged	Repair
Front Fender Left Damaged	Repair
Front Fender Right Damaged	Repair
Rear Fender Left Damaged	Repair
Rear Fender Right Damaged	Repair
Door Front Left Damaged	Repair
Door Front Right Damaged	Repair
Door Rear Left Damaged	Repair
Door Rear Right Damaged	Repair
Boot Lid / Hatch door Damaged	Repair
Rear bumper Damaged	Repair
Roof Damaged	Repair
Main Beam Left Damaged	Repair
Main Beam Right Welded	Repair
Gearbox Oil Leak	Repair
CV Joint(s) Boot(s) Front Right (inner/outer) Damaged	Replace

Front Bumper

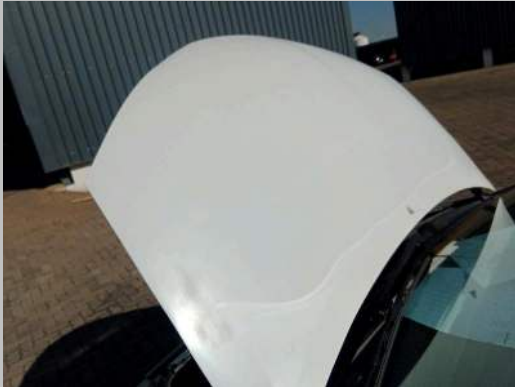
Bonnet

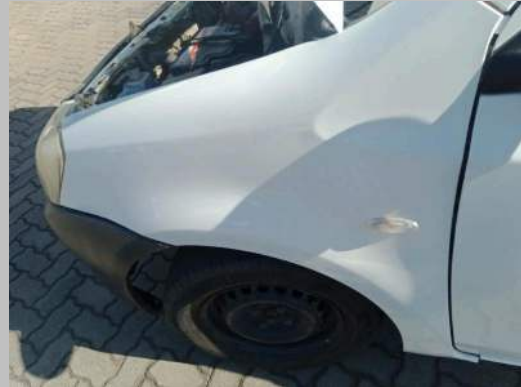
Front Fender Left

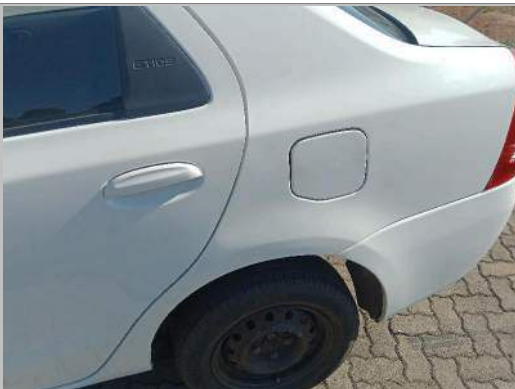
Rear Fender Left

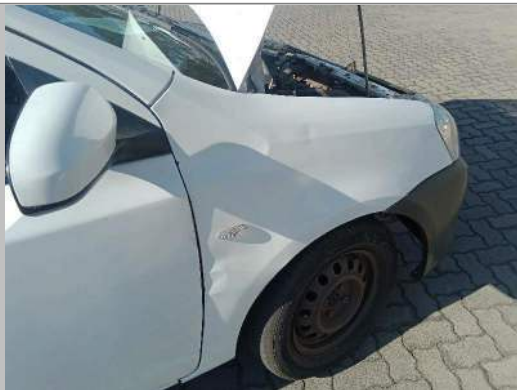
Front Fender Right

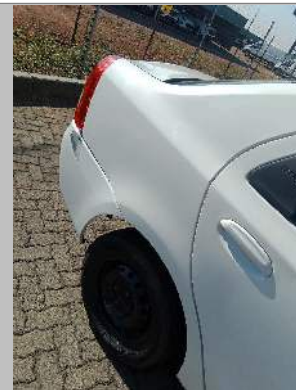
Rear Fender Right

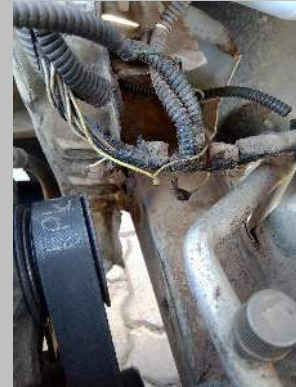
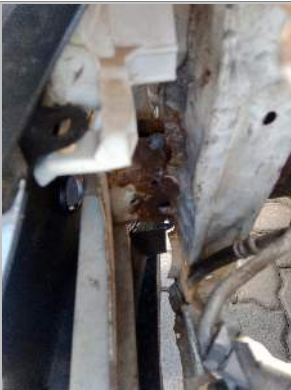
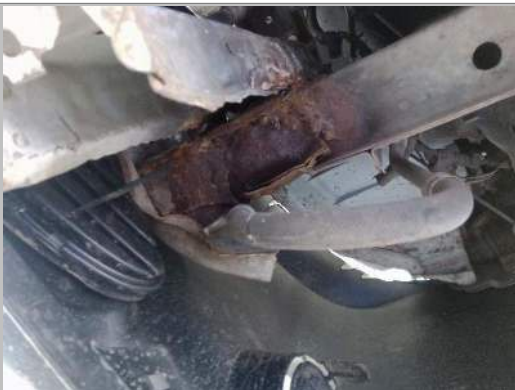
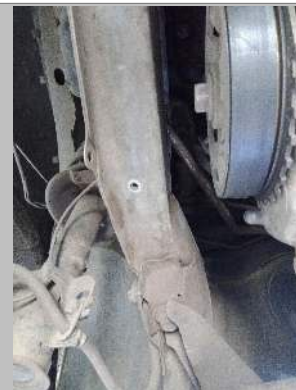
Main Beam Right

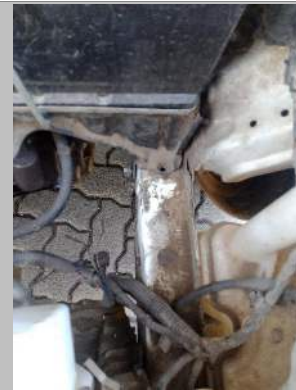
Main Beam Left

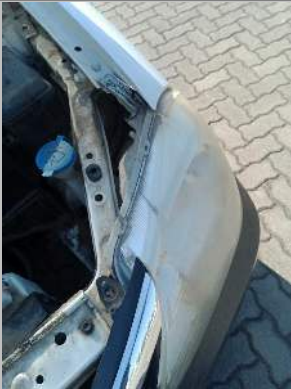
Headlight Left

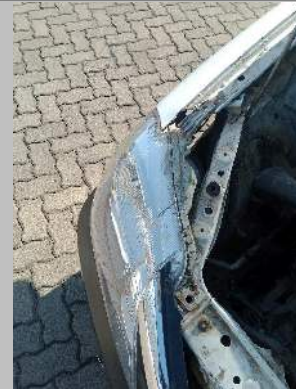
Headlight Right

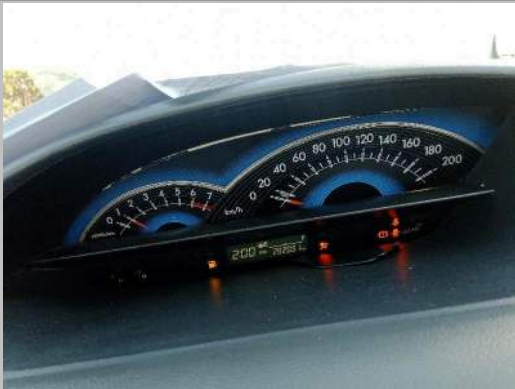
Engine Management Lights

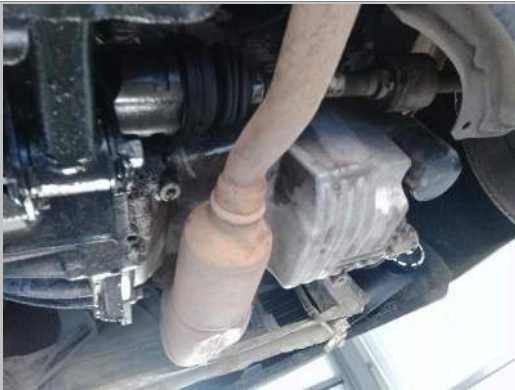
Engine

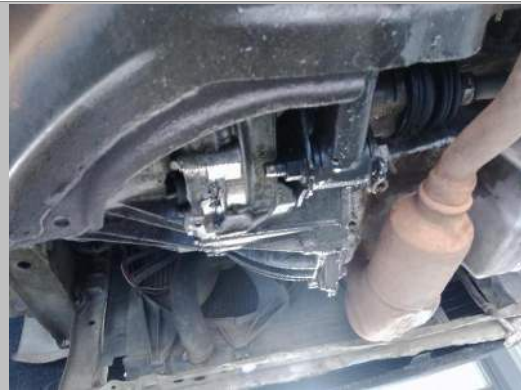
Gearbox

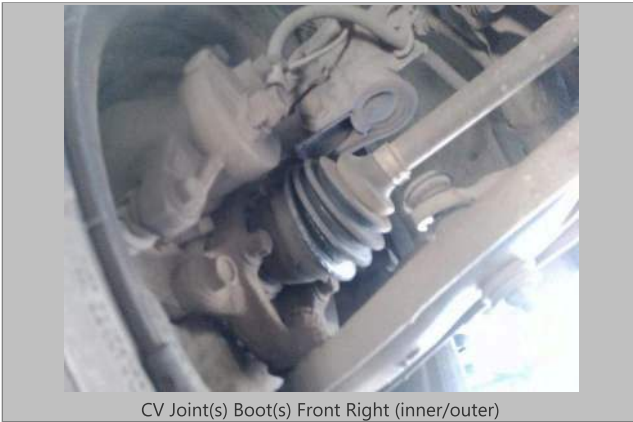
CV Joint(s) Boot(s) Front Right (inner/outer)
