CONDITION REPORT

Report No: 2016531573

MFC Auction House  
M57 Pretoria Rd, Glenmarais, KEMPTON PARK  
Gauteng

| Manufacturer | TOYOTA | Registration Number | JS39JFGP |

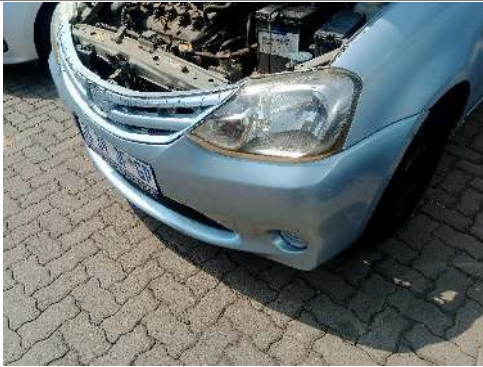
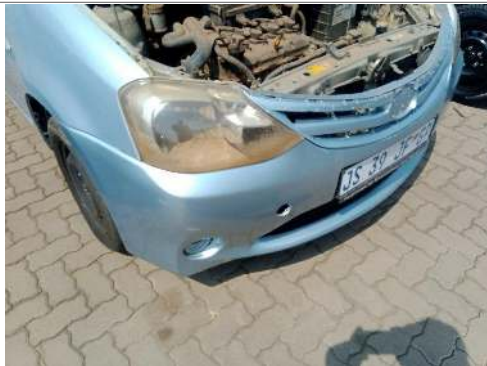
| Damage | Repair Way |
|---|---|
| Front Bumper Damaged | Repair |

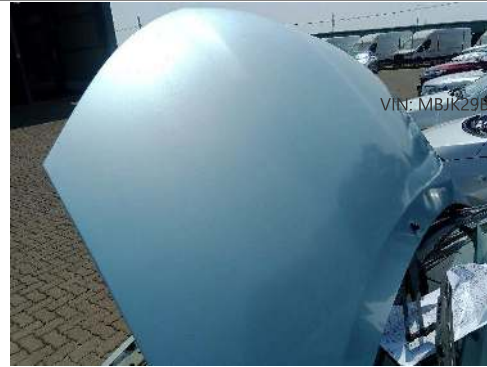
| Damage | Repair Way |
|---|---|
| Bonnet Damaged | Repair |

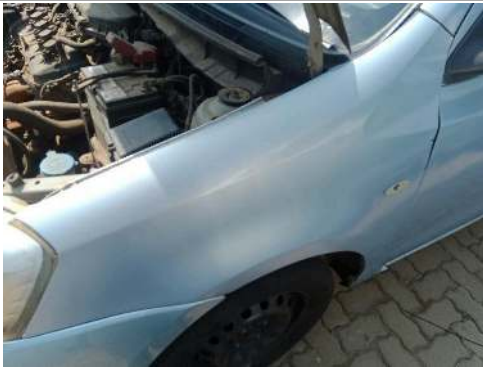
| Damage | Repair Way |
|---|---|
| Front Fender Left Damaged | Repair |

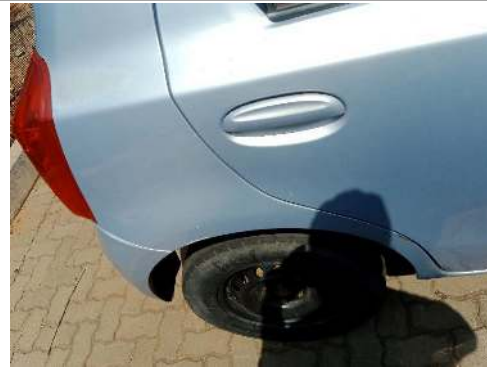
| Damage | Repair Way |
|---|---|
| Rear Fender Right Damaged | Repair |

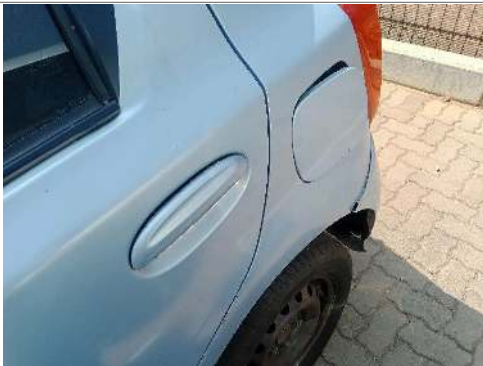
| Damage | Repair Way |
|---|---|
| Rear Fender Left Damaged | Repair |

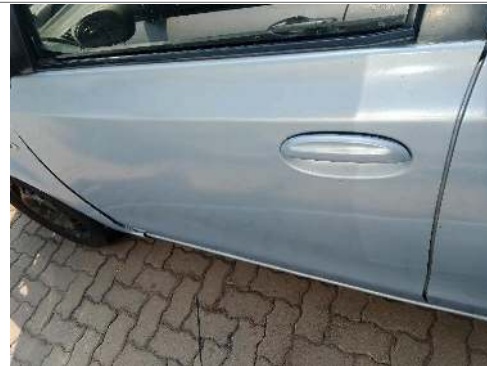
| Damage | Repair Way |
|---|---|
| Door Front Left Damaged | Repair |

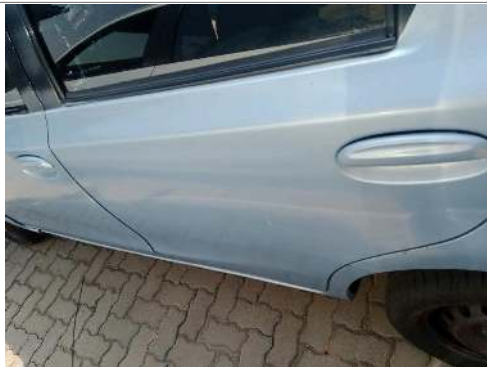
| Damage | Repair Way |
|---|---|
| Door Rear Left Damaged | Repair |

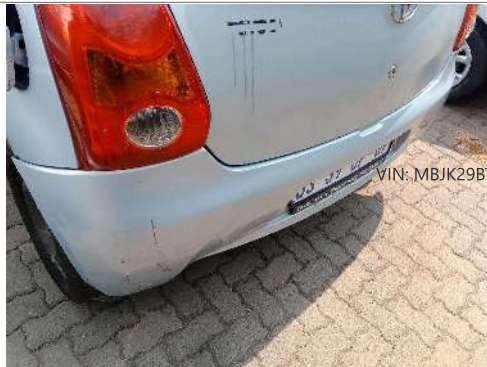
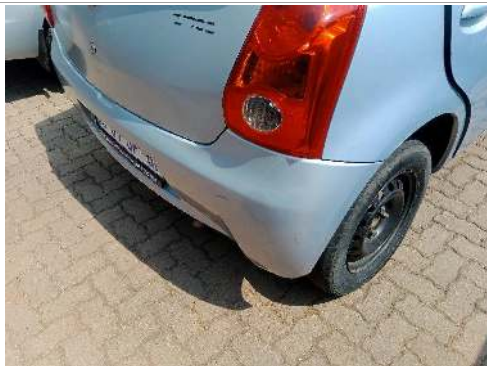
| Damage | Repair Way |
|---|---|
| Rear bumper Damaged | Repair |

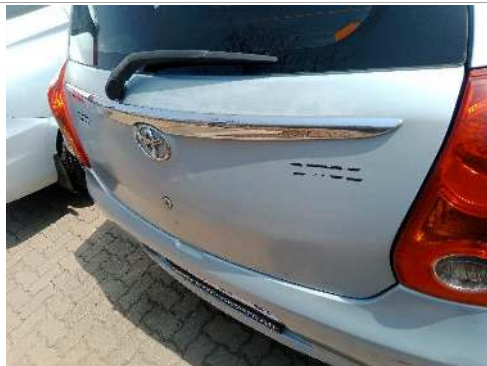
| Damage | Repair Way |
|---|---|
| Boot Lid / Hatch door Damaged | Repair |

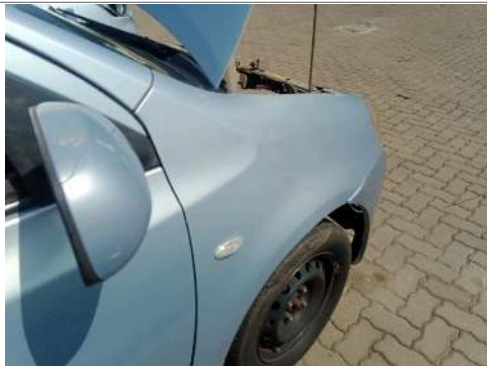
| Damage | Repair Way |
|---|---|
| Front Fender Right Damaged | Repair |

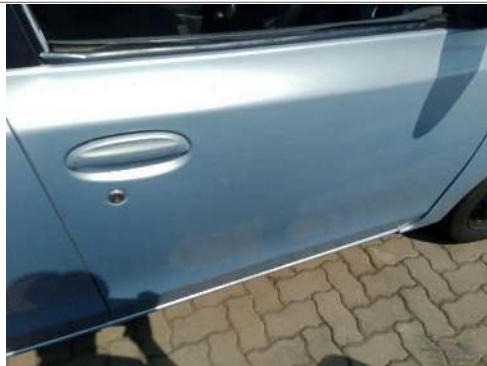
| Damage | Repair Way |
|---|---|
| Door Front Right Damaged | Repair |

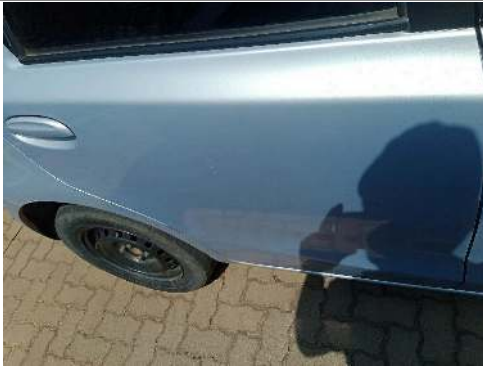
| Damage | Repair Way |
|---|---|
| Door Rear Right Damaged | Repair |

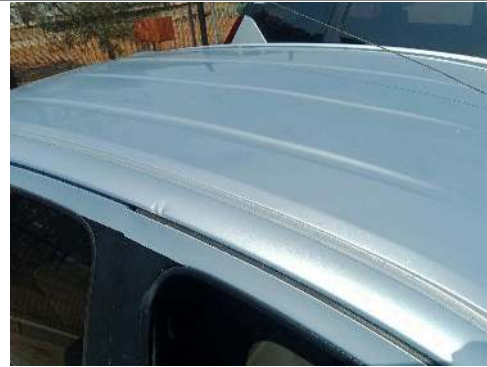
| Damage | Repair Way |
|---|---|
| Roof Damaged | Repair |

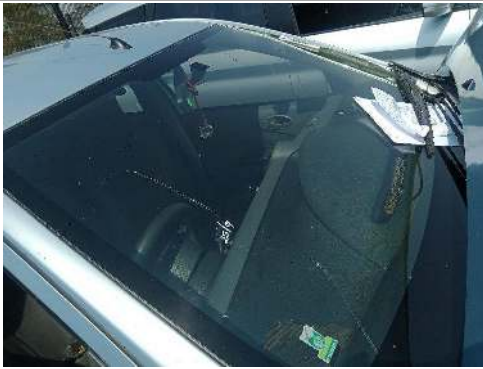
| Damage | Repair Way |
|---|---|
| Windscreen Damaged | Replace |

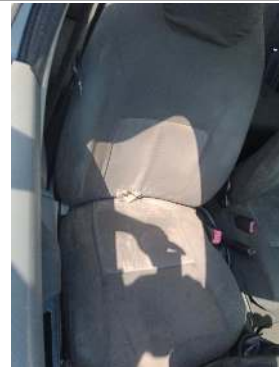
| Damage | Repair Way |
|---|---|
| Seat Front Right Damaged | Repair |

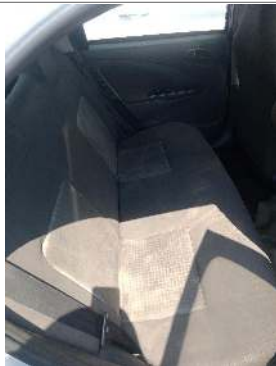
| Damage | Repair Way |
|---|---|
| Seat Rear Dirty | Repair |

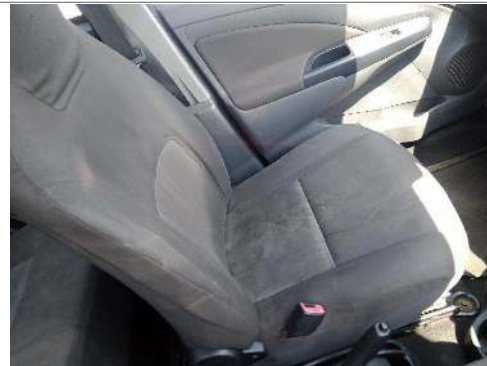
| Damage | Repair Way |
|---|---|
| Seat Front Left Dirty | Repair |

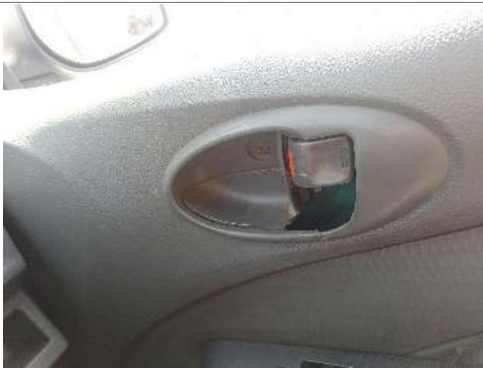
| Damage | Repair Way |
|---|---|
| Door Handle Front Right Damaged | Replace |

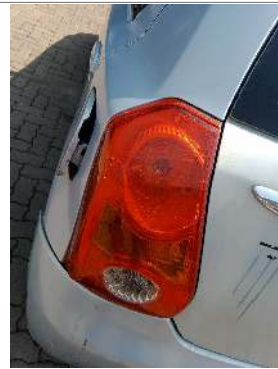
| Damage | Repair Way |
|---|---|
| Tail Light Left Damaged | Replace |

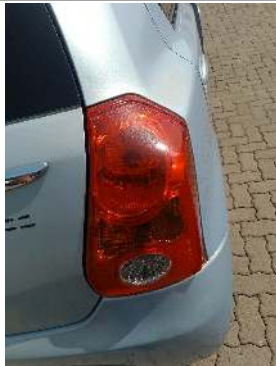
| Damage | Repair Way |
|---|---|
| Tail Light Right Damaged | Replace |

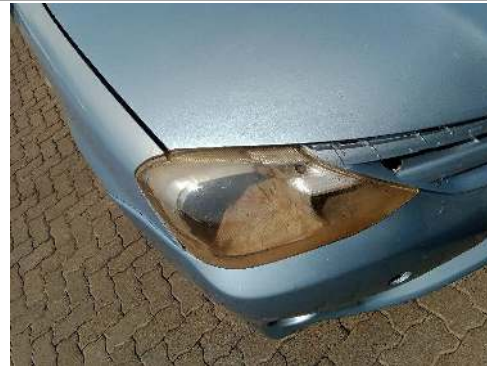
| Damage | Repair Way |
|---|---|
| Headlight Right Damaged | Repair |

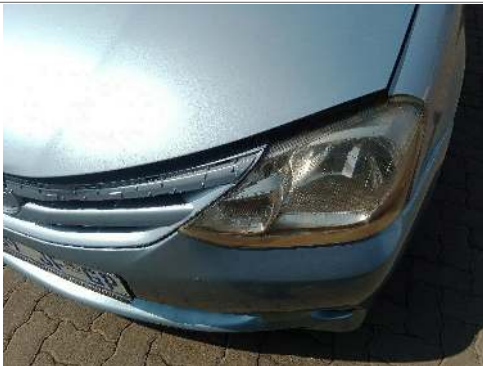
| Damage | Repair Way |
|---|---|
| Headlight Left Damaged | Replace |

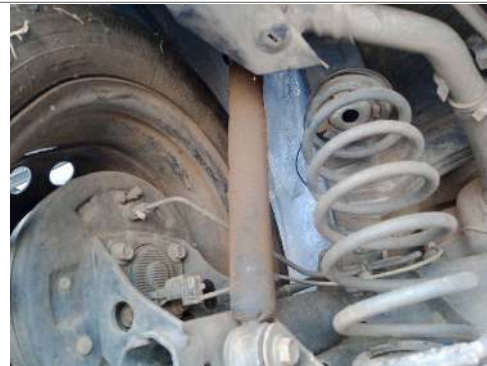
| Damage | Repair Way |
|---|---|
| Shock Absorber Rear Left Worn | Replace |

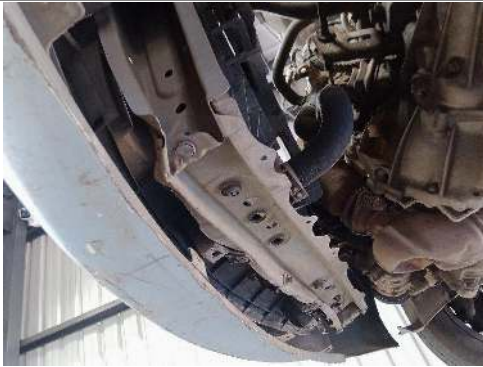
| Damage | Repair Way |
|---|---|
| Radiator Cradle Damaged | Repair |

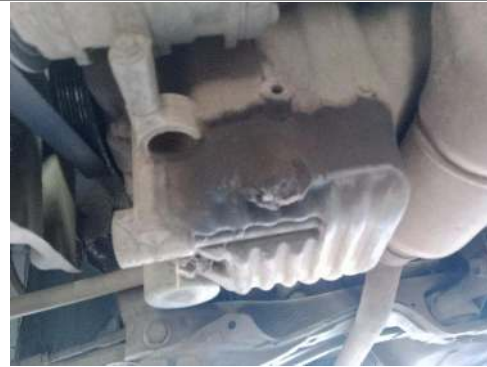
| Damage | Repair Way |
|---|---|
| Engine Oil Leak | Repair |

| Damage | Repair Way |
|---|---|
| Engine | Sump damage |

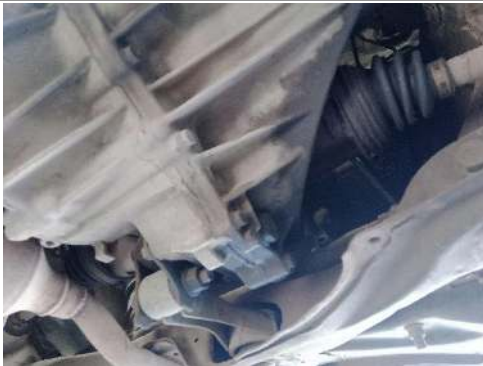
| Damage | Repair Way |
|---|---|
| Gearbox Oil Leak | Repair |

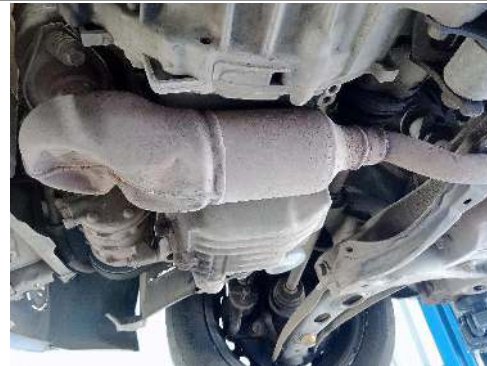
| Damage | Repair Way |
|---|---|
| Engine to silencer pipe Damaged | Replace |

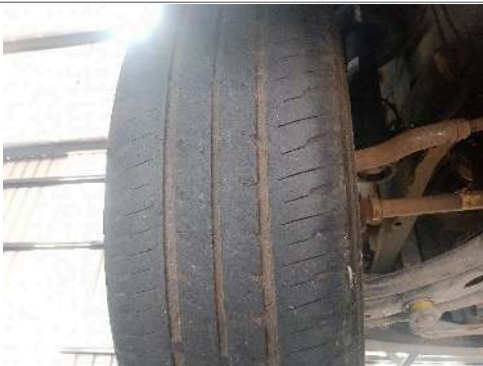
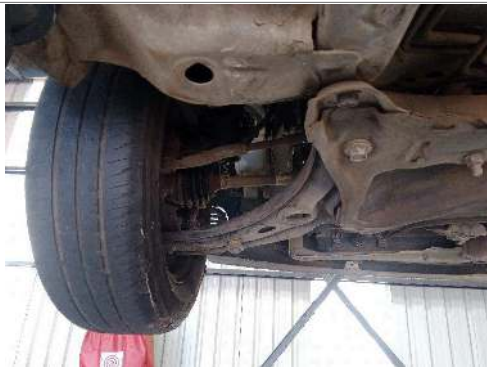
| Damage | Repair Way |
|---|---|
| Tyre Front Left Worn | Replace |

| | Size | Load/Speed Index | Manufacture | Model | Type* | Production Date | Tread Depth (mm) |
|---|---|---|---|---|---|---|---|
| Front Left | 185/60R14 | 82H | Firestone | Radial | V | 4721 | 0 mm |

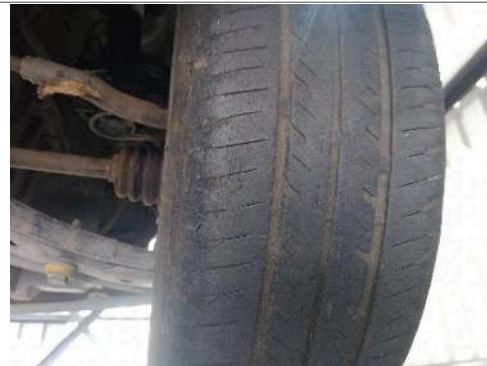
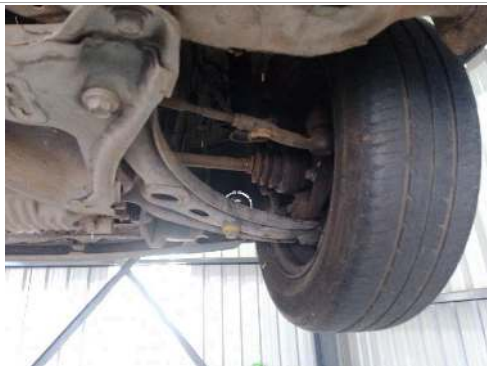
| Damage | Repair Way |
|---|---|
| Tyre Front Right Worn | Replace |

| | Size | Load/Speed Index | Manufacture | Model | Type* | Production Date | Tread Depth (mm) |
|---|---|---|---|---|---|---|---|
| Front Right | 185/60R14 | 82H | Firestone | Radial | V | 4721 | 0 mm |

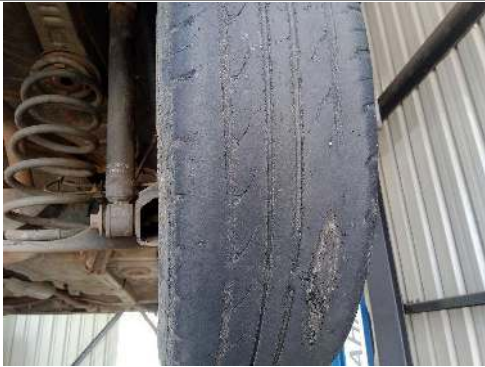
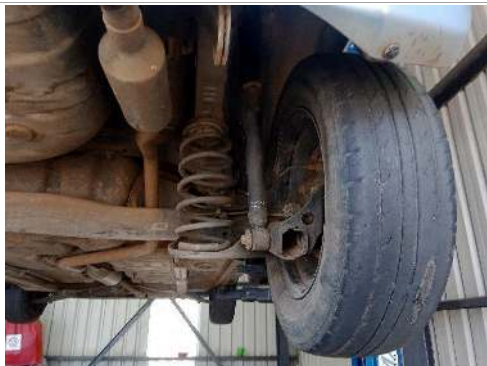
| Damage | Repair Way |
|---|---|
| Tyre Rear Right Worn | Replace |

| | Size | Load/Speed Index | Manufacture | Model | Type* | Production Date | Tread Depth (mm) |
|---|---|---|---|---|---|---|---|
| Rear Right | 185/65R14 | 86H | llink | Radial | V | 3220 | 0 mm |

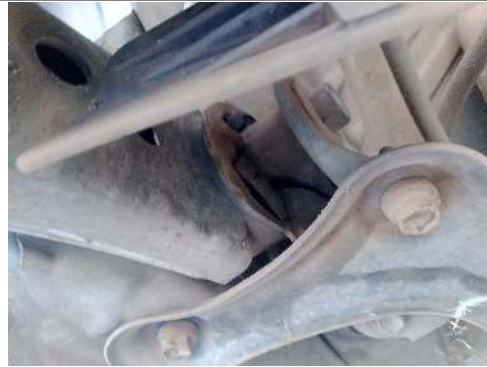
| Damage | Repair Way |
|---|---|
| Mounting Rubber(s) Rear Axle Left Worn | Replace |

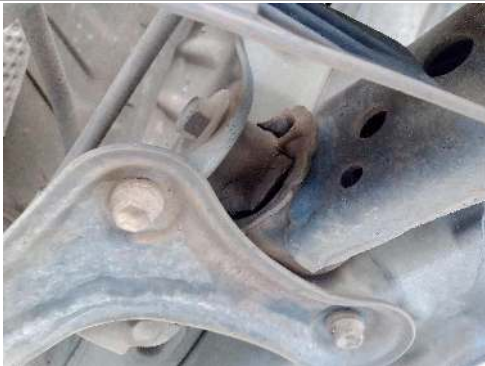
| Damage | Repair Way |
|---|---|
| Mounting Rubber(s) Rear Axle Right Worn | Replace |

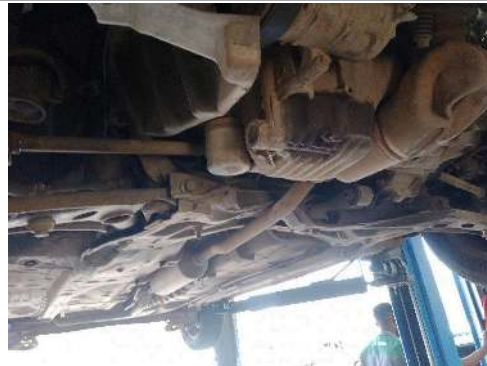
| Damage | Repair Way |
|---|---|
| Stabilizer Front Missing | Replace |
