## CONDITION REPORT

Report No:  
2016946719  
DATE  
15/07/2025

| Manufacturer | NISSAN | Registration Number | NO REG |
| Model | ALMERA 1.5 ACENTA AT [2016-2024] | Register Number | |

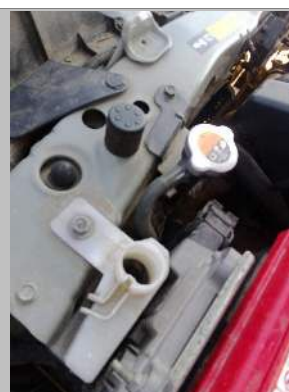
| Damage | Repair Way |
|---|---|
| Expansion Bottle Damaged | Repair |

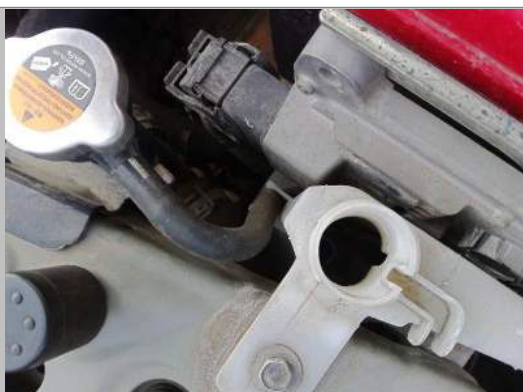
| Damage | Repair Way |
|---|---|
| Caps Missing | Replace |

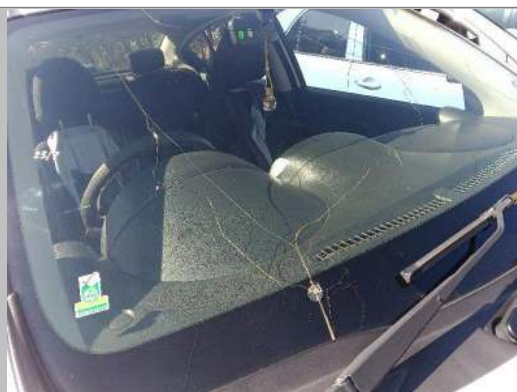
| Damage | Repair Way |
|---|---|
| Windscreen Cracked | Replace |

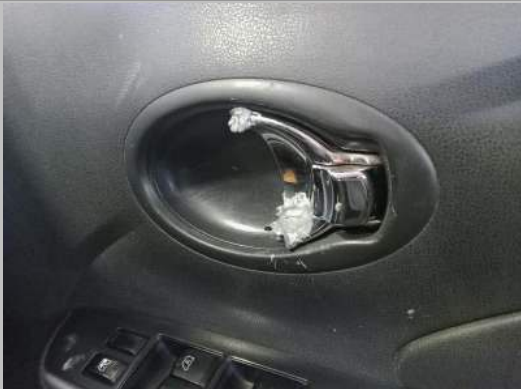
| Damage | Repair Way |
|---|---|
| Door Handle Front Right Damaged | Replace |

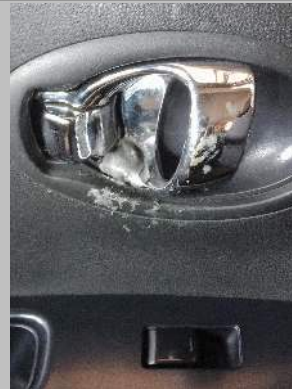
| Damage | Repair Way |
|---|---|
| Door Handle Rear Right Damaged | Replace |

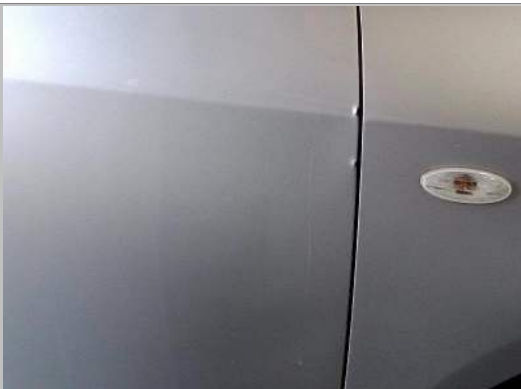
| Damage | Repair Way |
|---|---|
| Door Front Right Damaged | Repair |

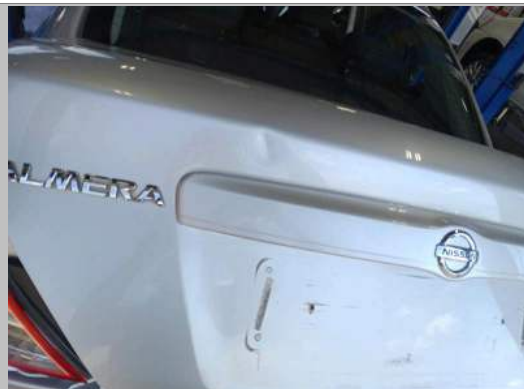
| Damage | Repair Way |
|---|---|
| Boot Lid / Hatch door Dented | Repair |

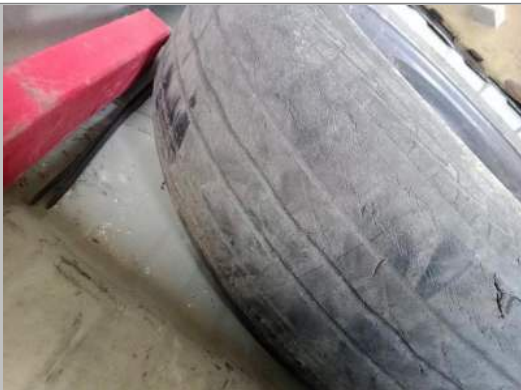
| Damage | Repair Way |
|---|---|
| Spare Tyre Smooth | Replace |

| | Size | Load/Speed Index | Manufacture | Model | Type* | Production Date | Tread Depth (mm) |
|---|---|---|---|---|---|---|---|
| Spare | 185/60R15 | 84H | Bridgestone | Turanza | V | 0000 | 0 mm |

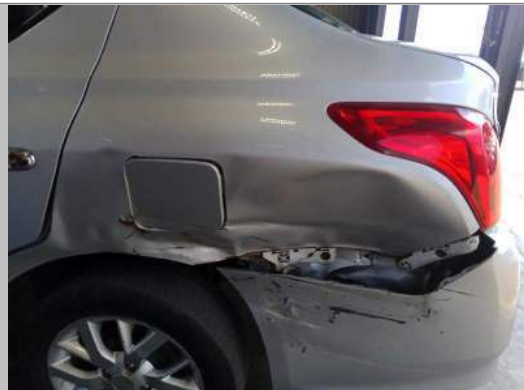
| Damage | Repair Way |
|---|---|
| Rear Fender Left Damaged | Repair |

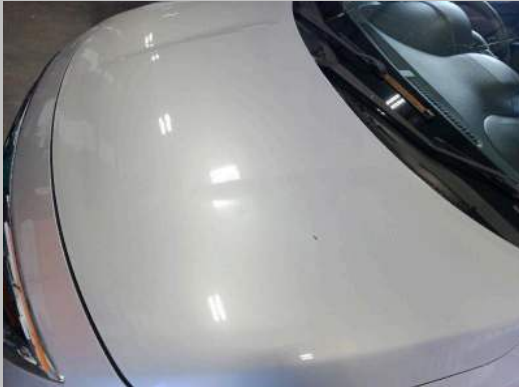
| Damage | Repair Way |
|---|---|
| Bonnet Dented | Repair |

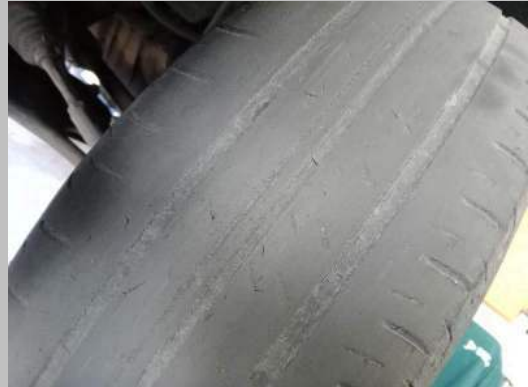
| Damage | Repair Way |
|---|---|
| Tyre Front Right Smooth | Replace |

| | Size | Load/Speed Index | Manufacture | Model | Type* | Production Date | Tread Depth (mm) |
|---|---|---|---|---|---|---|---|
| Front Right | 175/65R15 | 84H | Bridgestone | Ecopia | V | 0000 | 0 mm |

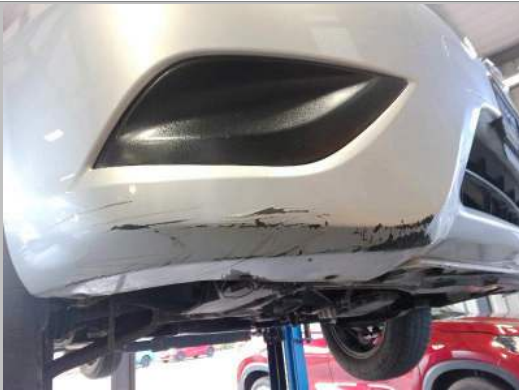
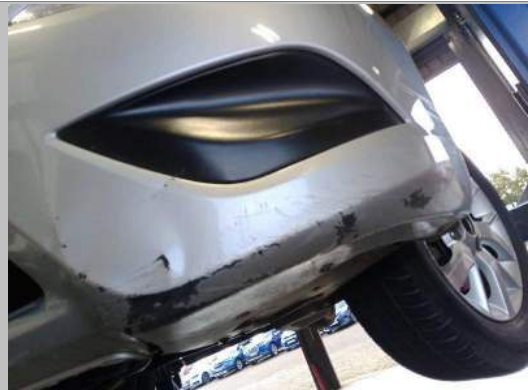
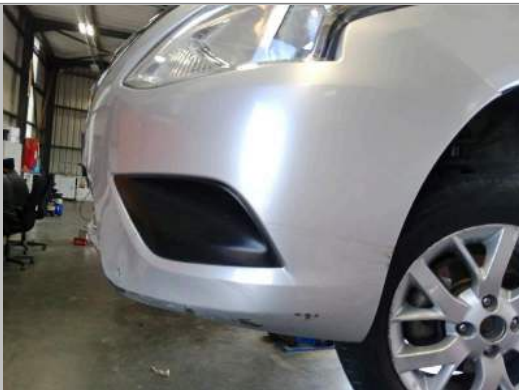
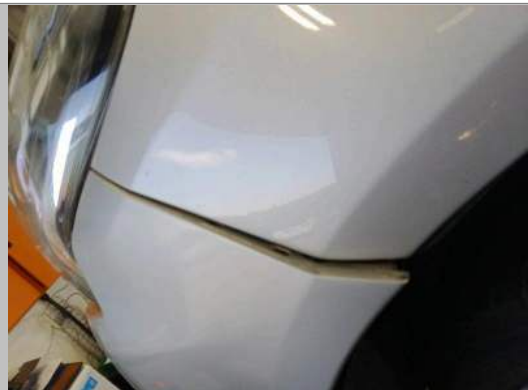
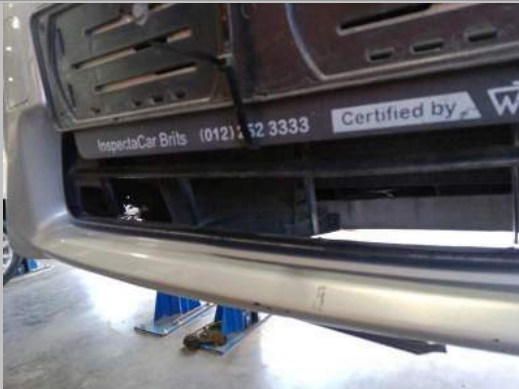
| Damage | Repair Way |
|---|---|
| Front Bumper Paintwork • Scratched | Repair |

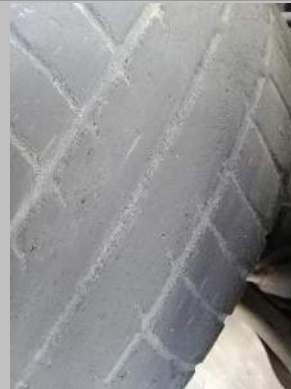
| Damage | Repair Way |
|---|---|
| Tyre Front Left Smooth | Replace |

| | Size | Load/Speed Index | Manufacture | Model | Type* | Production Date | Tread Depth (mm) |
|---|---|---|---|---|---|---|---|
| Front Left | 185/65R15 | 92T | Barum | Brillantis | V | 3624 | 0 mm |

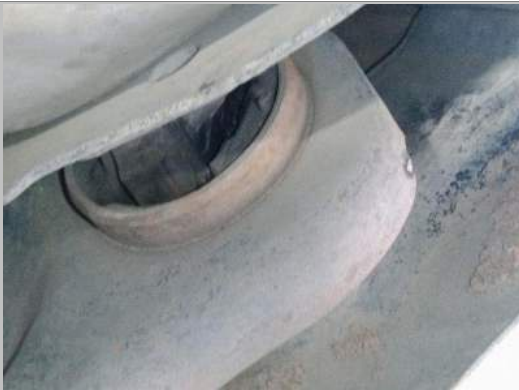
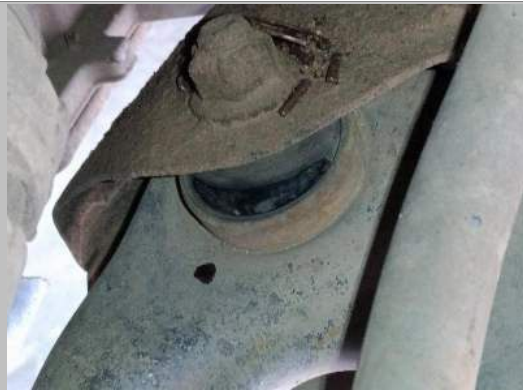
| Damage | Repair Way |
|---|---|
| Control Arm Bush(es) Front Axle Left Cracked | Replace |

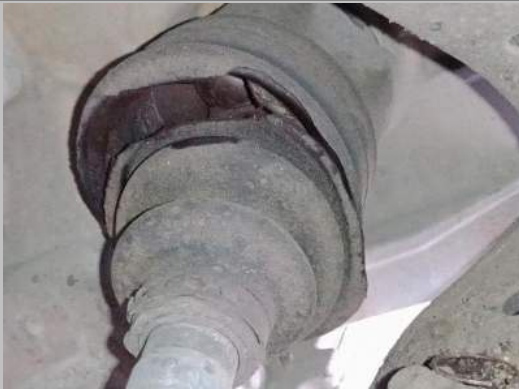
| Damage | Repair Way |
|---|---|
| CV Joint(s) Boot(s) Front Left (inner/outer) Damaged | Replace |

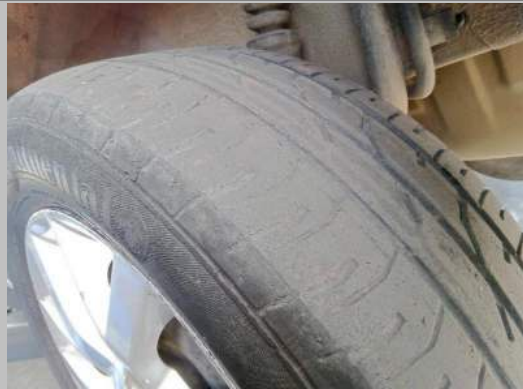
| Damage | Repair Way |
|---|---|
| Tyre Rear Left Excessive Wear & Tear | Replace |

| | Size | Load/Speed Index | Manufacture | Model | Type* | Production Date | Tread Depth (mm) |
|---|---|---|---|---|---|---|---|
| Rear Left | 185/60R15 | 84H | Continental | Contact | V | 3118 | 1 mm |

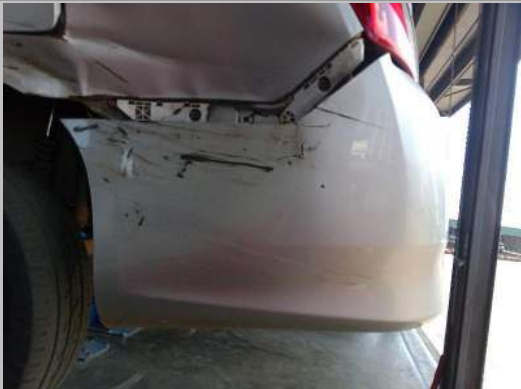
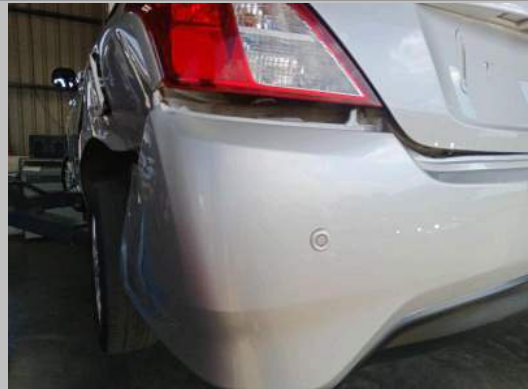
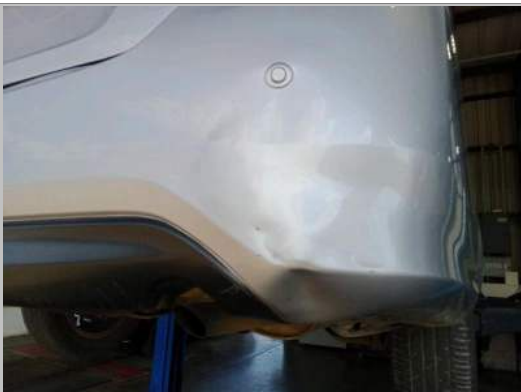
| Damage | Repair Way |
|---|---|
| Rear bumper Damaged | Repair |

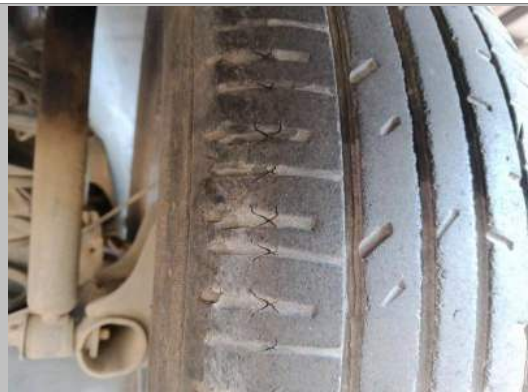
| Damage | Repair Way |
|---|---|
| Tyre Rear Right Excessive Wear & Tear | Replace |

| | Size | Load/Speed Index | Manufacture | Model | Type* | Production Date | Tread Depth (mm) |
|---|---|---|---|---|---|---|---|
| Rear Right | 195/65R15 | 91V | Dunlop | Sport | V | 4417 | 0 mm |

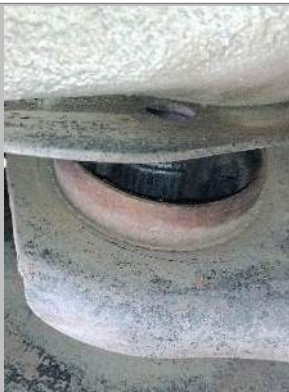
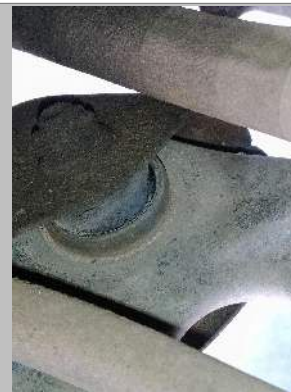
| Damage | Repair Way |
|---|---|
| Control Arm Bush(es) Front Axle Right Cracked | Replace |

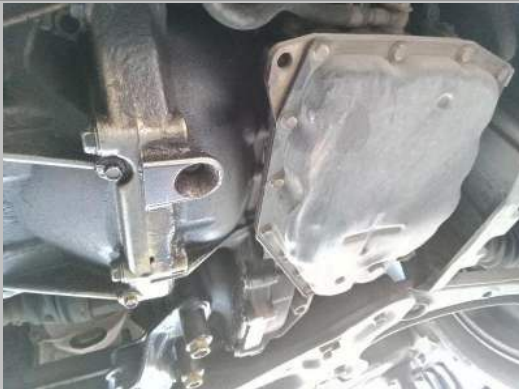
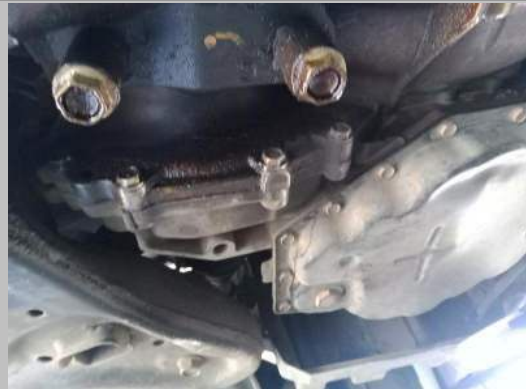
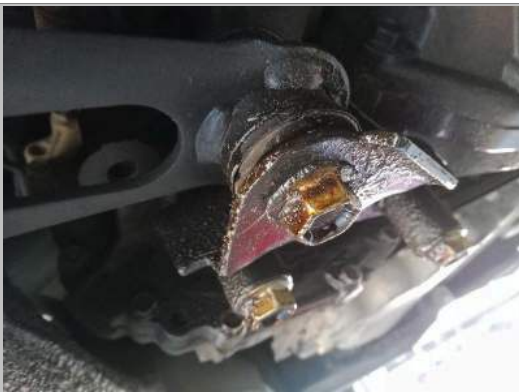
| Damage | Repair Way |
|---|---|
| Gearbox Oil Leak | Repair |

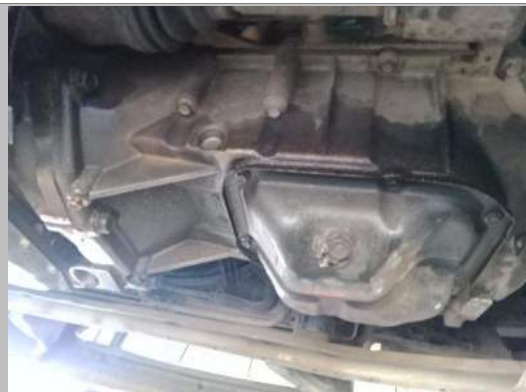
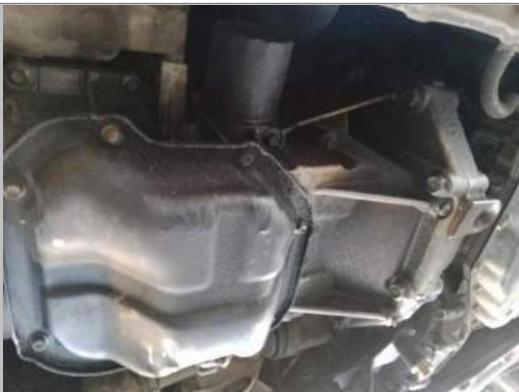
| Damage | Repair Way |
|---|---|
| Engine Oil Leak | Repair |

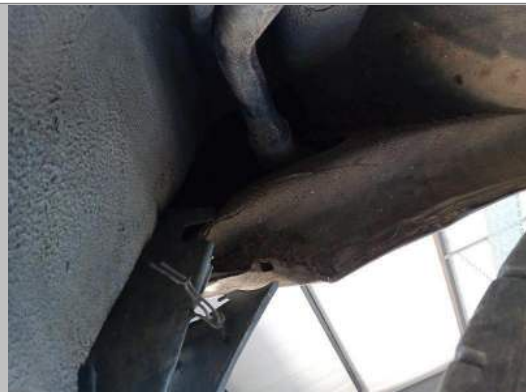
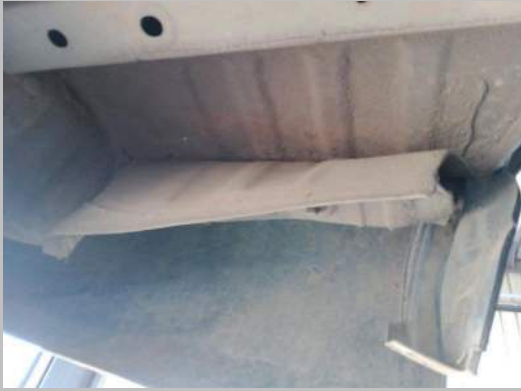
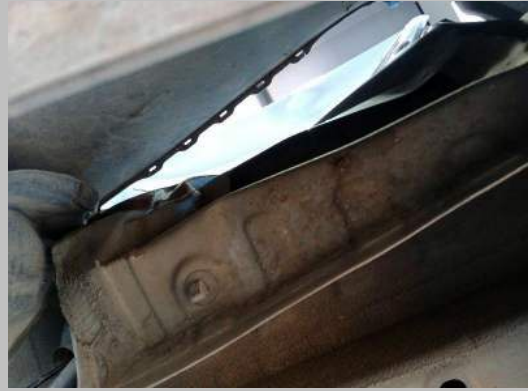
| Damage | Repair Way |
|---|---|
| Rear Fender Left / Inner Tray Damaged | Repair |

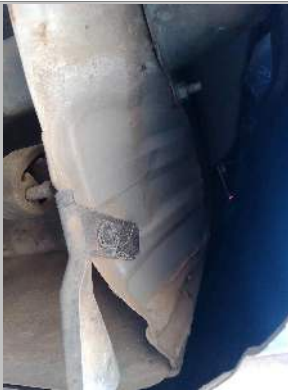
| Damage | Repair Way |
|---|---|
| Rear Lower Valance Damaged | Repair |
