## CONDITION REPORT

Report No: 2016276051

DATE  
21/02/2024

| Manufacturer | NISSAN | Registration Number | JS73PCGP |

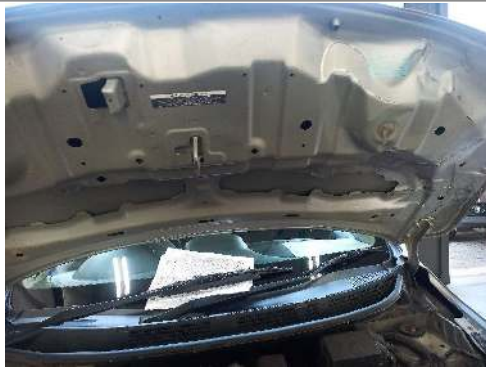
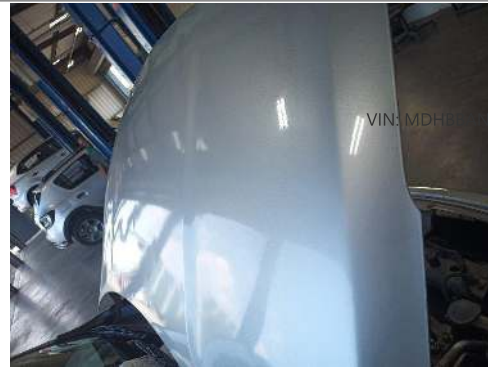
| Damage | Repair Way |
|---|---|
| Bonnet Damaged | Repair |

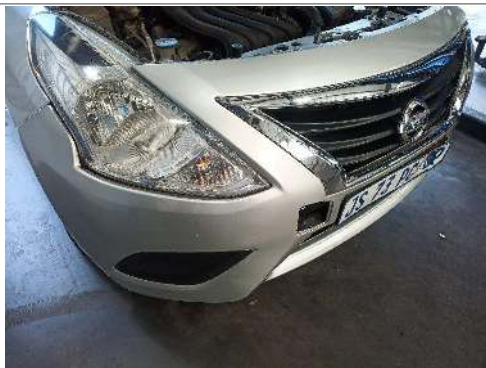
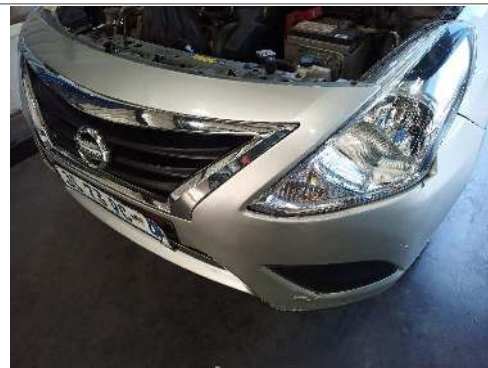
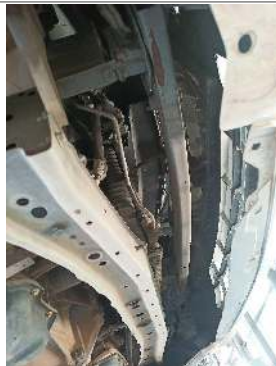
| Damage | Repair Way |
|---|---|
| Front Bumper Damaged | Repair |

| Damage | Repair Way |
|---|---|
| Body and exterior | Front bumper stiffener damaged |

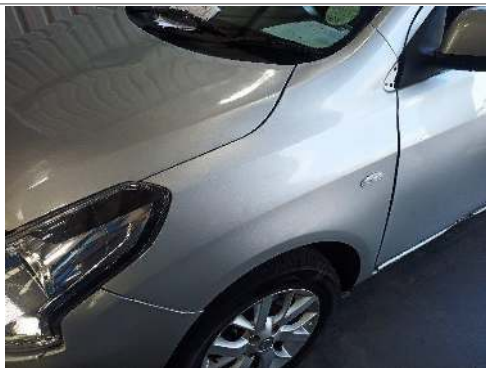
| Damage | Repair Way |
|---|---|
| Front Fender Left Damaged | Repair |

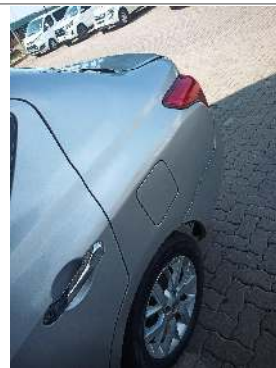
| Damage | Repair Way |
|---|---|
| Rear Fender Left Damaged | Repair |

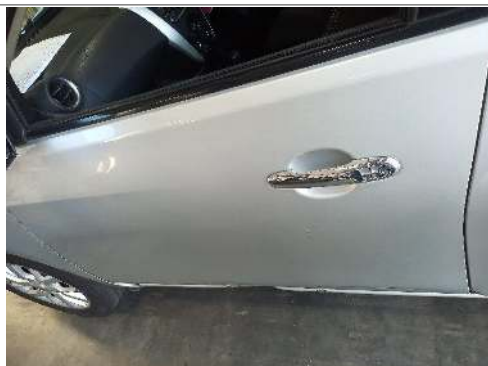
| Damage | Repair Way |
|---|---|
| Door Front Left Damaged | Repair |

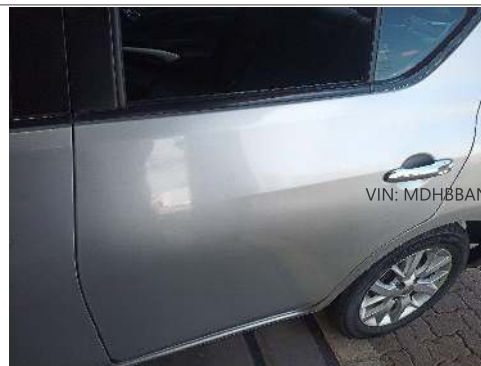
| Damage | Repair Way |
|---|---|
| Door Rear Left Damaged | Repair |

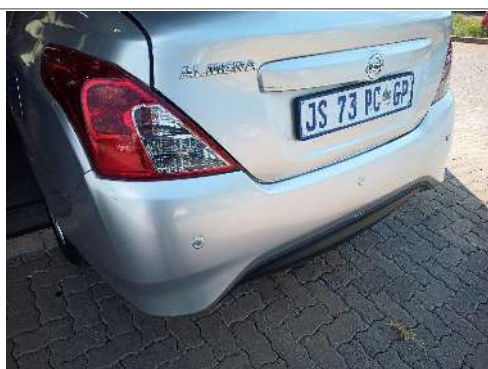
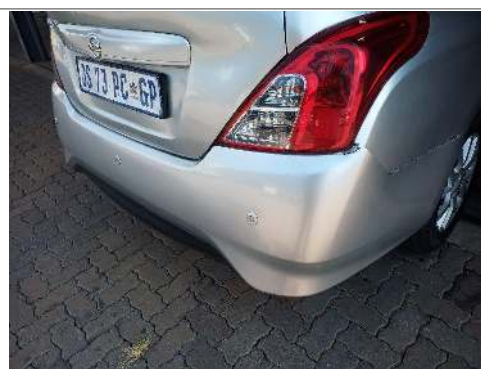
| Damage | Repair Way |
|---|---|
| Rear bumper Damaged | Repair |

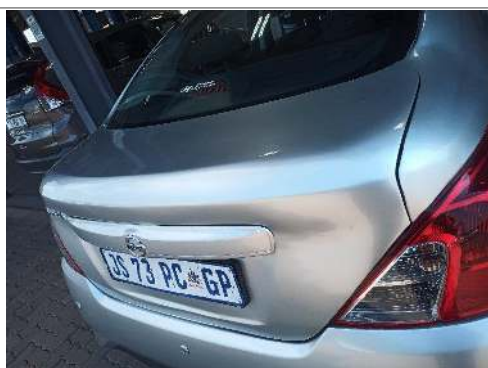
| Damage | Repair Way |
|---|---|
| Boot Lid / Hatch door Damaged | Repair |

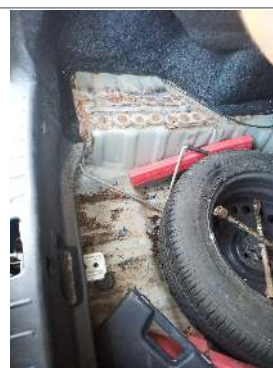
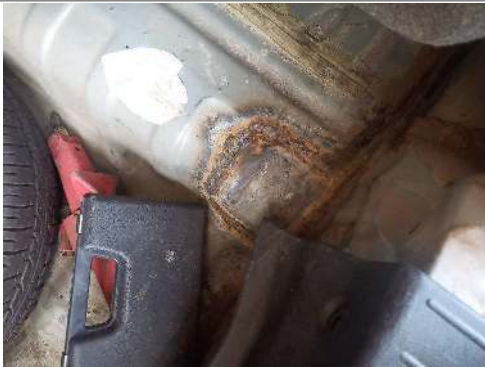
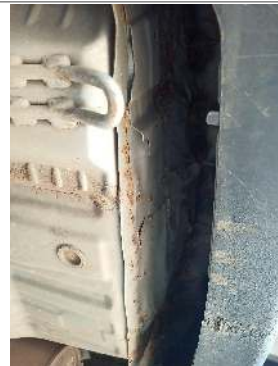
| Damage | Repair Way |
|---|---|
| Inner Boot Floor Pan and Spare Wheel Well Welded | Repair |

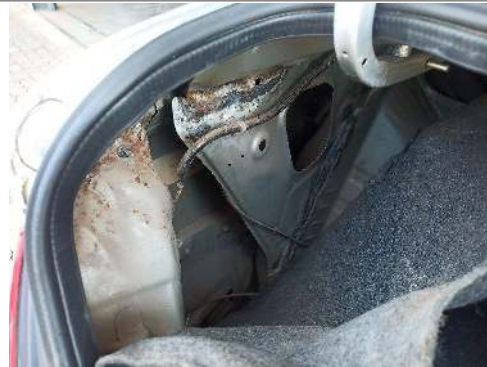
| Damage | Repair Way |
|---|---|
| Boot Panel Left Damaged | Repair |

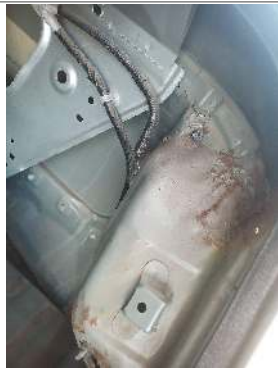
| Damage | Repair Way |
|---|---|
| Boot Panel Right Damaged | Repair |

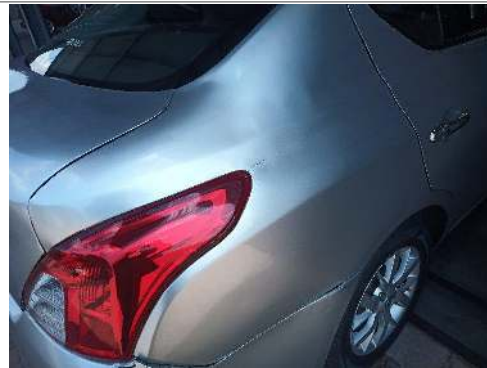
| Damage | Repair Way |
|---|---|
| Rear Fender Right Damaged | Repair |

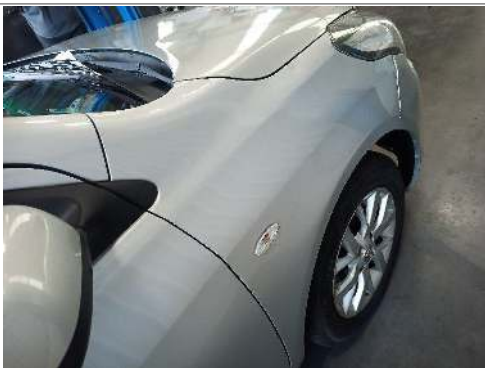
| Damage | Repair Way |
|---|---|
| Front Fender Right Damaged | Repair |

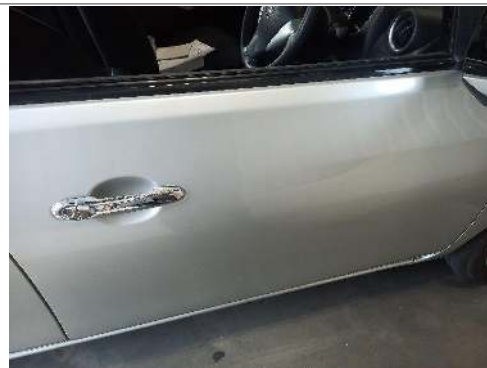
| Damage | Repair Way |
|---|---|
| Door Front Right Damaged | Repair |

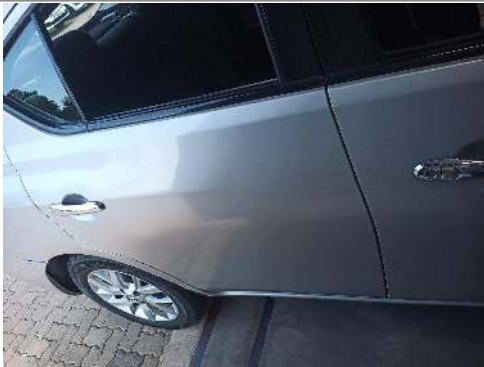
| Damage | Repair Way |
|---|---|
| Door Rear Right Damaged | Repair |

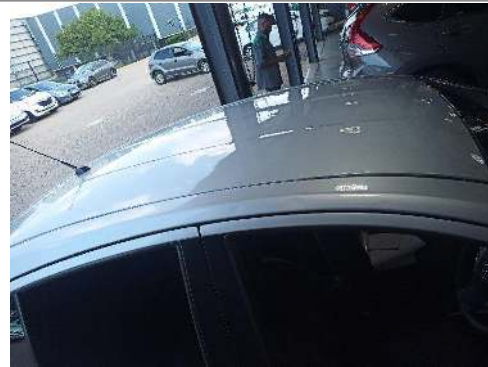
| Damage | Repair Way |
|---|---|
| Roof Damaged | Repair |

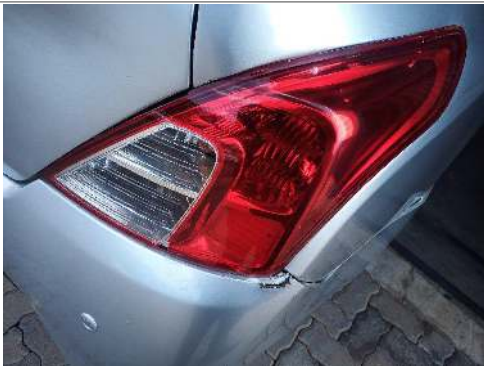
| Damage | Repair Way |
|---|---|
| Tail Light Right Damaged | Repair |

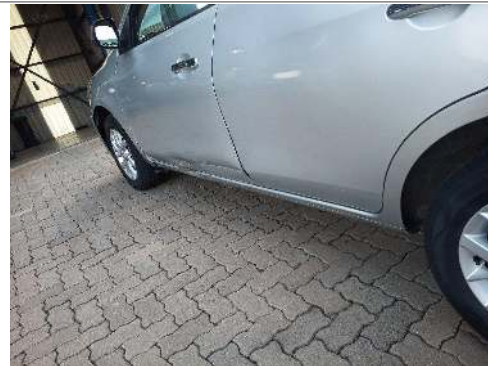
| Damage | Repair Way |
|---|---|
| Sill Panel Left Damaged | Repair |

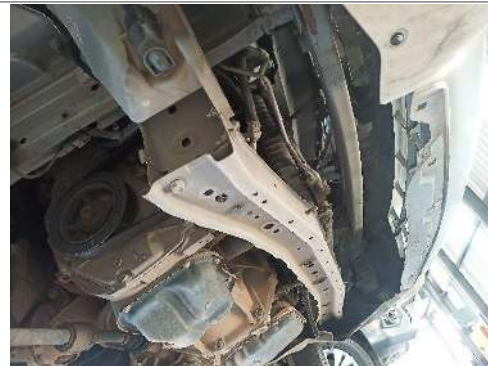
| Damage | Repair Way |
|---|---|
| Radiator Cradle Damaged | Repair |

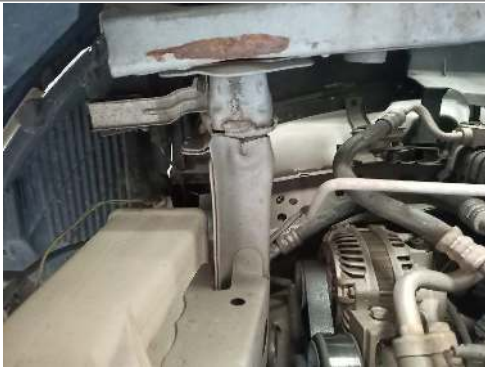
| Damage | Repair Way |
|---|---|
| Main Beam Right Damaged | Repair |

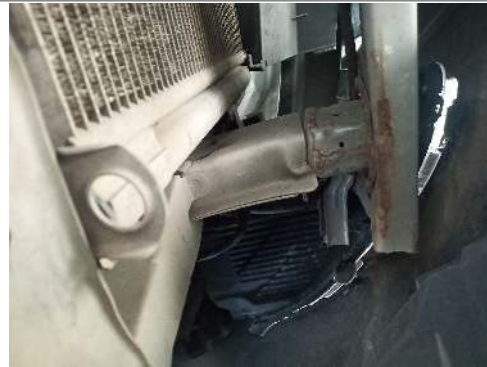
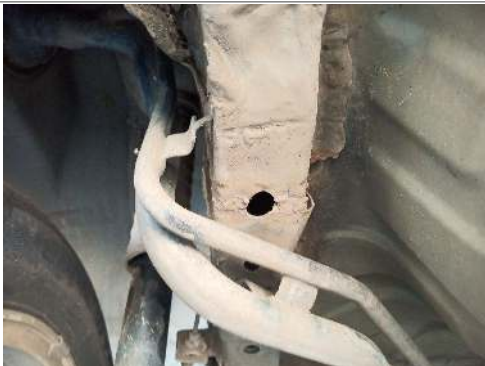
| Damage | Repair Way |
|---|---|
| Main Beam Left Damaged | Repair |

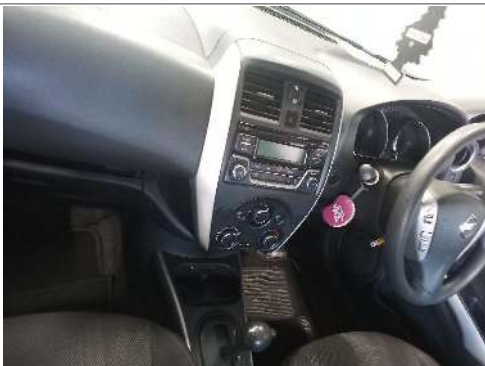
| Damage | Repair Way |
|---|---|
| Air Conditioner Insufficient | Repair |
