## CONDITION REPORT

Report No: 2016400506

MFC Auction House  
M57 Pretoria Rd, Glenmarais, KEMPTON PARK  
Gauteng

| Manufacturer | DATSUN | Registration Number | CX62870 |

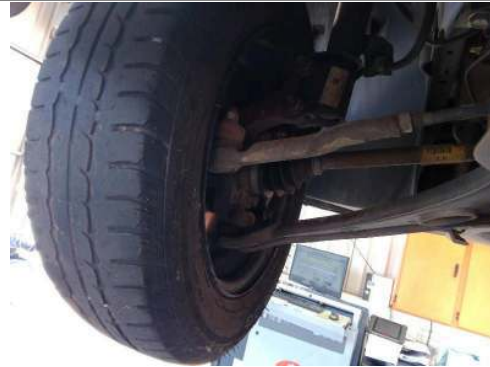
LF TYRE TREAD

| | Size | Load/Speed Index | Manufacture | Model | Type* | Production Date | Tread Depth (mm) |
|---|---|---|---|---|---|---|---|
| Front Left | 155/70R13 | 75T | Apollo | Amazer | V | 4720 | 1 mm |

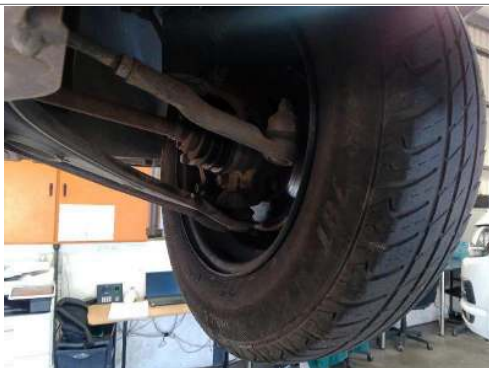
RF TYRE TREAD

| | Size | Load/Speed Index | Manufacture | Model | Type* | Production Date | Tread Depth (mm) |
|---|---|---|---|---|---|---|---|
| Front Right | 155/80R13 | 79T | Velocity | Reacta | V | 4720 | 2 mm |

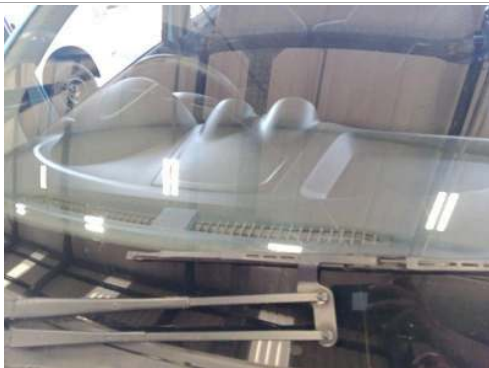
| Damage | Repair Way |
|---|---|
| Windscreen Cracked | Replace |

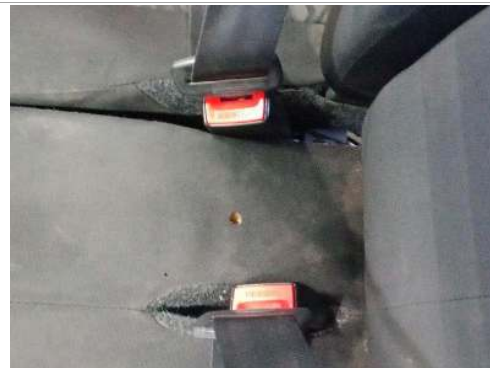
| Damage | Repair Way |
|---|---|
| Seat Front Left Torn / Cut | Repair |

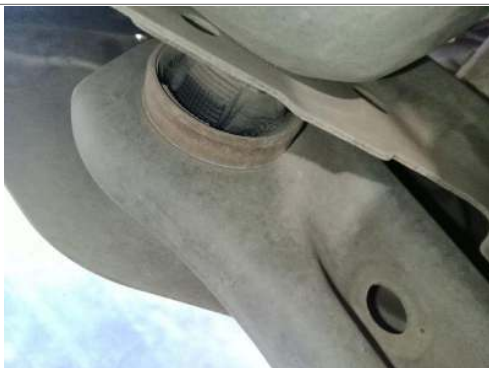
| Damage | Repair Way |
|---|---|
| Control Arm Bush(es) Front Axle Right Cracked | Replace |

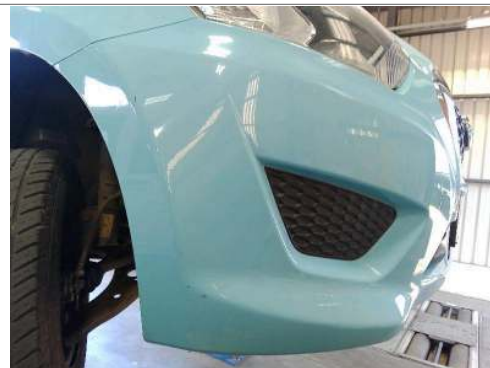
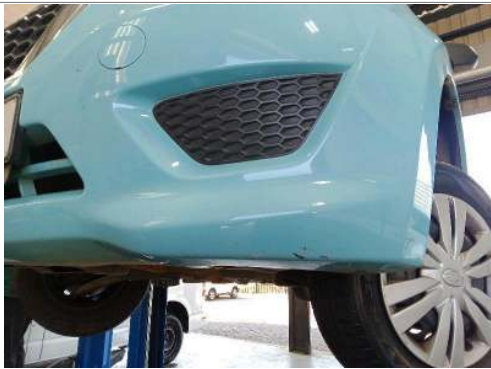
| Damage | Repair Way |
|---|---|
| Front Bumper Paintwork • Scratched | Repair |

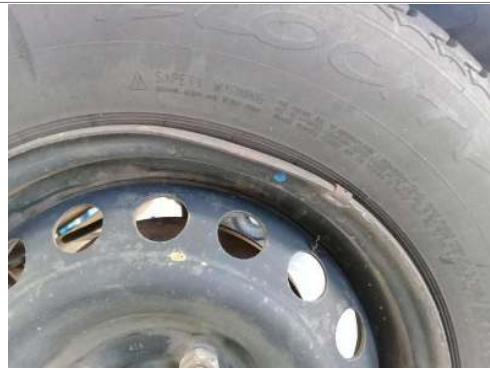
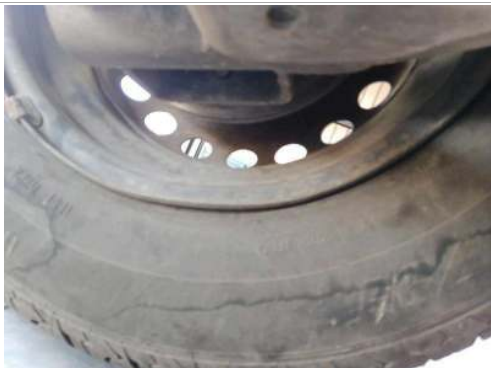
| Damage | Repair Way |
|---|---|
| Rim Rear Left Dented | Repair |
