## CONDITION REPORT

Report No:  
2016987079  
DATE  
29/08/2025

| Manufacturer | DATSUN | Registration Number | LY71NJGP |
| Model | GO | Register Number | |

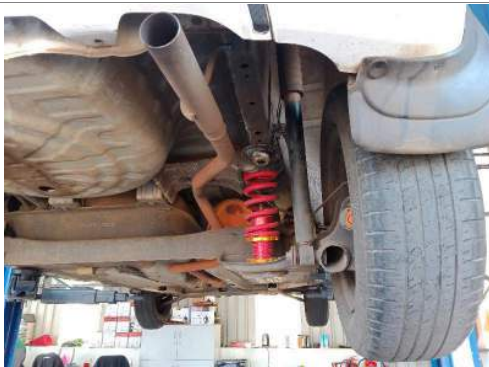
RR TYRE TREAD

| | Size | Load/Speed Index | Manufacture | Model | Type* | Production Date | Tread Depth (mm) |
|---|---|---|---|---|---|---|---|
| Rear Right | 175/65 R14 | 82T | Winrun | R380 | V | 2422 | 0 mm |

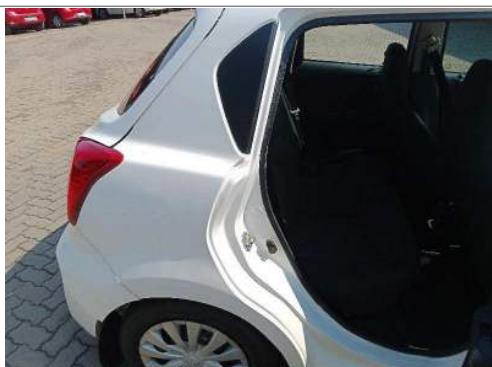
| C • Pillar Right Residual Traces of Repair | Repair |

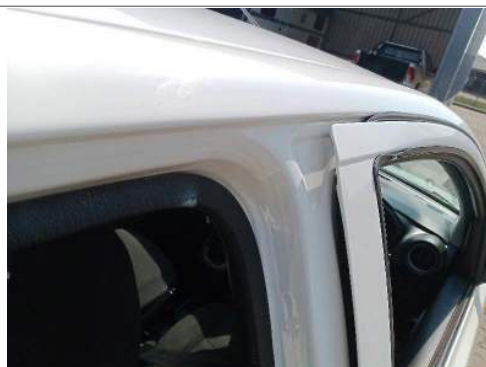
| B • Pillar Right Residual Traces of Repair | Repair |

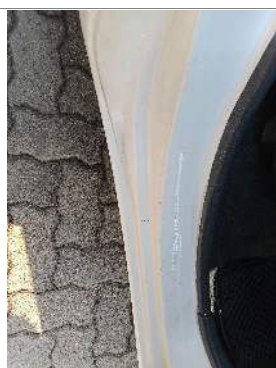
| Sill Panel Right Damaged | Repair |

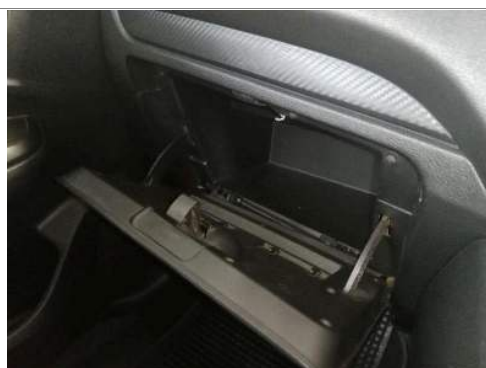
| Center Console / Cubbyhole + Lid Damaged | Repair |

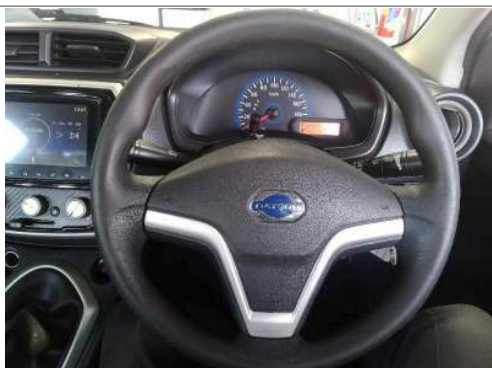
| Steering Wheel Trim Damaged | Replace |

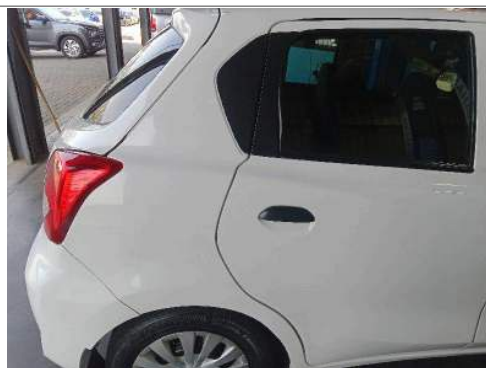
| Rear Fender Right Residual Traces of Repair | Repair |

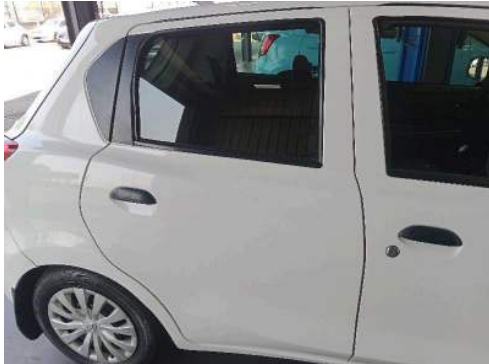
| Door Rear Right Residual Traces of Repair | Repair |

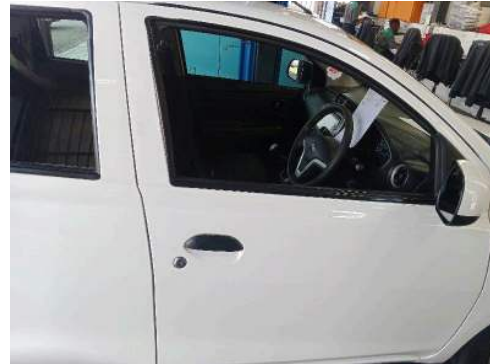
| Door Front Right Residual Traces of Repair | Repair |

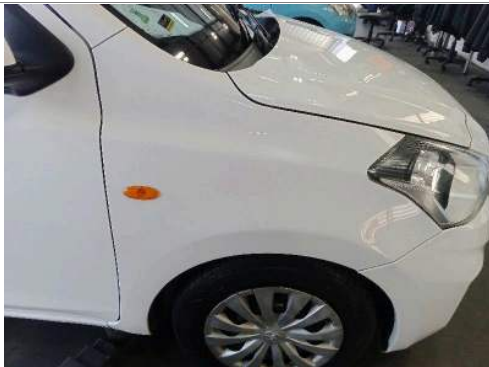
| Front Fender Right Residual Traces of Repair | Repair |

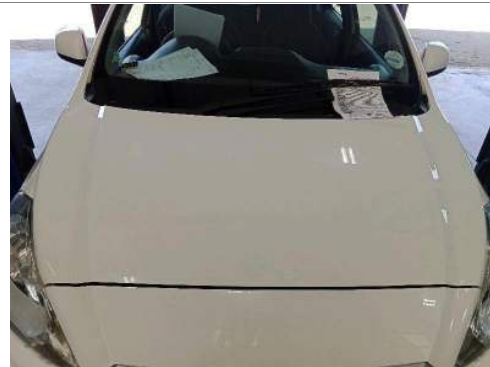
| Bonnet Residual Traces of Repair | Repair |

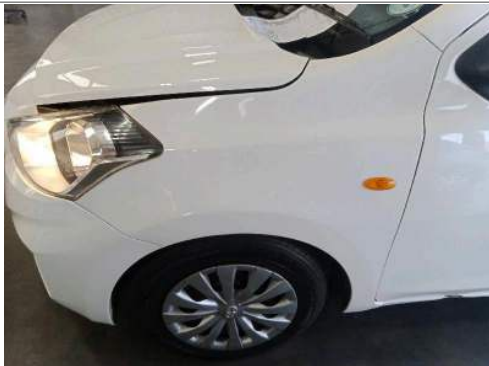
| Front Fender Left Residual Traces of Repair | Repair |

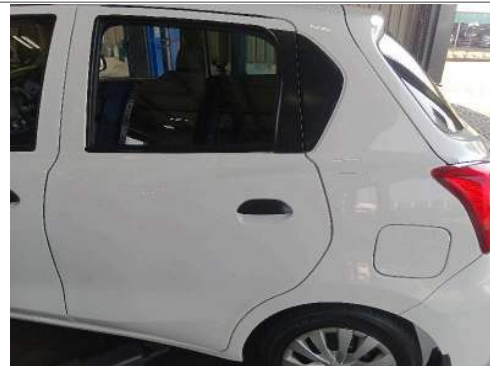
| Rear Fender Left Residual Traces of Repair | Repair |

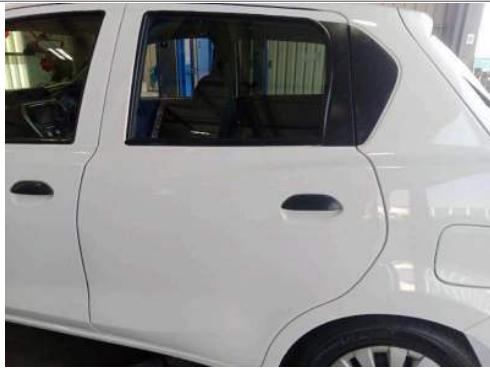
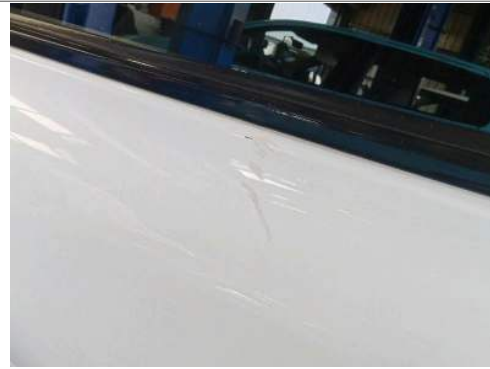
| Door Rear Left Paintwork • Scratched | Repair |

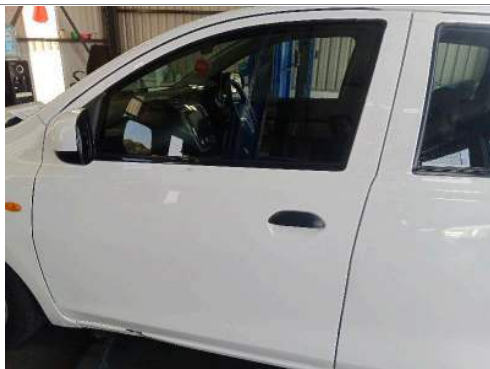
| Door Front Left Residual Traces of Repair | Repair |

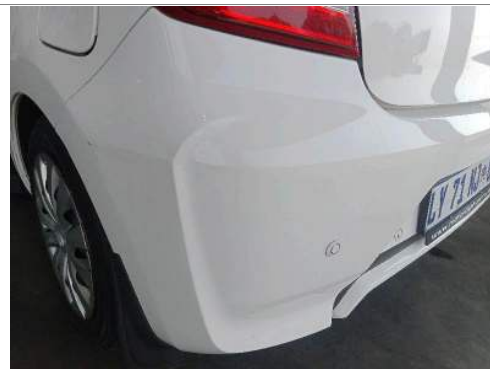
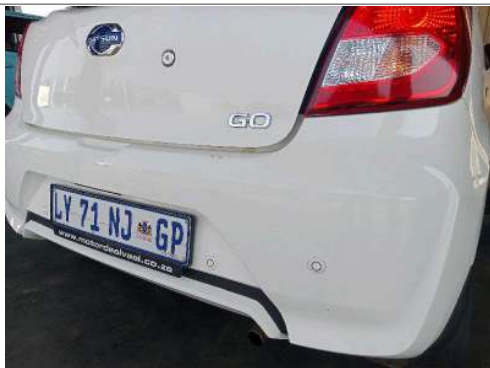
| Rear bumper Paintwork • Scratched | Repair |

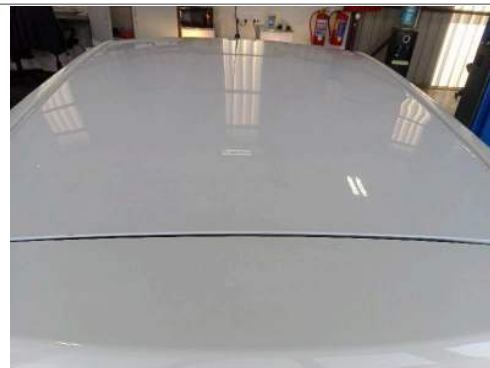
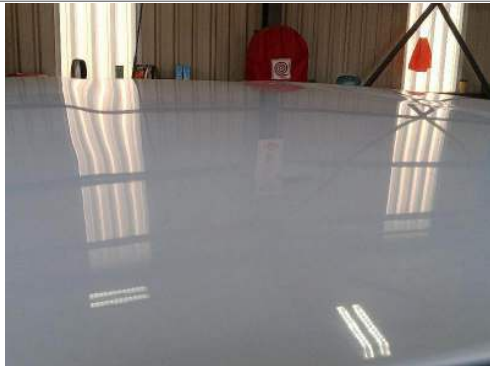
| Roof Dented | Repair |

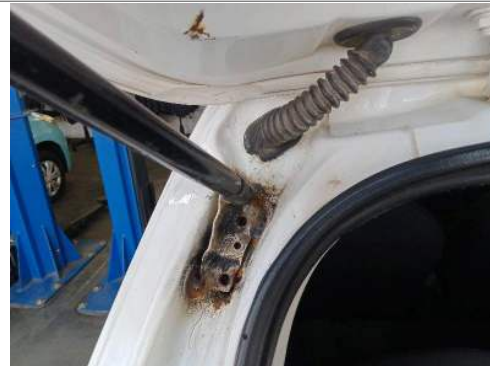
| C • Pillar Left Welded | Repair |

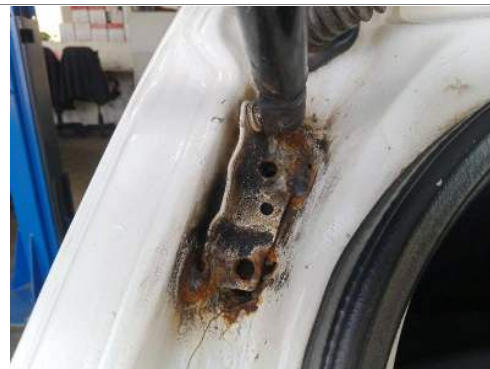
| Boot Lid / Hatch door Hinge Left Welded | Replace |

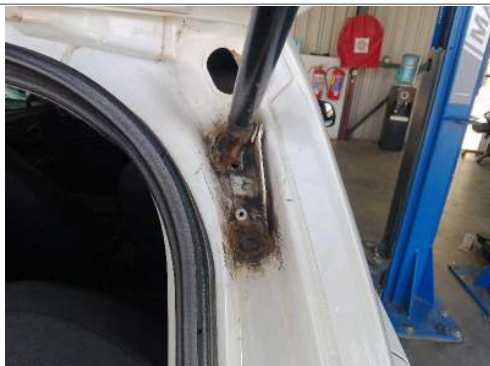
| Boot Lid / Hatch door Hinge Right Welded | Replace |

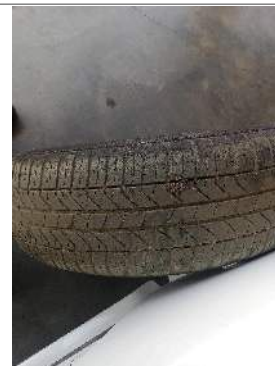
| Spare Tyre Damaged | Replace |

| | Size | Load/Speed Index | Manufacture | Model | Type* | Production Date | Tread Depth (mm) |
|---|---|---|---|---|---|---|---|
| Spare | 175/65 R14 | 82T | Regal | RST-300 | V | 4313 | 1 mm |

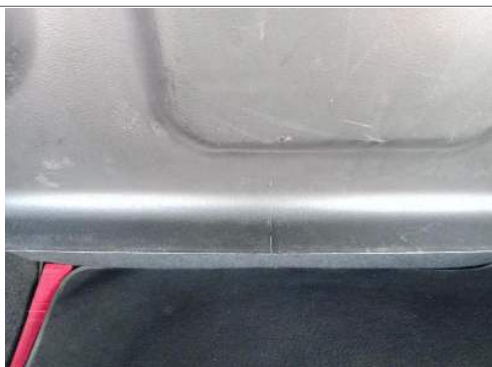
| Parcel Tray Cracked | Repair |

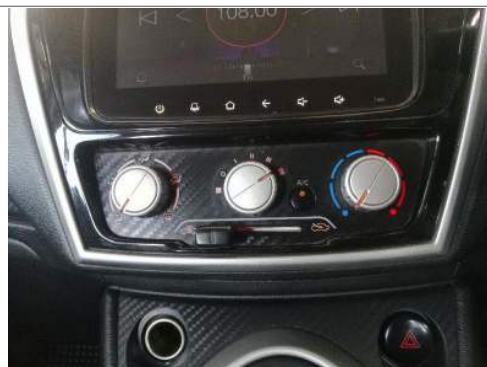
| Air Conditioner Insufficient | Replace |

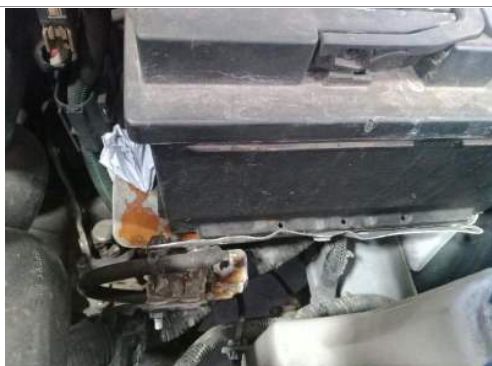
| Battery box Damaged | Repair |

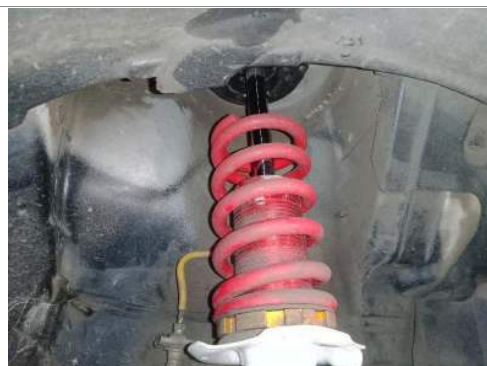
| Spring Front Right Defective | Replace |

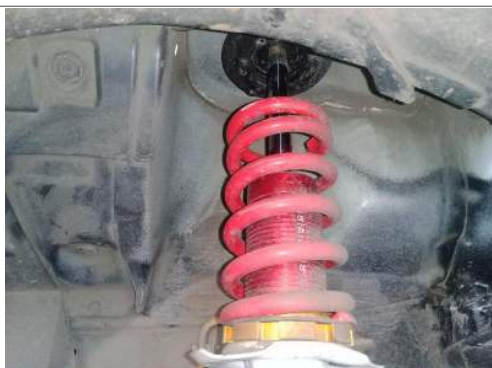
| Spring Front Left Defective | Replace |

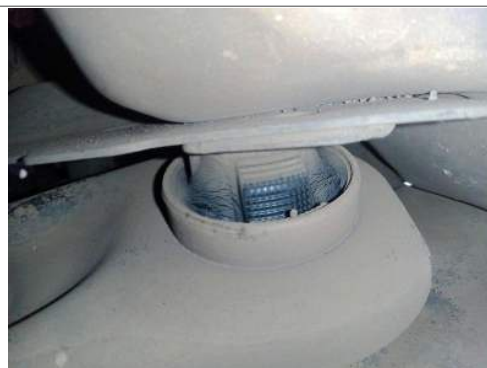
| Control Arm Bush(es) Front Axle Left Cracked | Replace |

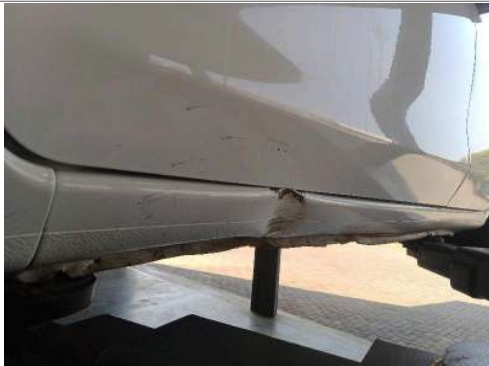
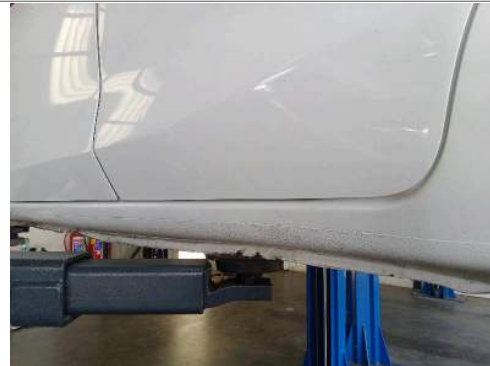
| Sill Panel Left Damaged | Repair |

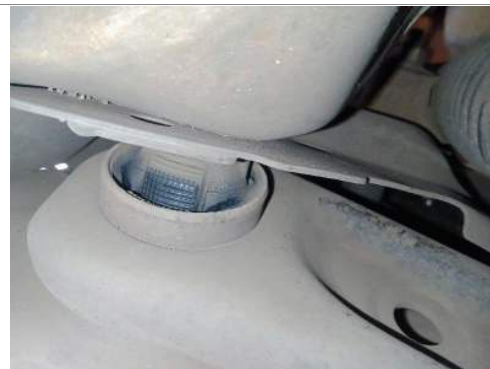
| Control Arm Bush(es) Front Axle Right Cracked | Replace |

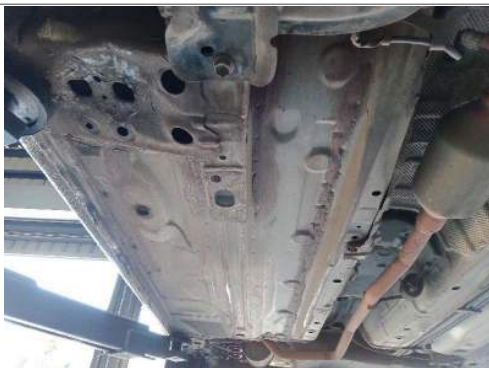
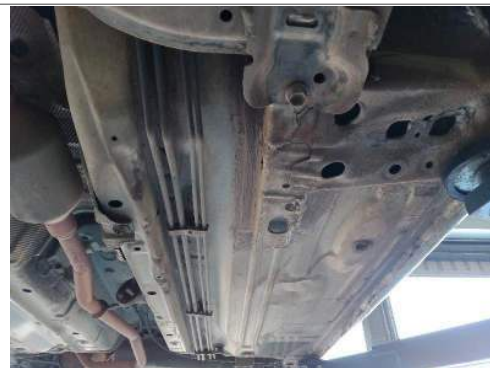
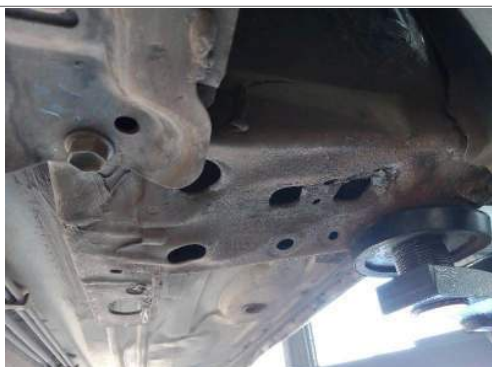
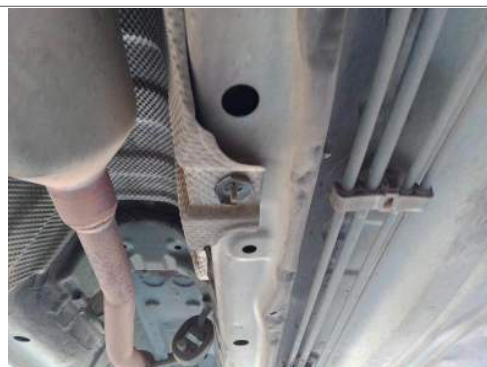
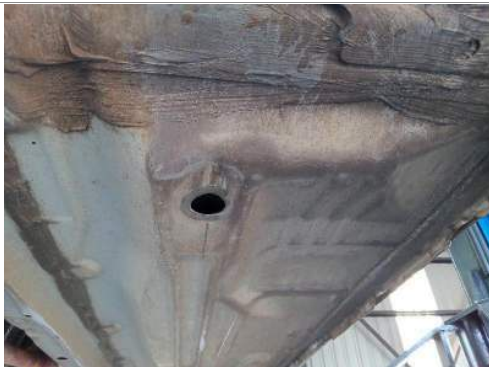
| Chassis Dented | Repair |

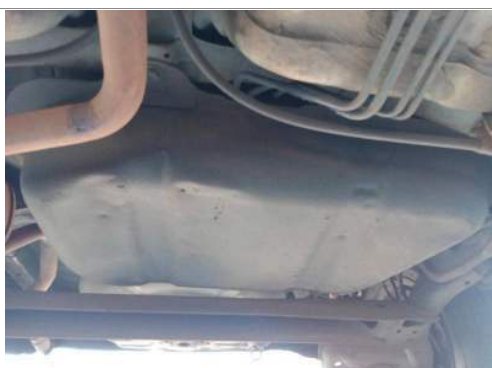
| Fuel Tank Damaged | Replace |

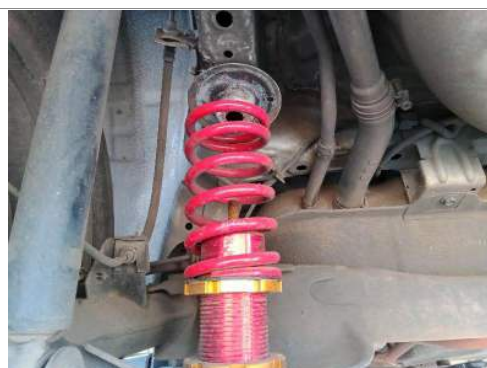
| Spring Rear Left Defective | Replace |

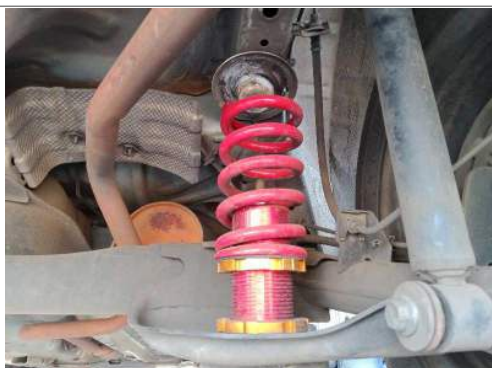
| Spring Rear Right Defective | Replace |

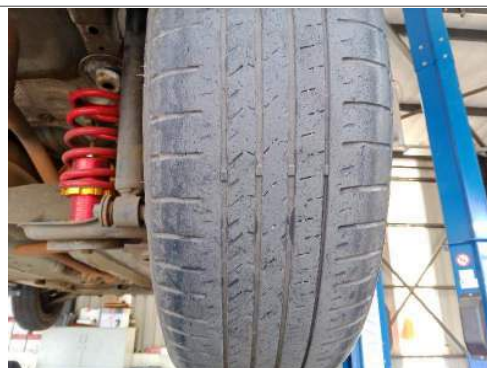
| Tyre Rear Right Damaged | Replace |

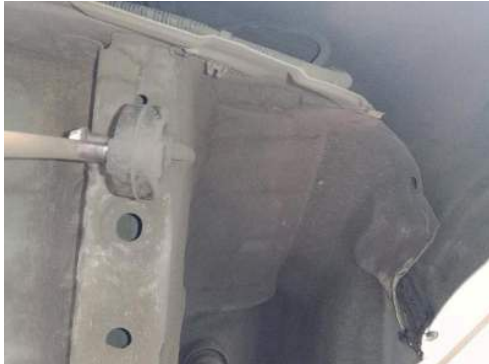
| Rear Fender Right / Inner Tray Damaged | Repair |

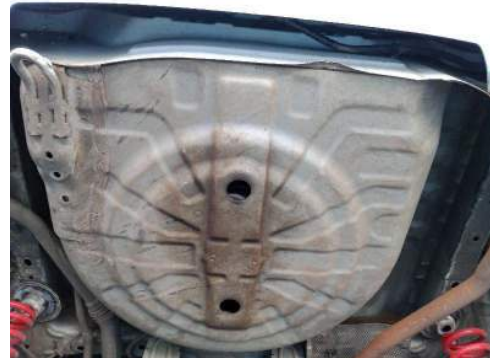
| Inner Boot Floor Pan and Spare Wheel Well Dented | Repair |
