## CONDITION REPORT

Report No:  
2016903310  
DATE  
05/06/2025

Vehicle Type	PASSENGER VEHICLE	Registered Owner	
Manufacturer	DATSON	Registration Number	KHN006MP
Model	GO 1.2 LUX ULC 5-DR [2019-2021]	Register Number	
VIN	MDHZBAA0Z0519290	Date Of First Licensing	
Engine Number		Last COR	
Doors	5	License Expiry Date	30/04/2026
Color	BLUE	Power / Displacement	
Year Model	2021	Paint Finish	TWO COAT UNI
Km Reading	56,122 KM	Fuel	PETROL
Cab / Body Type	HATCHBACK	Transmission	MANUAL

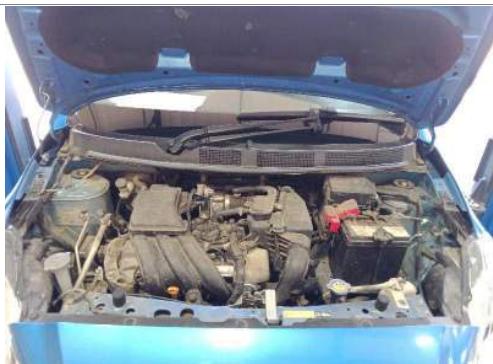
ENGINE 1

Damage	Repair Way
Seat Front Right Damaged	Repair
Parcel Tray Damaged	Repair
Steering Wheel Trim Defective	Repair
Front Bumper Paintwork • Scratched	Repair
Front Fender Right Damaged	Repair
Rear Fender Left Paintwork • Scratched	Repair
Rear Fender Right Paintwork • Scratched	Repair
Door Front Left Paintwork • Scratched	Repair
Door Front Right Dented	Repair
Door Rear Left Paintwork • Scratched	Repair
Boot Lid / Hatch door Paintwork • Scratched	Repair
Rear bumper Paintwork • Scratched	Repair
Tyre Front Left Damaged	Replace
Spare Tyre Damaged	Replace
Chassis Dented	Repair
Brakes	Front L/R brake pipes strapped with cable ties
Body and Exterior	Dents and scratches on some body panels
Tyres and rims	Front left and right tyre sizes different
Engine	Engine bay dirty.

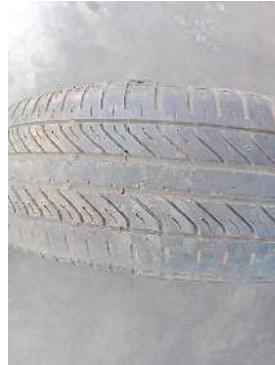
Spare Tyre

Size	Load/Speed Index	Manufacture	Model	Type*	Production Date	Tread Depth (mm)
Front Left	175/65 R14	82T	Sava	Effecta	V	0623	4 mm
Front Right	165/70 R14	81T	Apollo	Amazer	V	1121	5 mm
Rear Left	175/65 R14	82T	Sava	Effecta	V	0623	6 mm
Rear Right	175/65 R14	82T	Sava	Effecta	V	0623	5 mm
Spare	185/60 R14	82H	Dunlop	Sp-Sport	V	2121	0 mm
