## CONDITION REPORT

Report No:  
2016998625  
DATE  
01/09/2025

| Manufacturer | RENAULT | Registration Number | KC03KRGP |
| Model | KWID | Register Number | |

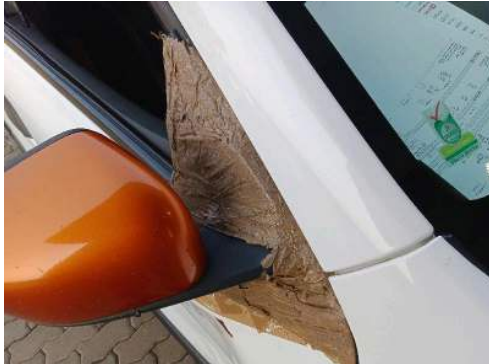
| Side Mirror Right Damaged | Replace |

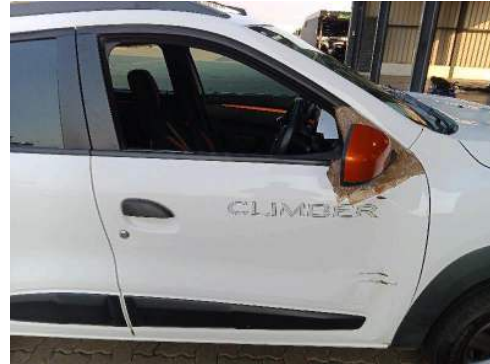
| Door Front Right Damaged | Repair |

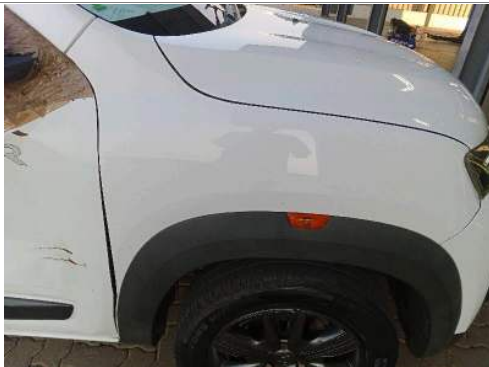
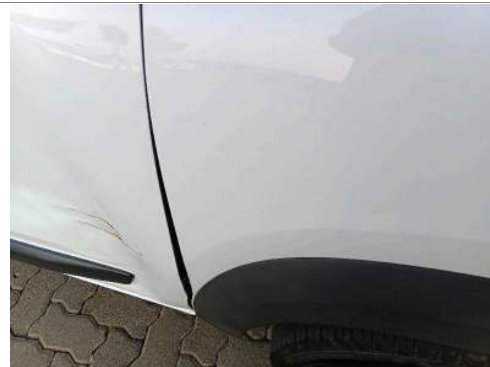
| Front Fender Right Dented | Repair |

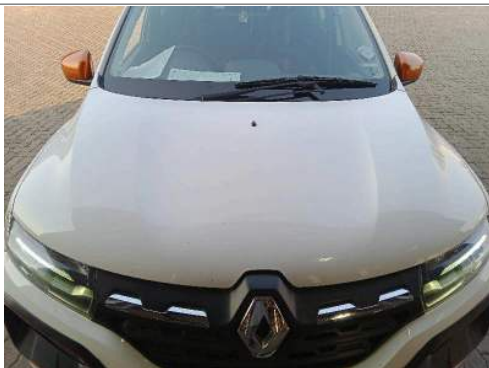
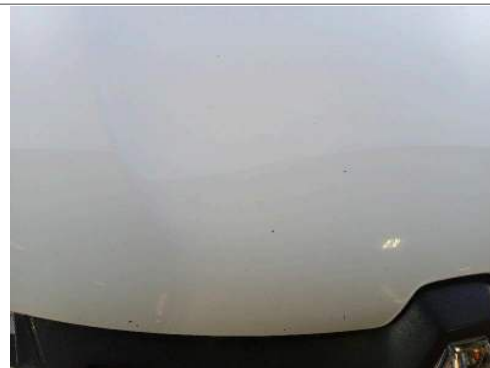
| Bonnet Paintwork • Chipmarks | Repair |

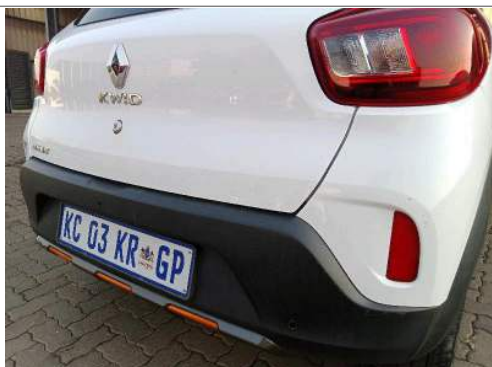
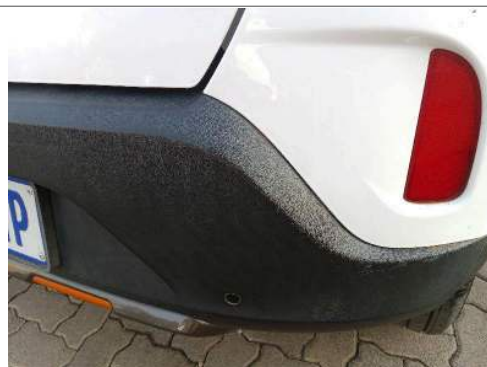
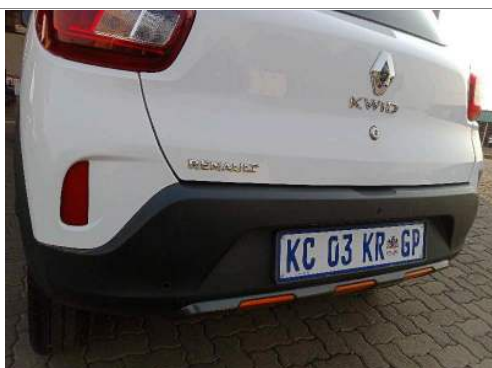
| Rear bumper Paintwork • Scratched | Repair |

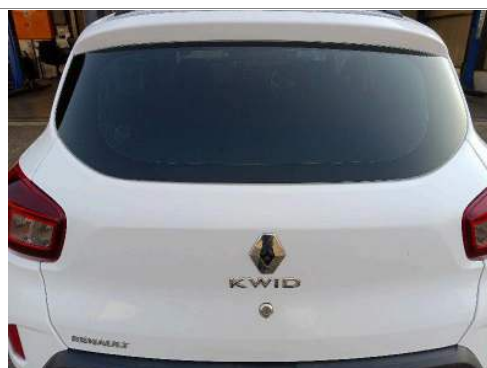
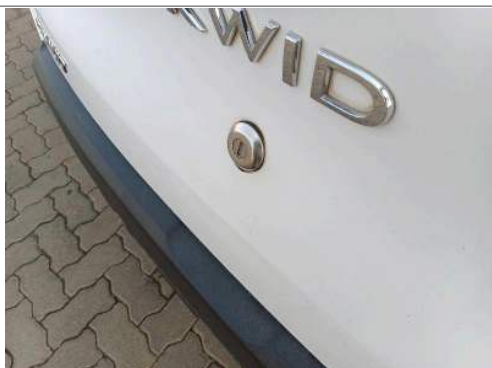
| Boot Lid / Hatch door Dented | Repair |

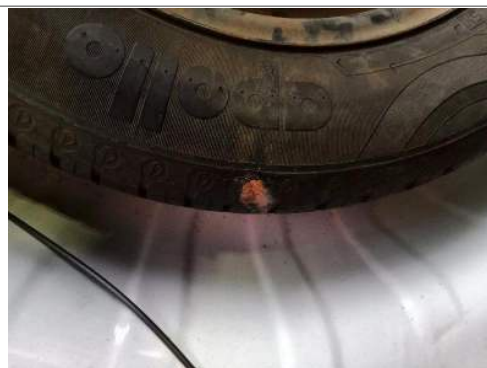
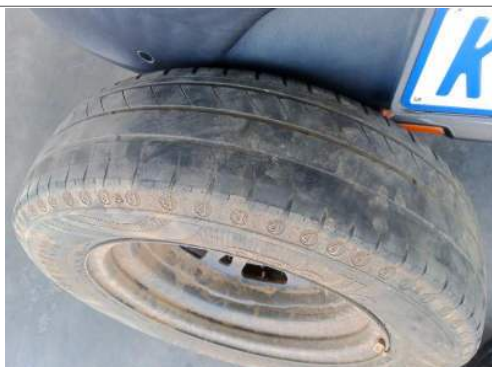
| Spare Tyre Damaged | Replace |

| | Size | Load/Speed Index | Manufacture | Model | Type* | Production Date | Tread Depth (mm) |
|---|---|---|---|---|---|---|---|
| Spare | 165/70 R14 | 81T | Apollo | Amazer | V | 0621 | 0 mm |

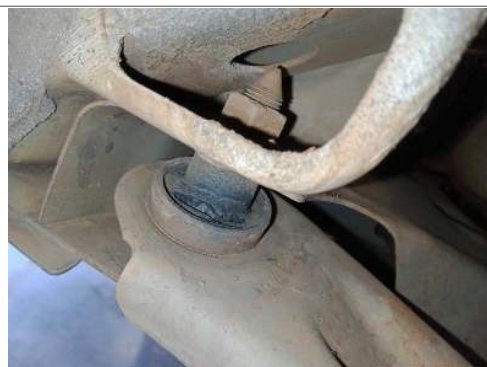
| Control Arm Bush(es) Front Axle Right Damaged | Replace |

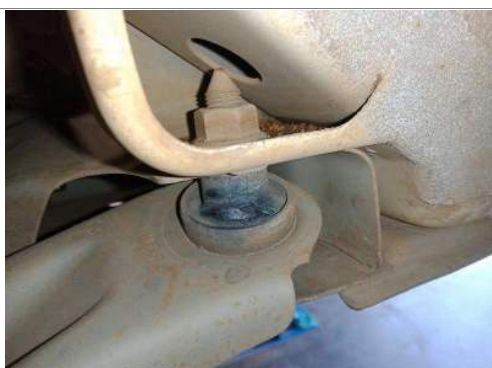
| Control Arm Bush(es) Front Axle Left Damaged | Replace |

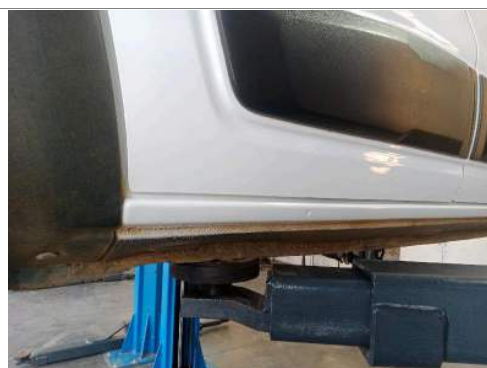
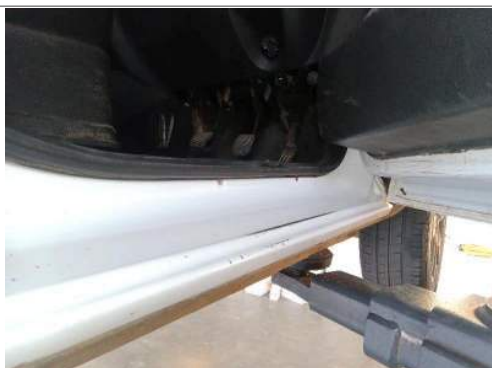
| Sill Panel Right Damaged | Repair |

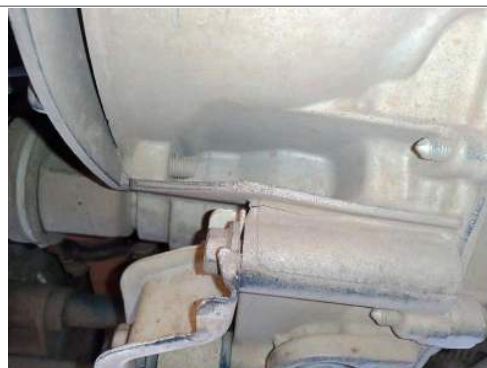
| Gearbox Damaged | Repair |

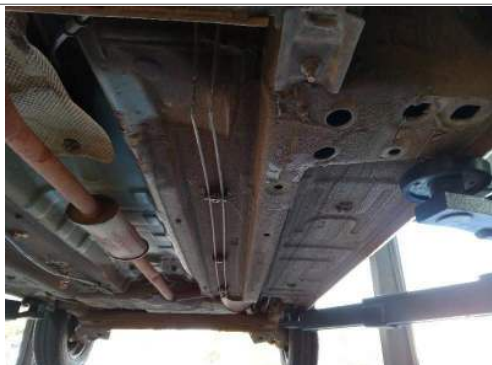
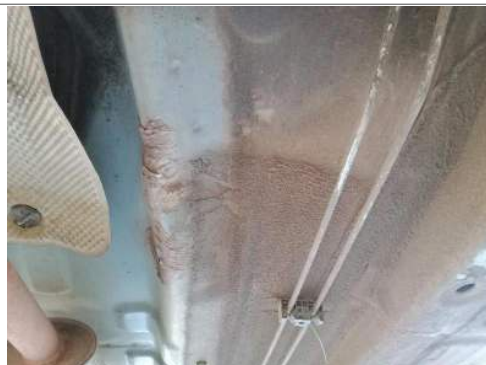
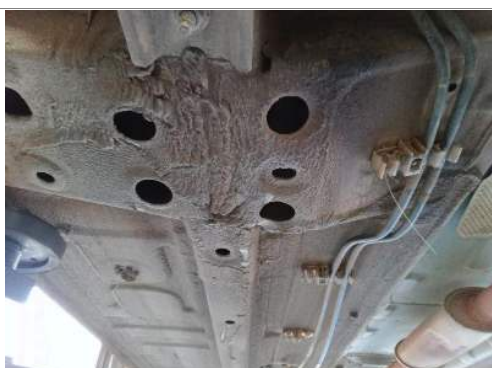
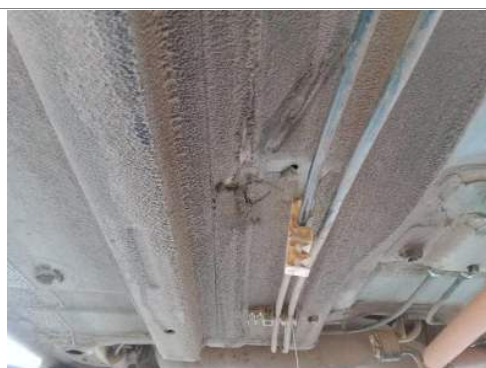
| Chassis Damaged | Repair |

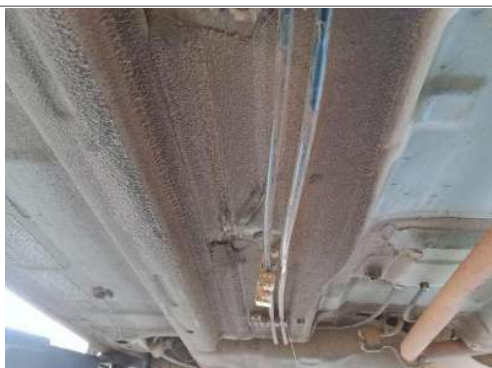
| Fuel Lines Defective | Repair |

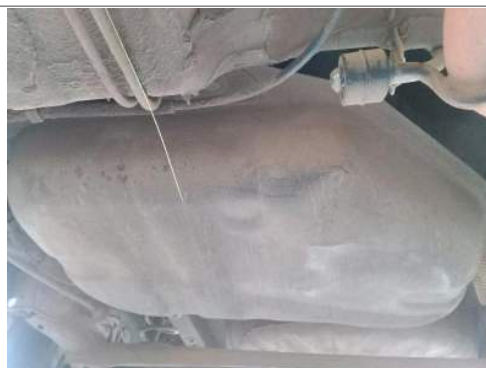
| Fuel Tank Damaged | Repair |

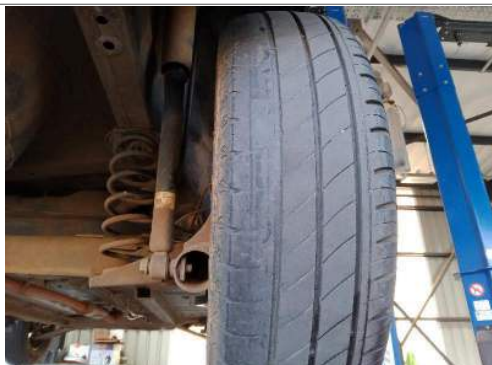
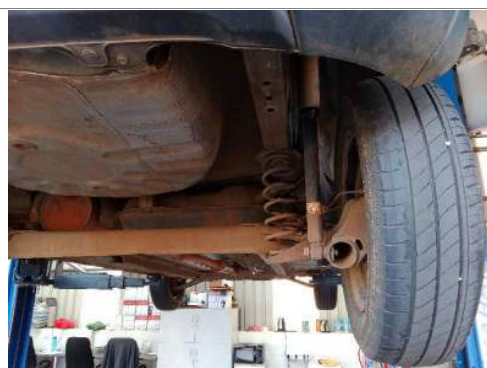
| Tyre Rear Right Worn | Replace |

| | Size | Load/Speed Index | Manufacture | Model | Type* | Production Date | Tread Depth (mm) |
|---|---|---|---|---|---|---|---|
| Rear Right | 165/70 R14 | 81T | Apollo | Amazer | V | 0621 | 0 mm |

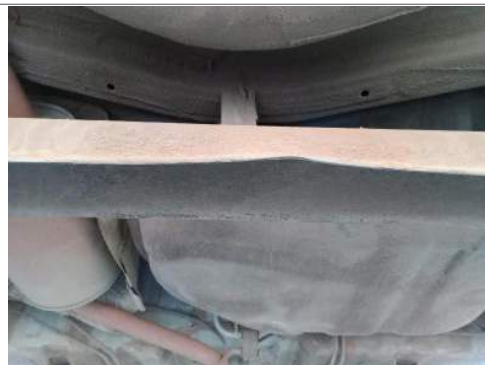
| Rear Axle Damaged | Repair |

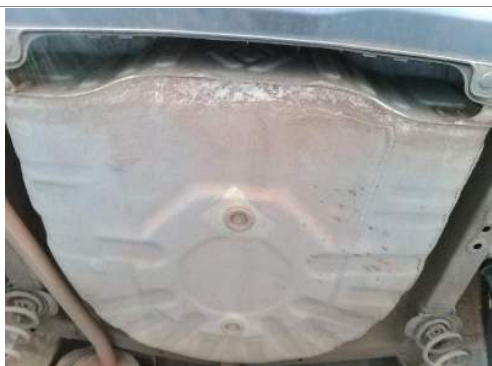
| Inner Boot Floor Pan and Spare Wheel Well Dented | Repair |

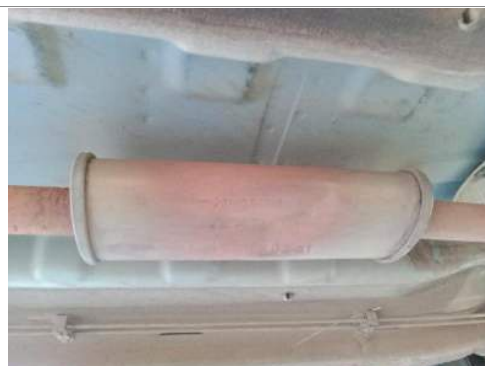
| Silencer Damaged | Repair |

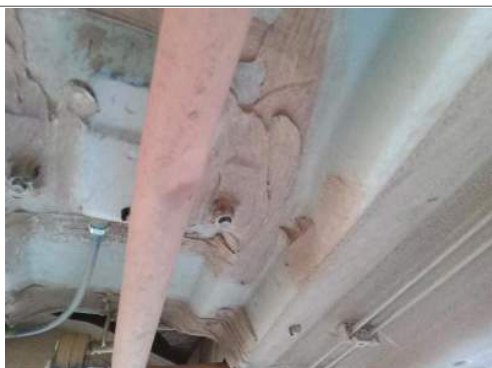
| Engine to silencer pipe Damaged | Repair |
