MFC Auction House  
M57 Pretoria Rd, Glenmarais, KEMPTON PARK  
Gauteng

| Manufacturer | RENAULT | Registration Number | JK22WGGP |

## CONDITION REPORT

Report No: 2016762833

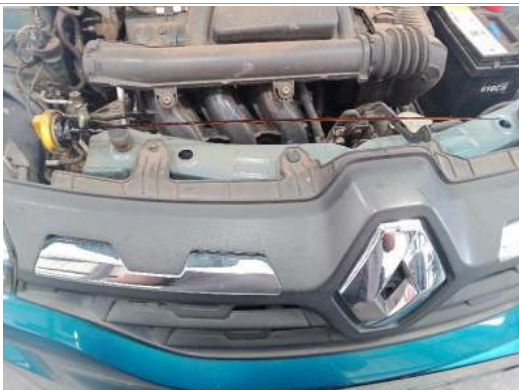
Oil cap and dipstick

| Damage | Repair Way |
|---|---|
| Sludge on oil cap | Repair |

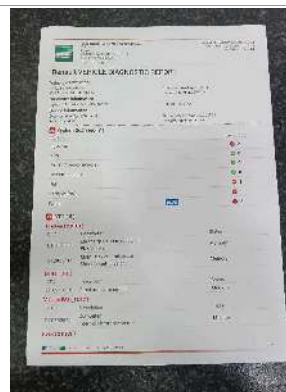
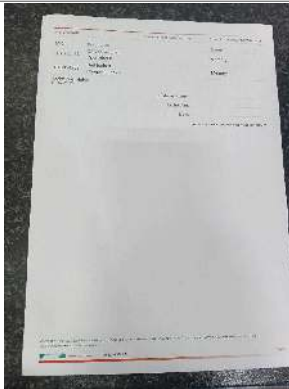
DIAGNOSTIC REPORT PAGE 1

| No | System | Code | Description | Status |
|---|---|---|---|---|
| 1 | MEMORY | DTC033564 | ENGINE SPEED SENSOR SIGNAL PLAUSIBLY | |

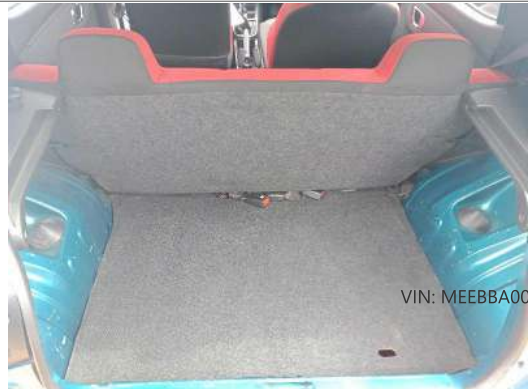
| Damage | Repair Way |
|---|---|
| Parcel Tray Missing | Replace |

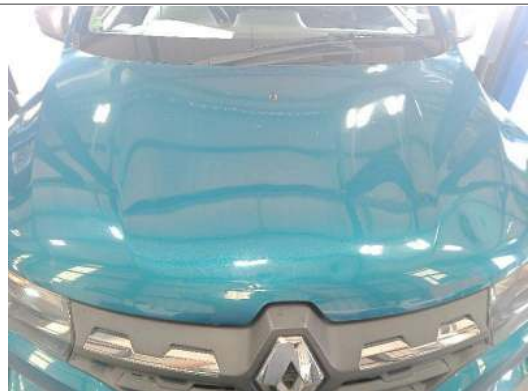
| Damage | Repair Way |
|---|---|
| Bonnet Dented | Repair |

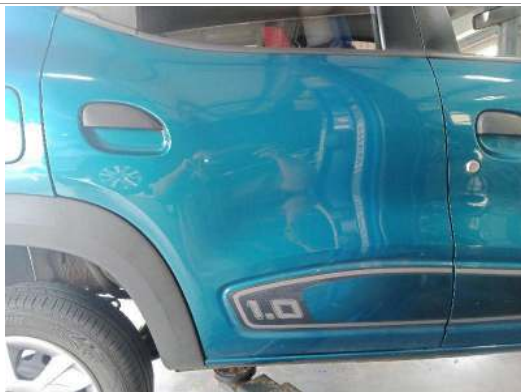
| Damage | Repair Way |
|---|---|
| Door Rear Right Paintwork • Scratched | Repair |

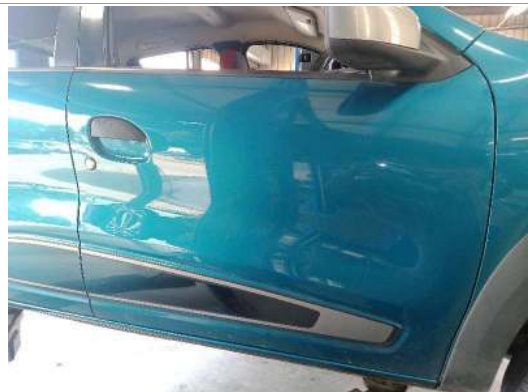
| Damage | Repair Way |
|---|---|
| Door Front Right Dented | Repair |

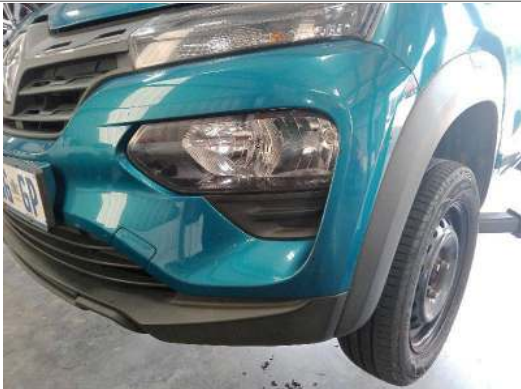
| Damage | Repair Way |
|---|---|
| Front Bumper Paintwork • Scratched | Repair |

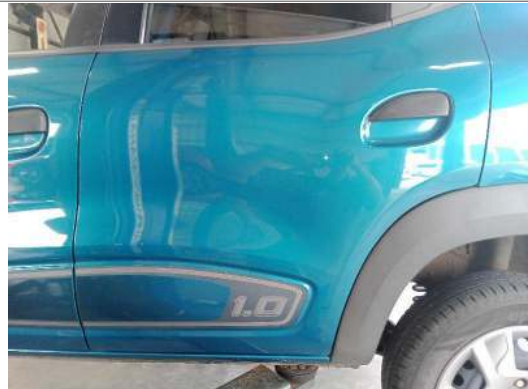
| Damage | Repair Way |
|---|---|
| Door Rear Left Dented | Repair |

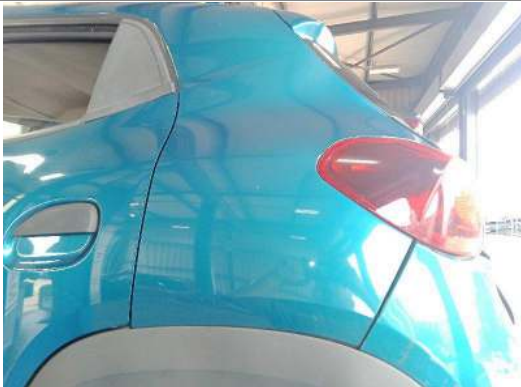
| Damage | Repair Way |
|---|---|
| Rear Fender Left Dented | Repair |

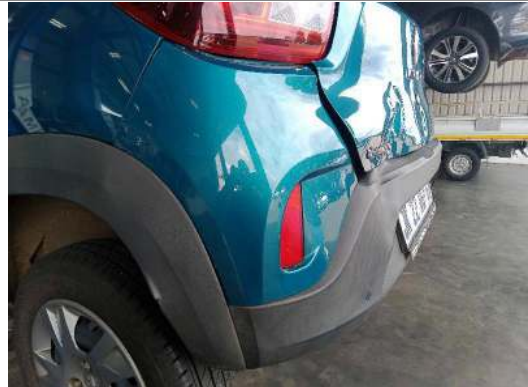
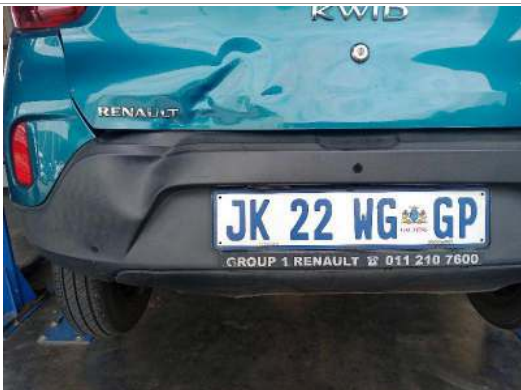
| Damage | Repair Way |
|---|---|
| Rear bumper Dented | Repair |

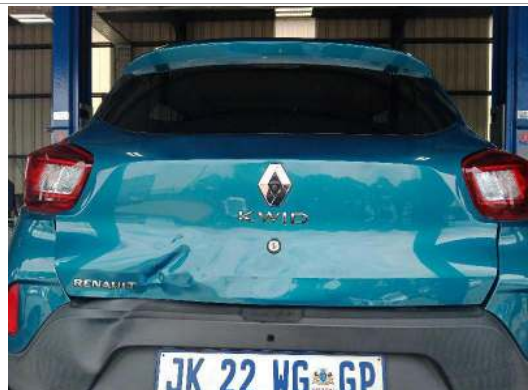
| Damage | Repair Way |
|---|---|
| Boot Lid / Hatch door Dented | Repair |
| Boot not closing properly | Repair |

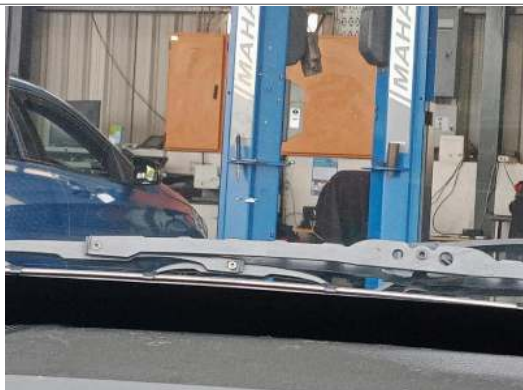
| Damage | Repair Way |
|---|---|
| Windscreen Chipped | Repair |

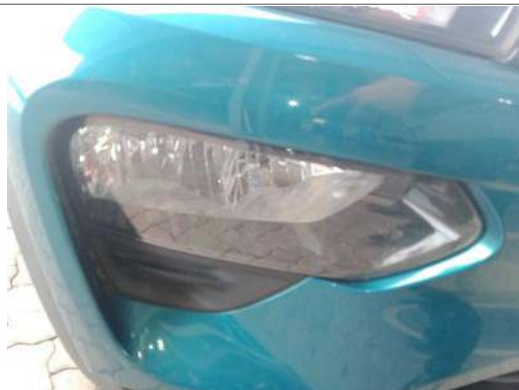
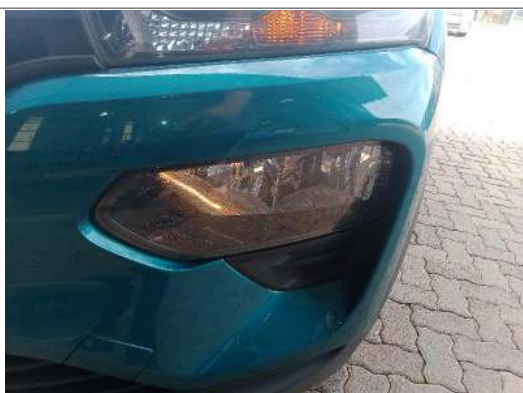
| Damage | Repair Way |
|---|---|
| Dim and Bright Indicator Light Malfunction | Repair |
