MFC Auction House  
M57 Pretoria Rd, Glenmarais, KEMPTON PARK  
Gauteng

| Manufacturer | RENAULT | Registration Number | JS14GDGP |

## CONDITION REPORT

Report No: 2016350585

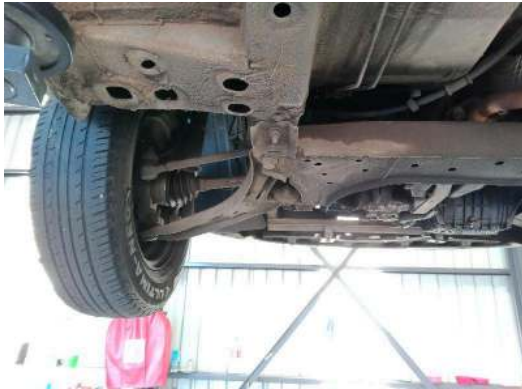
LF TYRE TREAD

| | Size | Load/Speed Index | Manufacture | Model | Type* | Production Date | Tread Depth (mm) |
|---|---|---|---|---|---|---|---|
| Front Left | 155/80R13 | 79T | JKTyre | Radial | V | 1417 | 1 mm |

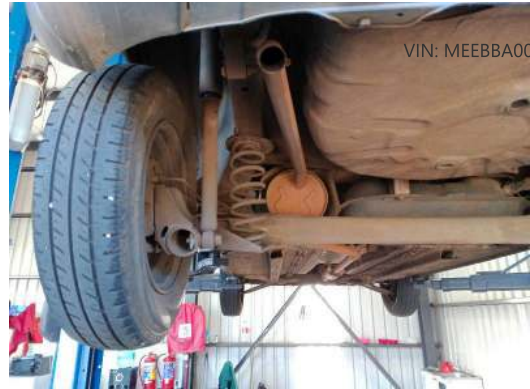
LR TYRE TREAD

| | Size | Load/Speed Index | Manufacture | Model | Type* | Production Date | Tread Depth (mm) |
|---|---|---|---|---|---|---|---|
| Rear Left | 155/80R13 | 79T | Ceat | Radial | V | 4718 | 3 mm |

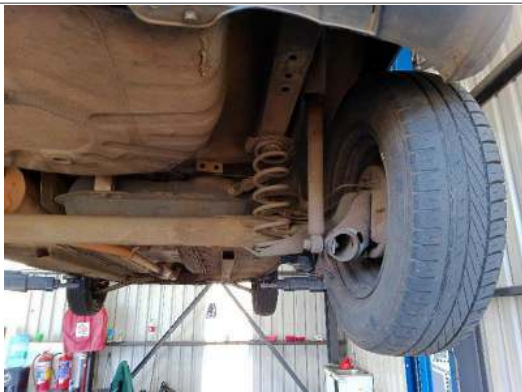
RR TYRE TREAD

| | Size | Load/Speed Index | Manufacture | Model | Type* | Production Date | Tread Depth (mm) |
|---|---|---|---|---|---|---|---|
| Rear Right | 165/80R13 | 83T | Goodyear | Duragrip | V | 2915 | 1 mm |

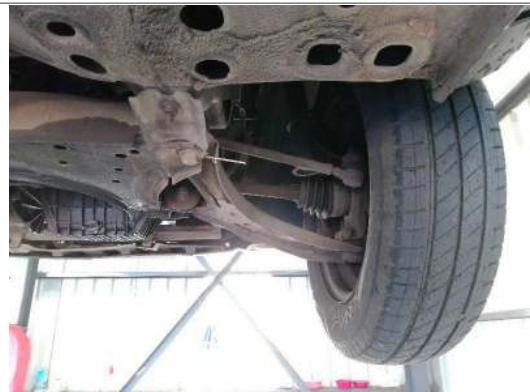
RF TYRE TREAD

| | Size | Load/Speed Index | Manufacture | Model | Type* | Production Date | Tread Depth (mm) |
|---|---|---|---|---|---|---|---|
| Front Right | 165/70R14 | 81T | Apollo | Radial | V | 1020 | 1 mm |

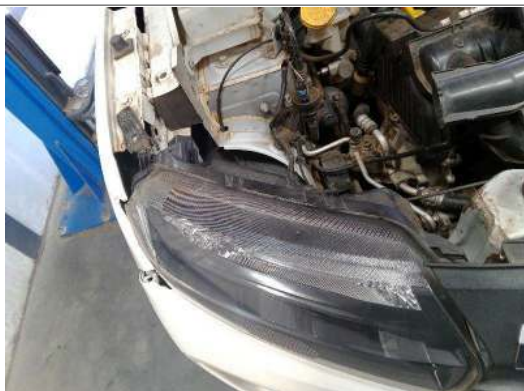
| Damage | Repair Way |
|---|---|
| Headlight Right Damaged | Replace |

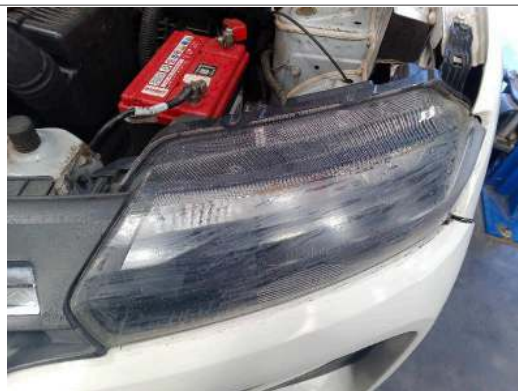
| Damage | Repair Way |
|---|---|
| Headlight Left Defective | Repair |

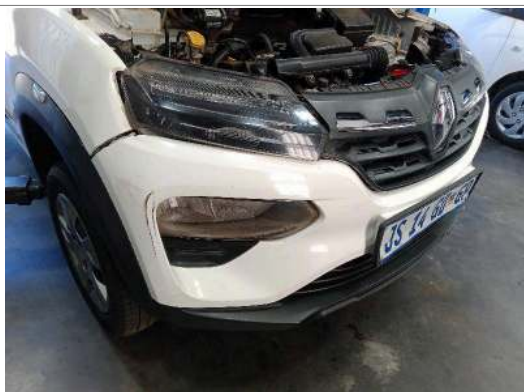
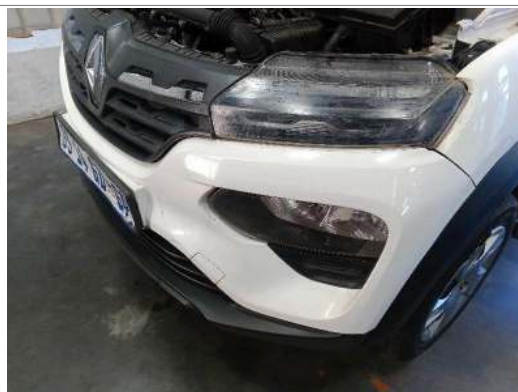
| Damage | Repair Way |
|---|---|
| Front Bumper Damaged | Repair |

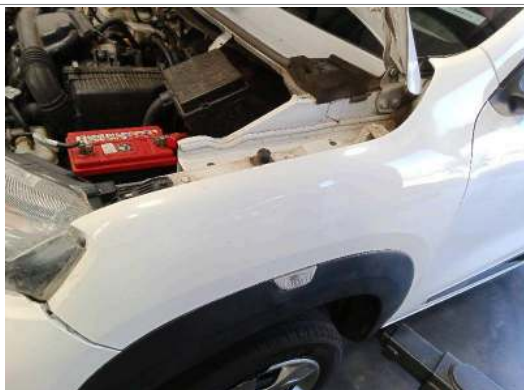
| Damage | Repair Way |
|---|---|
| Front Fender Left Damaged | Repair |

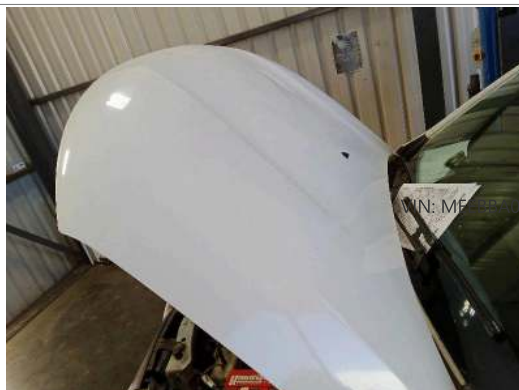
| Damage | Repair Way |
|---|---|
| Bonnet Damaged | Repair |

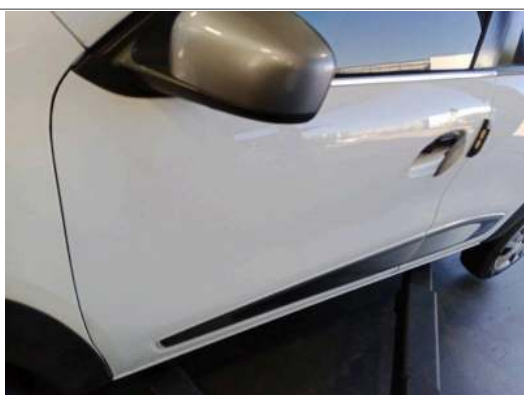
| Damage | Repair Way |
|---|---|
| Door Front Left Damaged | Repair |

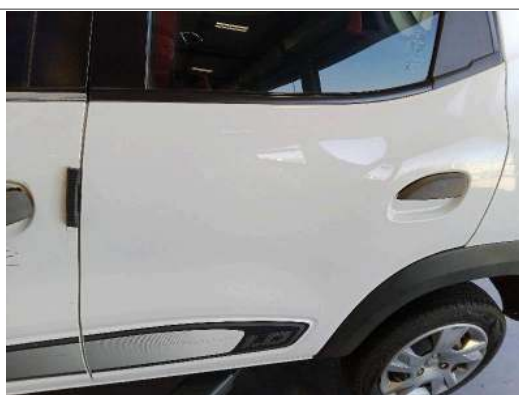
| Damage | Repair Way |
|---|---|
| Door Rear Left Damaged | Repair |

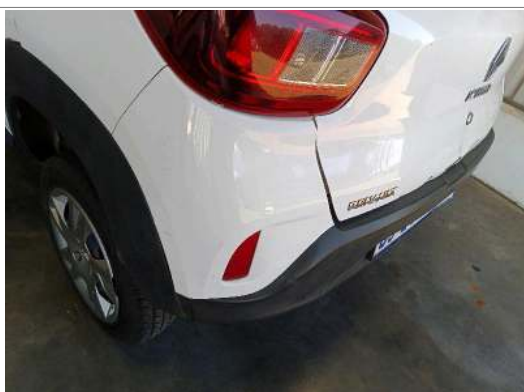
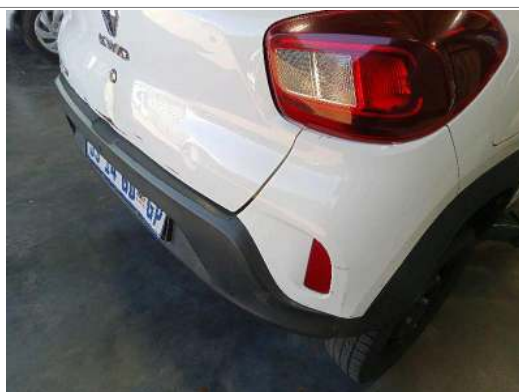
| Damage | Repair Way |
|---|---|
| Rear bumper Damaged | Repair |

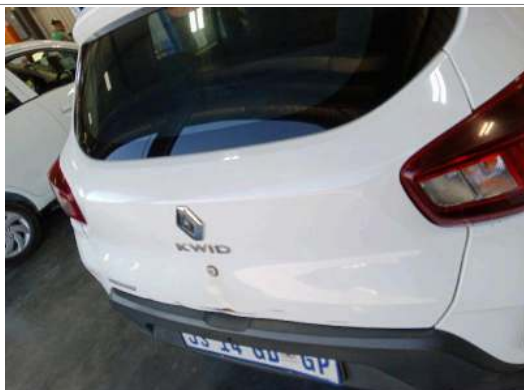
| Damage | Repair Way |
|---|---|
| Boot Lid / Hatch door Damaged | Repair |

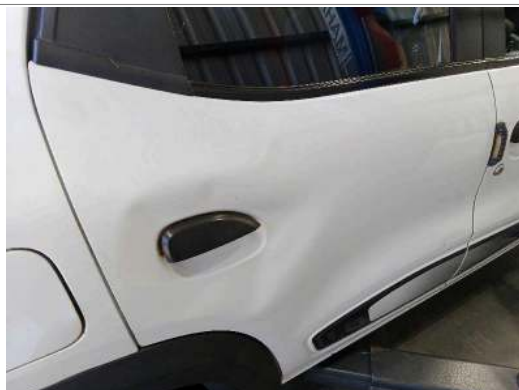
| Damage | Repair Way |
|---|---|
| Door Rear Right Damaged | Repair |

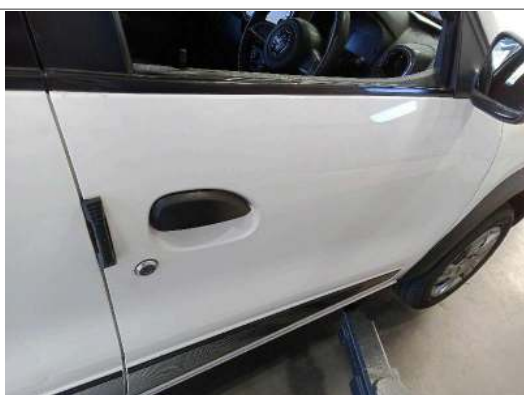
| Damage | Repair Way |
|---|---|
| Door Front Right Damaged | Repair |

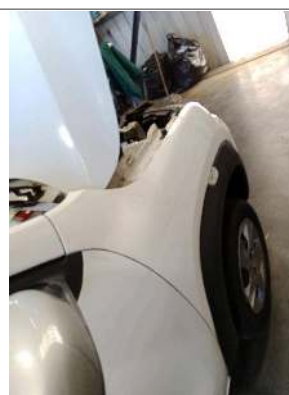
| Damage | Repair Way |
|---|---|
| Front Fender Right Damaged | Repair |

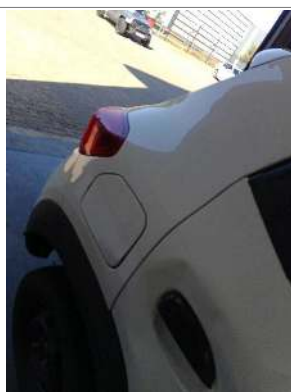
| Damage | Repair Way |
|---|---|
| Rear Fender Right Damaged | Repair |

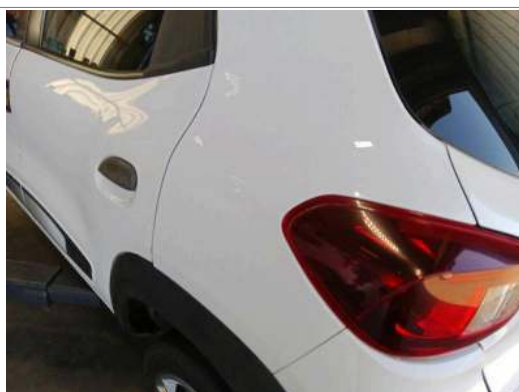
| Damage | Repair Way |
|---|---|
| Rear Fender Left Damaged | Repair |

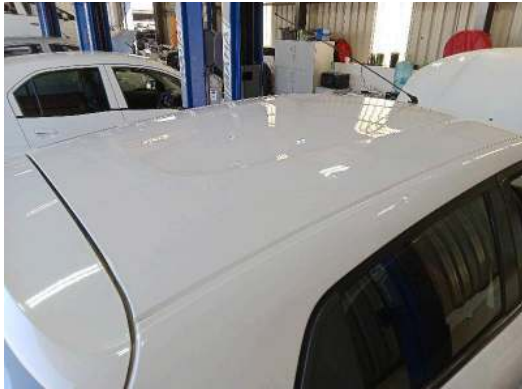
| Damage | Repair Way |
|---|---|
| Roof Damaged | Repair |

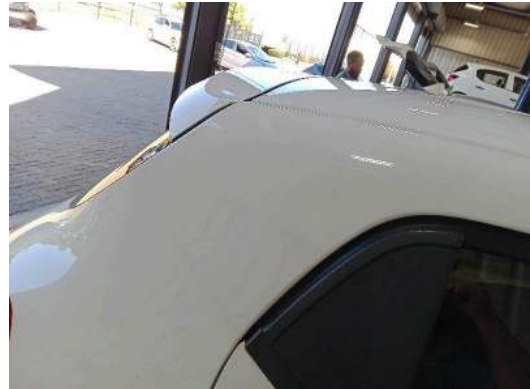
| Damage | Repair Way |
|---|---|
| C • Pillar Right Damaged | Repair |

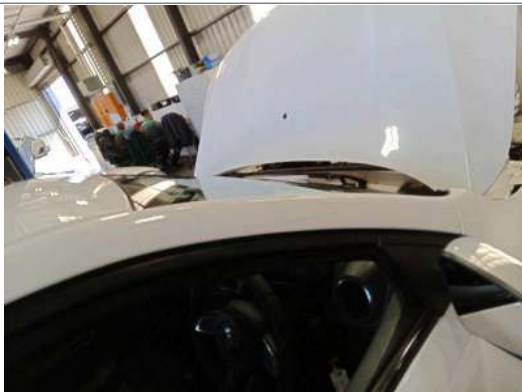
| Damage | Repair Way |
|---|---|
| B • Pillar Right Damaged | Repair |

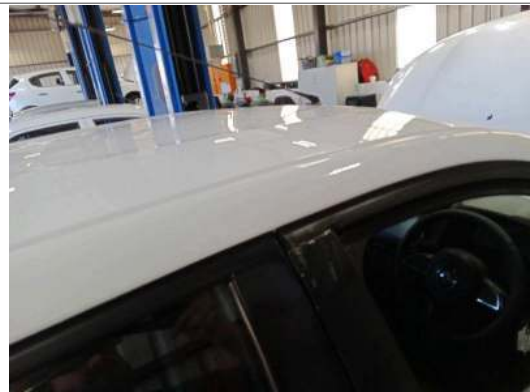
| Damage | Repair Way |
|---|---|
| A • Pillar Right Damaged | Repair |

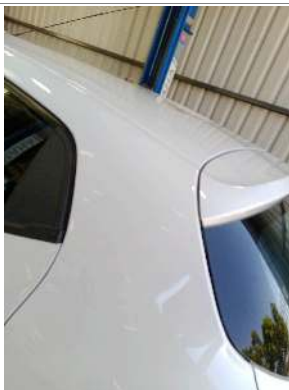
| Damage | Repair Way |
|---|---|
| C • Pillar Left Damaged | Repair |

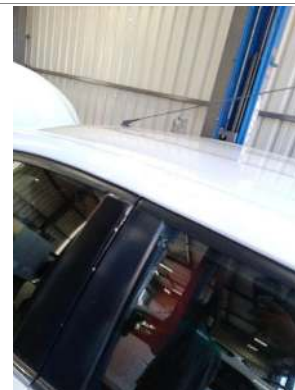
| Damage | Repair Way |
|---|---|
| B • Pillar Left Damaged | Repair |

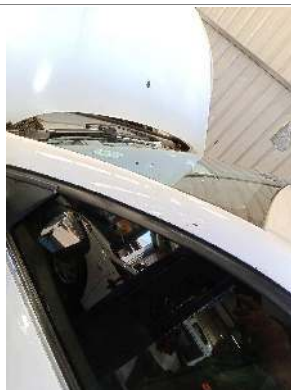
| Damage | Repair Way |
|---|---|
| A • Pillar Left Damaged | Repair |

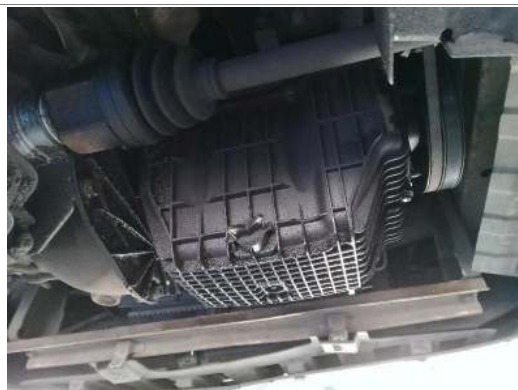
| Damage | Repair Way |
|---|---|
| Engine Oil Leak | Repair |

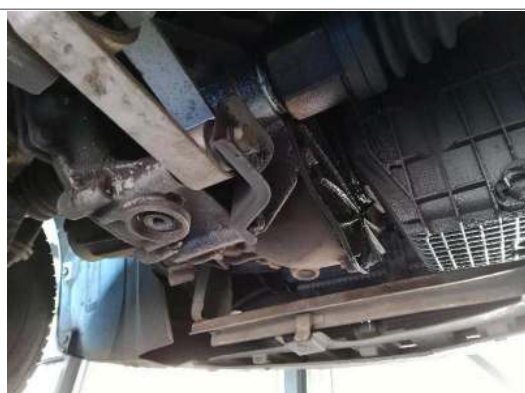
| Damage | Repair Way |
|---|---|
| Gearbox Oil Leak | Repair |
