MFC Auction House
M57 Pretoria Rd, Glenmarais, KEMPTON PARK
Gauteng

DEKRA MFC
M57 Pretoria Rd - 1619
KEMPTON PARK - GT
08610 33572

VEHICLE INSPECTION

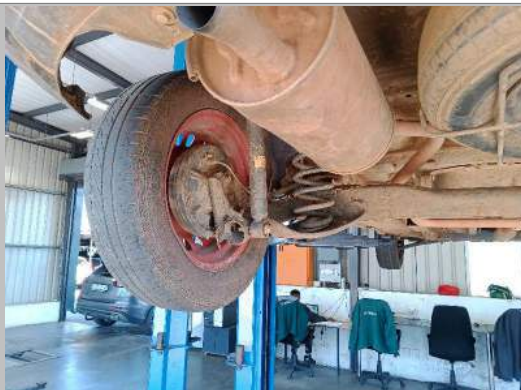
LR TYRE TREAD

Size	Load/Speed Index	Manufacture	Model	Type*	Production Date	Tread Depth (mm)
Front Left	185/60R14	82H	Dayton	Journey	V	3918	1 mm
Front Right	165/70R14	81T	Apollo	Amazer	V	3621	1 mm
Rear Left	165/70R14	81T	Goodyear	Duragrip	V	3509	2 mm
Rear Right	165/80R14	85T	Ceat	Fuel smart	V	3022	2 mm
Spare	165/80R14	85T	Ceat	Fuel smart	V	////	2 mm

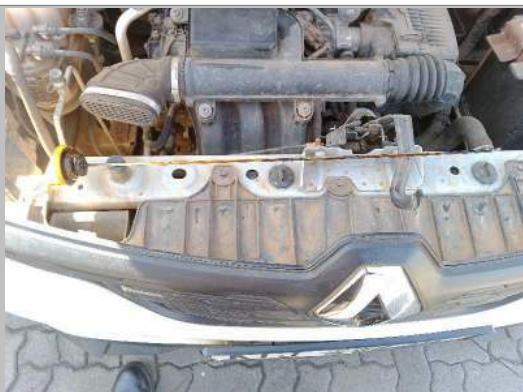
Oil cap and dipstick

Damage	Repair Way
Switch Electrical Window Winder front right Malfunction	Repair
Dim Light Left Malfunction	Repair
Dim Light Right Malfunction	Repair
Bonnet Dented	Repair
Front Fender Left Dented	Repair
Front Fender Right Dented	Repair
Rear Fender Left Paintwork • Scratched	Repair
Door Front Left Damaged	Replace
Door Front Right Paintwork • Scratched	Repair
Door Rear Left Paintwork • Scratched	Repair
Door Rear Right Paintwork • Scratched	Repair
Rear bumper Paintwork • Scratched	Repair
Roof Corrosion	Repair
Windscreen Chipped	Repair
Window Front Door Left Damaged	Replace
Brake disc 1. Axle right Corrosion	Replace
Tyre Rear Right Defective	Repair
Oil slugged on oil cap	Repair
L/F fender liner damage	Replace
