CONDITION REPORT

Report No: 2016312367

DATE  
20/03/2024

Vehicle Type	PASSENGER VEHICLE	Registered Owner	MFC AUCTION HOUSE
Manufacturer	TOYOTA	Registration Number	KP64VBGP
Model	AVANZA	Register Number	
VIN	MHKM5FB2N0K002339	Date Of First Licensing	
Engine Number		Last COR	
Doors	5	License Expiry Date	20/03/2024
Color	GOLDEN	Power / Displacement	
Year Model		Paint Finish	M - METALLIC
Km Reading	134,969 KM	Fuel	PETROL
Cab / Body Type	HATCHBACK	Transmission	MANUAL

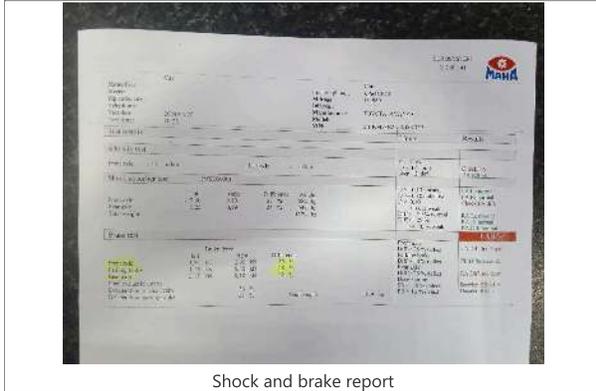
Service Brake Performance Front Axle Left / Right	Repair
Difference out of legal range

Damage	Repair Way
Service Brake Performance Rear Axle Left / Right Difference out of legal range	Repair
Parking Brake Performance Left / Right Difference out of legal range	Repair
Shock Absorber Rear Left Leak	Replace
Shock Absorber Rear Right Leak	Replace
Control Arm Bush(es) Front Axle Left Cracked	Replace
Control Arm Bush(es) Front Axle Right Cracked	Replace
Rim Front Right Damaged	Repair
Radiator Cradle Damaged	Replace
Body exterior.	Residual traces of poor repair work done on all b
Body exterior.	Minor dents scratches and stone chips on some bod.
Body exterior.	Signs of spray work done on all body panels.
Bottom of engine is fully covered	Body exterior
Comments	Vehicle is possible a code 3
Warning light illuminated	Repair
Driver window not closing properly	Repair

Shock and brake report

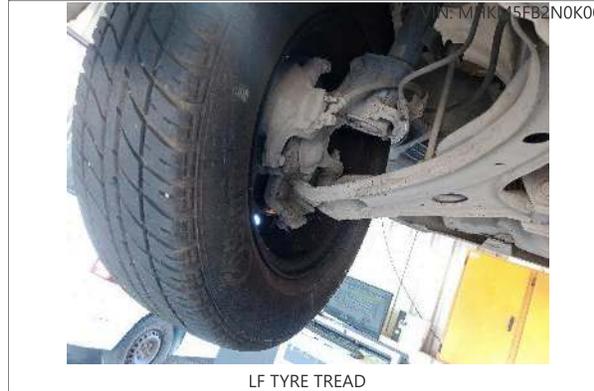
Size	Load/Speed Index	Manufacture	Model	Type*	Production Date	Tread Depth (mm)
Front Left	185/70R14	88H	Symmetry	SY101	V	4621	5 mm
Front Right	185/70R14	88H	Cachland	CH268	V	1722	1 mm
Rear Left	195R14	106/104R	Hilo	Brawin	V	2021	1 mm
Rear Right	195R14	106/104R	Hilo	Brawin	V	2021	1 mm

LF TYRE TREAD

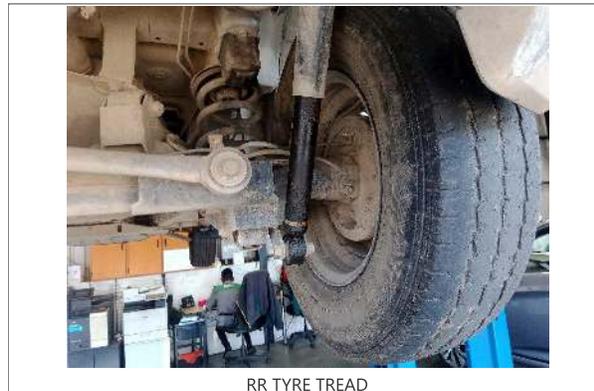
RR TYRE TREAD

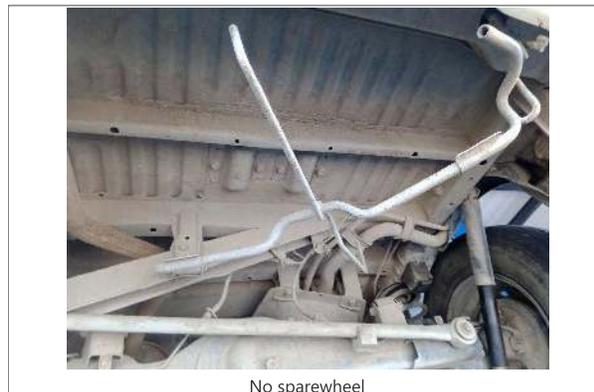
No sparewheel

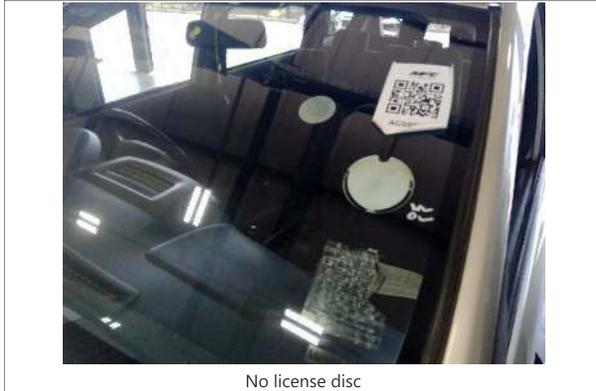
No license disc

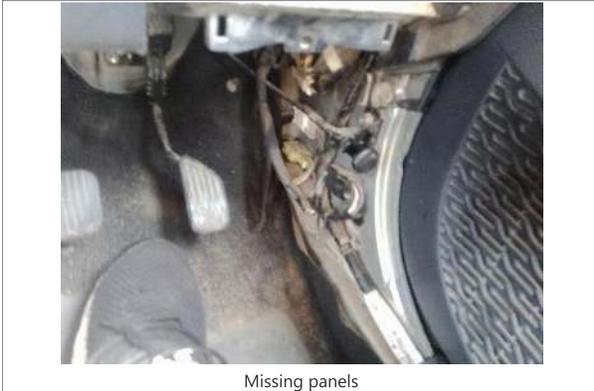
Missing panels

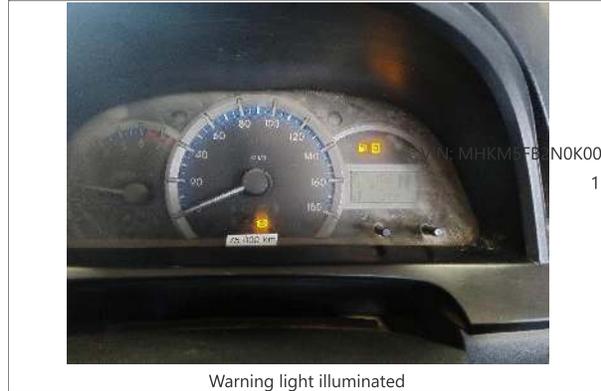
Warning light illuminated

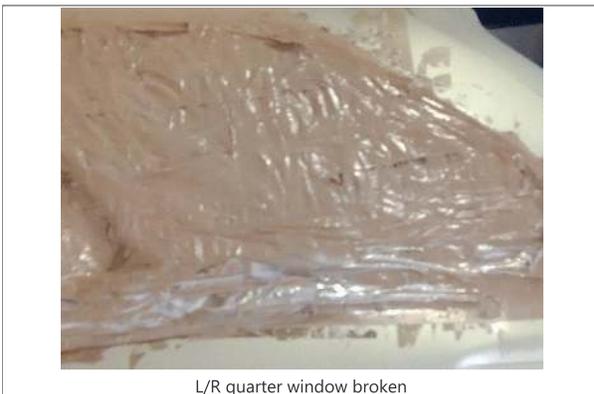
L/R quarter window broken

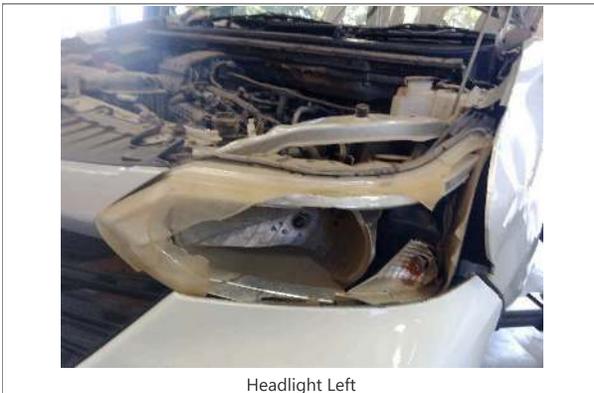
Damage	Repair Way
Battery clamps Defective	Replace
Indicator Light Front Left Damaged	Replace
Indicator Light Front Right Damaged	Replace
Tail Light Left Damaged	Replace
Tail Light Right Damaged	Replace
Headlight Left Damaged	Replace
Seat Front Right Torn / Cut	Repair
Seat Rear Torn / Cut	Repair
Sun Visor Left Missing	Replace
Door Panel Front Right Damaged	Repair
Carpet Rear Torn / Cut	Repair
Side Mirror Right Damaged	Replace
Front Bumper Damaged	Repair
Bonnet Damaged	Repair
Bonnet slam plate (Shock tower/ Inner tray) Welded	Repair
A • Pillar Right Dented	Repair
C • Pillar Right Residual Traces of Repair	Repair
Front Fender Left Dented	Repair
Front Fender Right Damaged	Repair
Rear Fender Left Damaged	Repair
Rear Fender Right Damaged	Repair
Front Fender Right / Inner Tray Welded	Replace
Door Front Right Damaged	Replace
Door Rear Left Paintwork • Scratched	Repair
Door Rear Right Residual Traces of Repair	Replace
Rear bumper Damaged	Repair
