## CONDITION REPORT

Report No: 2016364470

| Manufacturer | TOYOTA | Registration Number | FKF675L |
| Model | AVANZA | Register Number | |

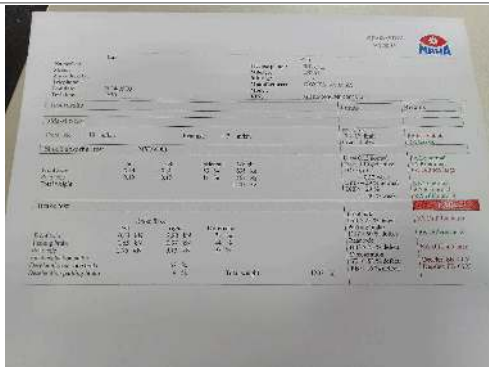
### Brake and shock test

| Damage | Repair Way |
|---|---|
| Brakes Insufficient | Repair |

Vehicle brakes fading away  
Bottom of engine and gearbox fully cover.

| | Left | Right | | |
|---|---|---|---|---|
| Front | 0.63 | 2.8 | - | |
| Rear | 2.76 | 0.13 | - | |

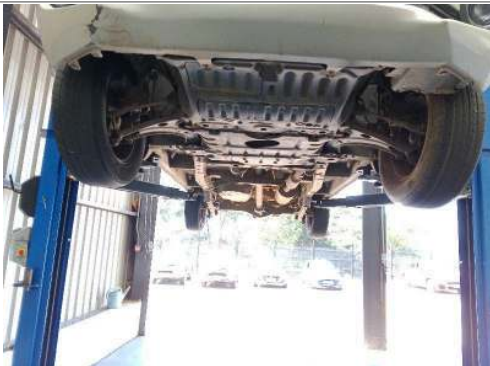
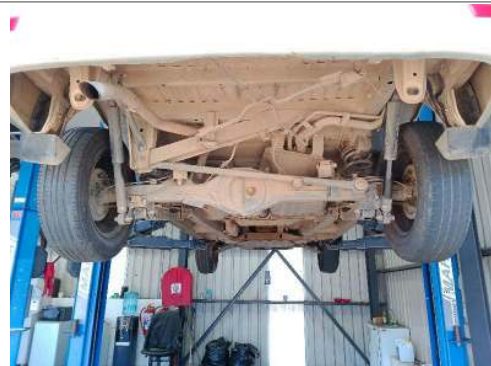
Undercarriage front.

Undercarriage rear.

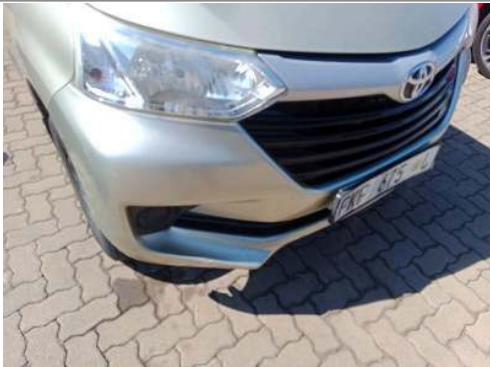
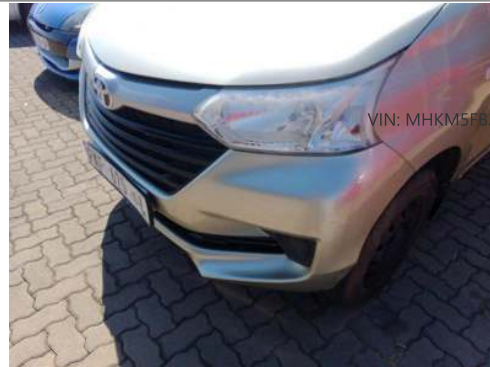
| Damage | Repair Way |
|---|---|
| Front Bumper Damaged | Repair |

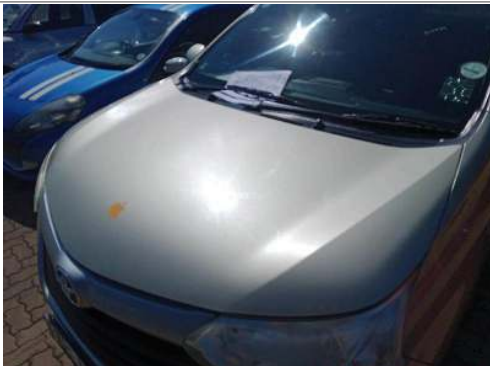
| Damage | Repair Way |
|---|---|
| Bonnet Damaged | Repair |

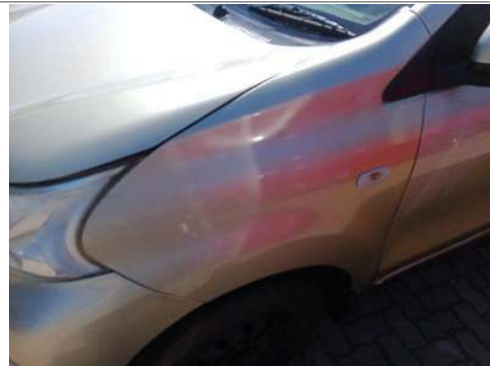
| Damage | Repair Way |
|---|---|
| Front Fender Left Damaged | Repair |

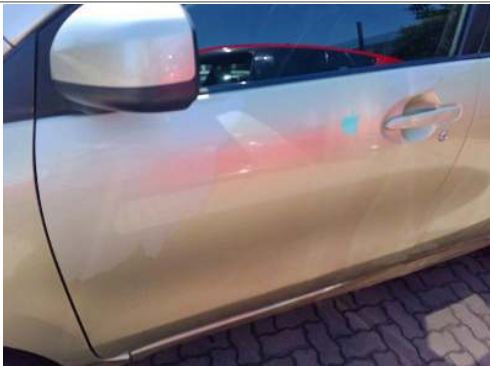
| Damage | Repair Way |
|---|---|
| Door Front Left Damaged | Repair |

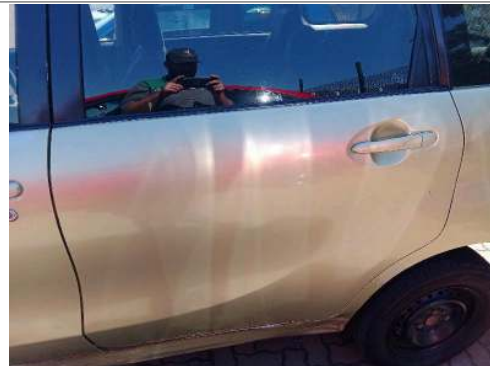
| Damage | Repair Way |
|---|---|
| Door Rear Left Damaged | Repair |

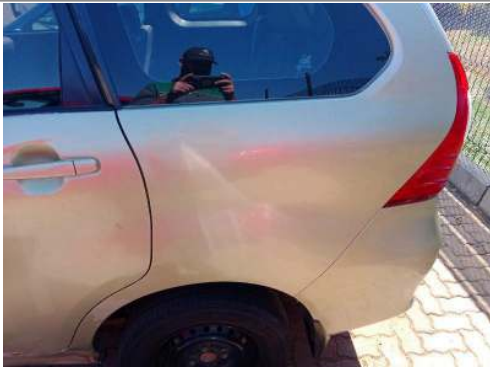
| Damage | Repair Way |
|---|---|
| Rear Fender Left Damaged | Repair |

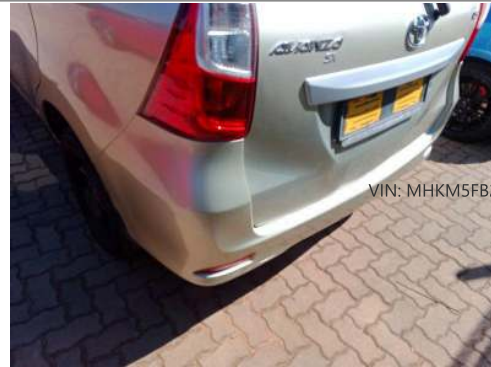
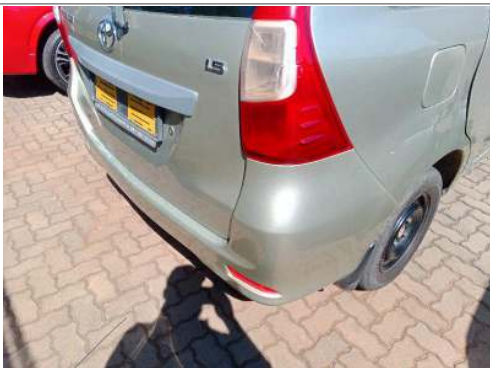
| Damage | Repair Way |
|---|---|
| Rear bumper Damaged | Repair |

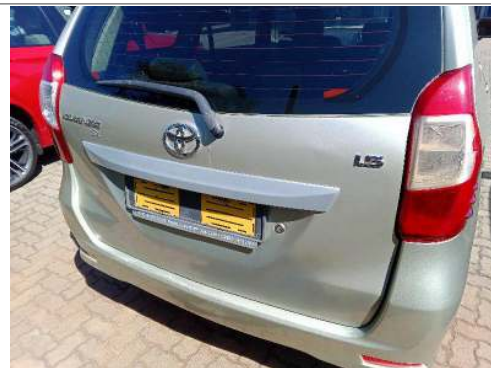
| Damage | Repair Way |
|---|---|
| Boot Lid / Hatch door Damaged | Repair |

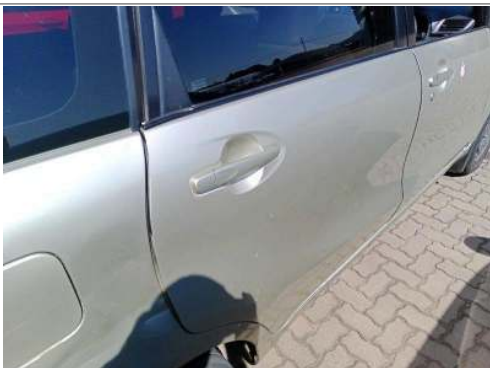
| Damage | Repair Way |
|---|---|
| Door Rear Right Damaged | Repair |

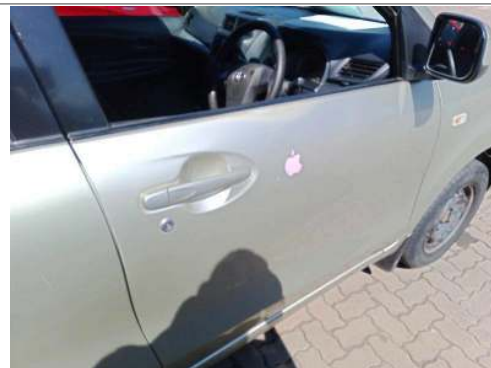
| Damage | Repair Way |
|---|---|
| Door Front Right Damaged | Repair |

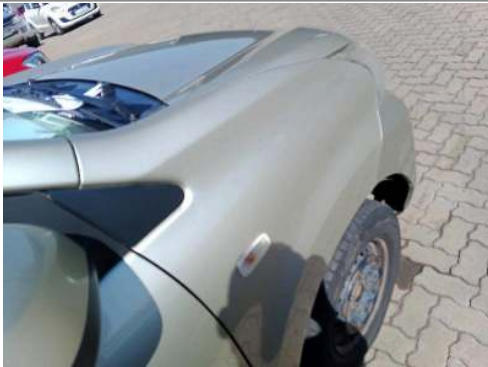
| Damage | Repair Way |
|---|---|
| Front Fender Right Damaged | Repair |

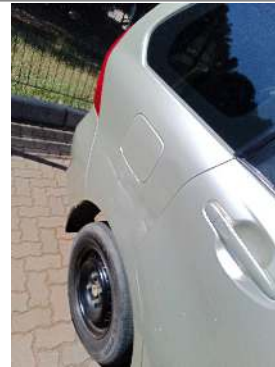
| Damage | Repair Way |
|---|---|
| Rear Fender Right Damaged | Repair |

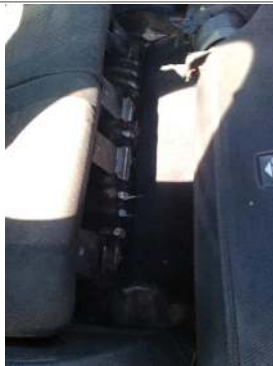
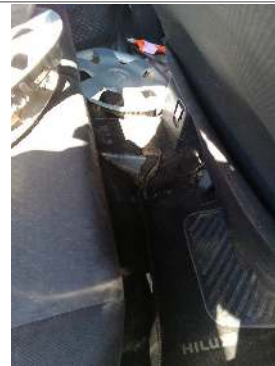
| Damage | Repair Way |
|---|---|
| Carpet Rear Damaged | Repair |

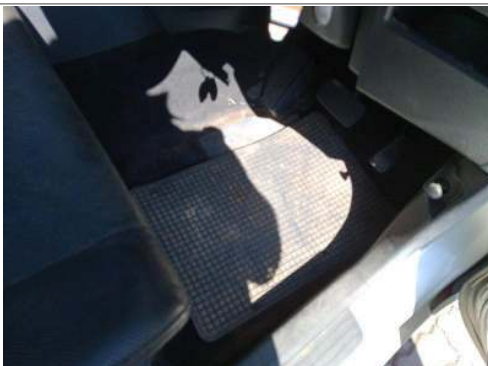
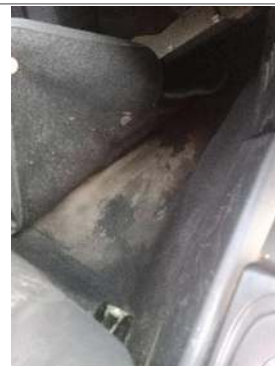
| Damage | Repair Way |
|---|---|
| Carpet Front Damaged | Repair |

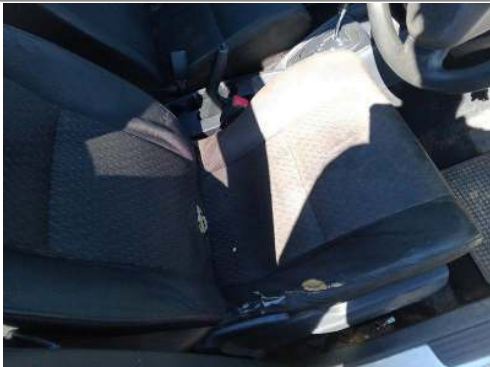
| Damage | Repair Way |
|---|---|
| Seat Front Right Damaged | Repair |

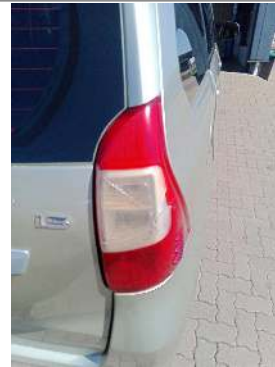
| Damage | Repair Way |
|---|---|
| Tail Light Right Damaged | Replace |

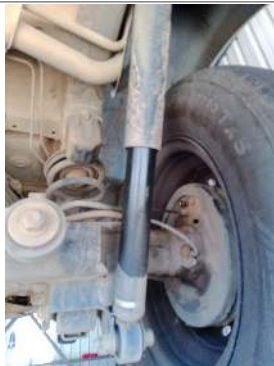
| Damage | Repair Way |
|---|---|
| Shock Absorber Rear Right Worn | Replace |

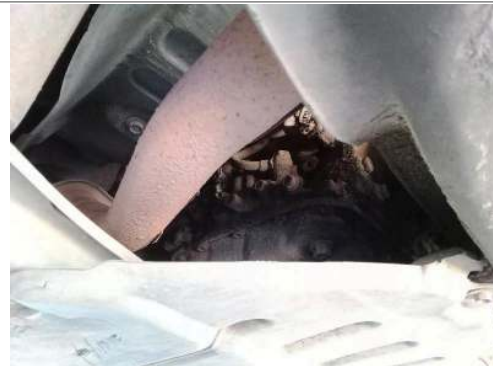
| Damage | Repair Way |
|---|---|
| Gearbox Oil Sweat | Repair |

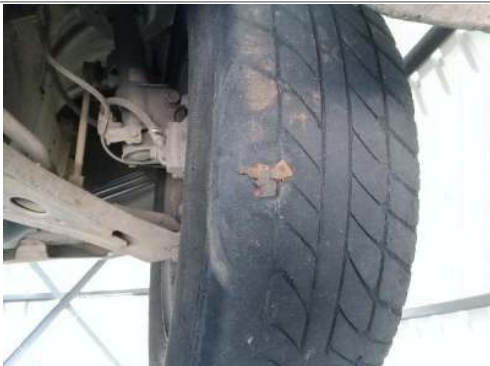
| Damage | Repair Way |
|---|---|
| Tyre Front Right Worn | Replace |

| | Size | Load/Speed Index | Manufacture | Model | Type* | Production Date | Tread Depth (mm) |
|---|---|---|---|---|---|---|---|
| Front Right | 185/70R14 | 88H | Symmetry | Radial | V | 4821 | 0 mm |

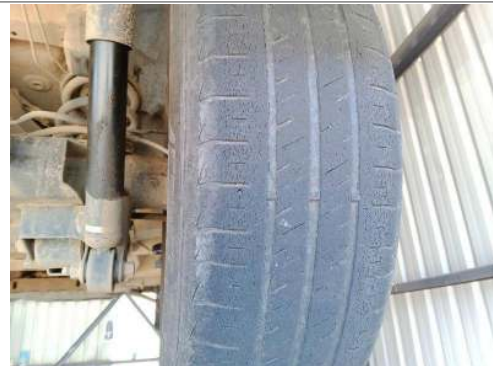
| Damage | Repair Way |
|---|---|
| Tyre Rear Right Worn | Replace |

| | Size | Load/Speed Index | Manufacture | Model | Type* | Production Date | Tread Depth (mm) |
|---|---|---|---|---|---|---|---|
| Rear Right | 185/70R14 | 88T | Tracmax | Radial | V | 4321 | 0 mm |

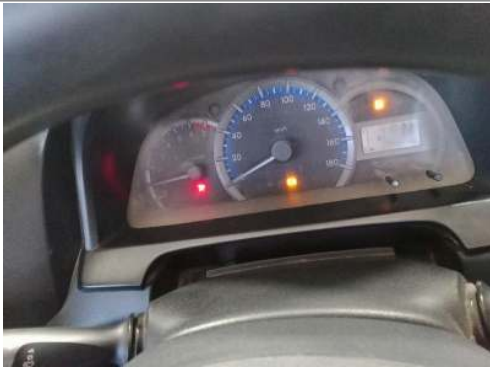
| Damage | Repair Way |
|---|---|
| Engine Management Lights Set | Repair |

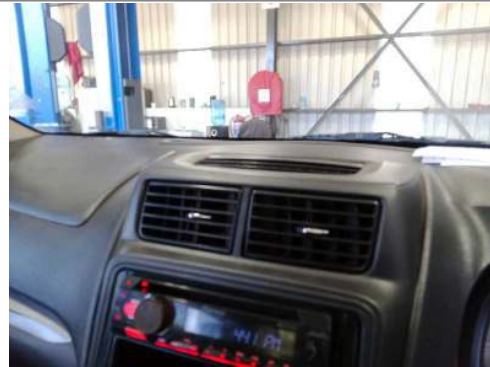
| Damage | Repair Way |
|---|---|
| Central Air Vent Damaged | Replace |

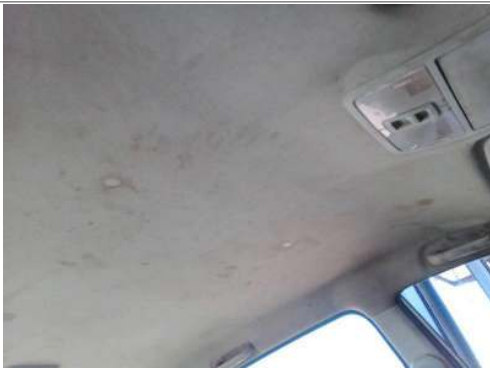
| Damage | Repair Way |
|---|---|
| Hood Lining Damaged | Repair |
