## CONDITION REPORT

Report No: 2016201503

MFC Auction House  
M57 Pretoria Rd, Glenmarais, KEMPTON PARK  
Gauteng

| Manufacturer | MAZDA | Registration Number | FJK005L |

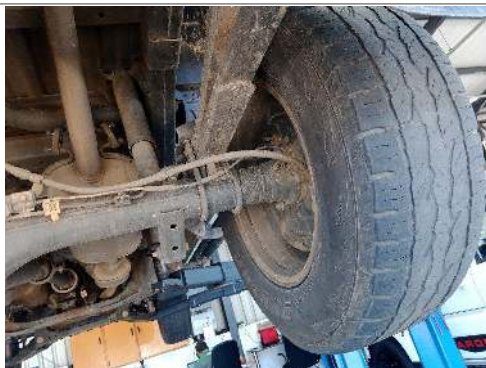
RR TYRE TREAD

| | Size | Load/Speed Index | Manufacture | Model | Type* | Production Date | Tread Depth (mm) |
|---|---|---|---|---|---|---|---|
| Rear Right | 265/65R17 | 112S | Dunlop | Grandtrek | V | 1821 | 2 mm |
