MFC Auction House
M57 Pretoria Rd, Glenmarais, KEMPTON PARK
Gauteng

Vehicle Type	PASSENGER VEHICLE	Registered Owner	MFC
Manufacturer	FORD	Registration Number	FMP866MP
Model	FIESTA	Register Number	
VIN	MNBAXXARJAAB17048	Date Of First Licensing	
Engine Number		Last COR	
Doors	4	License Expiry Date	30/06/2024
Color	SILVER	Power / Displacement	
Year Model		Paint Finish	M - METALLIC
Km Reading	138,045 KM	Fuel	PETROL
Cab / Body Type	SEDAN	Transmission	MANUAL

CONDITION REPORT

Report No: 2016209457

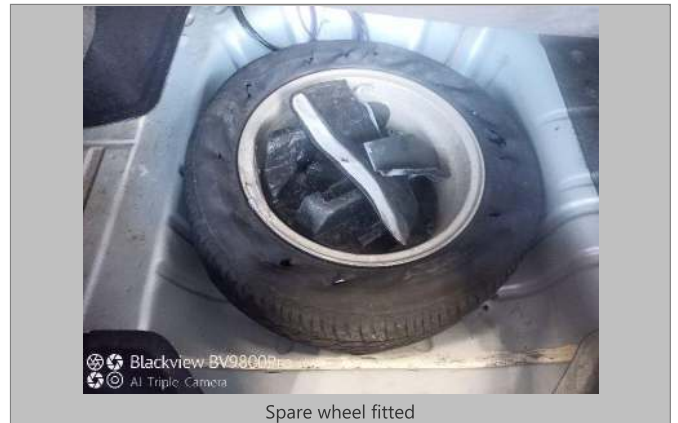
Spare wheel fitted

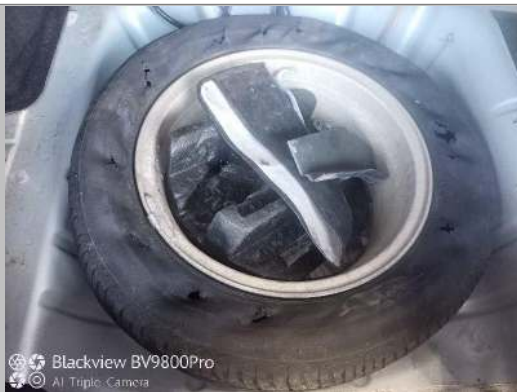
Damage	Repair Way
Tail Light Left Damaged	Replace
Tail Light Right Damaged	Replace
Headlight Left Scratched	Repair
Seat Rear Loose / Excessive Play	Repair
Side Mirror Left Damaged	Replace
Front Bumper Paintwork • Scratched	Repair
Bonnet Paintwork • Discoloured	Repair
Front Fender Left Paintwork • Scratched	Repair
Door Front Left Paintwork • Scratched	Repair
Door Front Right Paintwork • Scratched	Repair
Door Rear Left Paintwork • Scratched	Repair
Door Rear Right Dented	Repair
Boot Lid / Hatch door Paintwork • Discoloured	Repair
Rear bumper Paintwork • Scratched	Repair
Windscreen Damaged	Replace
Window Front Door Left Damaged	Replace
Window Front Door Right Damaged	Replace
Window Rear Door Left Damaged	Replace
Window Rear Door Right Damaged	Replace
Back Window Damaged	Replace
Spare Tyre Damaged	Replace
Both front fog lights malfunction	Repair

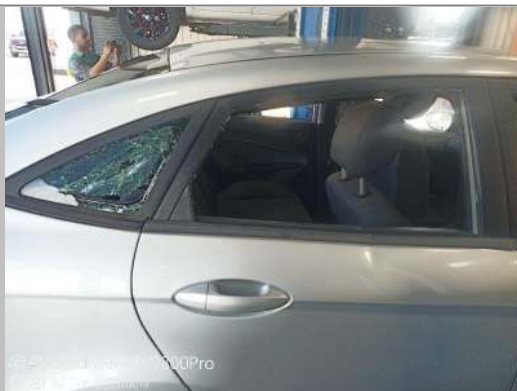
Window Rear Door Right

General Comments: ACCORDING TO AGE AND MILEAGE OF VEHICLE NORMAL WEAR AND TEAR ON INTERIOR, EXTERIOR, ELECTRICAL AND MECHANICAL PARTS.
 Body • Exterior: Vehicle got some scratches, stone chips and dents on some body panels and discolouring on some body panels. All the windows is damage
 Axle and Suspension: No shock test done due to shock machine not working
