## CONDITION REPORT

Report No:  
2016908254  
DATE  
10/06/2025

| Manufacturer | FORD | Registration Number | BC08PFGP |
| Model | FIESTA 1.4 AMBIENTE 5-DR [2010-2012] | Register Number | |

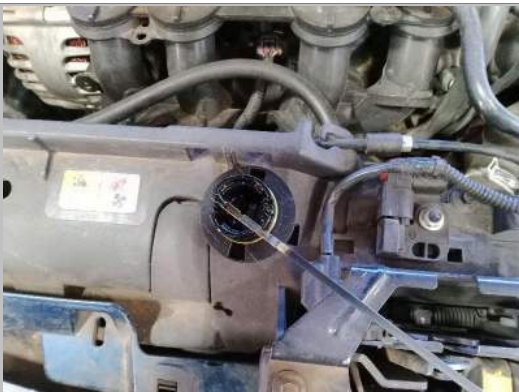
Oil cap and dipstick

| Damage | Repair Way |
|---|---|
| Engine Oil Leak | Repair |

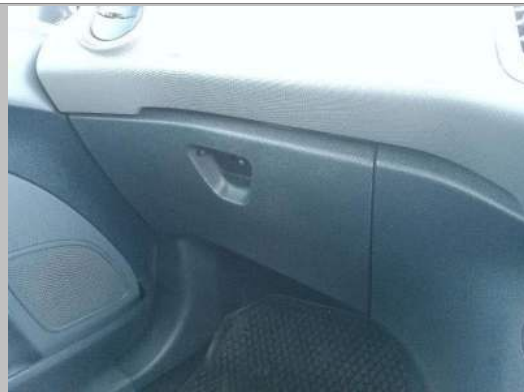
| Damage | Repair Way |
|---|---|
| Center Console / Cubbyhole + Lid Damaged | Replace |

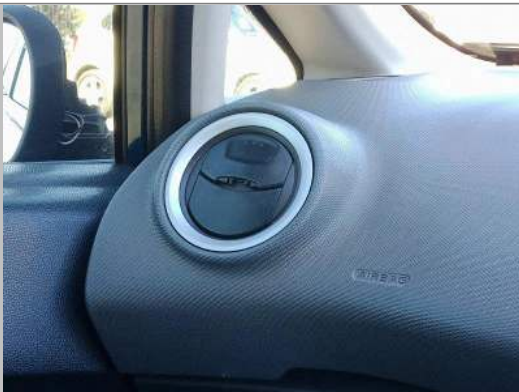
| Damage | Repair Way |
|---|---|
| Central Air Vent Defective | Repair |

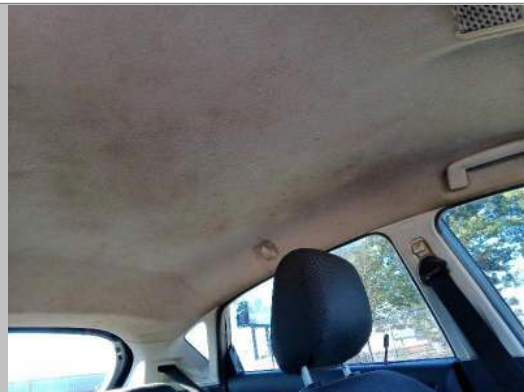
| Damage | Repair Way |
|---|---|
| Hood Lining Damaged | Repair |

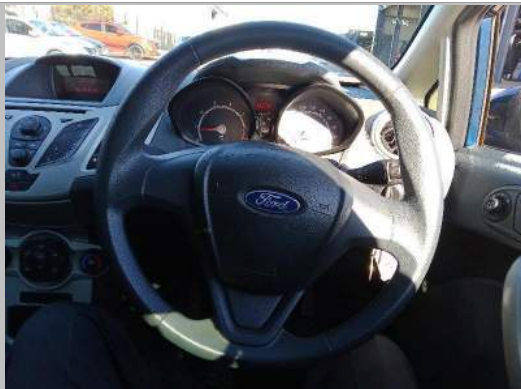
| Damage | Repair Way |
|---|---|
| Steering Wheel Trim Defective | Repair |

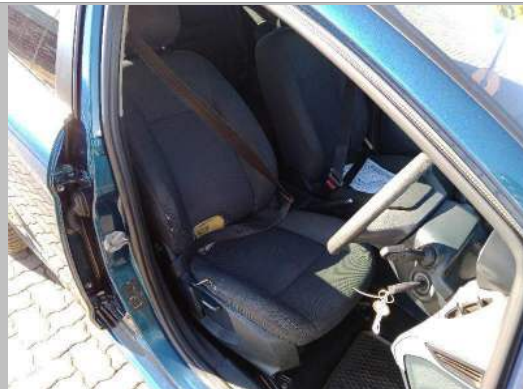
| Damage | Repair Way |
|---|---|
| Seat Front Right Damaged | Repair |

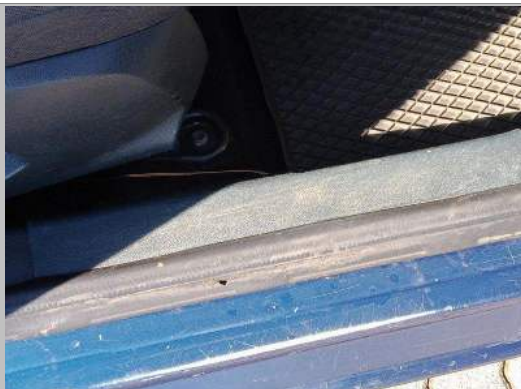
| Damage | Repair Way |
|---|---|
| Door Sealing Rubber Front Right Torn / Cut | Repair |

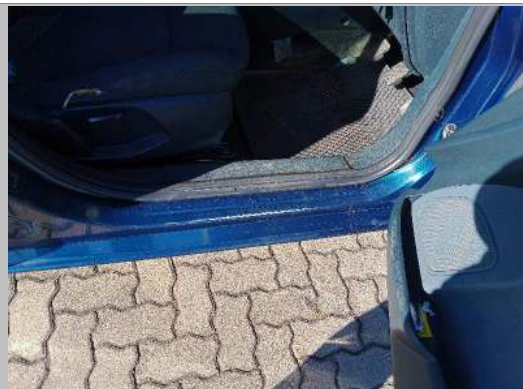
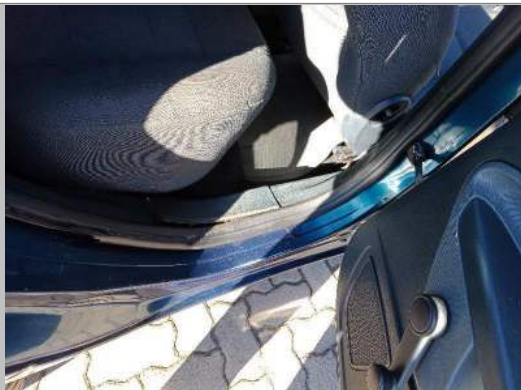
| Damage | Repair Way |
|---|---|
| Sill Panel Right Paintwork • Scratched | Repair |

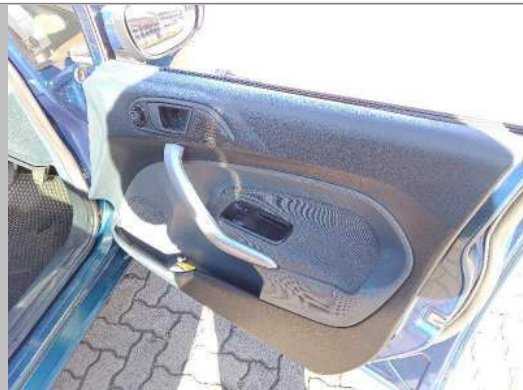
| Damage | Repair Way |
|---|---|
| Door Panel Front Right Damaged | Repair |

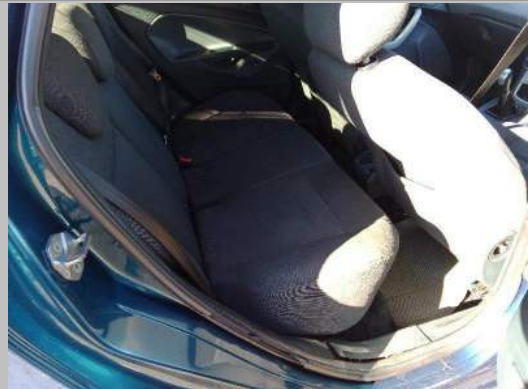
| Damage | Repair Way |
|---|---|
| Seat Rear Damaged | Repair |

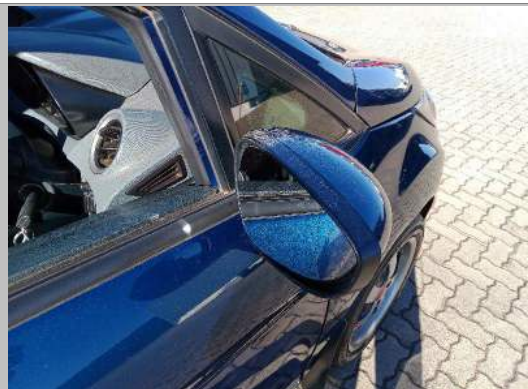
| Damage | Repair Way |
|---|---|
| Side Mirror Right Damaged | Replace |

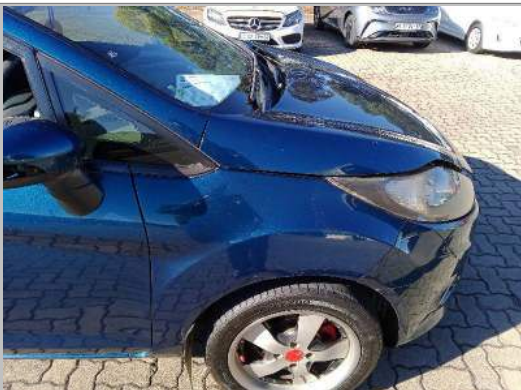
| Damage | Repair Way |
|---|---|
| Front Fender Right Damaged | Repair |

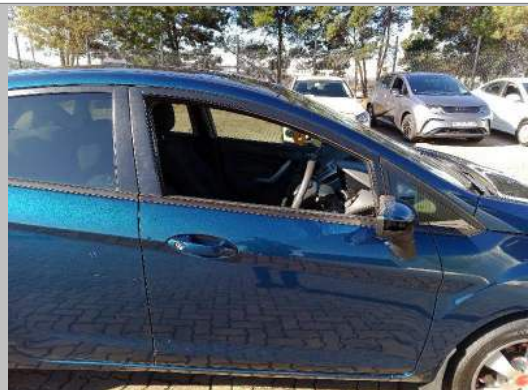
| Damage | Repair Way |
|---|---|
| Door Front Right Damaged | Repair |

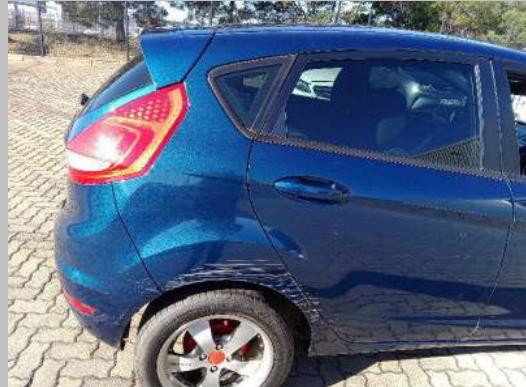
| Damage | Repair Way |
|---|---|
| Rear Fender Right Damaged | Repair |

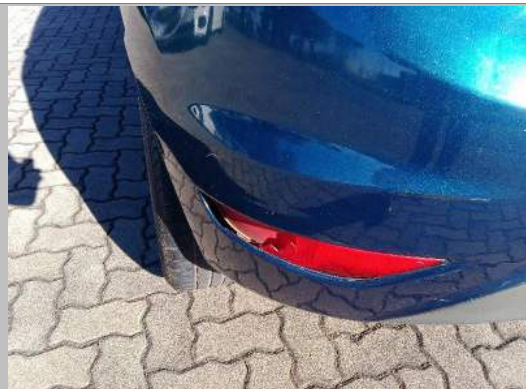
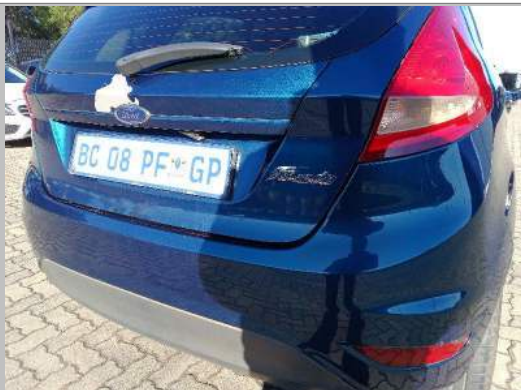
| Damage | Repair Way |
|---|---|
| Rear bumper Damaged | Repair |

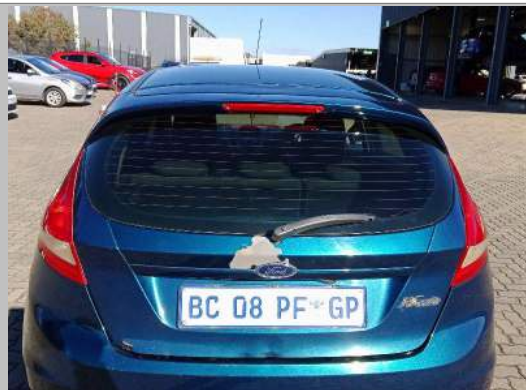
| Damage | Repair Way |
|---|---|
| Boot Lid / Hatch door Damaged | Repair |

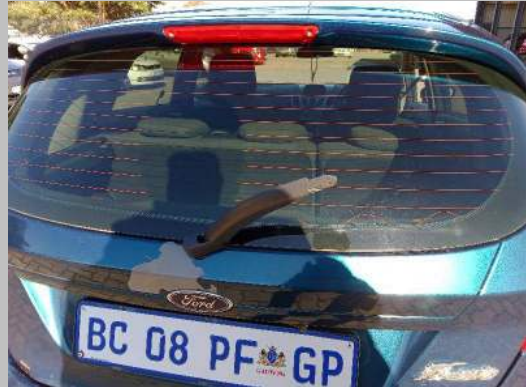
| Damage | Repair Way |
|---|---|
| Windscreen Wiper Missing | Replace |

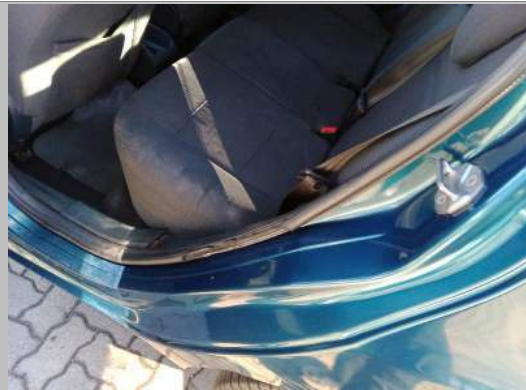
| Damage | Repair Way |
|---|---|
| Door Sealing Rubber Rear Left Damaged | Replace |

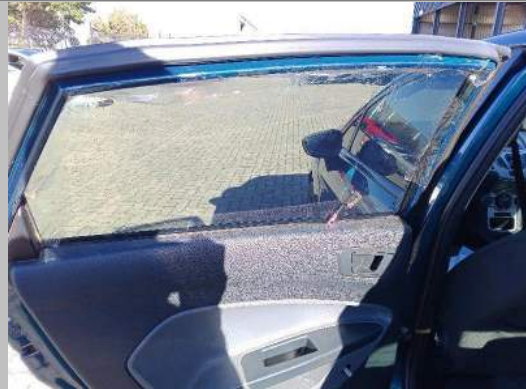
| Damage | Repair Way |
|---|---|
| Window Rear Door Left Defective | Repair |

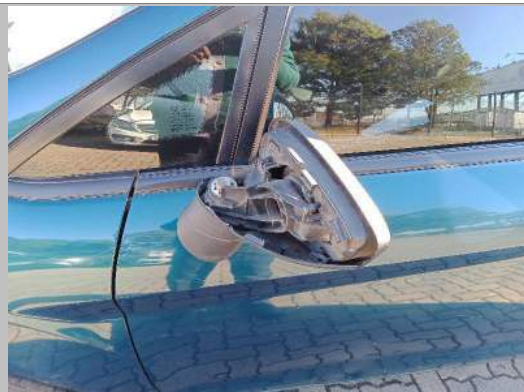
| Damage | Repair Way |
|---|---|
| Side Mirror Left Damaged | Replace |

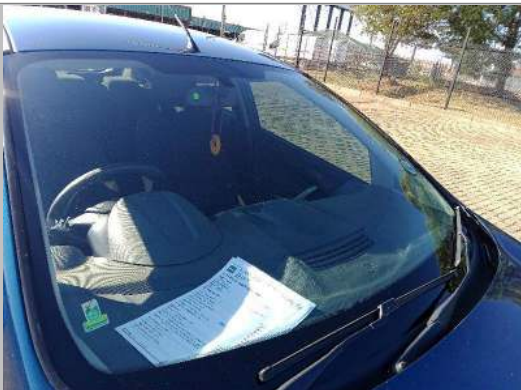
| Damage | Repair Way |
|---|---|
| Windscreen Chipped | Repair |

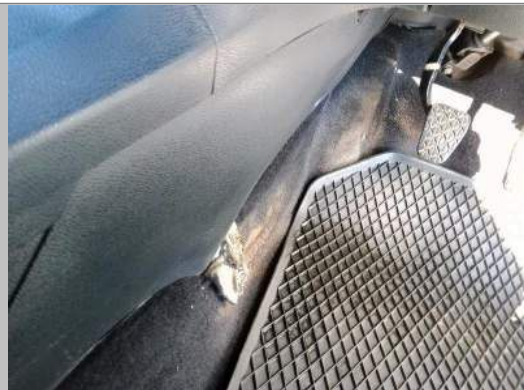
| Damage | Repair Way |
|---|---|
| Carpet Front Damaged | Repair |

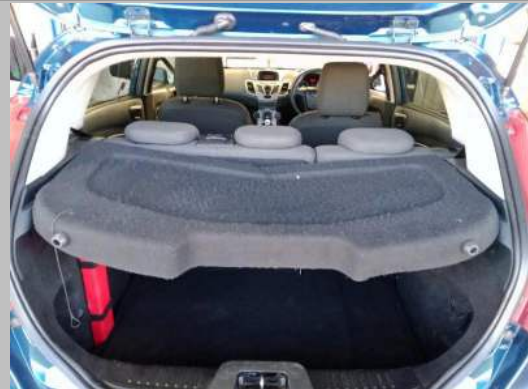
| Damage | Repair Way |
|---|---|
| Parcel Tray Damaged | Repair |

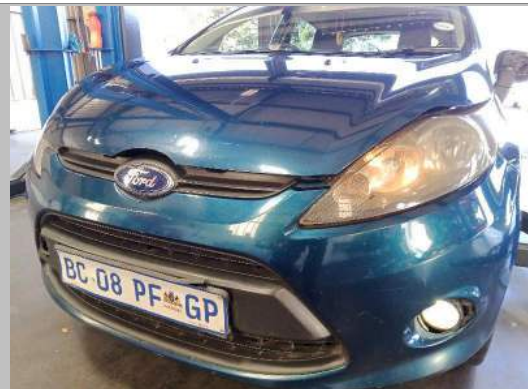
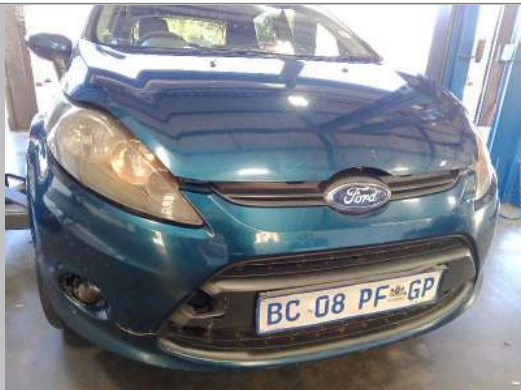
| Damage | Repair Way |
|---|---|
| Front Bumper Damaged | Repair |

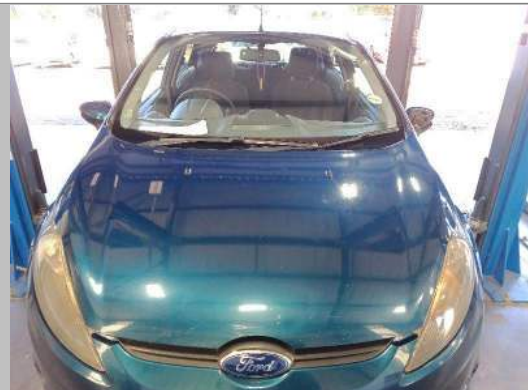
| Damage | Repair Way |
|---|---|
| Bonnet Damaged | Repair |

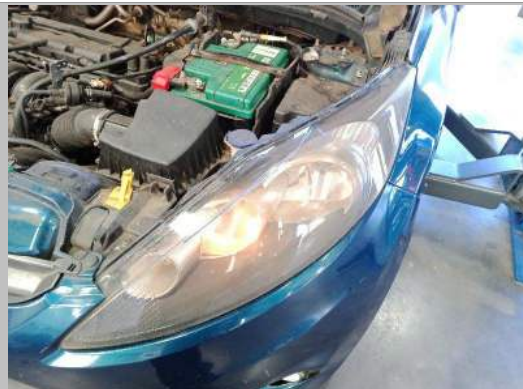
| Damage | Repair Way |
|---|---|
| Headlight Left Damaged | Replace |

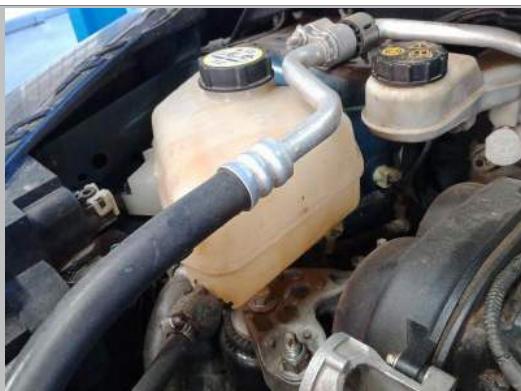
| Damage | Repair Way |
|---|---|
| Expansion Bottle Damaged | Replace |

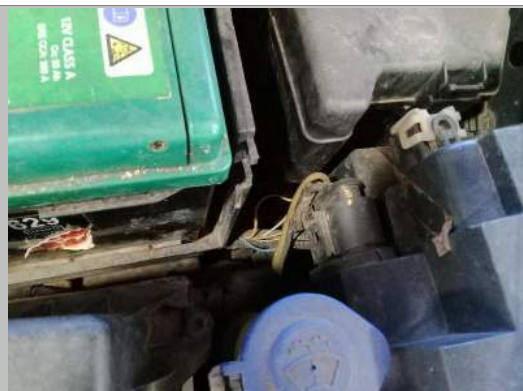
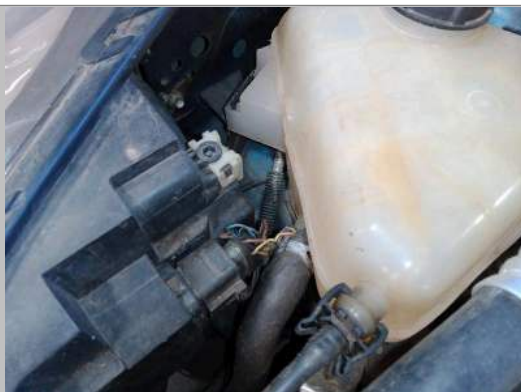
| Damage | Repair Way |
|---|---|
| Engine Wiring Defective | Repair |

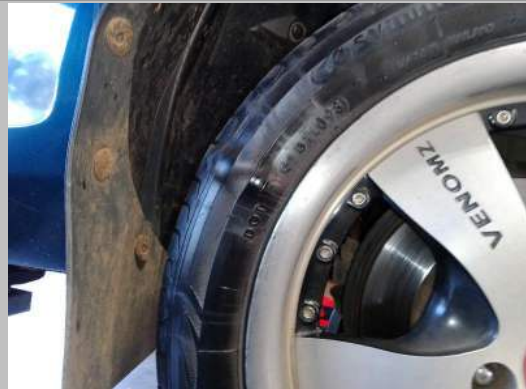
| Damage | Repair Way |
|---|---|
| Tyre Front Right Damaged | Replace |

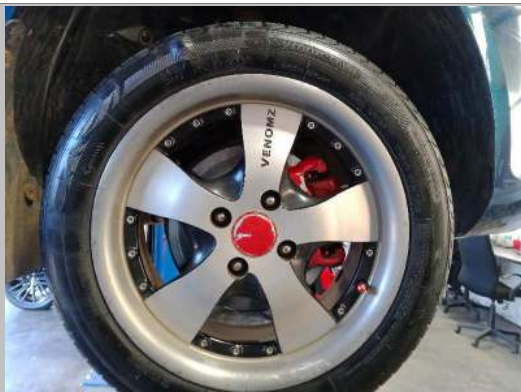
| Damage | Repair Way |
|---|---|
| Rim Front Right Dented | Repair |

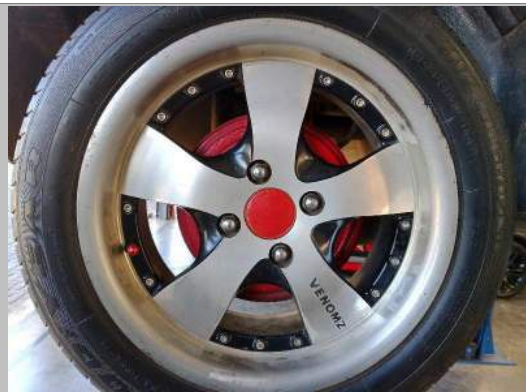
| Damage | Repair Way |
|---|---|
| Rim Rear Right Scratched | Repair |

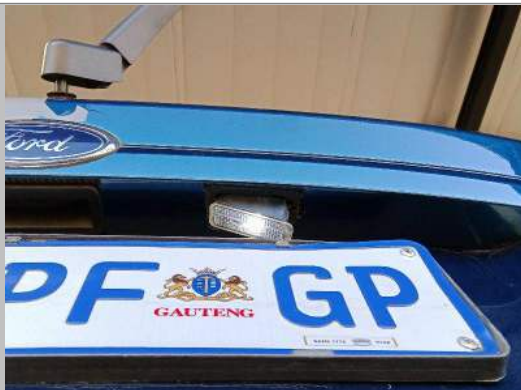
| Damage | Repair Way |
|---|---|
| Number Plate Light Right Defective | Repair |

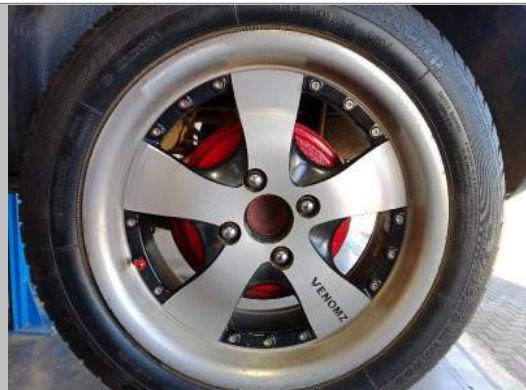
| Damage | Repair Way |
|---|---|
| Rim Rear Left Scratched | Repair |

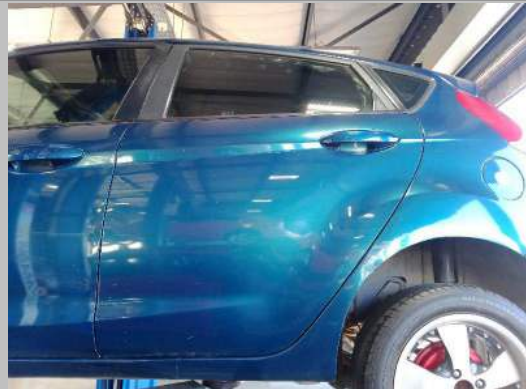
| Damage | Repair Way |
|---|---|
| Door Rear Left Residual Traces of Repair | Repair |

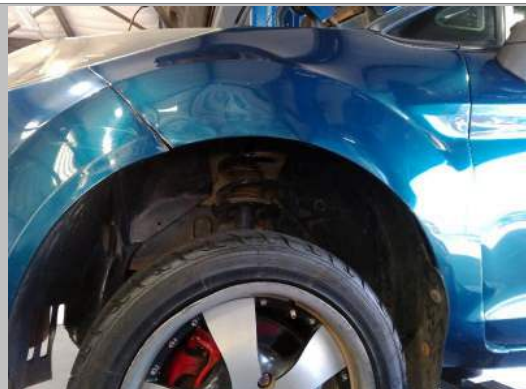
| Damage | Repair Way |
|---|---|
| Front Fender Left Damaged | Repair |

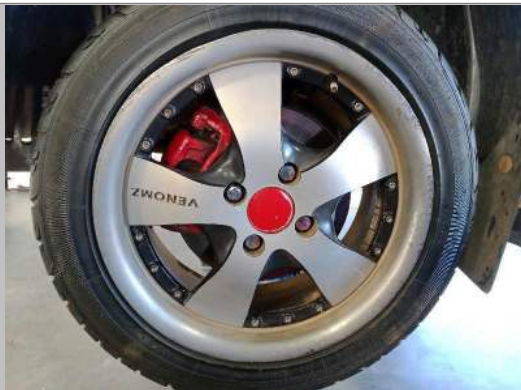
| Damage | Repair Way |
|---|---|
| Rim Front Left Dented | Repair |

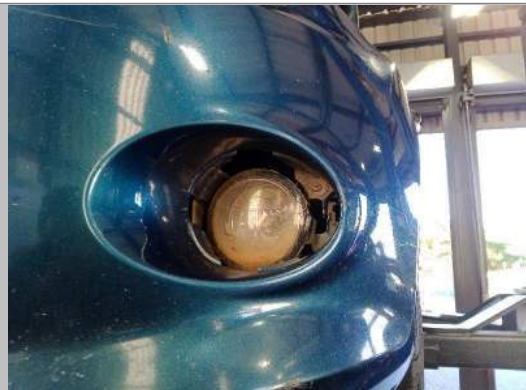
| Damage | Repair Way |
|---|---|
| Fog Light Front Left Damaged | Replace |

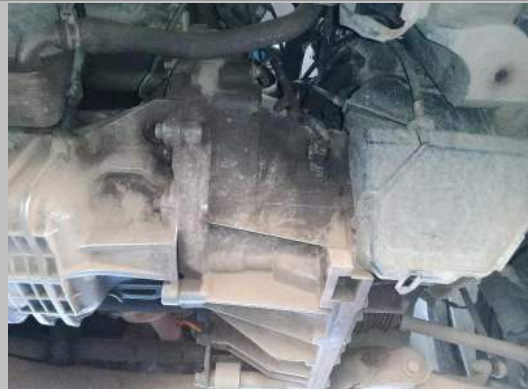
| Damage | Repair Way |
|---|---|
| Gearbox Oil Sweat | Repair |

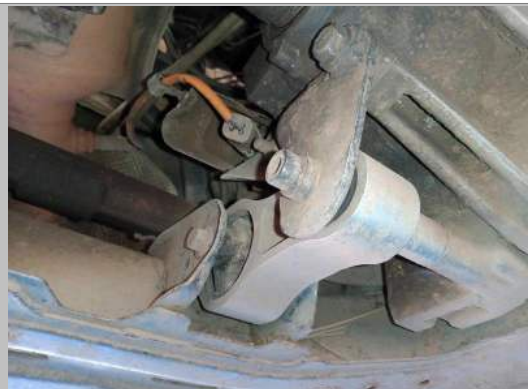
| Damage | Repair Way |
|---|---|
| Gearbox Mountings Cracked | Replace |

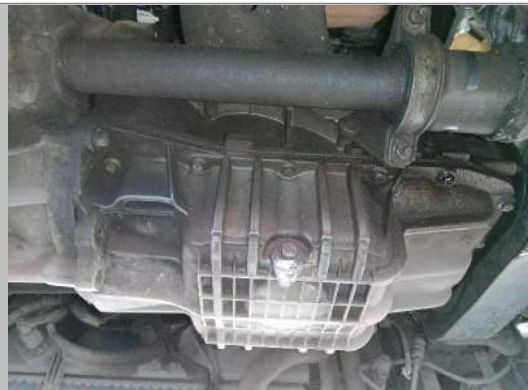
| Damage | Repair Way |
|---|---|
| Engine Noise Idling / Hunting | Repair |
| Engine | Some bolts missing on engine oil sump |

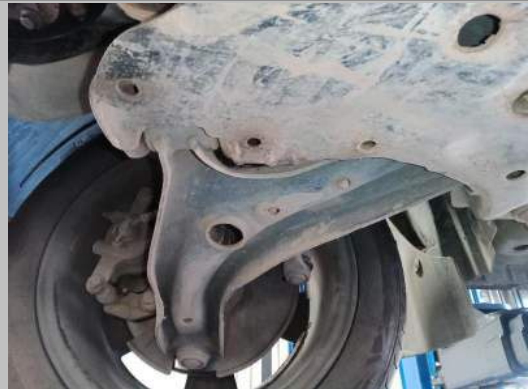
| Damage | Repair Way |
|---|---|
| Control Arm(s) Front Axle Right Damaged | Replace |

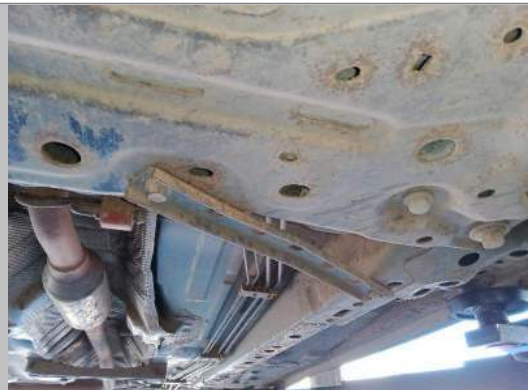
| Damage | Repair Way |
|---|---|
| Cross Member Front Left Dented | Repair |

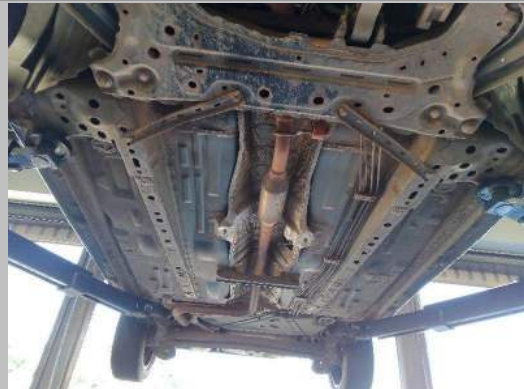
| Damage | Repair Way |
|---|---|
| Chassis Damaged | Repair |

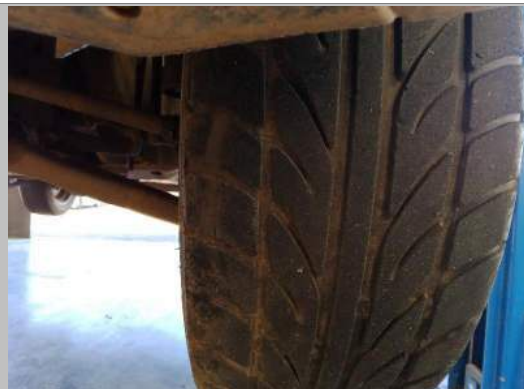
| Damage | Repair Way |
|---|---|
| Tyre Front Left Defective | Replace |

| | Size | Load/Speed Index | Manufacture | Model | Type* | Production Date | Tread Depth (mm) |
|---|---|---|---|---|---|---|---|
| Front Left | 195/50 R15 | 82V | Symmetry | SY201 | V | 4920 | 0 mm |

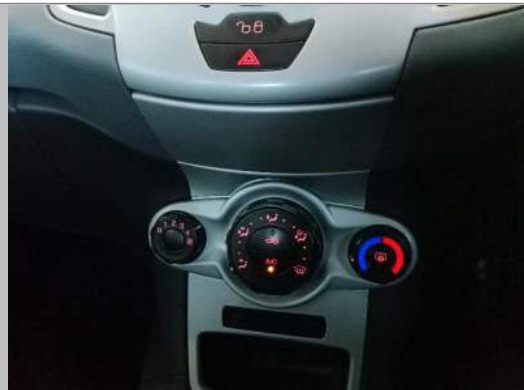
| Damage | Repair Way |
|---|---|
| Air Conditioner Insufficient | Replace |

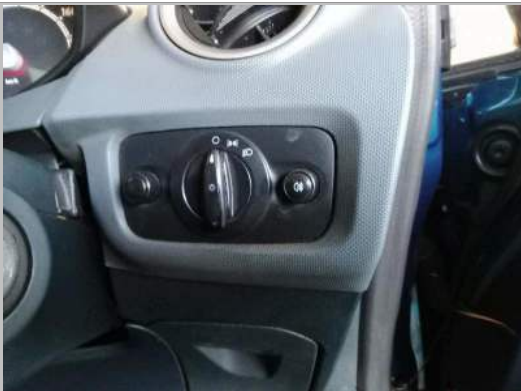
| Damage | Repair Way |
|---|---|
| Head Light Switch Defective | Replace |
