CONDITION REPORT

Report No: 2016598816

MFC Auction House  
M57 Pretoria Rd, Glenmarais, KEMPTON PARK  
Gauteng

| Manufacturer | NISSAN | Registration Number | CS47JJGP |

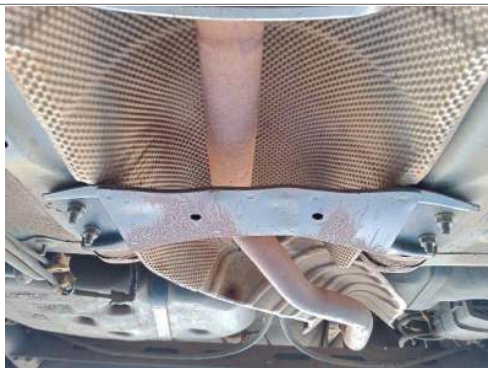
Rear exhaust cross member brace

| Damage | Repair Way |
|---|---|
| Undercarriage | Rear exhaust cross member bracket damaged |

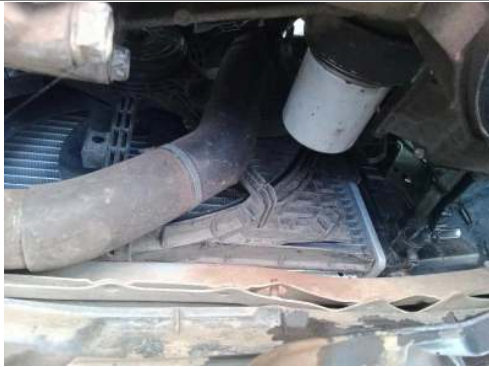
| Damage | Repair Way |
|---|---|
| Engine | Fan Cowley damaged |

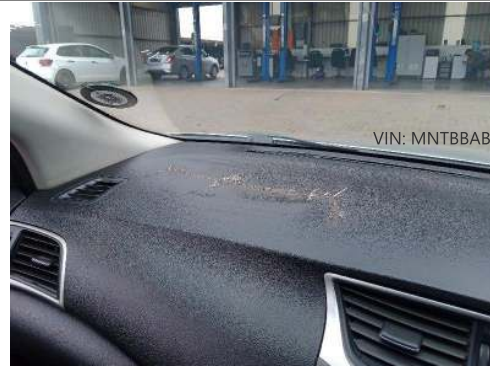
| Damage | Repair Way |
|---|---|
| Dash Padding Damaged | Repair |

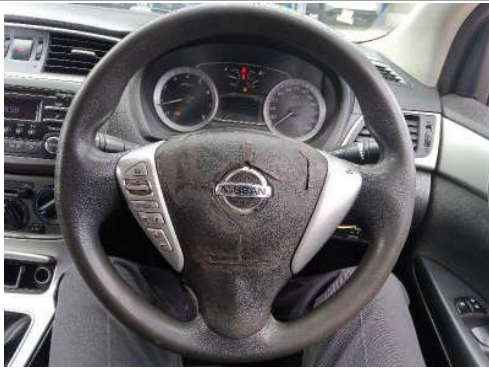
| Damage | Repair Way |
|---|---|
| Steering Wheel Trim Damaged | Replace |

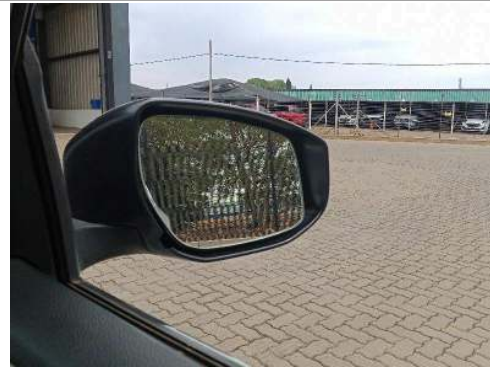
| Damage | Repair Way |
|---|---|
| Side Mirror Right Damaged | Replace |

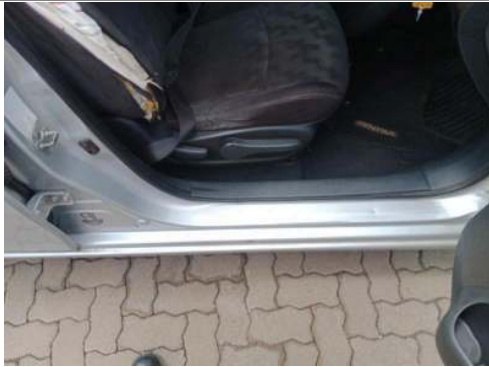
| Damage | Repair Way |
|---|---|
| Sill Panel Right Dented | Repair |

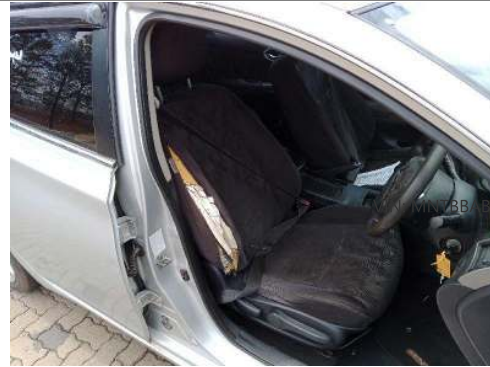
| Damage | Repair Way |
|---|---|
| Seat Front Right Damaged | Repair |

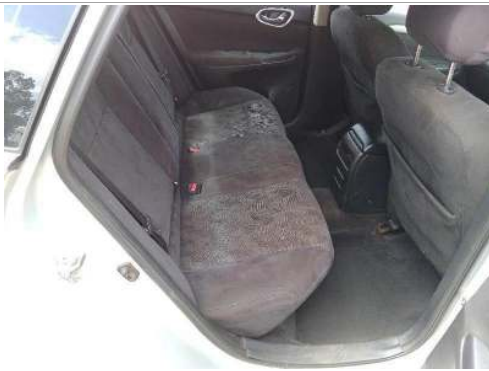
| Damage | Repair Way |
|---|---|
| Seat Rear Damaged | Repair |

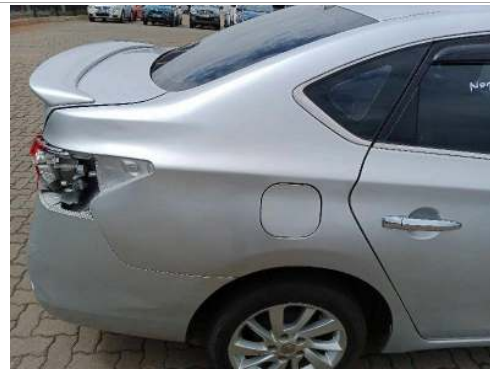
| Damage | Repair Way |
|---|---|
| Rear Fender Right Residual Traces of Repair | Repair |

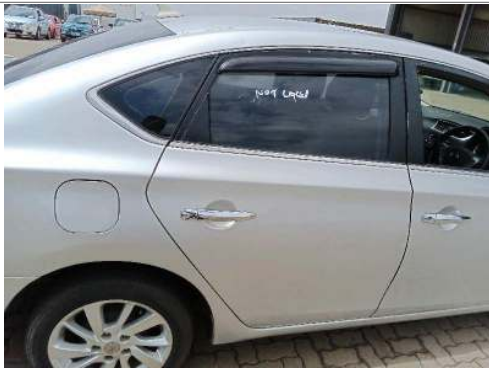
| Damage | Repair Way |
|---|---|
| Door Rear Right Residual Traces of Repair | Repair |

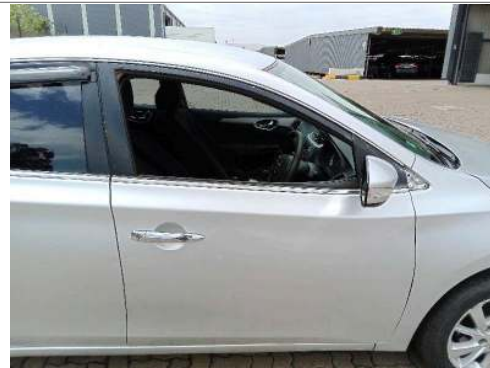
| Damage | Repair Way |
|---|---|
| Door Front Right Residual Traces of Repair | Repair |

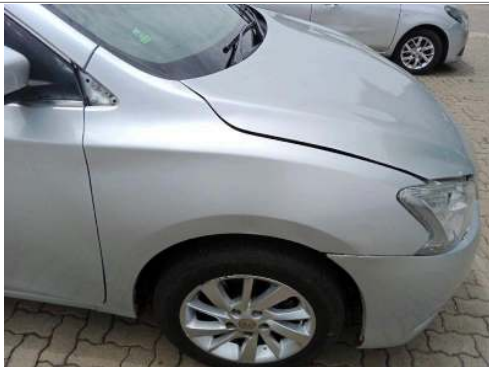
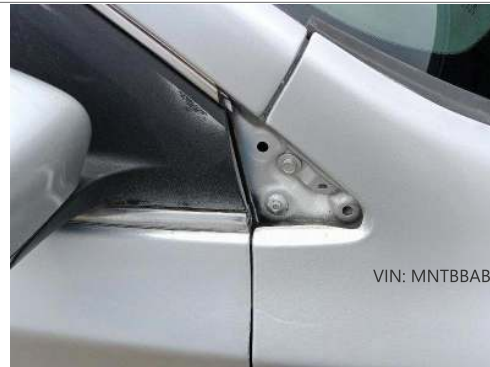
| Damage | Repair Way |
|---|---|
| Front Fender Right Residual Traces of Repair | Repair |

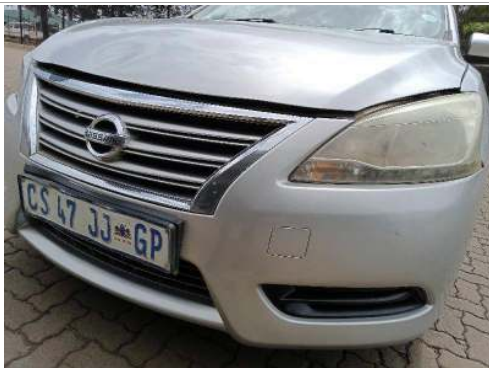
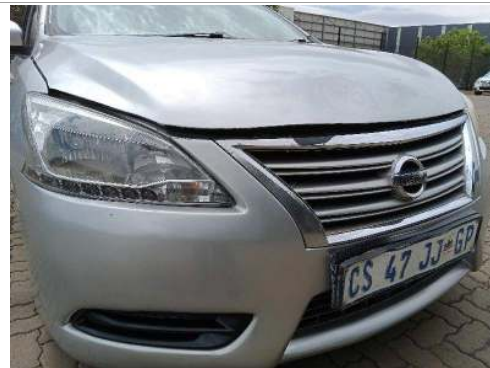
| Damage | Repair Way |
|---|---|
| Front Bumper Damaged | Repair |

| Damage | Repair Way |
|---|---|
| Body and Exterior | Signs of impact damage to front of vehicle. |

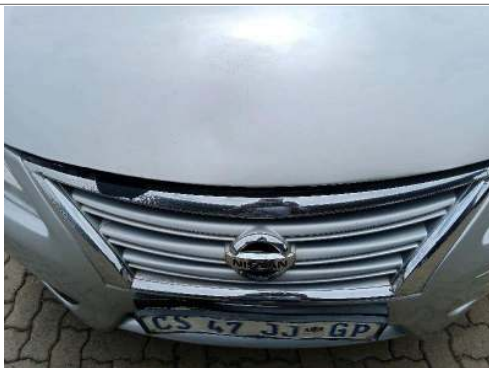
| Damage | Repair Way |
|---|---|
| Grill Damaged | Replace |

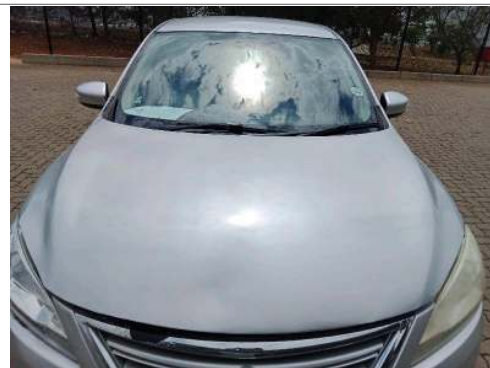
| Damage | Repair Way |
|---|---|
| Bonnet Welded | Replace |

| Damage | Repair Way |
|---|---|
| Body and Exterior | Bonnet does not close. |

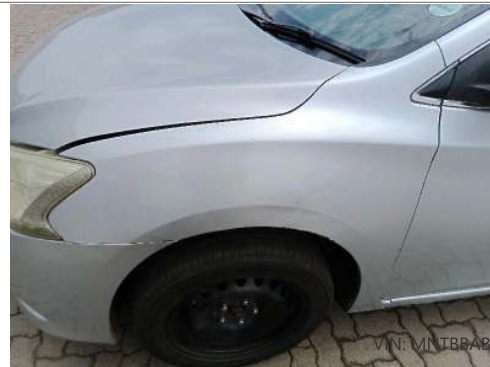
| Damage | Repair Way |
|---|---|
| Front Fender Left Damaged | Repair |

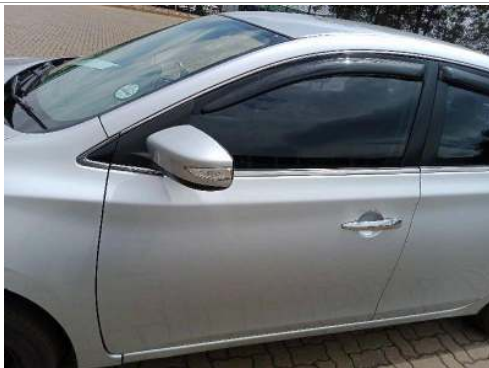
| Damage | Repair Way |
|---|---|
| Door Front Left Dented | Repair |

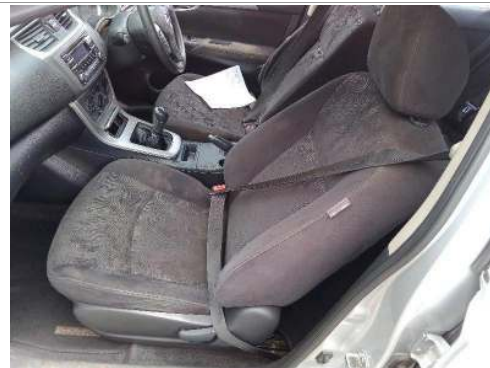
| Damage | Repair Way |
|---|---|
| Seat Front Left Damaged | Repair |

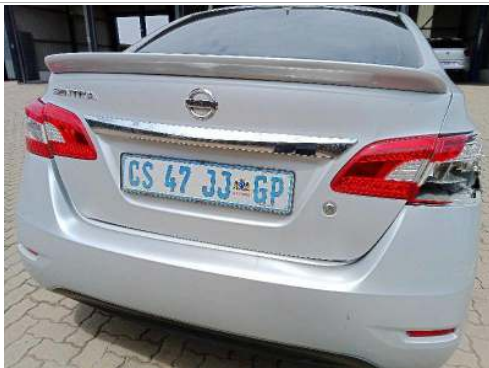
| Damage | Repair Way |
|---|---|
| Rear bumper Damaged | Repair |
| Body and Exterior | Signs of impact damage to rear of vehicle. |

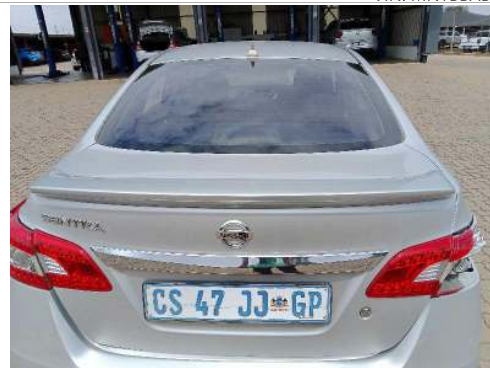
| Damage | Repair Way |
|---|---|
| Boot Lid / Hatch door Damaged | Repair |

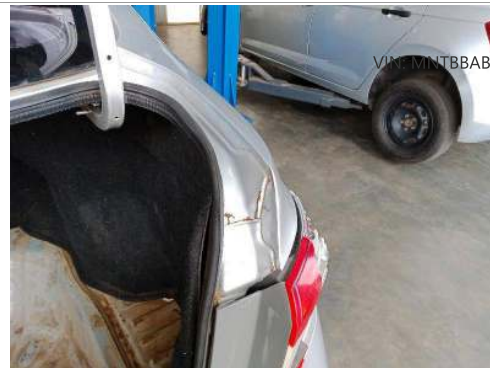
| Damage | Repair Way |
|---|---|
| C • Pillar Right Dented | Repair |

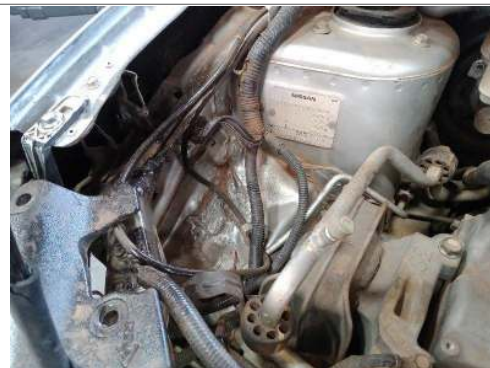
| Damage | Repair Way |
|---|---|
| Bonnet slam plate (Shock tower/ Inner tray) Damaged | Repair |

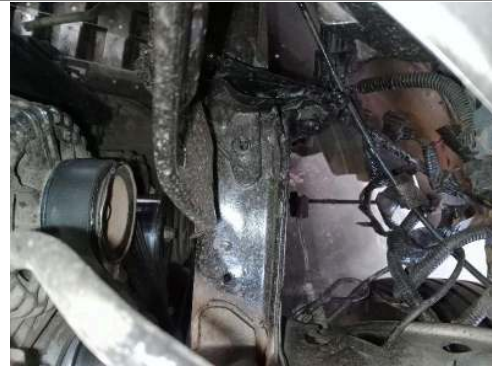
| Damage | Repair Way |
|---|---|
| Main Beam Right Damaged | Repair |

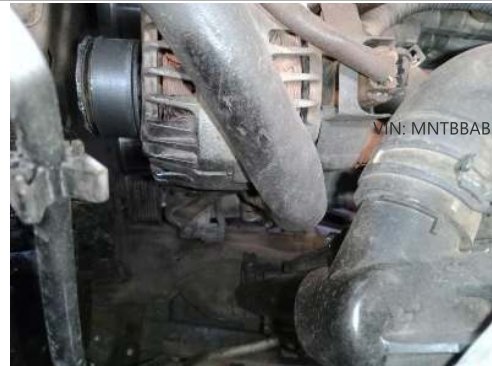
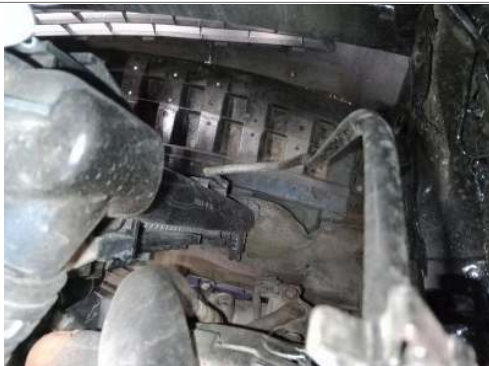
| Damage | Repair Way |
|---|---|
| Air conditioner pipes Damaged | Replace |

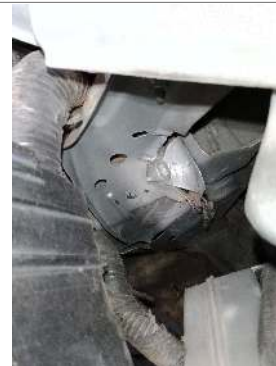
| Damage | Repair Way |
|---|---|
| Main Beam Left Damaged | Replace |

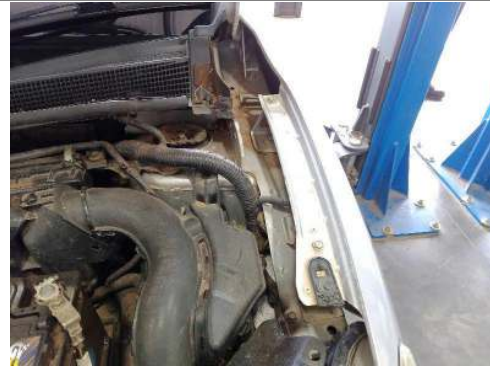
| Damage | Repair Way |
|---|---|
| Front Fender Left / Inner Tray Damaged | Repair |

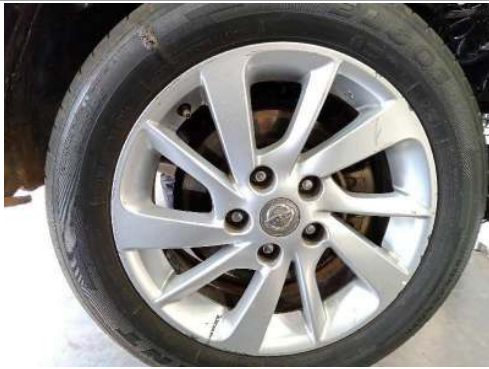
| Damage | Repair Way |
|---|---|
| Rim Front Right Dented | Repair |

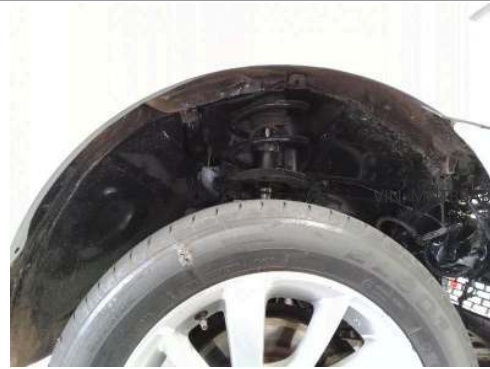
| Damage | Repair Way |
|---|---|
| Front Fender Right / Inner Tray Damaged | Repair |

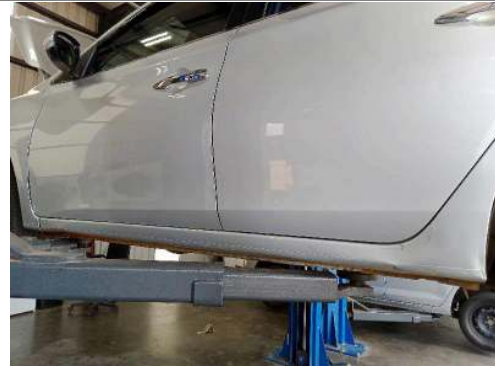
| Damage | Repair Way |
|---|---|
| Sill Panel Left Damaged | Repair |

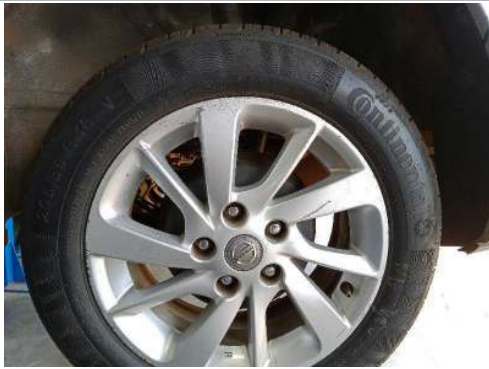
| Damage | Repair Way |
|---|---|
| Rim Rear Left Scratched | Repair |

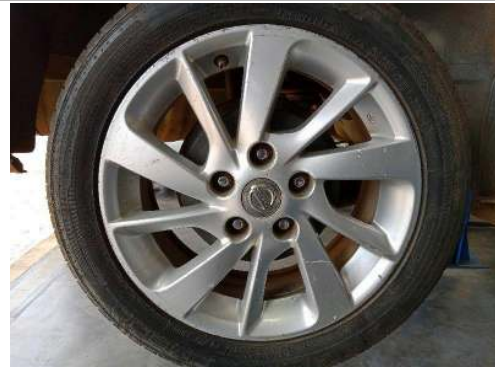
| Damage | Repair Way |
|---|---|
| Rim Rear Right Scratched | Repair |

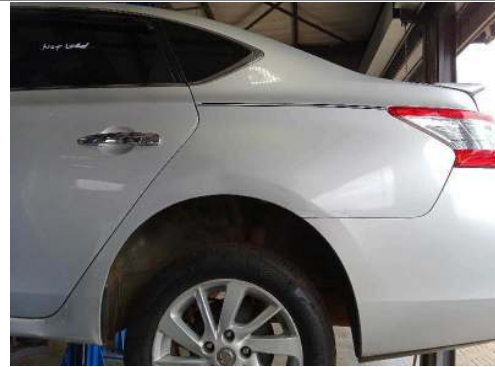
| Damage | Repair Way |
|---|---|
| Rear Fender Left Residual Traces of Repair | Repair |

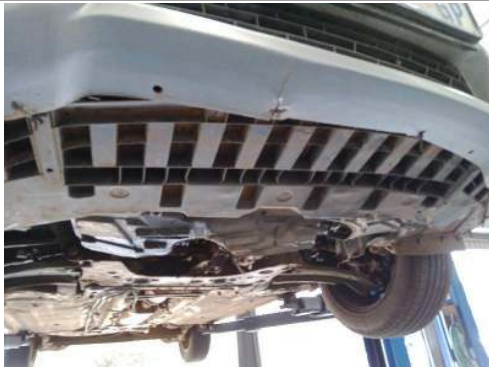
| Damage | Repair Way |
|---|---|
| Belly plates Damaged | Replace |

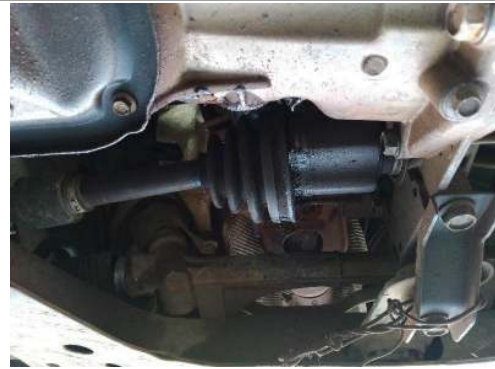
| Damage | Repair Way |
|---|---|
| CV Joint(s) Boot(s) Front Right (inner/outer) Damaged | Replace |

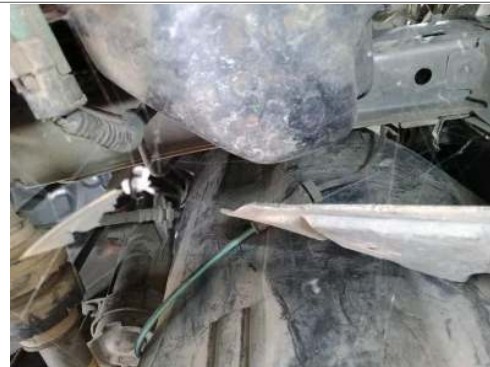
| Damage | Repair Way |
|---|---|
| Engine Wiring Defective | Repair |

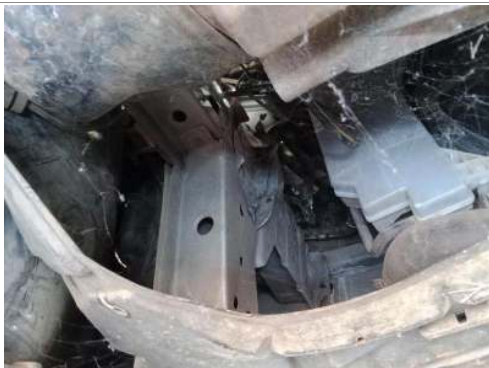
| Damage | Repair Way |
|---|---|
| Radiator Cradle Damaged | Replace |

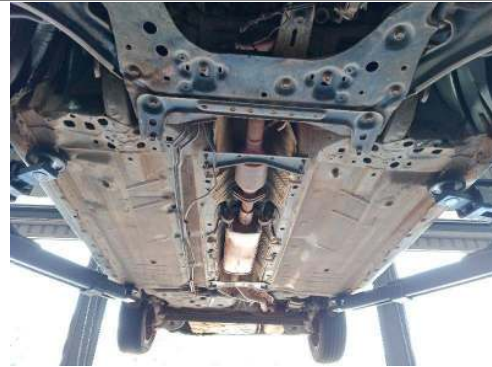
| Damage | Repair Way |
|---|---|
| Chassis Damaged | Repair |

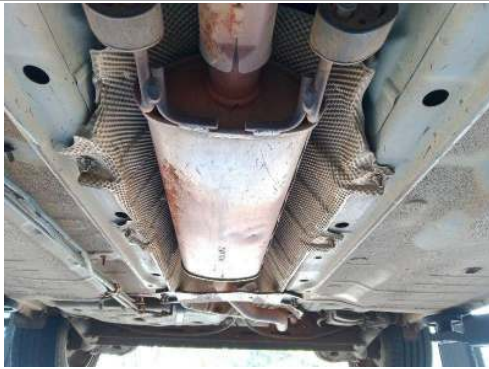
| Damage | Repair Way |
|---|---|
| Silencer Damaged | Replace |

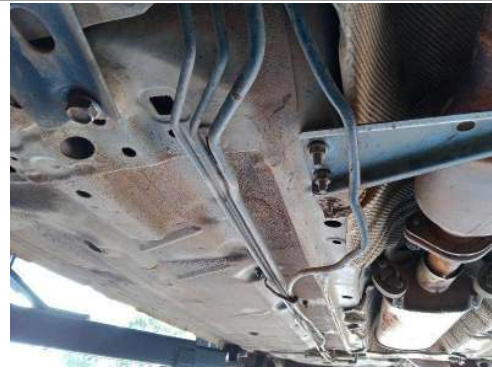
| Damage | Repair Way |
|---|---|
| Fuel Lines Defective | Repair |

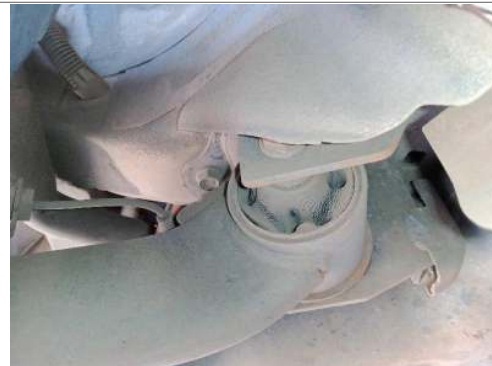
| Damage | Repair Way |
|---|---|
| Mounting Rubber(s) Rear Axle Right Cracked | Replace |

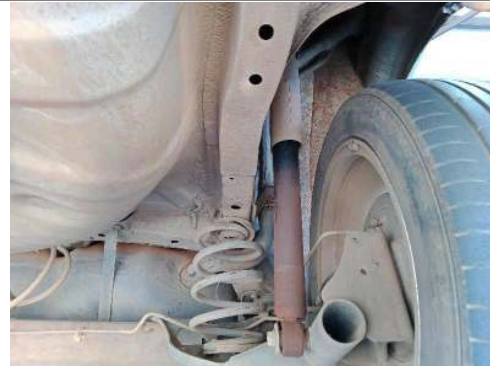
| Damage | Repair Way |
|---|---|
| Shock Absorber Rear Right Leak | Replace |

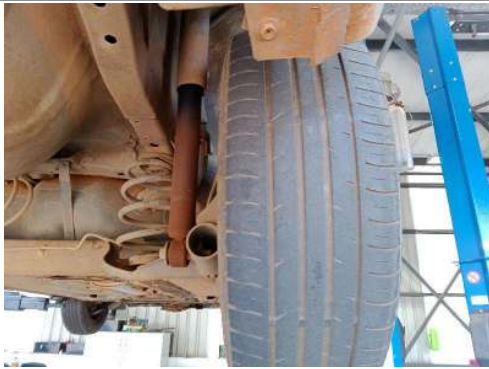
| Damage | Repair Way |
|---|---|
| Tyre Rear Right Worn | Replace |

| | Size | Load/Speed Index | Manufacture | Model | Type* | Production Date | Tread Depth (mm) |
|---|---|---|---|---|---|---|---|
| Rear Right | 195/55 R16 | 87V | Dunlop | Sp-Sport | V | 2318 | 0 mm |

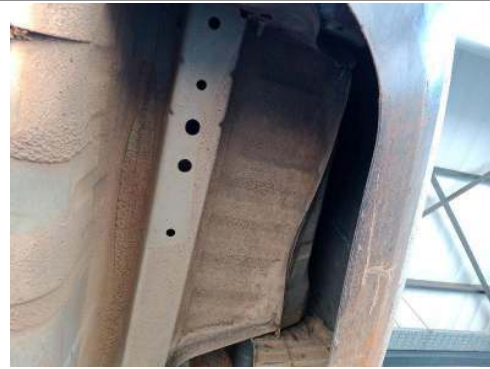
| Damage | Repair Way |
|---|---|
| Rear Fender Right / Inner Tray Damaged | Repair |

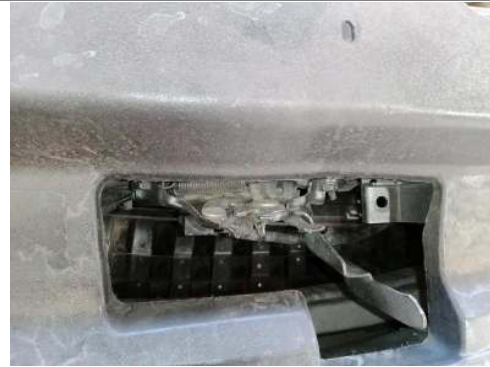
| Damage | Repair Way |
|---|---|
| Bonnet safety caps Damaged | Replace |
