CONDITION REPORT

Report No: 2016206512

MFC Auction House
M57 Pretoria Rd, Glenmarais, KEMPTON PARK
Gauteng

Vehicle Type	PASSENGER VEHICLE	Registered Owner	MFC
Manufacturer	NISSAN	Registration Number	HZ59XHGP
Model	QASHQAI	Register Number	
VIN	SJNFCAJ10Z2666252	Date Of First Licensing	
Engine Number		Last COR	
Doors	5	License Expiry Date	31/03/2024
Color	WHITE	Power / Displacement	
Year Model		Paint Finish	TWO COAT UNI
Km Reading	119,216 KM	Fuel	DIESEL
Cab / Body Type	HATCHBACK	Transmission	MANUAL

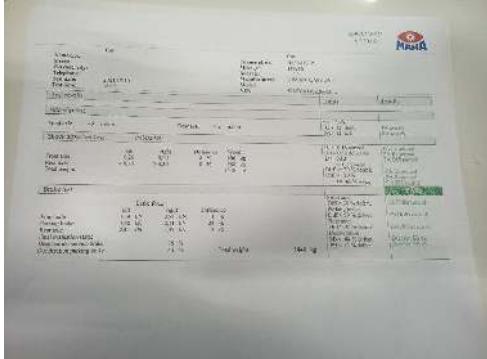
Brake test

Left	Right	Axle Weight [KG]	Deceleration [m/s ²]
	Braking Force [kN]	Braking Force [kN]		
Front	3.14	2.81	-	
Rear	2.44	2.37	-	
Emergency / Parking	1.6	2.11	-

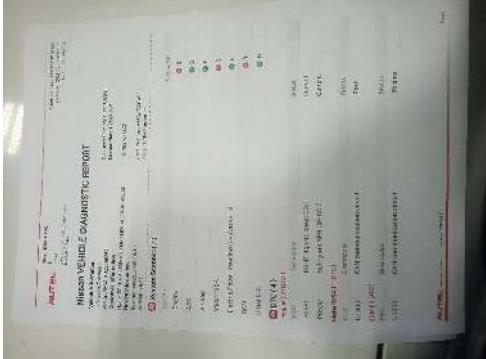
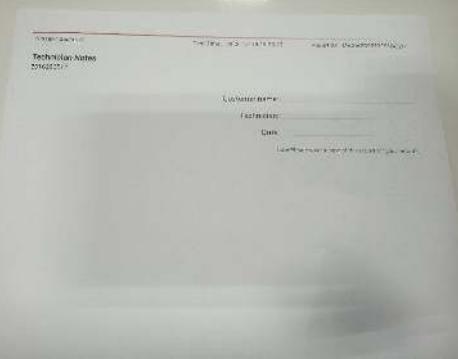
Diagnostic report

During the diagnostic no active error messages were detected. (See also attached Diagnostic Report. For more information regarding the Fault Codes (DTC) and the recommended rectifications please contact the workshops of the vehicle manufacture).

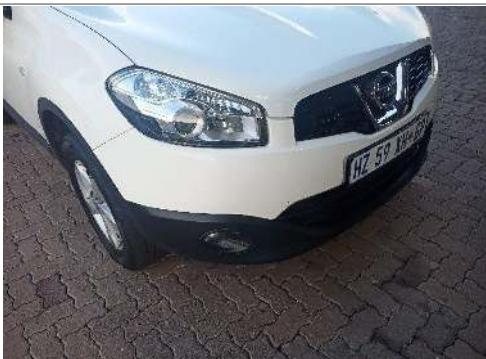
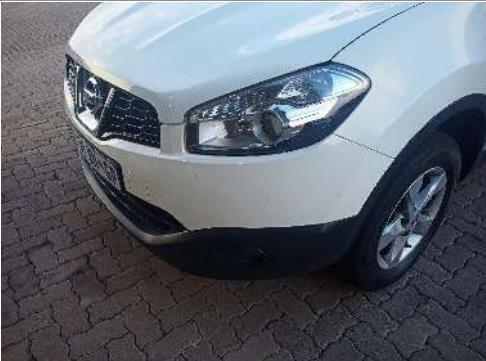
Damage	Repair Way
Seat Front Right Damaged	Repair
Front Bumper Damaged	Repair
Bonnet Damaged	Repair
Front Fender Left Damaged	Repair
Front Fender Right Damaged	Repair
Rear Fender Left Damaged	Repair
Rear Fender Right Damaged	Repair
Door Front Left Damaged	Repair
Door Rear Left Damaged	Repair
Rear bumper Damaged	Repair
Tyre Front Left Worn	Replace
Tyre Front Right Worn	Replace

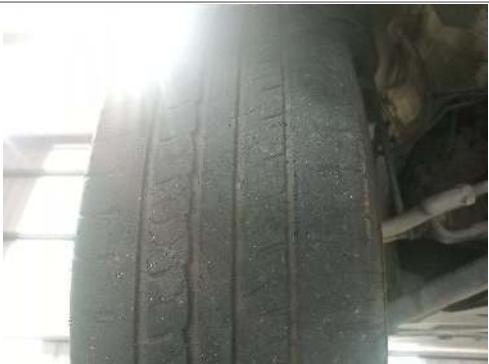
Tyre Front Left

Size	Load/Speed Index	Manufacture	Model	Type*	Production Date	Tread Depth (mm)
Front Left	215/65R16	98H	Powertrac	Radial	V	0117	0 mm
Front Right	215/65R16	98H	Powertrac	Radial	V	0217	0 mm
Rear Left	215/65R16	98H	Windforce	Radial	V	3918	2 mm
Rear Right	215/65R16	98H	Windforce	Radial	V	3918	2 mm
