## CONDITION REPORT

Report No: 2016867754

MFC Auction House  
M57 Pretoria Rd, Glenmarais, KEMPTON PARK  
Gauteng

| Model | QASHQAI 1.2T VISIA 5-DR [2014-2018] | Register Number | |

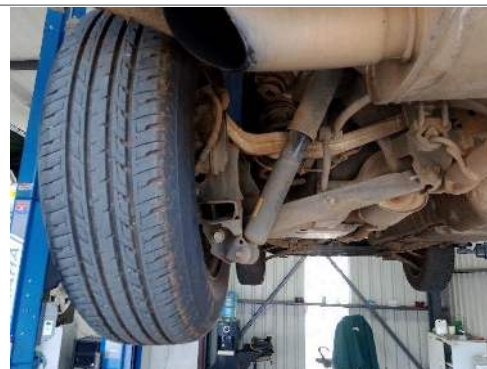
LR TYRE TREAD

| Damage | Repair Way |
|---|---|
| Rear tyres size differs | Replace |

| | Size | Load/Speed Index | Manufacture | Model | Type* | Production Date | Tread Depth (mm) |
|---|---|---|---|---|---|---|---|
| Rear Left | 205/65R16 | 95H | Firestone | Radial | V | 3116 | 2 mm |

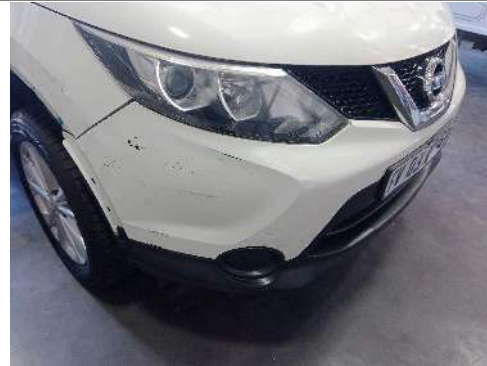
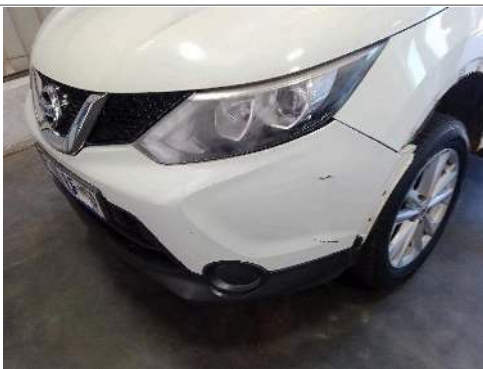
| Damage | Repair Way |
|---|---|
| Front Bumper Damaged | Repair |

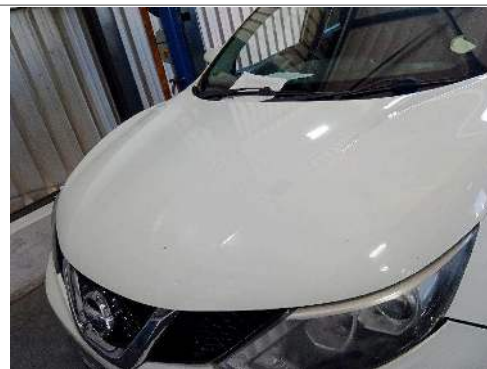
| Damage | Repair Way |
|---|---|
| Bonnet Damaged | Repair |

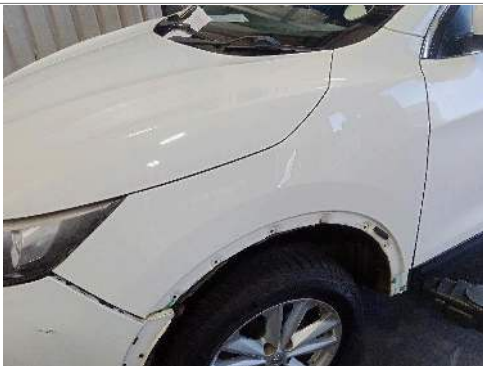
| Damage | Repair Way |
|---|---|
| Front Fender Left Damaged | Repair |

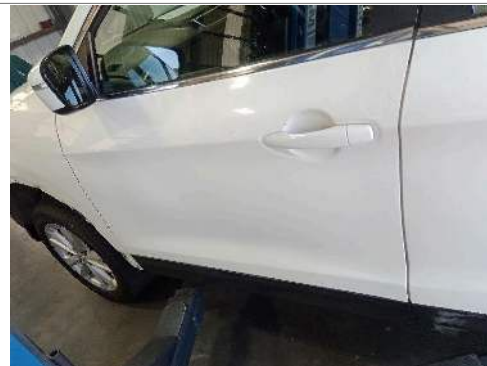
| Damage | Repair Way |
|---|---|
| Door Front Left Damaged | Repair |

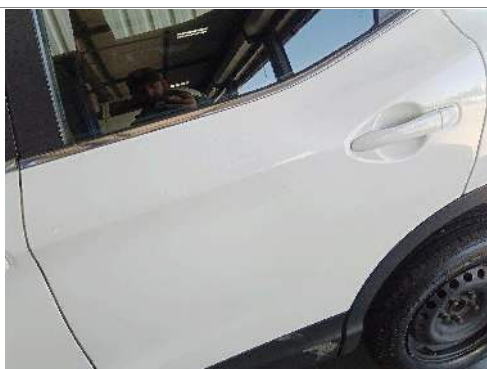
| Damage | Repair Way |
|---|---|
| Door Rear Left Damaged | Repair |

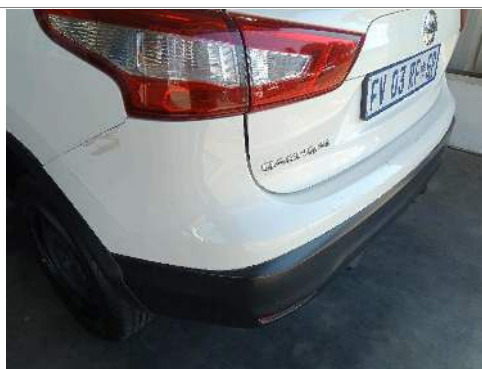
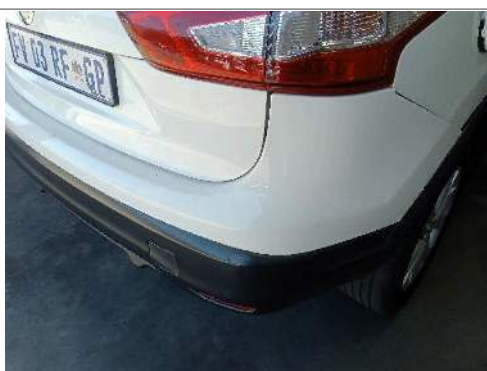
| Damage | Repair Way |
|---|---|
| Rear bumper Damaged | Repair |

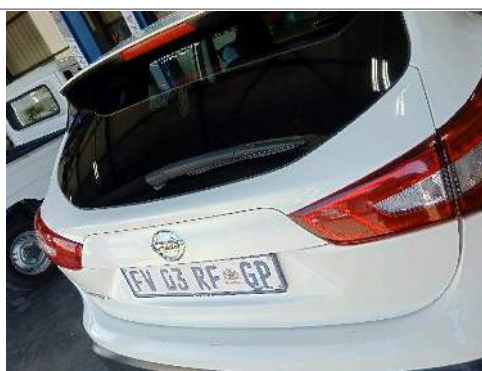
| Damage | Repair Way |
|---|---|
| Boot Lid / Hatch door Damaged | Repair |

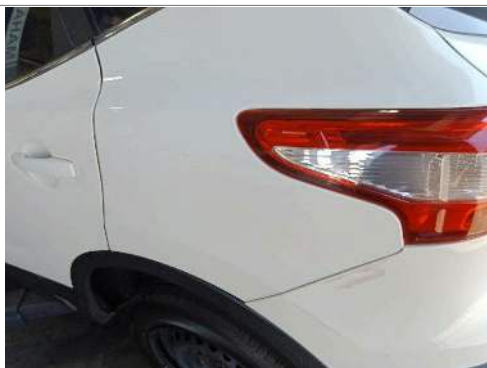
| Damage | Repair Way |
|---|---|
| Rear Fender Left Damaged | Repair |

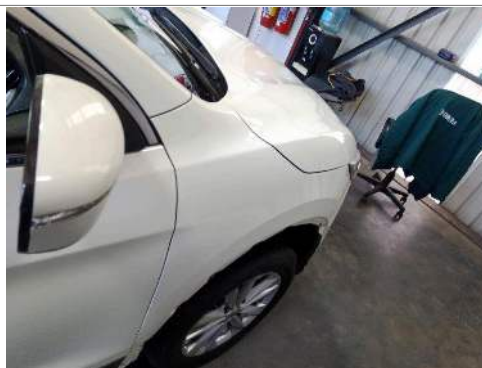
| Damage | Repair Way |
|---|---|
| Front Fender Right Damaged | Repair |

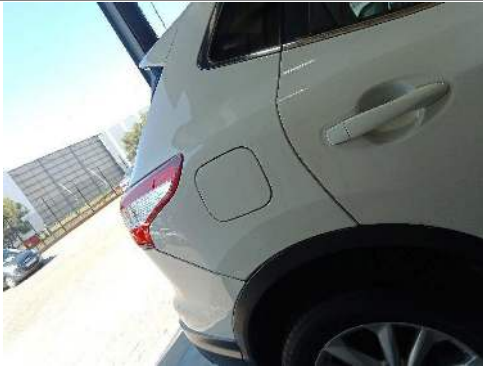
| Damage | Repair Way |
|---|---|
| Rear Fender Right Damaged | Repair |

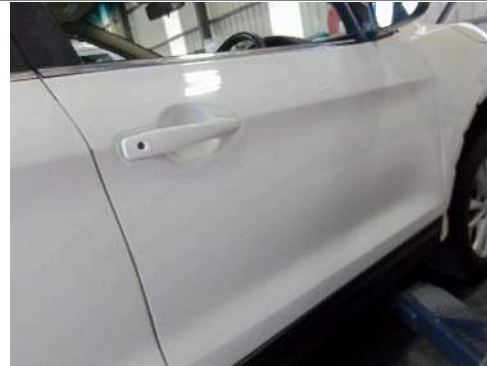
| Damage | Repair Way |
|---|---|
| Door Front Right Damaged | Repair |

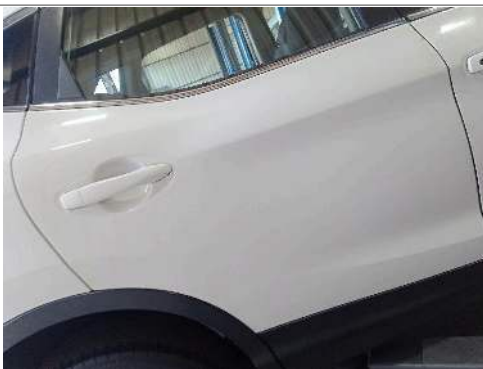
| Damage | Repair Way |
|---|---|
| Door Rear Right Damaged | Repair |

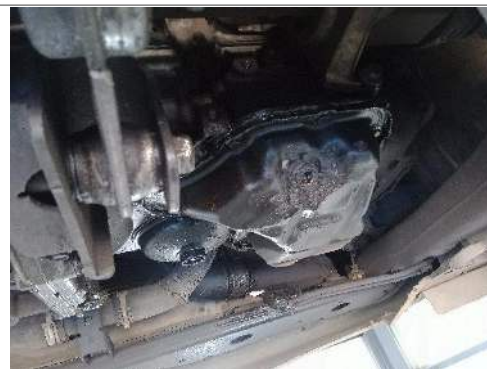
| Damage | Repair Way |
|---|---|
| Engine Oil Leak | Repair |

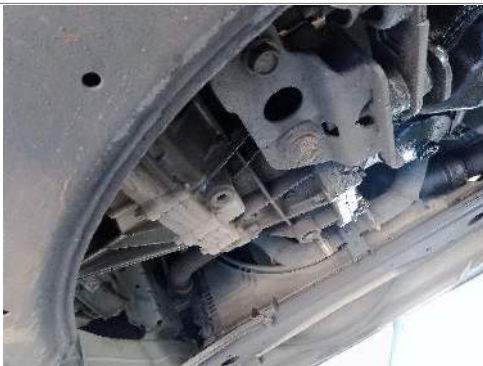
| Damage | Repair Way |
|---|---|
| Gearbox Oil Leak | Repair |

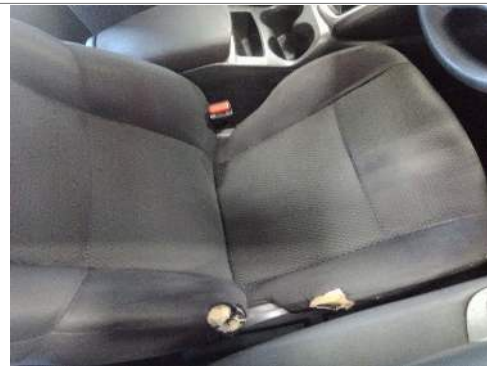
| Damage | Repair Way |
|---|---|
| Seat Front Right Damaged | Repair |

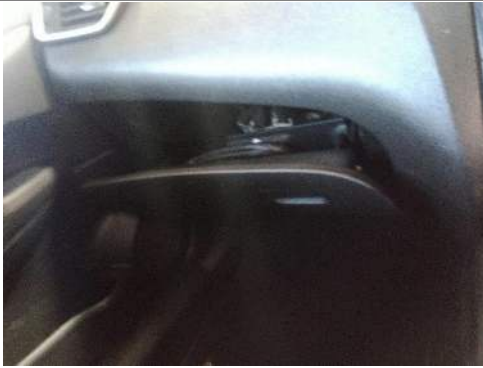
| Damage | Repair Way |
|---|---|
| Center Console / Cubbyhole + Lid Damaged | Repair |
