CONDITION REPORT

Report No: 2016221837

MFC Auction House
M57 Pretoria Rd, Glenmarais, KEMPTON PARK
Gauteng

Vehicle Type	PASSENGER VEHICLE	Registered Owner	MFC
Manufacturer	RENAULT	Registration Number	FRJ108L
Model	CLIO	Register Number	
VIN	VF15RSV0A61441020	Date Of First Licensing	
Engine Number		Last COR	
Doors	5	License Expiry Date	31/12/2023
Color	RED	Power / Displacement	
Year Model		Paint Finish	TWO COAT UNI
Km Reading	82,057 KM	Fuel	PETROL
Cab / Body Type	HATCHBACK	Transmission	MANUAL

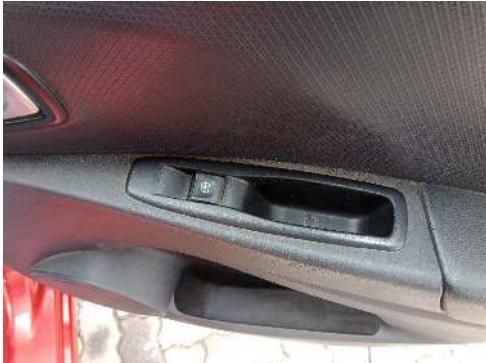
Damage	Repair Way
Engine Wiring Defective	Repair
Hoses Oil Sweat	Repair
Center Console / Cubbyhole + Lid Defective	Repair
Switch Electrical Window Winder front left Missing	Replace
Electrical Window Winder rear right Malfunction	Replace
Windscreen Wiper Damaged	Replace
Headlight Left Defective	Repair
Headlight Right Defective	Repair
Seat Front Left Dirty	Repair
Seat Front Right Damaged	Repair
Seat Rear Dirty	Repair
Hood Lining Dirty	Repair
Side Mirror Left Paintwork • Scratched	Repair
Front Bumper Damaged	Repair
Bonnet Dented	Repair
Front Fender Left Paintwork • Scratched	Repair
Rear Fender Left Damaged	Repair
Rear Fender Right Damaged	Repair
Door Front Left Damaged	Repair
Door Front Right Dented	Repair
Door Rear Left Damaged	Repair
Door Rear Right Paintwork • Scratched	Repair
Boot Lid / Hatch door Paintwork • Scratched	Repair
Rear bumper Paintwork • Scratched	Repair
Sill Panel Left Paintwork • Scratched	Repair
Sill Panel Right Paintwork • Scratched	Repair

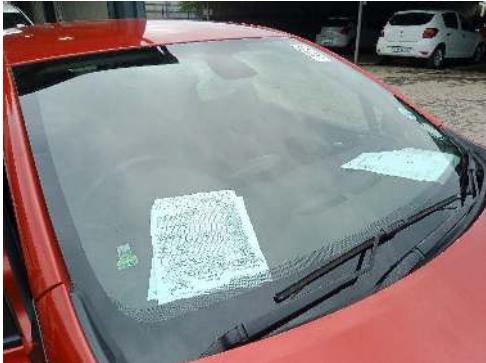
Damage	Repair Way
Windscreen Chipped	Repair
Service Brake Performance Rear Axle Left / Right Difference out of legal range	Repair
Parking Brake Performance Left / Right Difference out of legal range	Repair
Mounting Rubber(s) Rear Axle Left Cracked	Replace
Tyre Rear Right Defective	Replace
Spare Tyre Damaged	Replace
Rim Front Right Dented	Repair
Chassis Dented	Repair
Sub Frame Damaged	Replace
Belly plates Damaged	Replace
Radiator Cradle Dented	Repair
Warning lights illuminated on dashboard	Repair

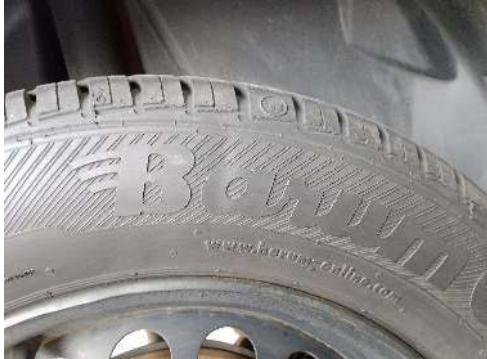
Tyre Rear Right

Size	Load/Speed Index	Manufacture	Model	Type*	Production Date	Tread Depth (mm)
Front Left	195/55 R16	91V	Autogrip	P308	V	4520	2 mm
Front Right	195/55 R16	87V	Linglong	Green-Max	V	0621	2 mm
Rear Left	195/55 R16	91V	Autogrip	P308	V	4520	3 mm
Rear Right	185/65 R15	88T	Barum	Brillantis	V	2918	7 mm
Spare	195/55 R16	87H	Continental	ContiEco	V	2618	0 mm

Road Test: Vehicle unsafe to drive due to rear right wheel binding.

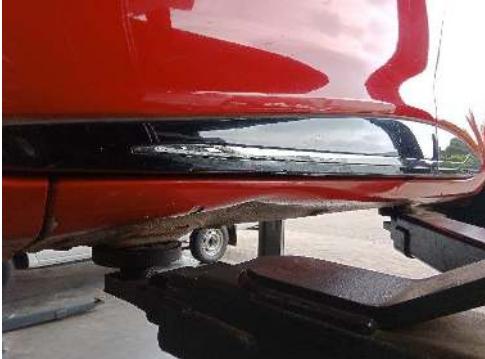
Rocker Panel Left Damaged	Repair
Rocker Panel Right Dented	Repair
Roof Dented	Repair
